CONTRACT REPORT

Road Safety Audit - Cambridge and Moorebank Avenues, Moorebank - Construction Traffic Accesses

Project No: PRS17114

date August 2017

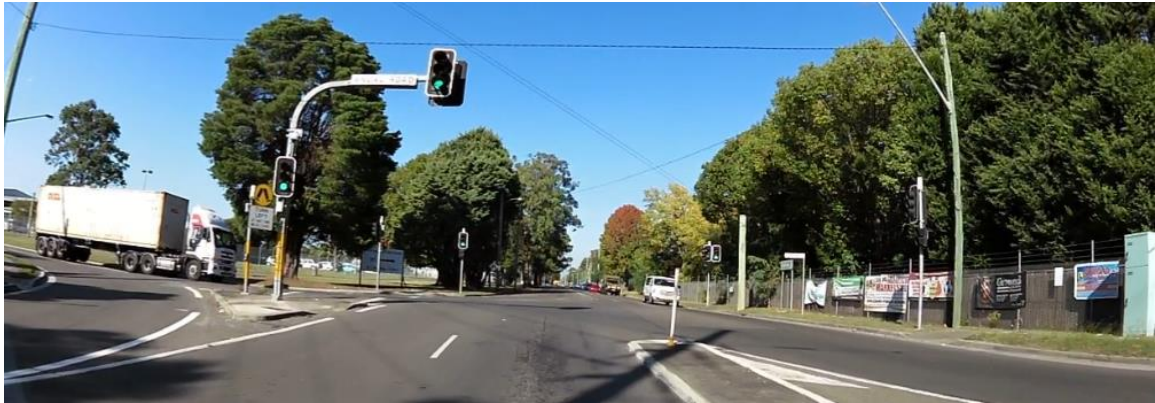
Issue no.	Site photo	Road safety issue	Risk rating	Suggested actions (Risk mitigation options)	Residual risk	Primary responsibility	Client response/action
Moorebank Avenue southbound commencing at M5 Motorway							
1	A	Missing stop lines at the signalised intersection with a pedestrian crossing. A vehicle may stop further into the path of crossing pedestrians and turning vehicles. Risk of collision with turning vehicles and crossing pedestrians.	Medium	Install Stop lines at traffic signals to indicate location for stopped traffic and pedestrian path	Low	Road asset manager	
2	B	Unprotected and non-delineated culvert may create a hazard for a vehicle moving outside the lane particularly in darkness.	High	<ol style="list-style-type: none"> 1. Adjust culvert to remove the impact hazard (e.g. convert to a side entry pit for example. 2. Delineate culvert by installing two delineator posts to indicate to drivers the location and extent of culvert. 	Very low Low	Road asset manager

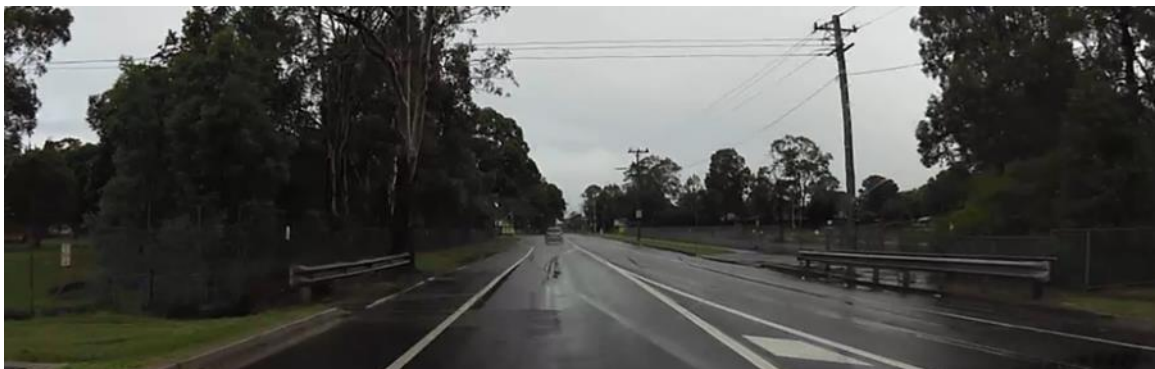
C

3	C, D	Non-conforming safety barrier terminal which may spear a vehicle in the event of a crash. Further, the barrier terminates at a non-frangible tree, directing an errant vehicle toward impact with this tree.	High	Install an approved (RMS compliant) road safety barrier terminal and consider removal of the tree or extending the safety barrier past tree.	Low	Road asset manager	
4A	E	Gate 7 is presently an uncontrolled entry/exit gate, which risks collisions with through traffic, and disruption of traffic along Moorefield Avenue.	High	Activate the existing traffic signals (No. 2646) at Gate 7 to permit all turning in/out of Gate 7.	Low	Road asset manager/SIMTA	
4B	E	Gate 7 : 'Do Not Queue Across Intersection' sign is old faded and inappropriately located, i.e. too low. It is a hazard that partly obstructs line of sight view to approaching traffic.	Medium	Remove sign, and if considered required, relocated to an alternate location.	Low	Road asset manager/SIMTA

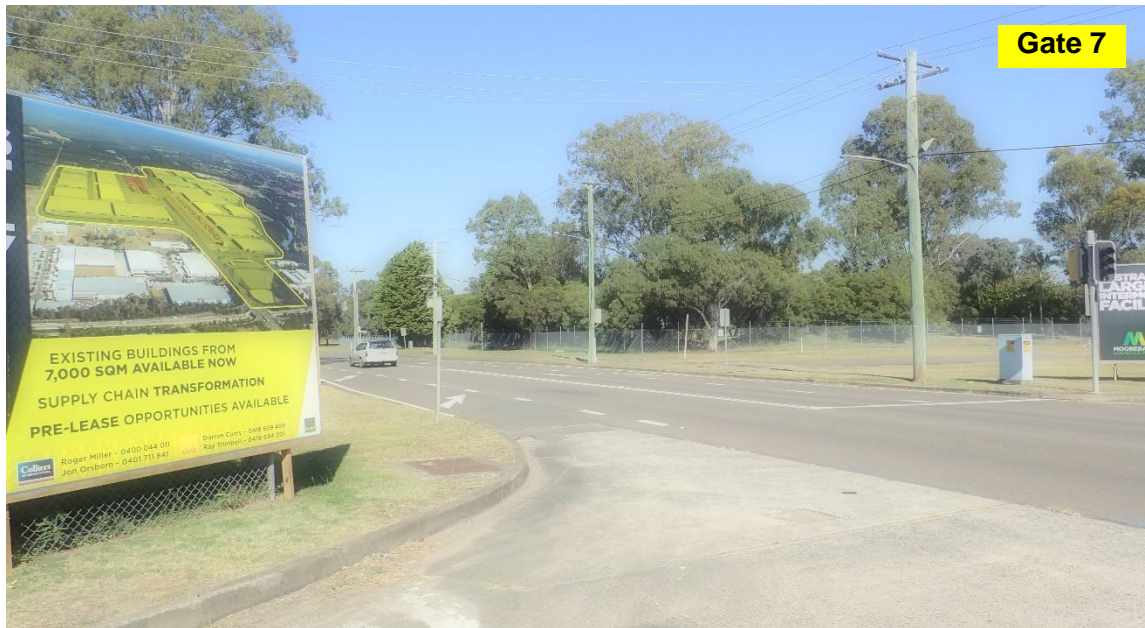
5	F	Gate 7 : A large project advertising sign is located too close to the intersection partly blocking line of sight for exiting traffic.	Medium	Remove Project sign to allow clear line of sight to the south.	Low	SIMTA

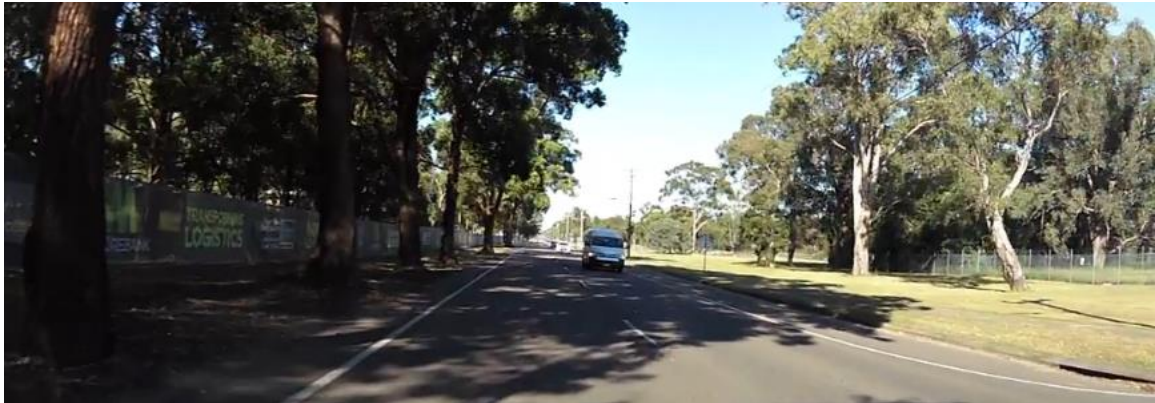
Issue no.	Site photo	Road safety issue	Risk rating	Suggested actions (Risk mitigation options)	Residual risk	Primary responsibility	Client response/action
6	G	The row of trees at this location is very close to the edgeline at approximately 1 m distance. These large trees are a roadside impact hazard and in the path of vehicles that may veer slightly off the edgeline, particularly in darkness.	High	It is preferable to remove these trees, or alternatively provide a suitable road safety barrier (offset may preclude this). However, if this is not possible then action is required to provide enhanced delineation and audit-tactile linemarking of the road edge and highlight the trees to allow them to be visible to drivers.	Medium Medium-high	Road asset manager	
7	H, I	Gate 8: Deteriorated pavement arrow markings on both the left turn lane and straight lane at the signalised intersection. This may cause confusion and result in a conflict between left turning and straight vehicles without clear direction for the correct lane manoeuvre.	Medium	Renew all pavement markings to ensure clear delineation and guidance for road users.	Low	Road asset manager

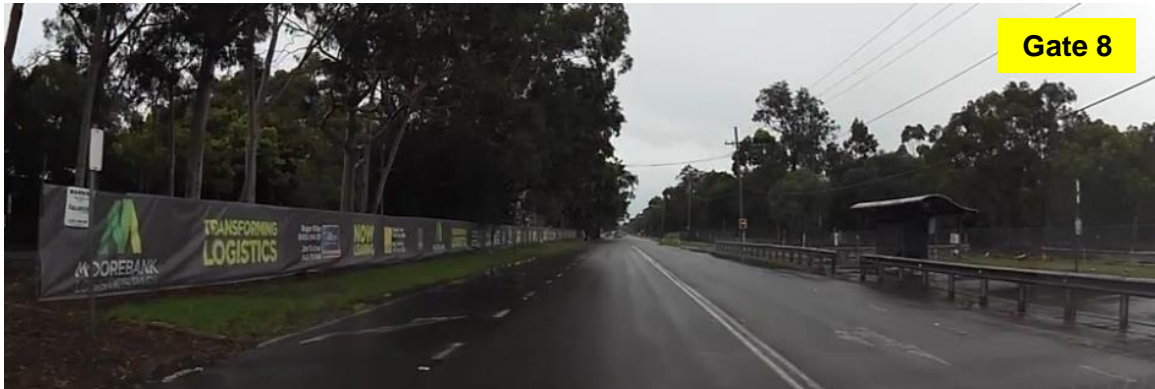
J

8	J, K	Gate 8: Deteriorated pavement markings for the merge lane south of the traffic signals, which may result in vehicles merging suddenly resulting in a crash with straight through traffic	Medium	Renew all pavement markings to ensure clear delineation and guidance for road users.	Low	Road asset manager	
9	L, M	Gate 2: Deteriorated pavement markings at the signalised intersection and turn into Chatham Ave (Gate 2). This may cause confusion and result in conflict between vehicles movements due to poor direction about correct lane manoeuvres.	Medium	Renew all pavement markings to ensure clear delineation and guidance approaching and at the intersection of Moorebank Ave and Chatham Ave (Gate 2).	Low	Road asset manager/SIMTA	
10	N	Gate 2: Heavy vehicles turning left into Gate 9A may hold up the traffic on the one through lane and could increase the risk of a rear end collisions.	Medium	Upgrade the shoulder area to provide a left turn lane to remove turning vehicles from the through traffic and protect the roadside area from deterioration.	Low	Road asset manager/SIMTA

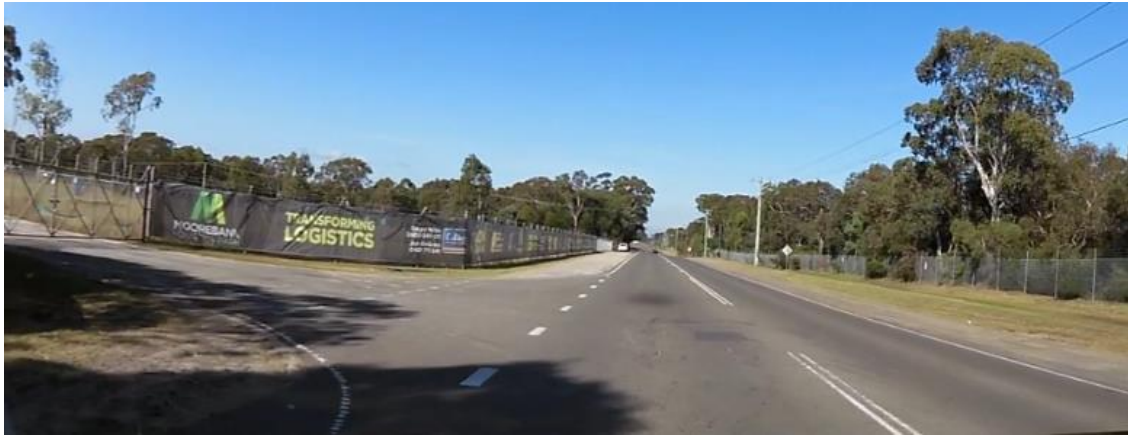
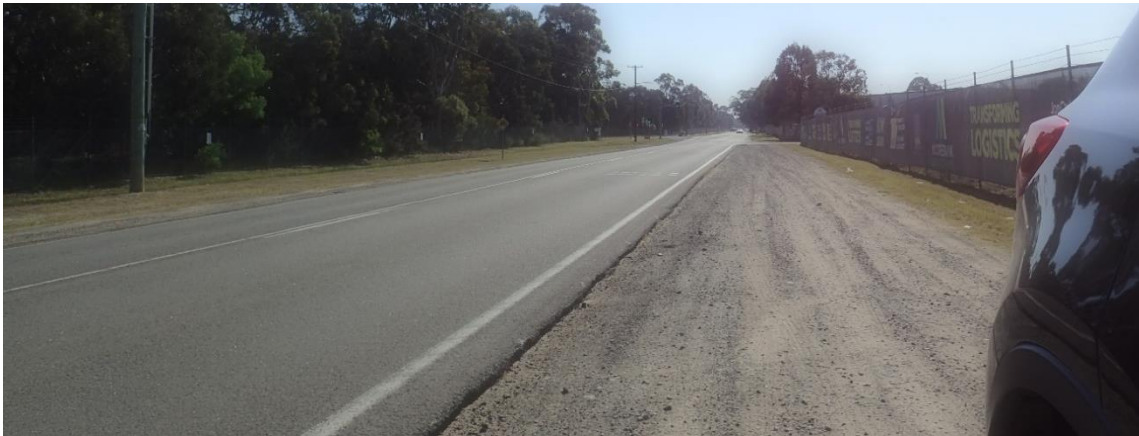
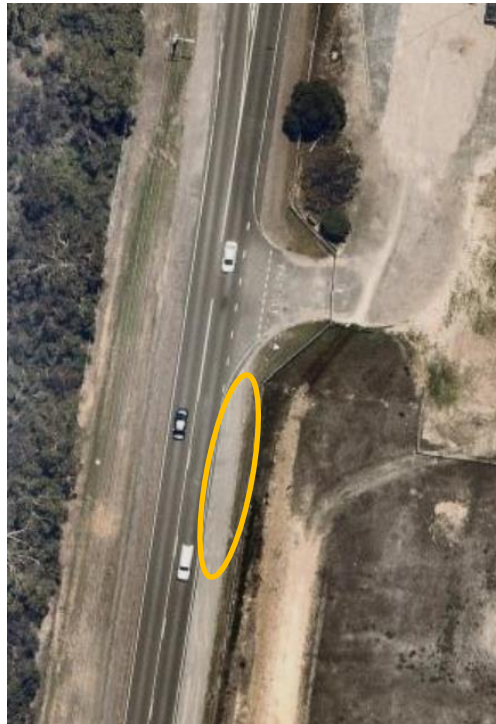
Photo
Id
0

Issue no.	Site photo	Road safety issue	Risk rating	Suggested actions (Risk mitigation options)	Residual risk	Primary responsibility	Client response/action
11	O	<p>Gate 9A, 9B: Heavy vehicles turning left out of Gate 9B will have a wheel path on the unsealed shoulder which also has a drop from the sealed carriageway. This manoeuvre will cause deterioration to the unsealed shoulder, the edge of seal and create unstable driving conditions for vehicles, particularly in wet conditions.</p>	Medium	<p>Upgrade shoulder area to provide sufficient turning path onto Moorebank Ave, and repair the edge drop at the sealed pavement shoulder interface.</p>	Low	Road asset manager/SIMTA	
12	P	<p>Gate 3 and 11: The traffic movements associated with the staggered T intersection (formed by proposed Gate 3 and Gate 11 with Moorebank Ave) may create traffic flow disruptions and the potential for rear end crashes on Moorebank Avenue.</p> <p><i>[Note: Advice from CPB Contractors is that right turn movements from Moorebank Ave into Gates 3 and 11 are not required for the proposed operations and therefore potential safety issues associated with these movements are not considered.]</i></p>	Medium	<p>Formalise the Gate 3 and Gate 11 intersections with Moorebank Ave by appropriately treating the road shoulder areas to provide for left turn movements (i.e. both from and into Moorebank Ave) for the largest regular vehicle using the location.</p> <p>Provide 'Truck Turning' warning signs (to AS1742 design) on the north and southbound approaches.</p>	Low	SIMTA

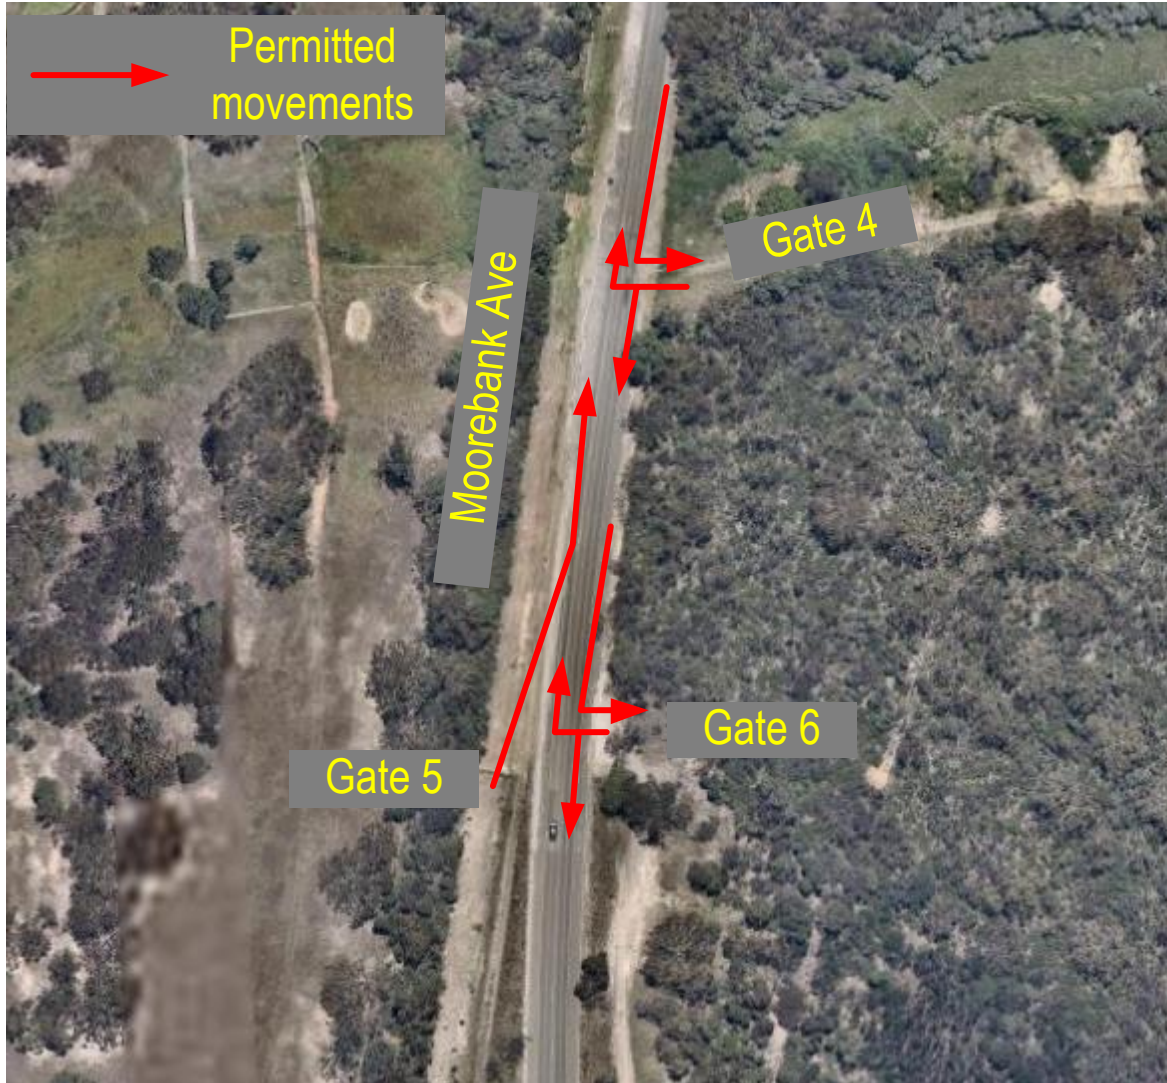
Photo
Id
Q

Issue no.	Site photo	Road safety issue	Risk rating	Suggested actions (Risk mitigation options)	Residual risk	Primary responsibility	Client response/action
13	Q	<p>Gate 4, 5, 6: Traffic movements associated with Gates 4, 5 and 6 may create traffic flow disruptions and potential rear-end and side-swipe crashes.</p> <p>Additionally, Gate 5 will run parallel with Moorebank Ave and potentially form an 'on-ramp merge' arrangement in close proximity to Gate 4.</p> <p><i>[Note: Advice from CPB Contractors is that right turn movements from Moorebank Ave into Gates 4, 5 and 6 are not required for the proposed operations and therefore potential safety issues associated with these movements are not considered.]</i></p>	Medium	<p>Formalise the Gate 4 and Gate 6 intersections with Moorebank Ave by appropriately treating the road shoulder areas to provide for left turn movements (i.e. both from and into Moorebank Ave) for the largest regular vehicle using the locations.</p> <p>Formalise Gate 5 by appropriately treating the road verge and shoulder areas to form a suitable merge lane onto Moorebank Ave (ensure due regard to the presence of the overhead powerlines).</p> <p>Provide 'Truck Turning' warning signs (to AS1742 design) on the north and southbound approaches.</p>	Low	SIMTA

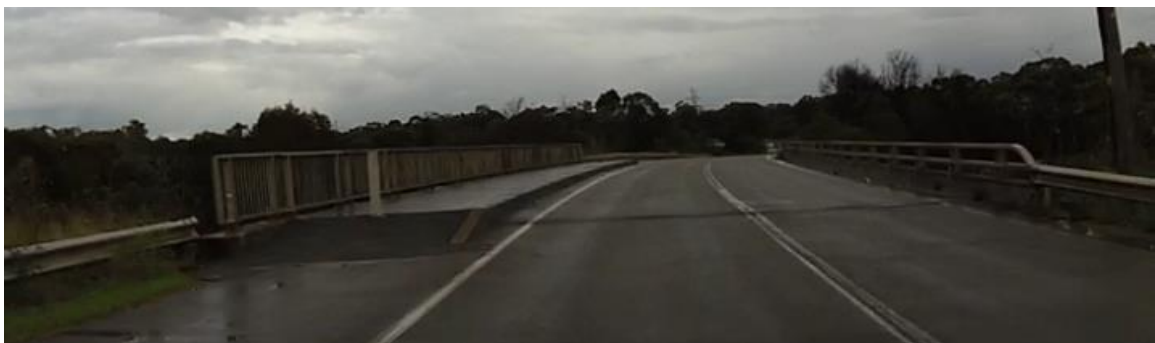
R

14	R, S	The ramped footpath at the bridge over the rail line combined with poor delineation may cause errant vehicles to launch off the bridge onto the rail line below.	High	<ul style="list-style-type: none"> ▪ Improve delineation of the road curve through renewed linemarking, RPMs and signage such as lateral shift markers. ▪ Replace the bridge fence with an appropriate safety barrier 	Low	Road asset manager	
Cambridge Ave Westbound							
15	T	Road flooding occurs at culvert creating a possible run off road crash.	Low	Improve drainage and delineation to reduce the likelihood of water ponding on the traffic lanes.	Nil	Road asset manager	
16	U, V	Incorrect sign used for warning of narrow bridge (causeway). Sign is located too far ahead of bridge location. This presents incorrect information of the road conditions ahead and the effectiveness of the warning signs is diminished.	Low	Replace incorrect 'Road Narrows' sign with (W4-1) 'Narrow Bridge' sign and install in accordance with AS 1742.2.	Nil	Road asset manager

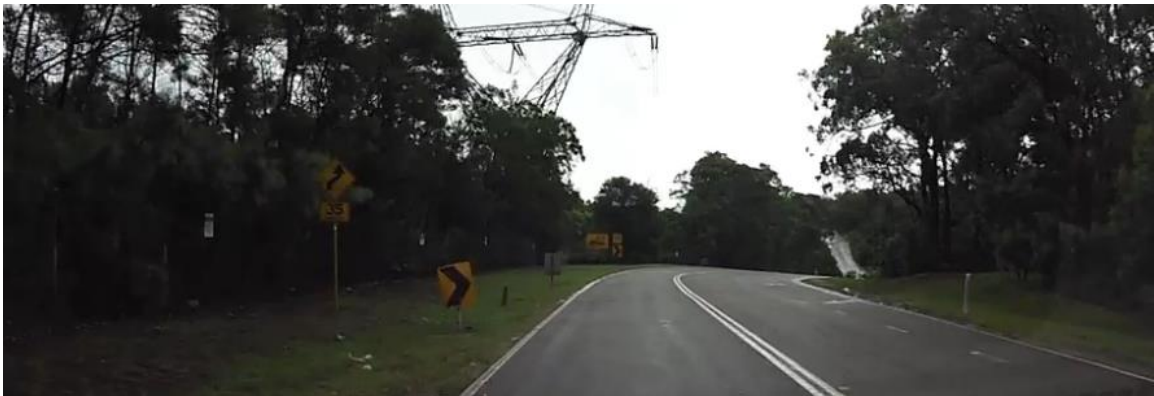
W

Issue no.	Site photo	Road safety issue	Risk rating	Suggested actions (Risk mitigation options)	Residual risk	Primary responsibility	Client response/action
17	W, X	Curve warning sign is hidden behind overgrown vegetation. Missing curve alignment marker (CAM), creating insufficient warning of curvature of road ahead and curve/bridge advisory speed.	Medium	To improve driver's awareness of the road curve, trim vegetation and replace missing CAM's in accordance with AS1742.2.	Low	Road asset manager	
18	Y, Z	'Narrow Causeway' sign is located too close to other warning signs, risking drivers missing the warning message. This sign is also located too far from the bridge/causeway.	Medium	To ensure drivers are provided adequate warning of the narrow bridge, relocate 'Narrow Causeway' sign closer to the causeway in accordance with AS1742.2.	Low	Road asset manager	
19	AA, AB	It is noted that light and heavy vehicles are currently permitted to use the narrow bridge/causeway. The following factors are considered to contribute to an increased risk of vehicle collisions on the bridge/causeway: <ul style="list-style-type: none"> ▪ Restricted line of sight (westbound) around curved road approach due to overgrown vegetation on the east riverbank ▪ Lack of effective delineation approaching and along the bridge. Missing left road width marker.	Medium	To improve a driver's awareness and approach to the narrow bridge: <ul style="list-style-type: none"> ▪ Trim and remove the excessive vegetation obstructing driver lines of sight ▪ Replace missing left road width markers Improve linemarking and reflector delineation on the approach and across the bridge.	Low	Road asset manager

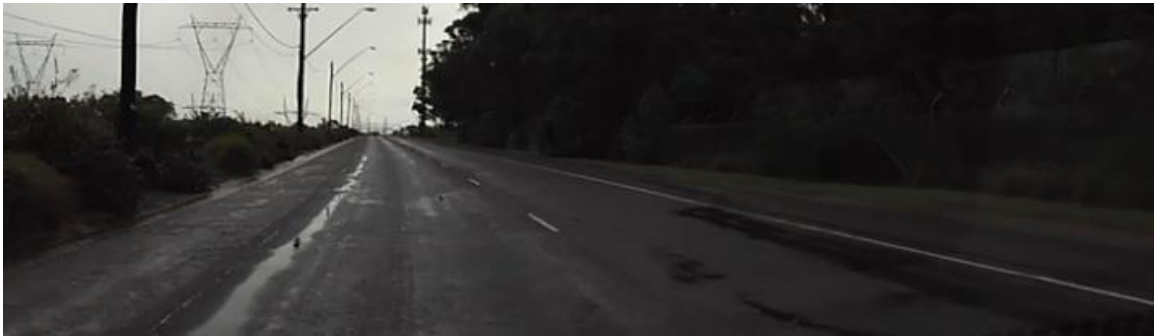
AC

20	AC, AD	Deteriorated linemarking creates inadequate delineation in darkness which may cause a driver to veer into the power poles located along the side of the road.	Medium	Remark road edge and centrelines and improve delineation with the use of raised pavement markers.	Low	Road asset manager	
21	AE, AF	Damaged guardrail has reduced capacity to protect the structure behind from an errant vehicle crash	High	Repair damaged guardrail sections.	Low	Road asset manager

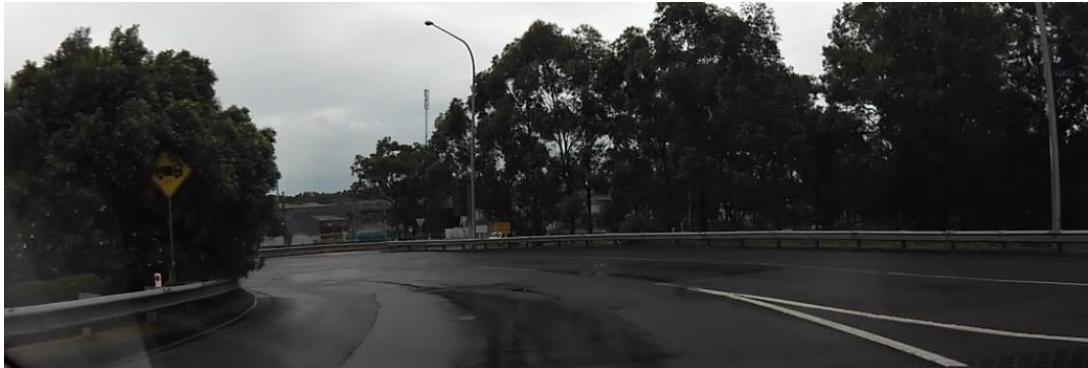
AG

Issue no.	Site photo	Road safety issue	Risk rating	Suggested actions (Risk mitigation options)	Residual risk	Primary responsibility	Client response/action
22	AG, AH	Missing linemarking on roundabout exit creates confusion for drivers as to the correct lane and may cause sideswipe crashes. Truck sign is hidden behind vegetation and vehicles miss the warning of presence of trucks.	Medium	Repaint correct lane linemarking and trim vegetation to improve sign visibility.	Low	Road asset manager/SIMTA	
Cambridge Ave Eastbound							
23	AI, AJ, AK, AL, AM, AN	Gate 1: Damaged guardrail has reduced capacity to protect the structure behind from a heavy vehicle crash.	High	Repair damaged guardrail sections.	Low	Road asset manager	
24	AO, AP	Overgrown vegetation covering guardrail at the start of a merge reduces the effectiveness of the delineation of the barrier end and may cause a vehicle to crash into the hidden guardrail. Incorrect sign used for warning of narrow bridge. Sign is located too far ahead of location and presents incorrect information of road ahead. The warning sign installed too far ahead are not effective in warning of hazard ahead.	Low	Remove vegetation to allow guardrail to be visible. Replace incorrect 'Road narrows' sign with (W4-1) 'Narrow bridge' sign and install in accordance with AS 1742.2.	Nil	Road asset manager

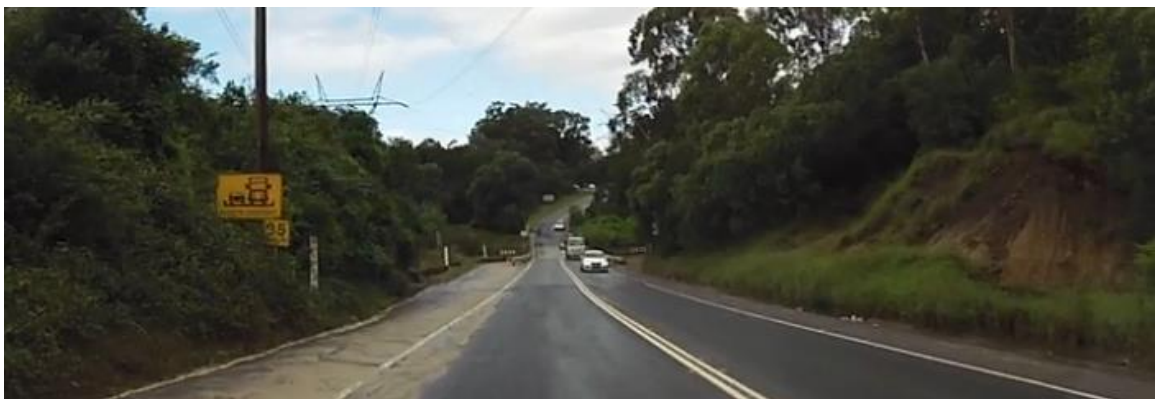
AQ

25	AQ, AR	'Narrow Causeway' sign and speed advisory sign are hidden behind vegetation. 'Narrow causeway' sign is located too far from the causeway. Drivers may not see the signs hidden not at the correct location.	Medium	Trim vegetation and relocate 'Narrow Causeway' sign closer to the bridge/causeway in accordance with AS1742.2.	Low	Road asset manager	
26	AS, AT	Lateral shift markers are incorrectly used at this location. Vehicles travelling in the shoulder in darkness may think they can turn right which may cause a crash into the back of the guardrail.	Medium	Replace lateral shift marker signs with road narrow width marker signs.	Low	Road asset manager

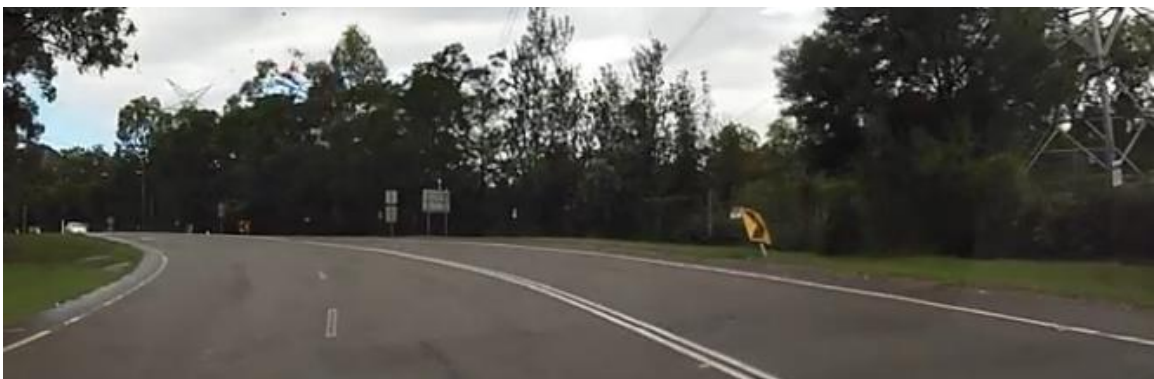
AU

Issue no.	Site photo	Road safety issue	Risk rating	Suggested actions (Risk mitigation options)	Residual risk	Primary responsibility	Client response/action
27	AU, AV	Rotated CAM and missing CAM removes proper delineation of curve and in darkness may cause a vehicle to veer to the other side of the road by going straight on the curve.	Medium	Correct rotation of existing CAM and install missing CAMs in accordance with AS1742.2.	Low	Road asset manager	
Moorebank Ave Northbound							
28	Q	Gate 4, 5, 6: Refer to Issue 13					
29	P	Gate 3, 11: Refer to Issue 12					
30	AW	Gate 2: Major stormwater ponding adjacent the kerb and drainage swale on approach to Chatham Avenue potentially creates an unsafe vehicle turning path with the possibility of loss of control (aquaplaning) and impact with traffic signals or other vehicles. Drivers may choose to turn from the right side of the lane to avoid flooding, which may further risk a crash into another oncoming vehicle.	Medium	Improve drainage at intersection to remove flood hazard.	Low	Road asset manager/SIMTA

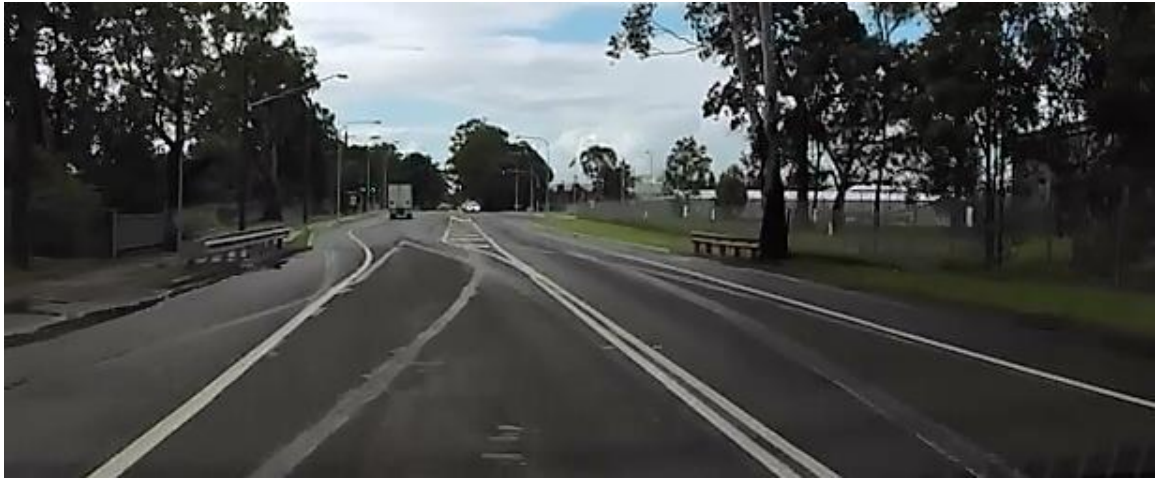
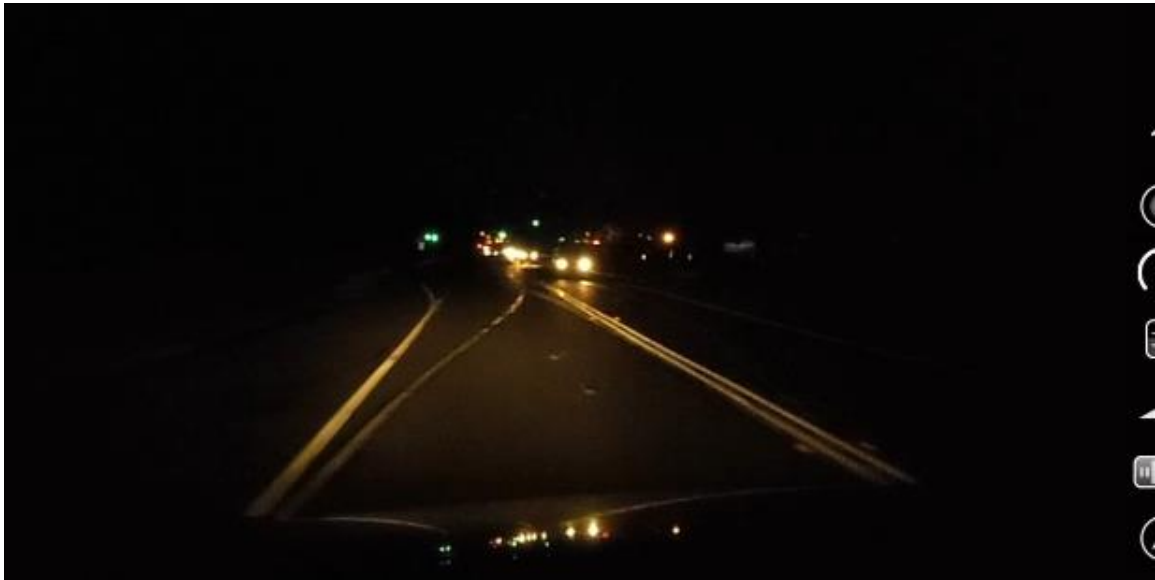
Photo
Id
AX

31	AX, AY	Old linemarking creates confusion as to the correct line to follow particularly at night. This increases the risk of a crash with adjacent or oncoming traffic.	Medium	Ensure old linemarking is better removed/obscured and remark existing linemarking to better differentiate old vs new and provide drivers with improved guidance.	Low	Road asset manager	
32	AZ	Deteriorated pavement marking and stop line at signalised intersection may cause confusion as to the correct movement from each lane and increase the risk of side swipe crashes.	Medium	Renew Stop lines and correct lane linemarking.	Low	Road asset manager

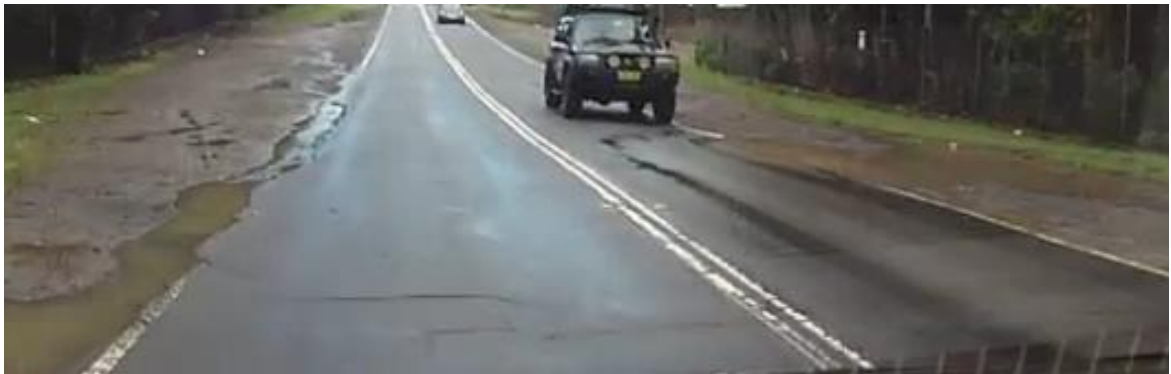
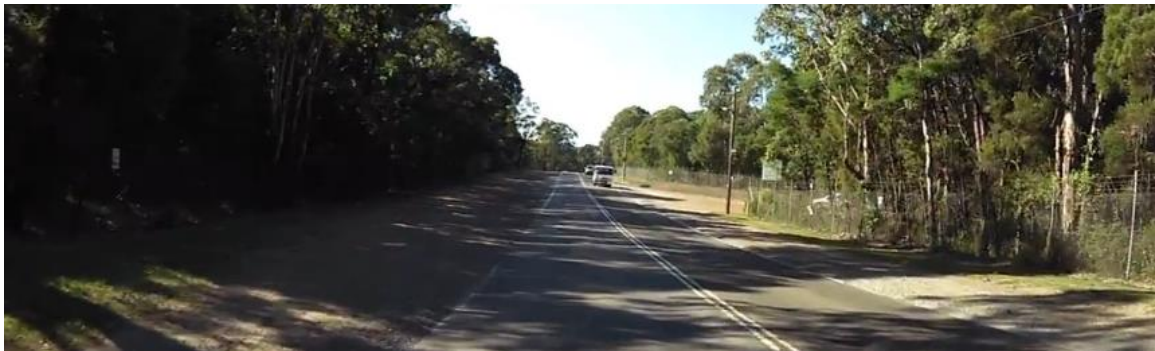
Issue no.	Site photo	Road safety issue	Risk rating	Suggested actions (Risk mitigation options)	Residual risk	Primary responsibility	Client response/action
General Issues - present along the length of each road at numerous locations							
33	BA	Sections of faded, non-reflective linemarking and missing linemarking are present along the length of Moorebank Ave and Cambridge Ave. This creates poor delineation and guidance which increases the risk of drivers to veering off the road or into the path of oncoming vehicles particularly when in the wet and dark conditions.	Medium	Repaint linemarking in reflective white paint.	Low	Road asset manager	
34	BB	Unsealed shoulders combined with narrow carriageway have created a drop off edge along sections of the audited road. This increases the risk for run off road type crashes due to the combined conditions of the drop off and the unstable conditions on the shoulders, particularly in wet conditions.	Medium	Construct and seal shoulders and re-stabilise the unsealed shoulders. Repair edge of road seal and ensure edge linemarking is provided along the length of the road to ensure adequate delineation.	Low	Road asset manager
