Moorebank Precinct East – Stage 2 WSUD Independent Audit

Report Prepared for:
Department of Planning &
Infrastructure and Environment

September, 2023
Project No. 255

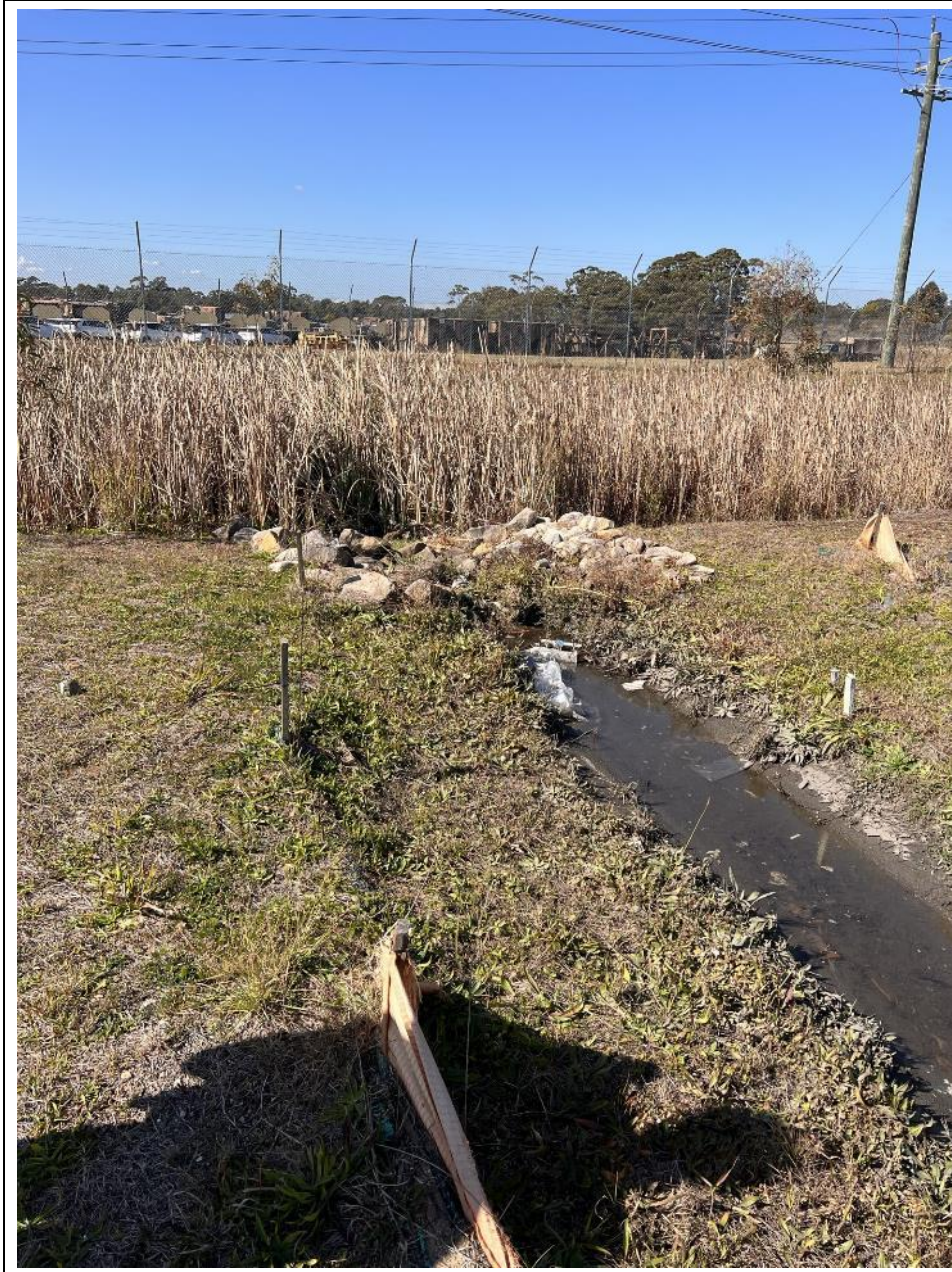
Photo	Description
  A photograph of a bioretention basin (OSD 1) showing improved plant growth throughout the basin, with denuded batters. The basin is a long, narrow, shallow depression filled with dry, brown grasses. The batters (slopes) are mostly bare and light-colored. In the background, there are several large, white industrial buildings and a clear blue sky.	<p>OSD 1 bioretention basin showing much improved plant growth throughout whole basin, denuded batters</p>

- 1) Vegetate the batters with a mix of small shrubs and drought tolerant plants such as Lomandra. This will help to shade the bioretention system through summer as well as suppress weeds. It is preferable to have a well-established vegetative cover rather than continuously spraying the basin batters with glyphosate which is toxic to macroinvertebrates and aquatic fauna and which will ultimately impact on water quality.

- 2) At very low cost, LOGOS would be able to place a small weir inside the OSD 1 outlet pit. This would raise the water level in the bioretention basin by nominally 200mm. This would aid in plant survival during extreme summer heat and drought. Given there has been good investment in getting the vegetation to achieve good coverage, this low cost action would then protect the investment in vegetation in the basin.

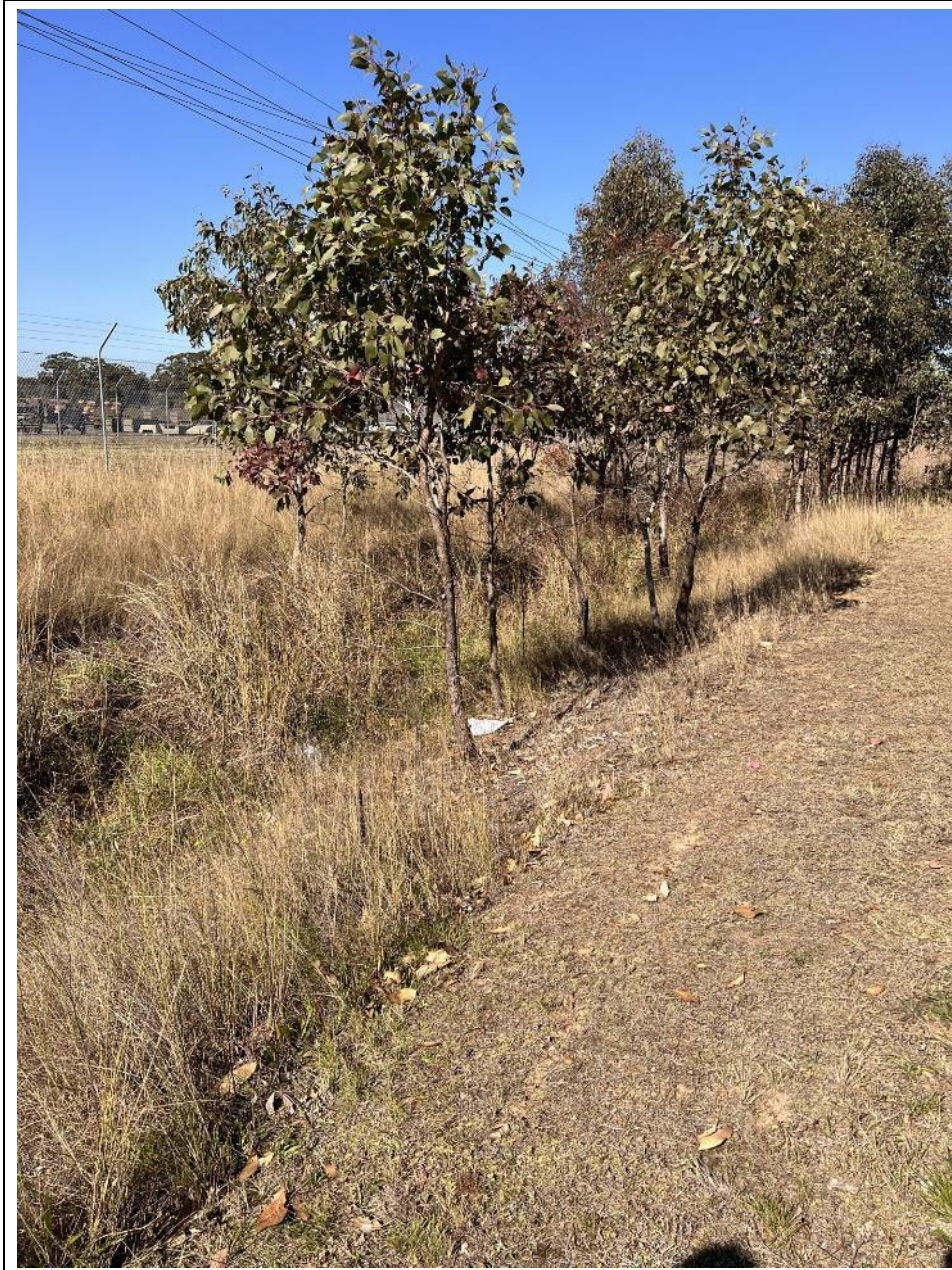
Photo showing some litter present prior to discharge into Swale 1. This is from an untreated part of the existing development which is yet to be developed.

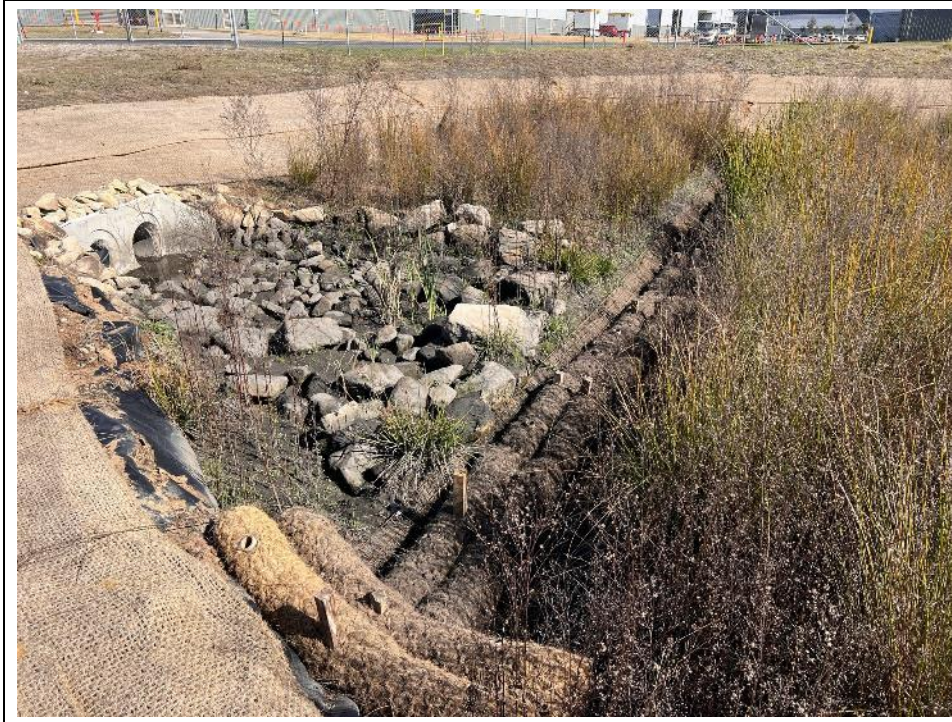
Swale adjacent to the OSD 1 in good condition – following maintenance and removal of weeds. Typha is healthy and frogs were present in the swale.
