MOOREBANK LOGISTICS PARK

Moorebank Precinct East: Six-Monthly Operations Compliance Report

Report: #5

Period: May 2022 - November 2022

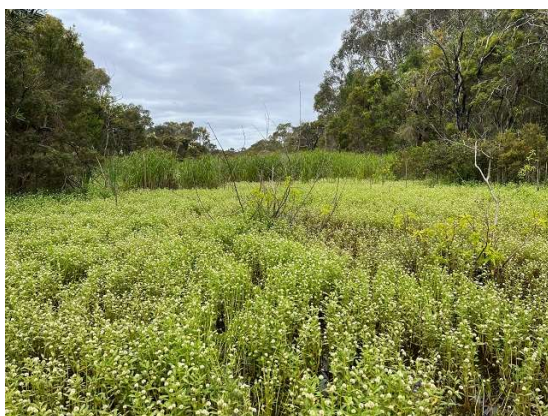
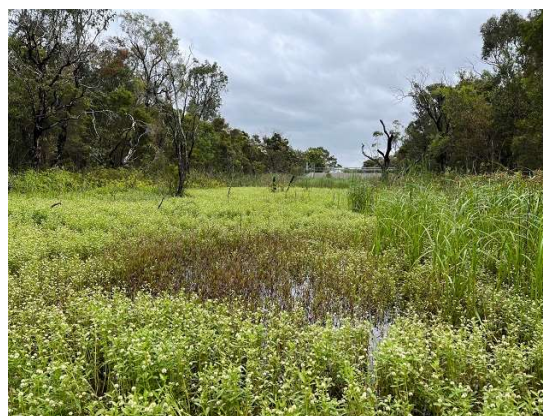
At the time of the spring 2022 surveys, the stream channel at Site AQ1 was mostly colonised by the noxious plant, Alligator Weed (*Alternanthera philoxeroides*), and the native species, Slender knotweed (*Persicaria decipiens*) (Plates 1&2). Other species of aquatic plant observed at Site AQ1 included Marsh Club-rush (*Bolboschoenus fluviatilis*) and Typha (*Typha* sp.). The tree canopy was mostly comprised by *Melaleuca* spp. and *Eucalyptus* spp. (Plates 1&2). *Myriophyllum variifolium* Hook.f., a species of water milfoil native to eastern Australia, was found growing in shallow water near the stream bank.

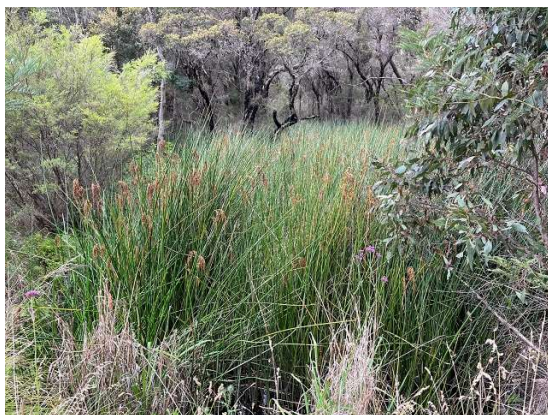
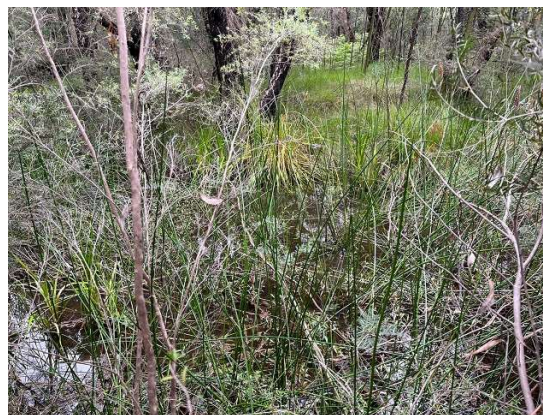
Since the baseline survey, stands of the emergent macrophyte, Jointed Twig Rush (*Baumea articulata*) and Twig Rush (*Baumea rubiginosa*) have formed across the downstream reaches of stream channel (Plate 4). Jointed Twig Rush, Slender Knotweed and Frog's Mouth (*Philydrum lanuginosum*) continue to be common in the upstream reaches (Plate 4).

The active channel zone, composed of fine sediments, was up to approximately 4 m wide (Plates 3&4). No indicators of significant erosion were observed suggesting that Anzac Creek continues to be relatively stable at this site, particularly since colonisation of the stream channel by emergent macrophytes (Plate 3&4, Appendix 2).

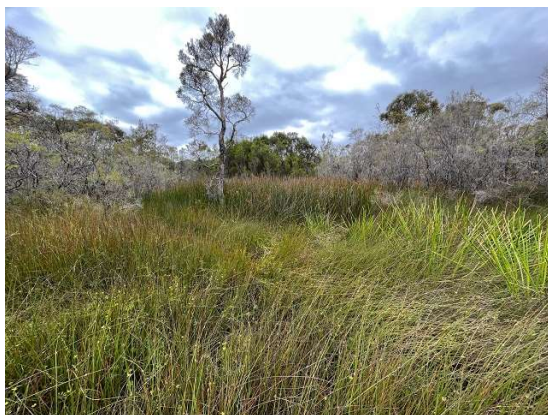
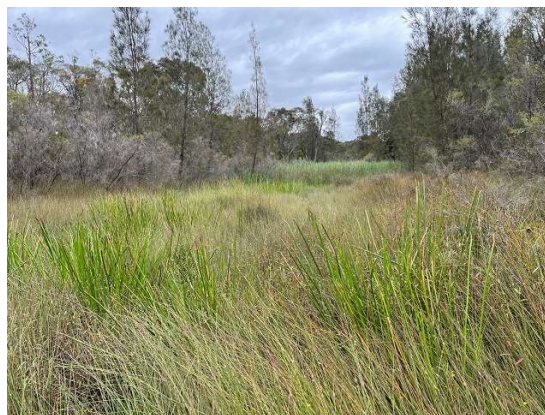
Similar to previous surveys, the study reach was mostly colonised by Heron Bristle Sedge (*Chorizandra cymbaria*), Jointed Twig Rush and Tall Spikerush (*Eleocharis sphacelata*), with occasional Frogmouth (*Philydrum lanuginosum*), Slender Knotweed and the introduced species, Umbrella Sedge (*Cyperus eragrostis*), present throughout (Plates 5&6). Riparian vegetation was dominated by *Casuarina* trees. Common Reed/Phragmites (*Phragmites australis*) was present at the downstream end of the site (Plate 6).

The stream channel at Site AQ8 (up to approximately 20 m wide) continues to be classified as stable, mostly due to dense cover by emergent macrophytes in addition to a relatively intact, woody riparian zone (Appendix 2).

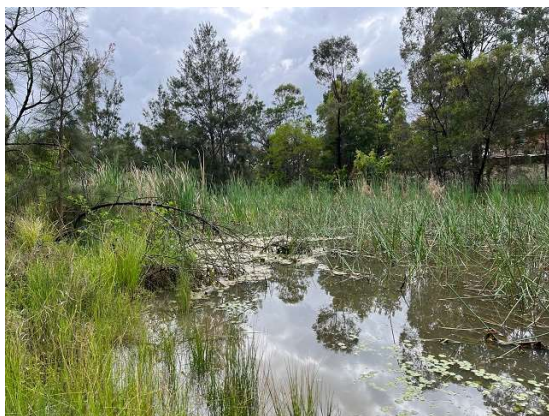
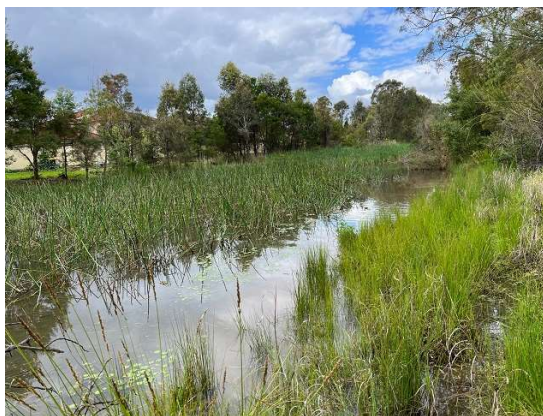
The submerged macrophyte species, Ribbonweed (*Vallisneria* sp.) and *Potamogeton ochreatus* were common, in addition to Slender Knotweed and dense stands of Typha, Phragmites and Tall Spike Rush (Plate 7). *Nymphoides geminata* (Entire Marshwort), with mostly floating leaves and accumulations of green filamentous algae were abundant in areas close to the shore (Plates 7&8). Also noted during spring 2022 was the native perennial, *Utricularia* sp., that floats submerged. *Egeria* (*Egeria densa*), which was collected close to the left-bank (facing downstream) of the pool in spring 2020, has not been collected subsequently.

Riparian vegetation included Casuarina, Eucalyptus and Melaleuca trees and Spiny-head Mat-rush/Basket Grass (*Lomdandra longifolia*) (Plates 7&8).

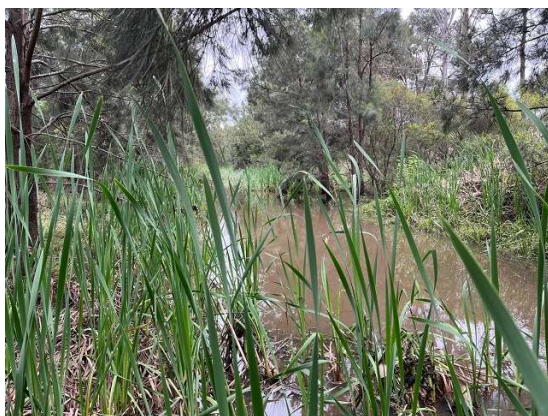
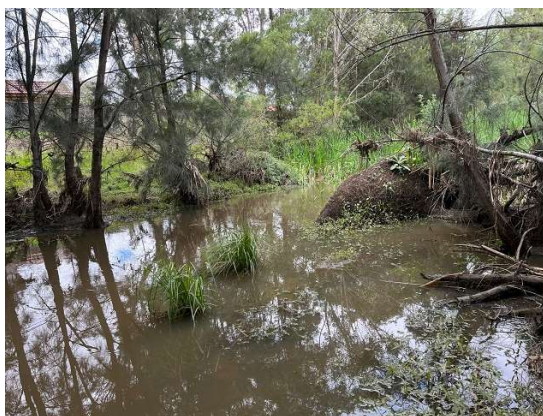
Site AQ13 is situated approximately 200 m downstream of Site AQ12 (**Error! Reference source not found.**). This site is located approximately 150 m downstream from an overflow channel that enters the creek from Wattle Grove. Water to a depth of approximately 0.4 m was present at Site AQ13 at the time of Survey 2, and flow was apparent (Plates 9&10). Unlike the findings of surveys done prior to autumn 2022, there was no apparent iron floc or anoxic layer covering the stream substratum. A large proportion of the stream channel and edges were colonised by Typha and Slender Knotweed. River Clubrush (*Schoenoplectus validus*) was also common. The stream channel appeared stable (Appendix 2).

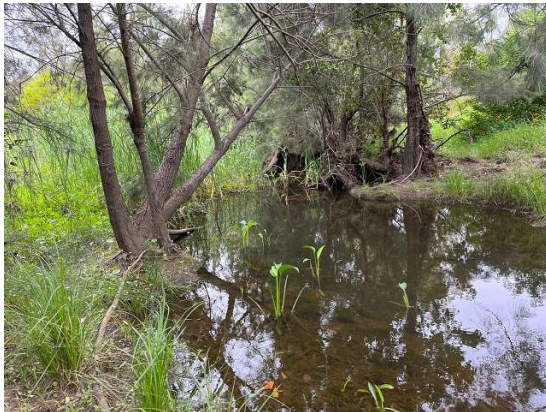
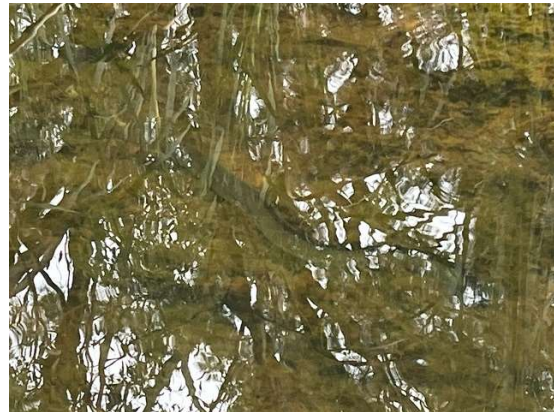
Site AQ14 is situated approximately 150 m downstream of Site AQ13 and immediately downstream of the culvert that links the dam within Commonwealth Department of Defence Lands to Anzac Creek (Figure 1). Flow was apparent at the time of both spring 2022 surveys and water clarity was good (Plates 11&12).

Typha, Slender Knotweed, River Clubrush and Whorled Pennywort/Shield Pennywort were common (Plates 11&12). This section of Anzac Creek remains mostly stable due to dense instream vegetation and vegetated banks (Appendix 2). Water visibility was good at the time of Survey 2 (Plates 11&12).
