FWD Testing Results for Intermodal Terminal

Project No: PSS16279

for CPB Contractors Pty Ltd

FWD TESTING RESULTS FOR INTERMODAL TERMINAL

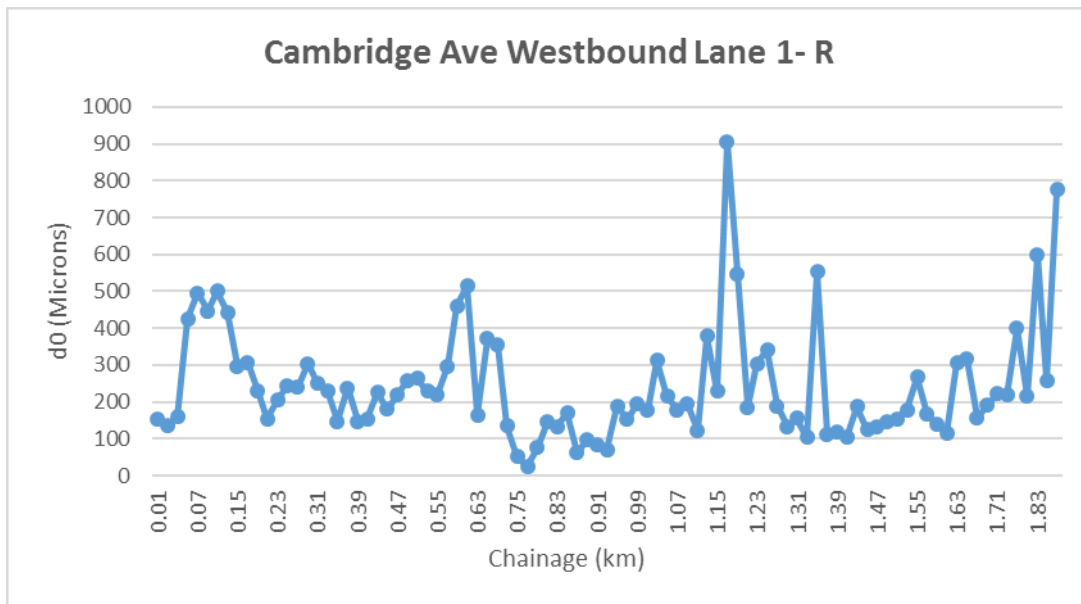
Figure 3.6: Deflection (d0) for Cambridge Avenue Westbound Lane 1 right wheel path

Glenfield Road westbound lane 1 left wheel at 1.6km is found with over 1000 microns deflection, which might indicate potential weak pavement structure. Road sections with close to 1000 microns deflection points include 1.6km of Glenfield Road westbound lane 1 right wheel path and Cambridge Avenue westbound lane 1 right lane.

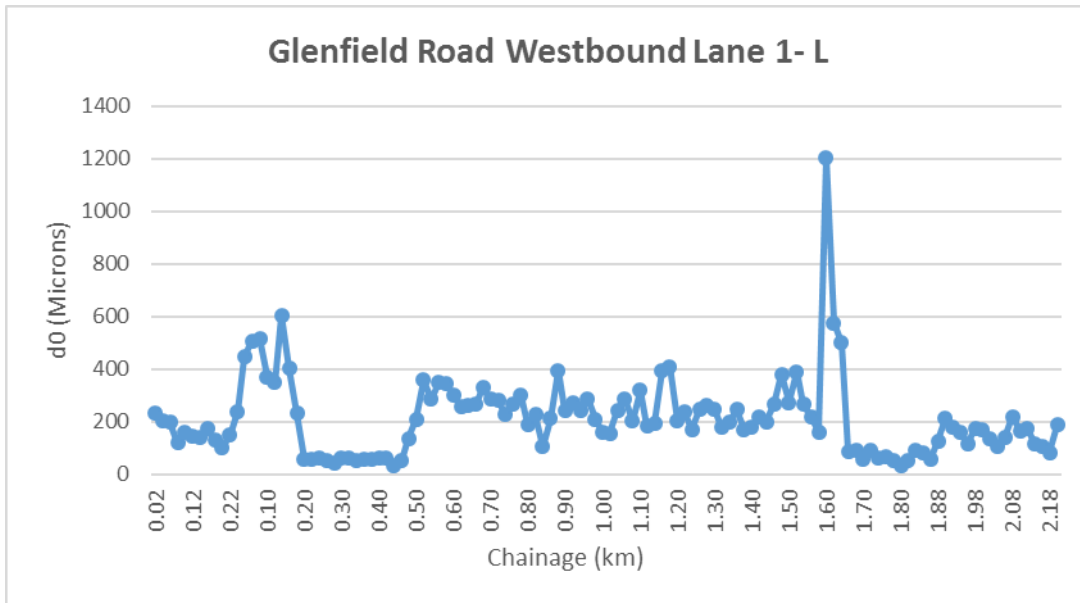
Figure 3.31: Deflection (d0) for Glenfield Road Westbound Lane 1 left wheel path

- Glenfield Road at 1.6km westbound lane 1 left wheel is found with over 1000 microns deflection, which might indicate potential weak pavement structure.
- All other sections are at good deflection state.
