**MOOREBANK PRECINCT EAST STAGE 1
RALP No 1**

PRE-CONSTRUCTION DILAPIDATION REPORT

MOOREBANK AVENUE GLENFIELD

FOR
CPB CONTRACTORS PTY LTD
Level 2 – 177 Pacific Highway North Sydney

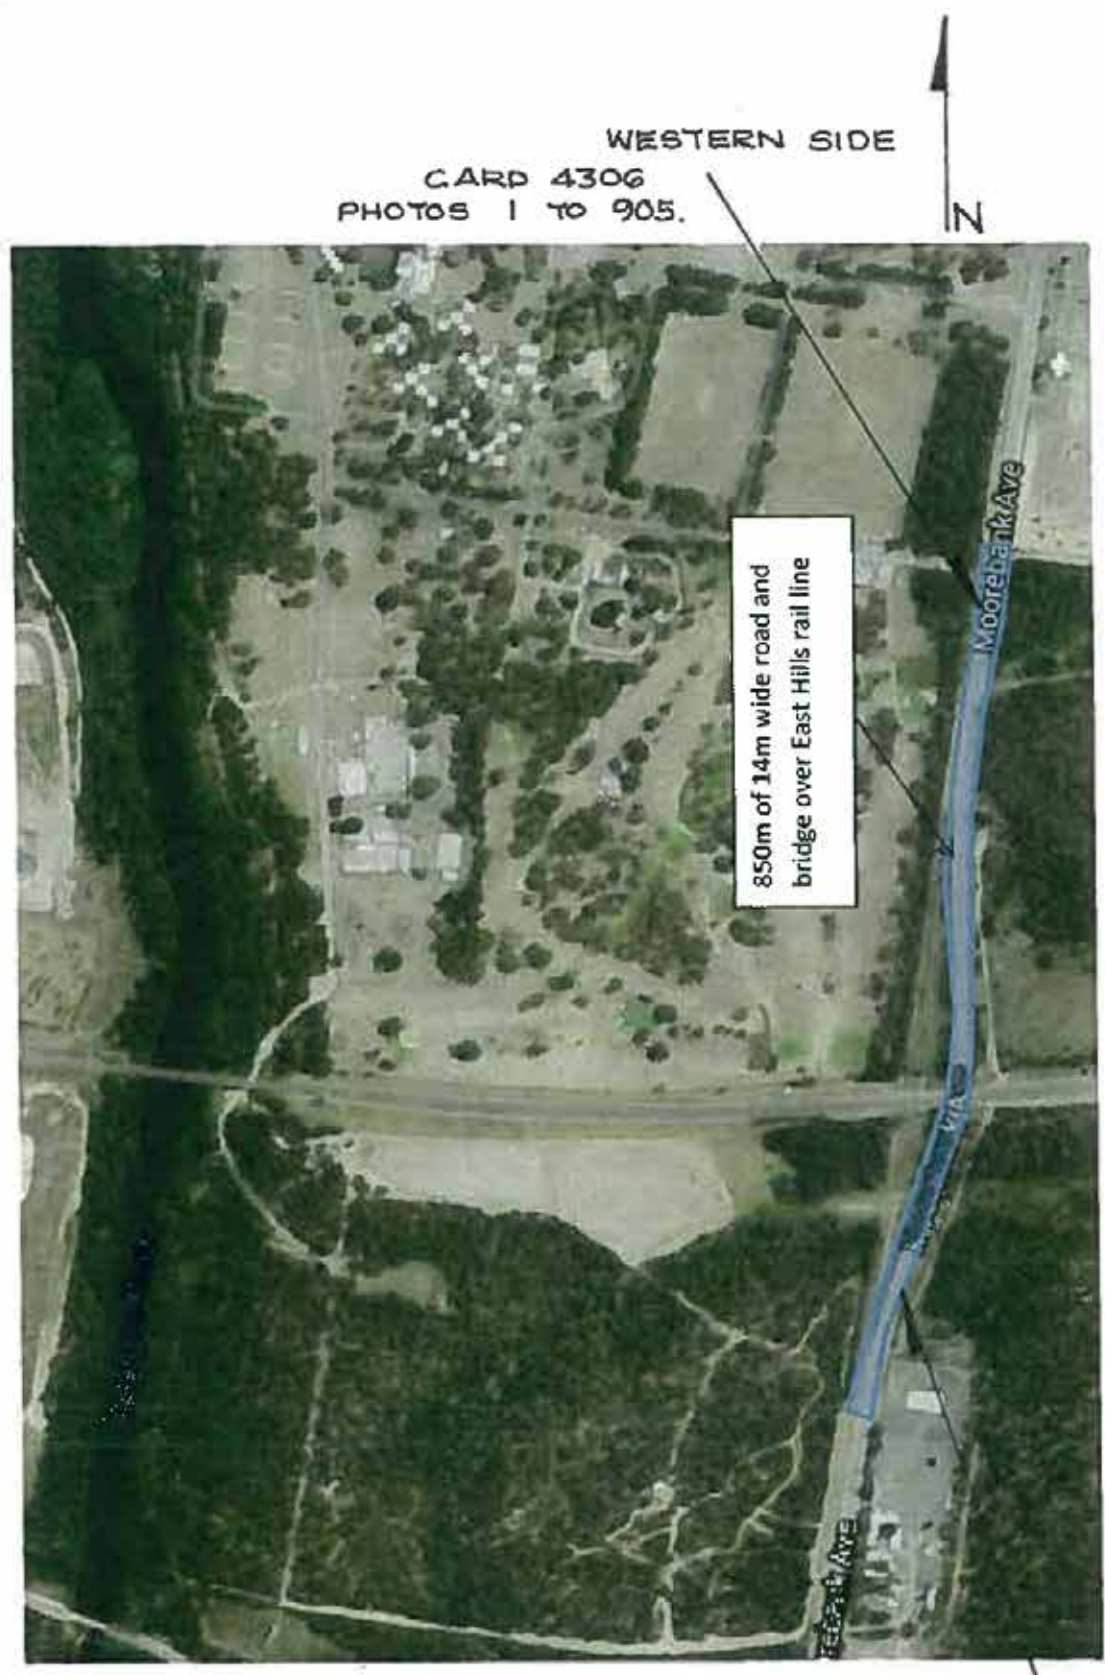
SK 1.

SK 1	Sketch showing location of area surveyed on Moorebank Avenue	1

WESTERN SIDE
CARD 4306
PHOTOS 1 TO 905.

EASTERN
SIDE
CARD 4298
PHOTOS 1 TO 789.
