**MOOREBANK PRECINCT EAST STAGE 1  
RALP No 1**

**PRE-CONSTRUCTION DILAPIDATION REPORT**

**CAMBRIDGE AVENUE GLENFIELD**

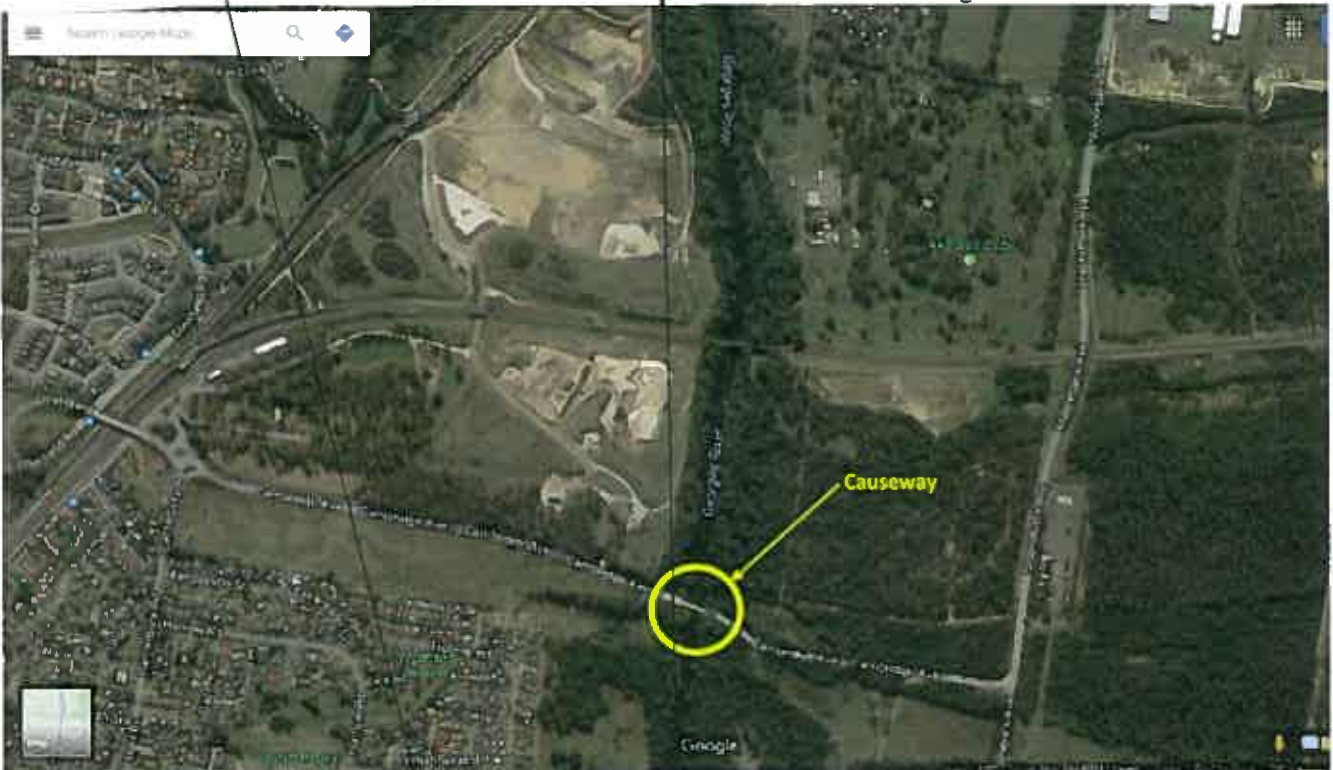
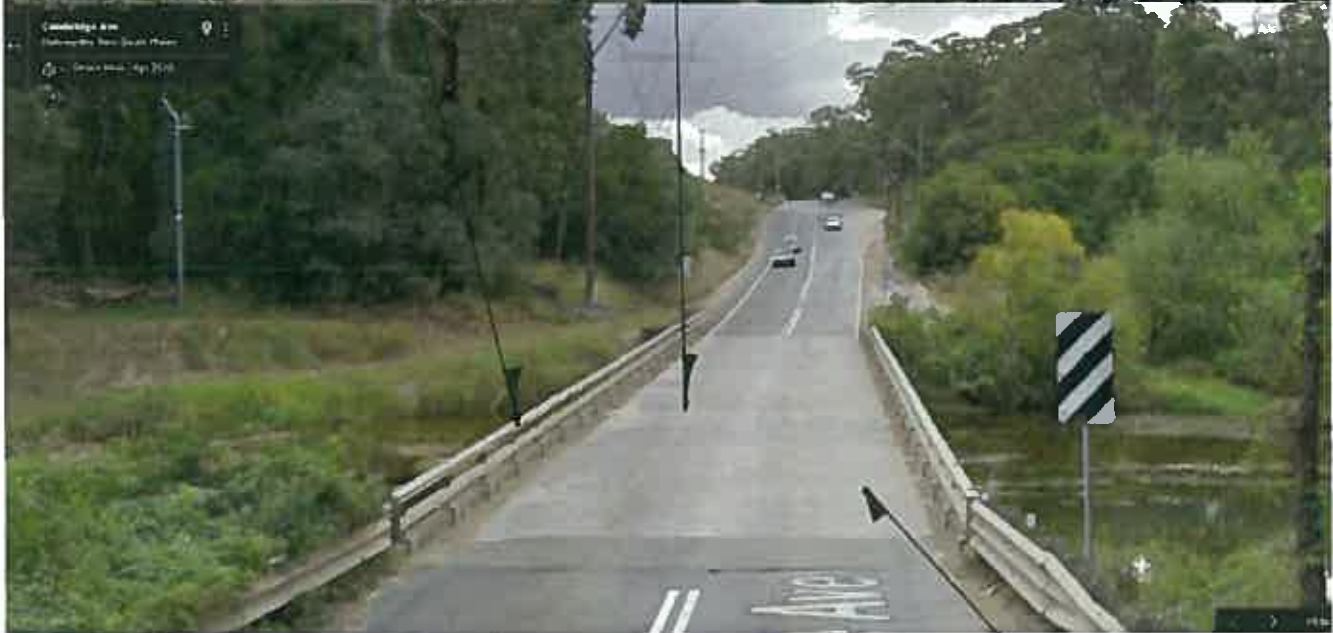
**SK 1.**

SK 1	Sketch showing location of area surveyed on Cambridge Avenue	1
