MOOREBANK LOGISTICS PARK

Moorebank Precinct East: Six-Monthly Operations Compliance Report

Report: #7

Period: June 2023 – October 2023

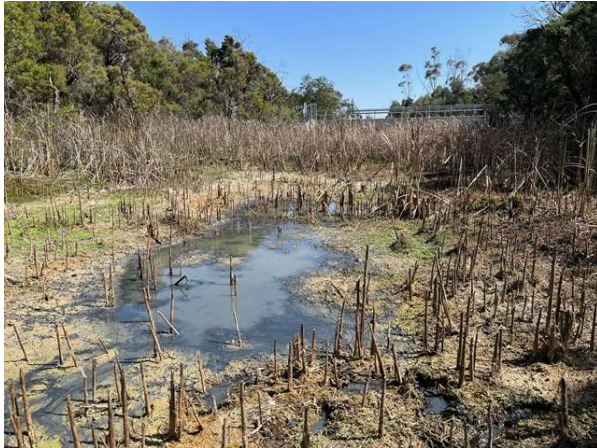
Plate 1: AQ1 – View upstream (20/09/23)

The active channel zone at this site (up to approximately 5 m wide) remains stable (i.e., no signs of active erosion), due to the absence of flow, cover of remaining aquatic plants and the relatively intact woody riparian vegetation (Appendix 2). The channel bed consisted of fine sediment, the upper layers of which were anoxic (Plate 1).

Alligator Weed (*Alternanthera philoxeroides*) had recolonised much of the channel since autumn 2023 surveys and the first spring 2023 survey in September 2023 (Plates 1&2), most likely due to rainfall during November 2023. Native plant species included Marsh Club-rush (*Bolboschoenus fluviatilis*), Typha (*Typha* sp.), Slender knotweed (*Persicaria decipiens*) and *Myriophyllum variifolium*. The tree canopy was mostly comprised of *Melaleuca* spp. and *Eucalyptus* spp. (Plates 1&2).

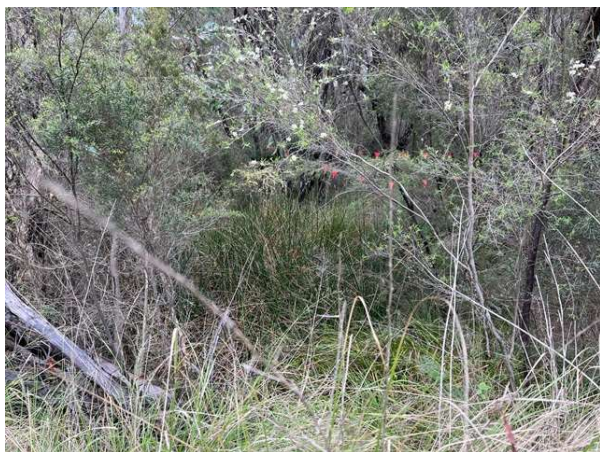
Plate 3: AQ4 – View upstream (15/11/23)

The active channel zone, composed of fine sediments, was up to approximately 4 m wide (Plates 3&4). No indicators of significant erosion were observed suggesting that Anzac Creek continues to be relatively stable at this site, particularly since colonisation of the stream channel by emergent macrophytes and reduced flow within the creek since spring 2022 (Plate 3&4, Appendix 2).

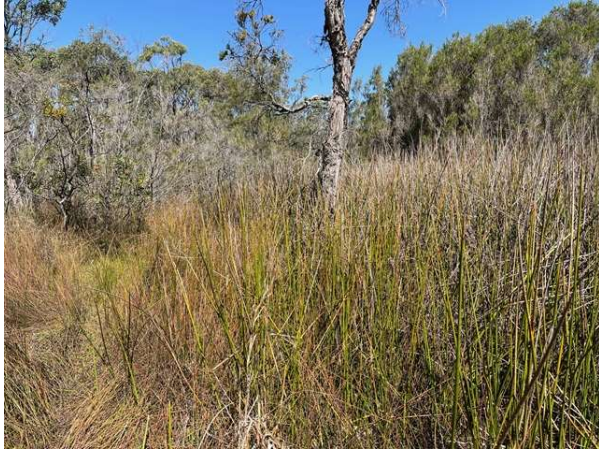
Plate 5: Site AQ8 – view upstream (20/09/23)

Most notably, taller species of emergent macrophyte, including Jointed Twig Rush and Tall Spikerush (*Eleocharis sphacelata*) have encroached upon habitat previously dominated by Heron Bristle Sedge (*Chorizandra cymbaria*) (Plates 5&6). Other shorter plants, including Frogsmouth (*Philydrum lanuginosum*), Slender Knotweed and the introduced species, Umbrella Sedge (*Cyperus eragrostis*) have also declined in abundance. Riparian vegetation continues to be dominated by *Casuarina* trees. Common Reed/Phragmites (*Phragmites australis*) was present at the downstream end of the site. Blackberry (*Rubus fruticosus*), which is listed as a weed of national significance, was also present.

The stream channel at Site AQ8 (up to approximately 20 m wide) continues to be classified as stable, mostly due to the dense cover by emergent macrophytes in addition to a relatively intact, woody riparian zone (Appendix 2).

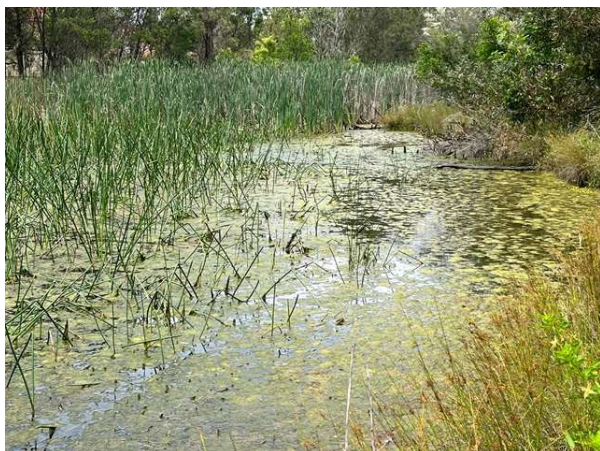
Plate 7: Site AQ12 – view upstream (15/11/23)

The submerged macrophyte species, Ribbonweed (*Vallisneria* sp.) and *Potamogeton ochreatus* were common, in addition to Slender Knotweed and dense stands of Typha, Phragmites and Tall Spike Rush (Plate 7). *Nymphoides geminata* (Entire Marshwort), with mostly floating leaves, and accumulations of green filamentous algae continue to be abundant in areas close to the shore (Plates 7&8). Also noted during spring 2022, autumn and spring 2023 was the native perennial, *Utricularia* sp., which occurs on wet soil and in freshwater as terrestrial or aquatic species. *Egeria* (*Egeria densa*), which was collected close to the left-bank (facing downstream) of the pool in spring 2020, was present. Riparian vegetation included

Casuarina, Eucalyptus and Melaleuca trees and Spiny-head Mat-rush/Basket Grass (*Lomdandra longifolia*) (Plates 7&8).

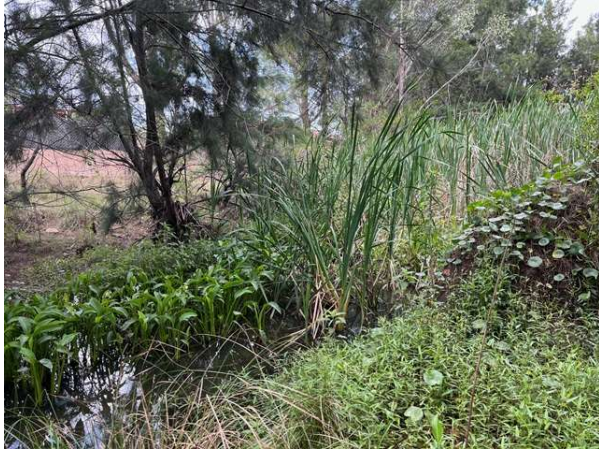
Plate 9: Site AQ13 – view downstream (15/11/23)

A large proportion of the stream channel and edges were colonised by Typha and Slender Knotweed. The aquatic weed, *Sagittaria platyphylla* (*Sagittaria*) continued to expand its distribution within the channel of the creek. River Clubrush (*Schoenoplectus validus*) was also common. The stream channel appeared stable (Appendix 2).

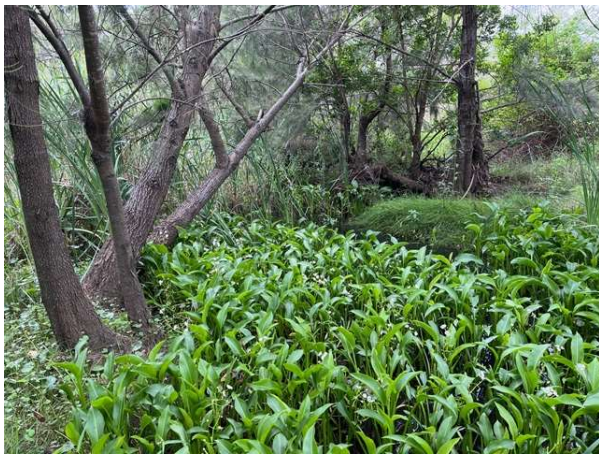
Plate 11: Site AQ14 – view downstream (20/09/23)

Site AQ14 was situated approximately 150 m downstream of Site AQ13 and immediately downstream of the culvert that links the dam within Commonwealth Department of Defence land to Anzac Creek (Figure 1). Flow was not apparent at the time of both spring 2023 surveys (Plates 11&12).

Typha, Slender Knotweed, River Clubrush and Whorled Pennywort/Shield Pennywort continue to be common (Plates 11&12). Sagittaria continued to expand its distribution within the channel of the creek (Plates 11&12). This section of Anzac Creek remains mostly stable due to dense instream vegetation and vegetated banks (Appendix 2). Water visibility was ‘good’ at the time of both surveys (Plates 11&12).
