**Moorebank Avenue – Anzac Road (MAAI)
Works: Phase 2A**

Post-Opening Road Safety Audit Report

March 2024

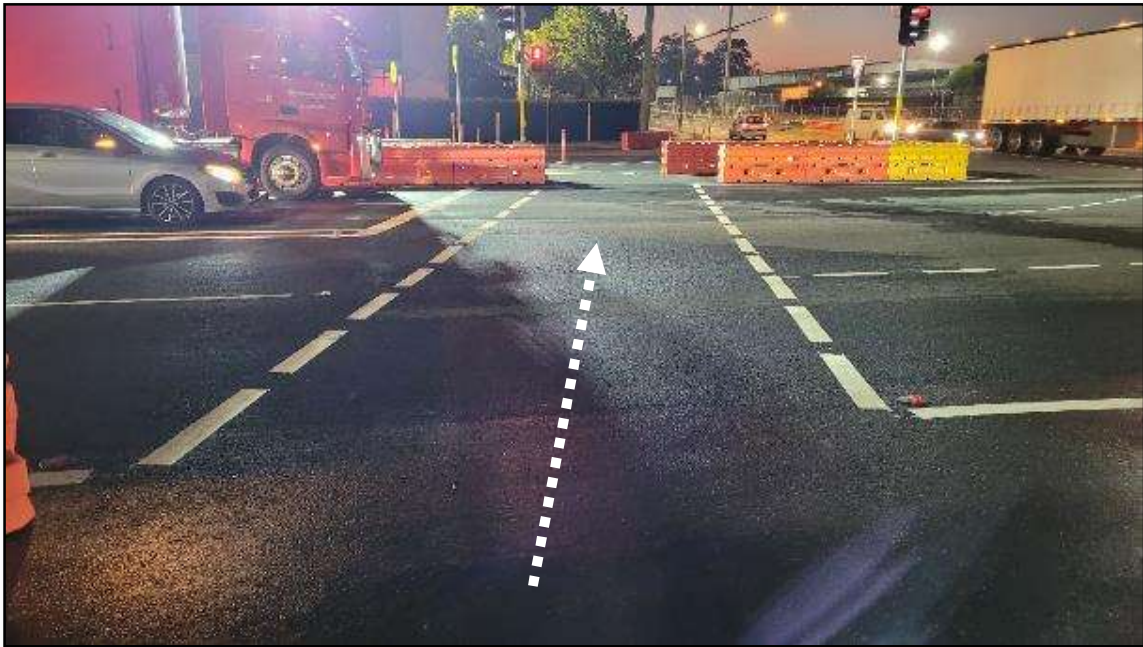
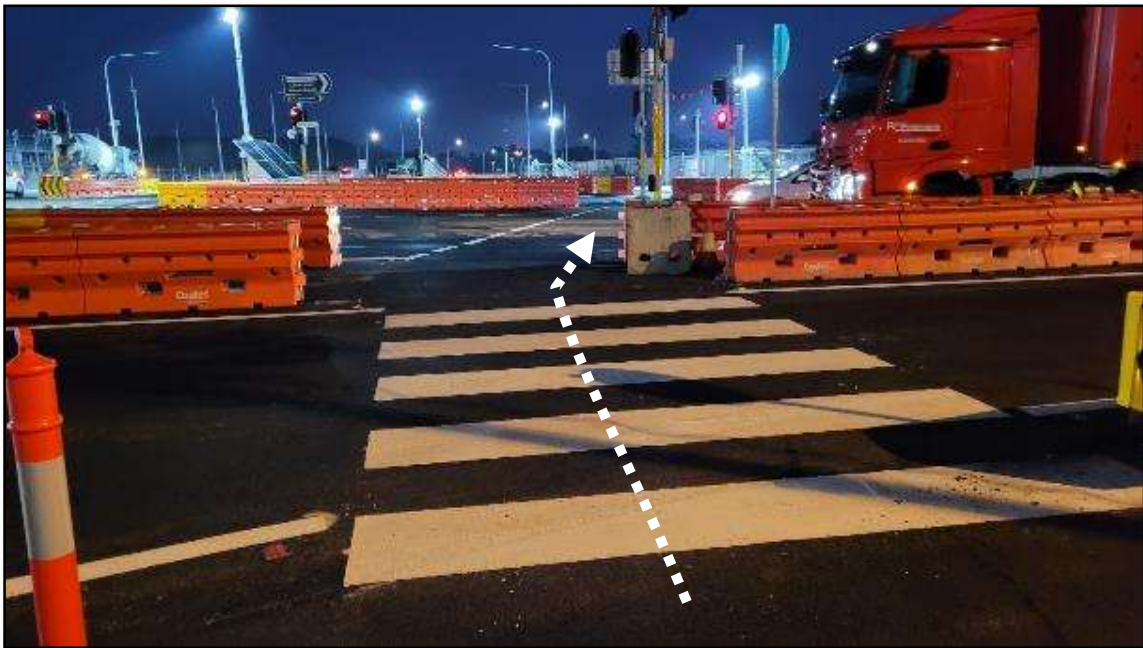
<i>For completion by BMD</i>	
No.	Description of Road Safety Issue	Risk Rating	Road Safety Category	Action by	Response	
1.	For some of the pedestrian crossing legs, there are no 'hold' lines to guide and separate pedestrian waiting areas from adjacent live traffic lanes – refer to <i>Photos 1 and 2</i> in <i>Appendix A</i> . This includes the marked pedestrian crossing across the Moorebank Avenue southbound left-turn slip-lane into Anzac Road.	Medium - High	Pedestrian infrastructure	Northrop BMD	<p>Linemarking of 'hold' lines to be implemented to delineate edge pedestrian waiting areas and adjacent live traffic.</p> <p>Completed on 25/03/2024</p>

PHOTOS 1 & 2: For the pedestrian crossing across Moorebank Avenue (north) (top photo) as well as across the Moorebank Avenue southbound left-turn slip-lane into Anzac Road (bottom photo), there are no 'hold' lines to guide and separate pedestrian waiting areas from adjacent live traffic lanes.

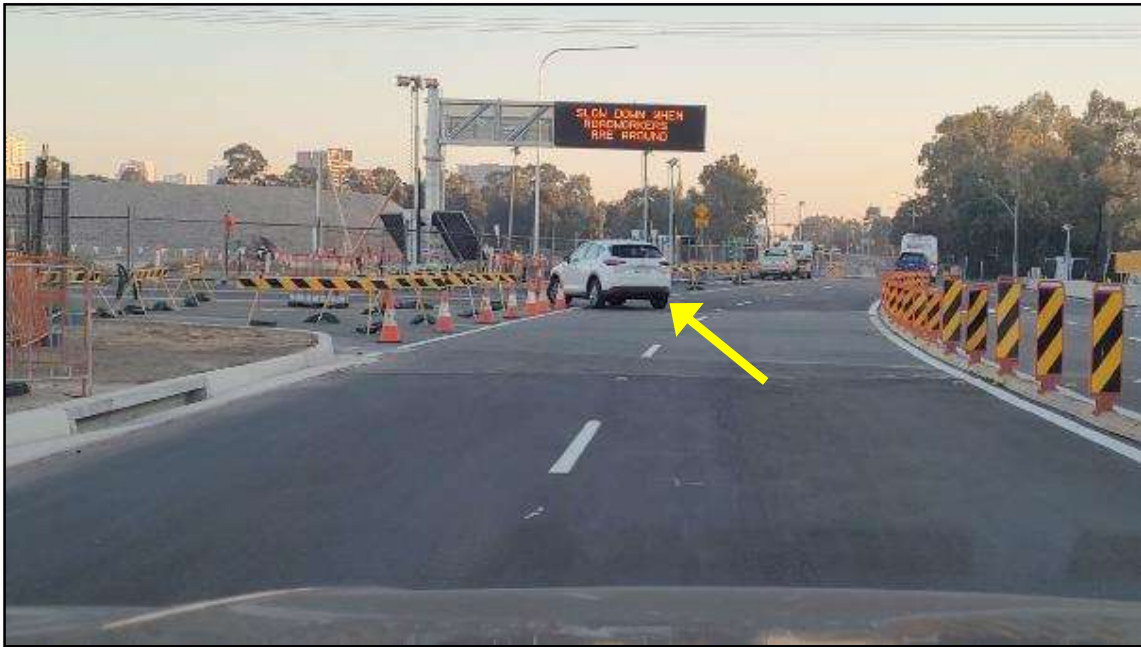
<i>For completion by BMD</i>	
No.	Description of Road Safety Issue	Risk Rating	Road Safety Category	Action by	Response
2.	<p>For Moorebank Avenue northbound travel, there is no physical obstruction to prevent a left-turn movement into Bapaume Road, which is a one-way exit only. Moreover, the 'No Left Turn' restriction sign for northbound Moorebank Avenue traffic could be reinforced with a 'No Entry' or 'One Way Exit' sign at Bapaume Road.</p> <p>During the site inspections, vehicles were observed entering Bapaume Road, ie. turning left from Moorebank Avenue northbound – refer to <i>Photo 3</i> in <i>Appendix A</i>. This is possibly due to a lack of adequate directional / destination signage to advise approaching traffic of the new intersection legs and their destinations as well as to advise traffic destined for the former Bapaume Road route to use the new Bushmaster Avenue intersection leg. This applies to traffic approaching from the south (along Moorebank Avenue northbound) and the east (along Anzac Road westbound).</p>	Medium	Delineation	Northrop BMD	<p>Additional 'Klemmfix' or similar to be installed to further restrict left turn movements into Bapaume Road.</p> <p>Completed on 26/03/2024</p>

PHOTO 3: For Moorebank Avenue northbound travel, there is no physical obstruction to prevent a left-turn movement into Bapaume Road, which is a one-way exit only. During the site inspections, vehicles were observed entering Bapaume Road, ie. turning left from Moorebank Avenue northbound.

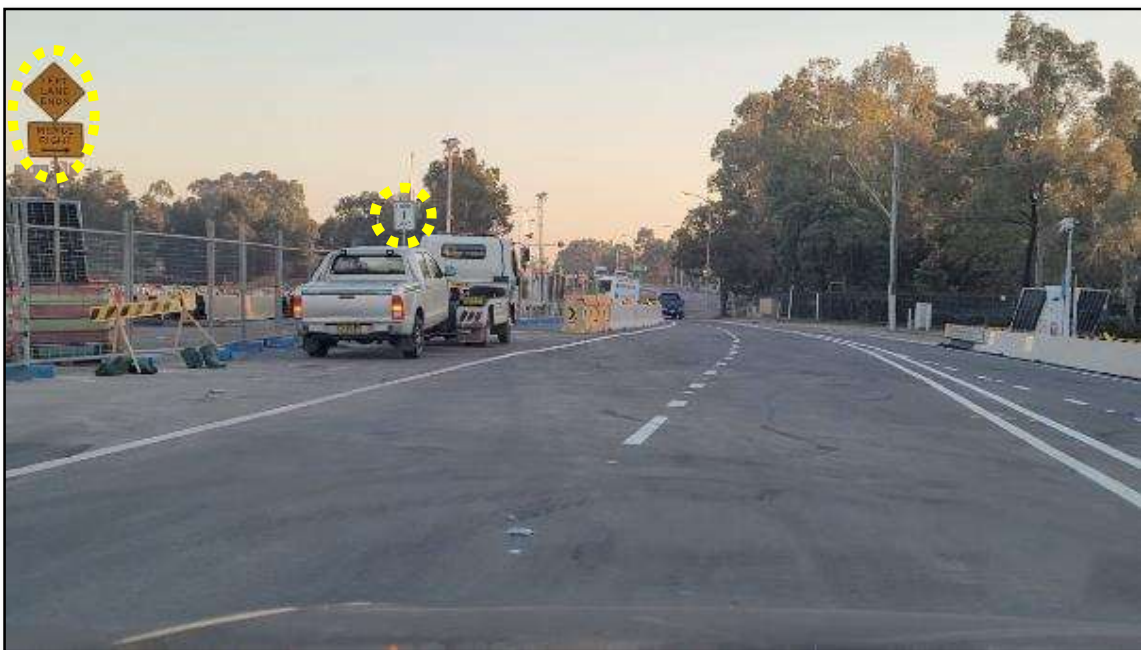
<i>For completion by BMD</i>	
No.	Description of Road Safety Issue	Risk Rating	Road Safety Category	Action by	Response
3.	For Moorebank Avenue northbound travel, the lane-drop north of Bapaume Road is poorly defined with a lack of merge arrows and the 'Left Lane Ends / Merge Right' and 'Form 1 Lane' signage being located too far left of the approach travel path – refer to <i>Photo 4</i> in <i>Appendix A</i> .	Medium	Delineation	North rop BMD	<p>Signage to be shifted closer to the edge of the carriageway, as these signs are on temporary concrete blocks they are to be placed 5m from the edge of the carriageway. Refer AS1742.2 Appendix D, TS 02642 Supplement to Austroads Guide to Road Design and TS 06307 Installation and Maintenance of Signs</p> <p>Completed on 27/03/2024</p>

PHOTO 4: For Moorebank Avenue northbound travel, the lane-drop north of Bapaume Road is poorly defined with a lack of merge arrows and the 'Left Lane Ends / Merge Right' and 'Form 1 Lane' signage being located too far left of the approach travel path.

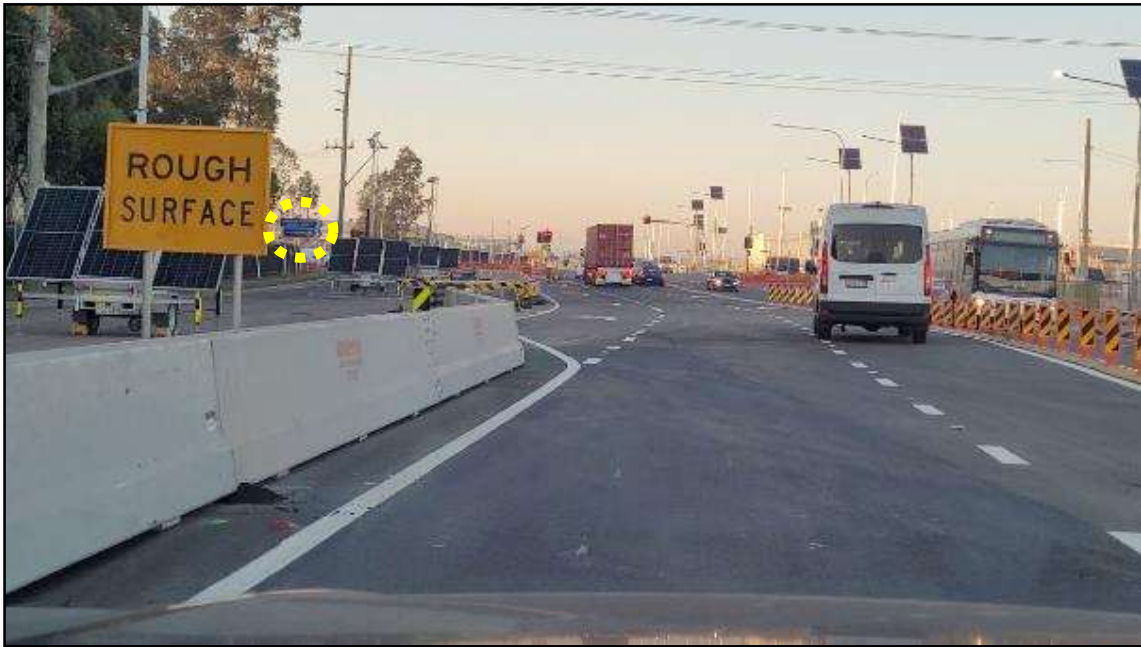
<i>For completion by BMD</i>	
No.	Description of Road Safety Issue	Risk Rating	Road Safety Category	Action by	Response
4.	For Moorebank Avenue southbound travel, the intersection direction signage approaching Bushmaster Avenue is located too far to the left of the approach travel path and is obstructed by lighting solar panels and other work-site obstructions – refer to <i>Photo 5</i> in <i>Appendix A</i> . Moreover, the signage would be better located to the right to reflect the destinations it is directing to.	Medium	Delineation / Traffic signs	BMD	<p>Signage to be shifted closer to carriageway behind existing temporary road safety barriers</p> <p>Completed 17/04/2024</p>

PHOTO 5: For Moorebank Avenue southbound travel, the intersection direction signage approaching Bushmaster Avenue is located too far to the left of the approach travel path and is obstructed by lighting solar panels and other work-site obstructions. Moreover, the signage would be better located to the right to reflect the destinations it is directing to.

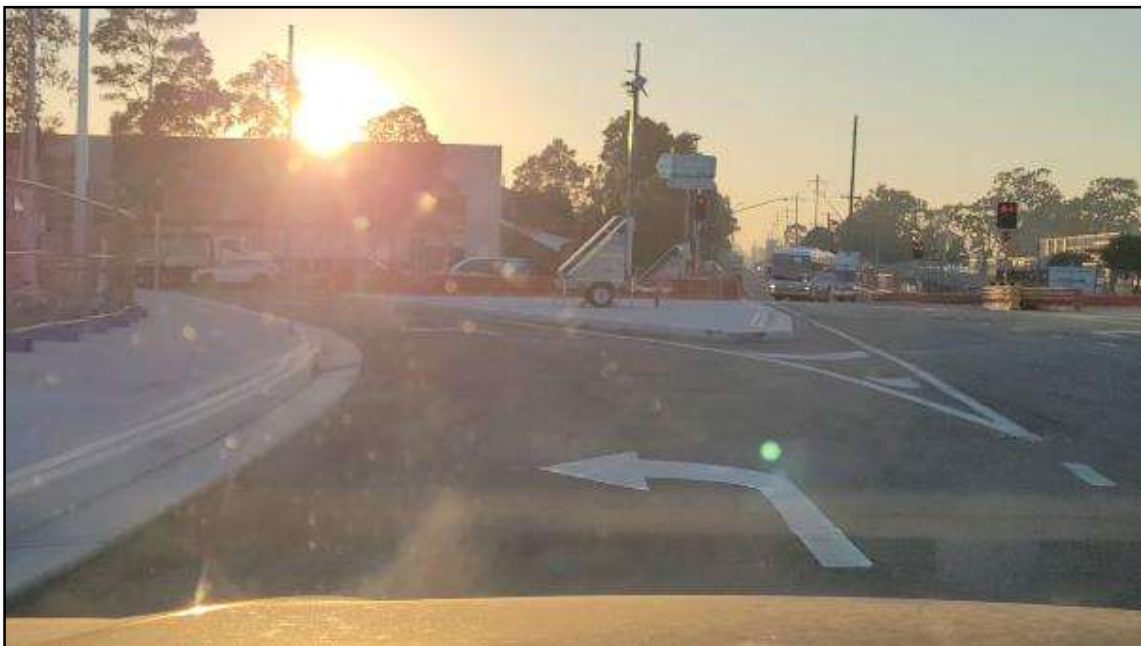
5.	The issue of sun-glare during certain periods of the year at sunset and sunrise is applicable for east-west travel along Anzac Road and Bushmaster Avenue. Consequently, advisory / information signage and traffic control devices may be difficult to sight due to sun glare – refer to <i>Photo 6</i> in <i>Appendix A</i> .	Low - Medium	Delineation	North rop	Temporary traffic signals have been installed with target boards and visors.

PHOTO 6: The issue of sun-glare during sunrise is applicable for eastbound travel along Bushmaster Avenue approaching the Moorebank Avenue intersection. Consequently, advisory / information signage and traffic control devices may be difficult to sight due to sun glare.

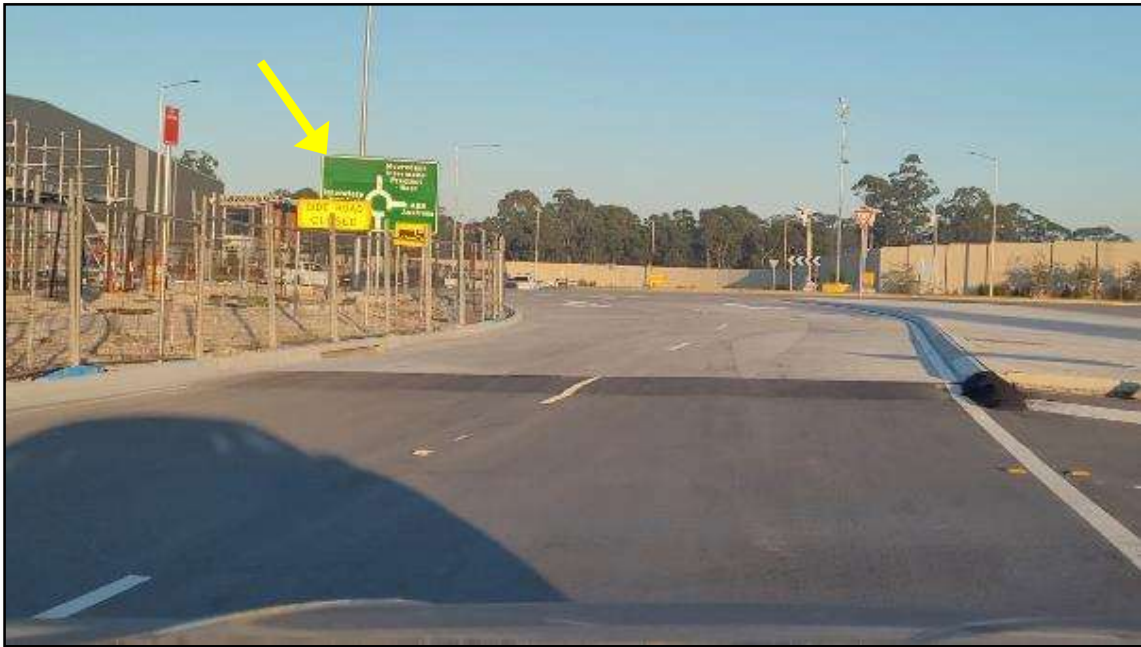
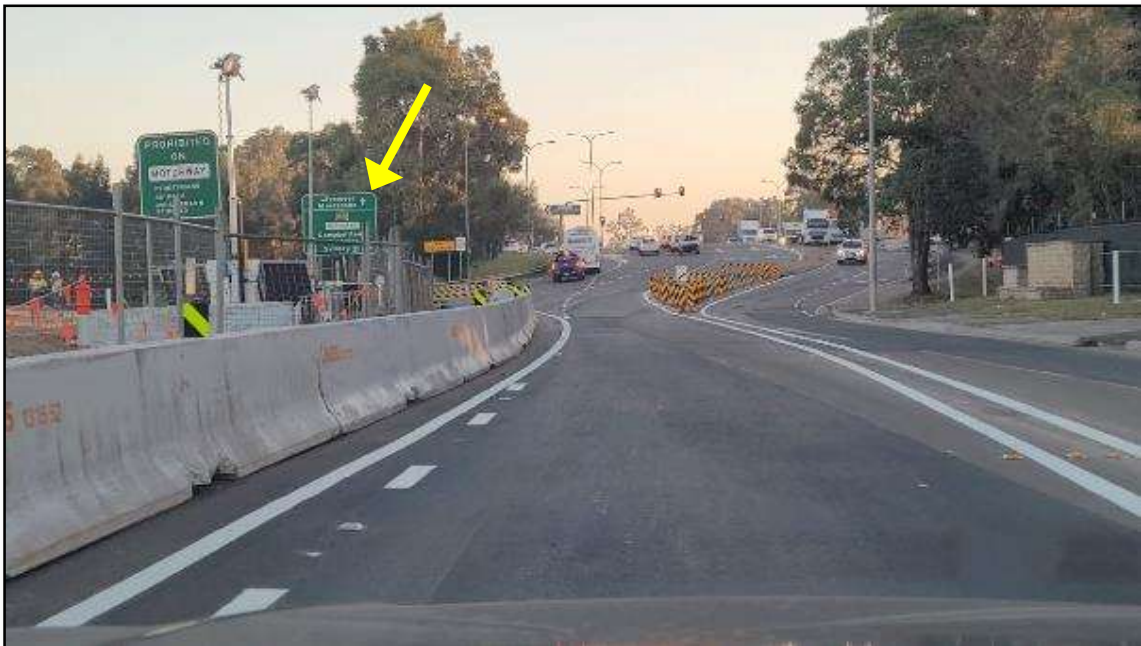
<p>6.</p>	<p>Existing directional signage is difficult to sight / read for westbound travel along Bushmaster Avenue approaching the precinct roundabout as well as along Moorebank Avenue northbound near the northern extent of the project works area – refer to <i>Photos 7 and 8</i> in <i>Appendix A</i>.</p>	<p>Low - Medium</p>	<p>Traffic signs</p>	<p>LOG OS BMD BMD</p>	<p>Signage at Bushmaster Ave Truck sign to be removed SIDE ROAD CLOSED to be relocated to east Completed 11/04/2024</p>

PHOTOS 7 & 8: Existing directional signage is difficult to sight / read for westbound travel along Bushmaster Avenue approaching the precinct roundabout (top photo) as well as along Moorebank Avenue northbound near the northern extent of the project works area (bottom photo).

<p>PROHIBITED ON MOTORWAY sign which was blocking the sighting of the large directional sign to be relocated to south for better visibility of the large directional sign. Completed 15/04/2024</p>
-----------	--	-------------------------	----------------------	--	---

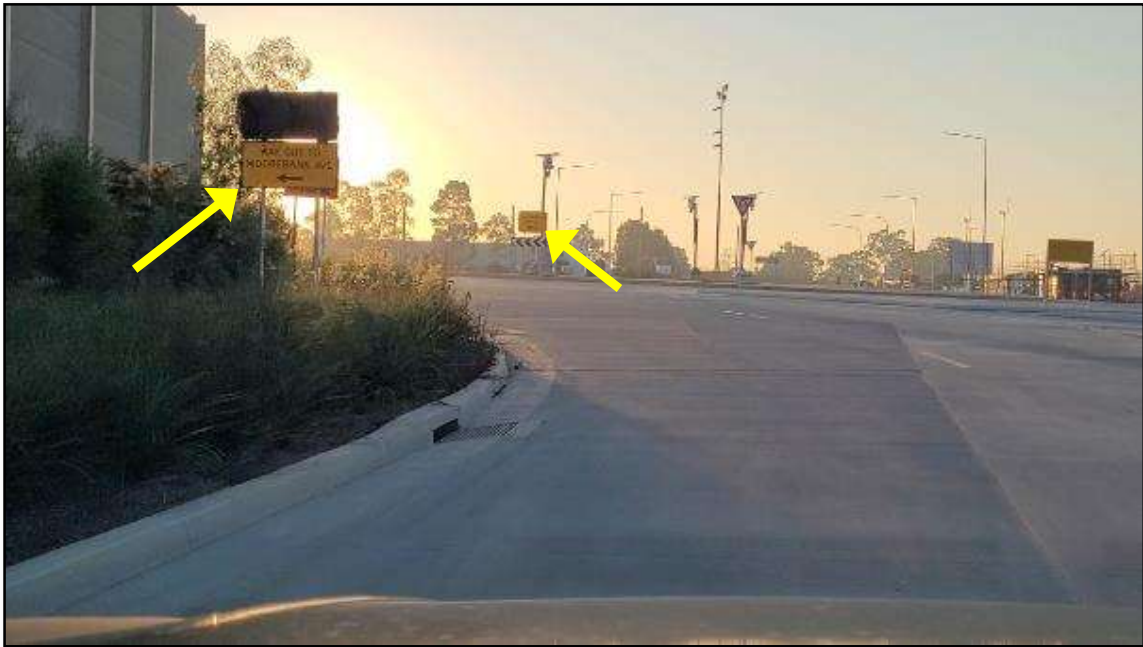
7.	Temporary directional signage for eastbound travel along the Loop Road approaching the roundabout still indicates the precinct exit is via Bapaume Road, which is now incorrect – refer to <i>Photo 9</i> in <i>Appendix A</i> .	Low - Medium	Delineation	LOG OS BMD	Change the arrow sticker to show go straight Completed 26/03/2024

PHOTO 9: Temporary directional signage for eastbound travel along the Loop Road approaching and at the roundabout still indicates the precinct exit is via Bapaume Road, which is now incorrect.

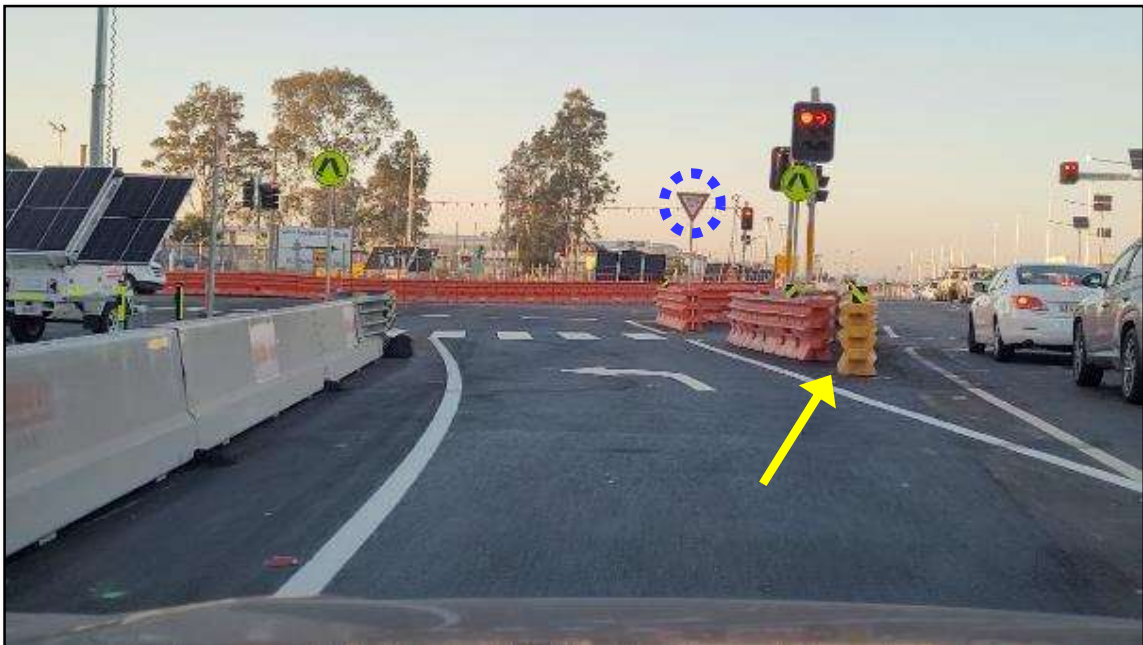
<i>For completion by BMD</i>	
No.	Description of Road Safety Issue	Risk Rating	Road Safety Category	Action by	Response
8.	Some temporary safety barrier ends do not have hazard markers to adequately delineate them, which is undesirable, eg. approach to the Anzac Road left-turn splitter island for Moorebank Avenue southbound travel – refer to <i>Photo 10</i> in <i>Appendix A</i> .	Low - Medium	Delineation	BMD	<p>Klemmfix delineation installed Completed 26/03/2024</p>

<i>For completion by BMD</i>	
No.	Description of Road Safety Issue	Risk Rating	Road Safety Category	Action by	Response
11.	For southbound travel along Moorebank Avenue turning left into Anzac Road, the 'Give Way' sign located on the right side of the approach only, which is non-standard and should be duplicated on the left side to reinforce the intersection control – refer to <i>Photo 10</i> in <i>Appendix A</i> .	Low	Traffic signs	Northrop BMD	<p>A 'Give Way' may be installed with minimum of 2m clearance to the sign in accordance with AS1742.2 2022, Appendix D (D.2.3.2 and D.2.3.3) and should not be installed on a large temporary concrete block.</p> <p>Completed 17/04/2024</p>

PHOTO 10: For the approach to the Anzac Road left-turn splitter island for Moorebank Avenue southbound travel, the temporary safety barrier ends do not have hazard markers to adequately delineate them. Also, note the 'Give Way' sign located on the right side of the approach only, which is non-standard and should be duplicated on the left side to reinforce the intersection control

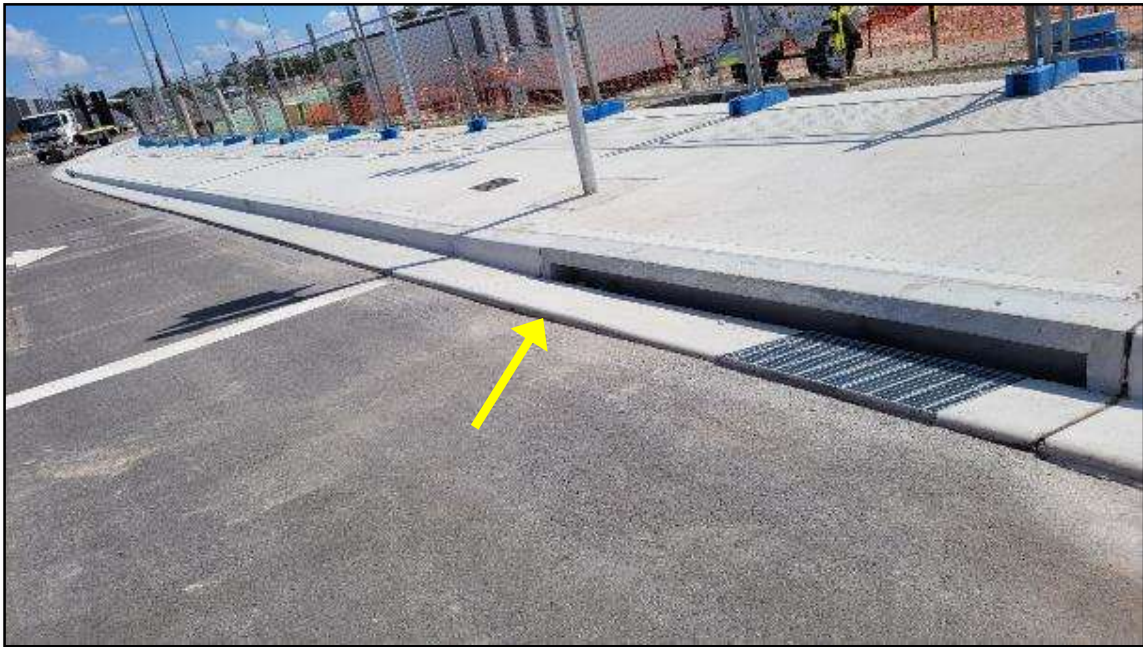
9.	On Bushmaster Avenue, there is a lip between the temporary, incomplete pavement surface and the gutter and drains. This may result in excessive water ponding and extending into the adjacent travel lanes – refer to <i>Photo 11</i> in <i>Appendix A</i> . It is acknowledged that the travel speeds are likely to be relatively low (minimising the risk of any aquaplaning) and that temporary drain holes have been provided on the pavement surface into drains at some sag points.	Low	Drainage	BMD	<p>Temporary drain hole not required for this location (refer MAAI RFI-124)</p> <p>There wasn't any water pooling observed post-rain event drive through check on 05th Apr 2024</p>

PHOTO 11: On Bushmaster Avenue, there is a lip between the temporary, incomplete pavement surface and the gutter and drains. This may result in excessive water ponding and extending into the adjacent travel lanes.

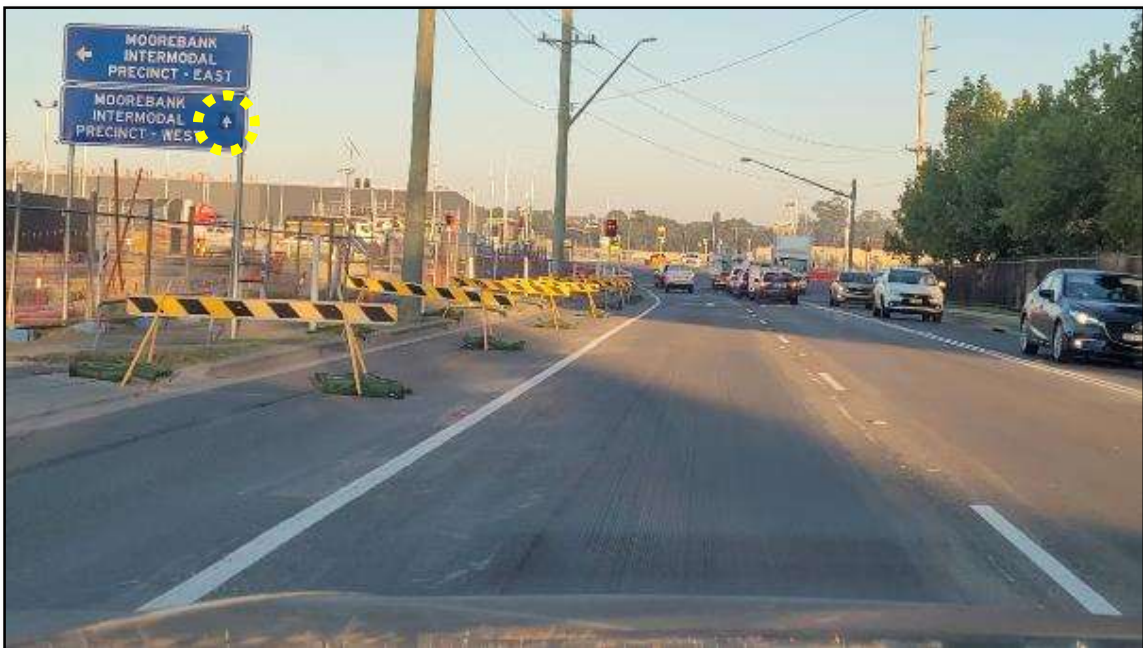
<i>For completion by BMD</i>	
No.	Description of Road Safety Issue	Risk Rating	Road Safety Category	Action by	Response
13.	For Anzac Road westbound travel, the directional sign for 'Moorebank Intermodal – West / ABB Australia' has an arrow that appears to be too small in size and is inconsistent with the arrow size for the adjacent 'Moorebank Intermodal – East' sign – refer to <i>Photo 12</i> in <i>Appendix A</i> .	Low	Delineation / Traffic signs	BMD	Correct size arrow sticker has been installed Completed on 26/03/2024

PHOTO 12: For Anzac Road westbound travel, the directional sign for 'Moorebank Intermodal – West / ABB Australia' has an arrow that appears to be too small in size and is inconsistent with the arrow size for the adjacent 'Moorebank Intermodal – East' sign.
