Moorebank Avenue: MAAI Stage 1A

Post-Opening Road Safety Audit Report

May 2023

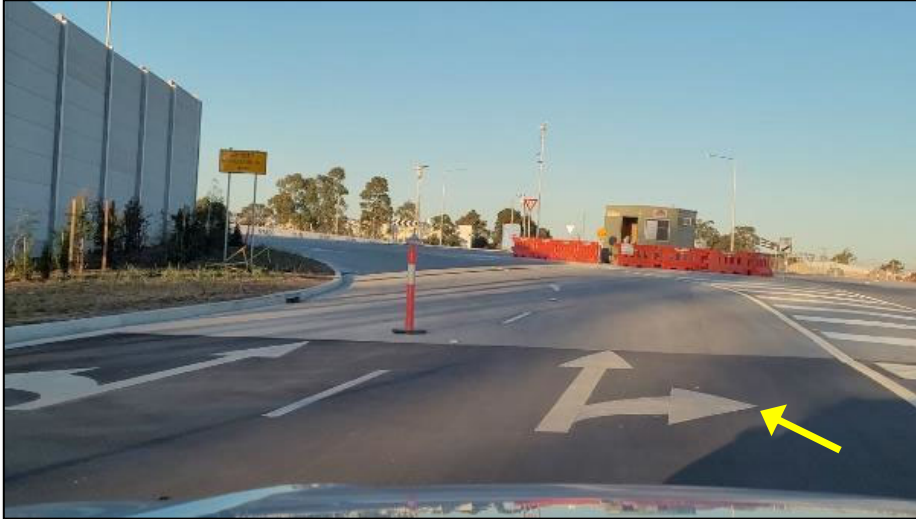
No.	Description of Road Safety Issue	Risk Rating	Road Safety Category	For completion by BMD	
				Action by	Response
1.	For the Western Ring Road approach to the roundabout near the BMD site office, there are two lanes on the northbound approach with only single lane exit lanes from the roundabout. Moreover, pavement markings show a through / right-turn in the median lane when there is no right-turn available – refer to <i>Photo 1 in Appendix A</i> . Consideration should be given to restricting travel to a single lane (similar to the rest of the Western Ring Road) in the kerbside lane to accommodate the large left-turn movement (Moorebank Precinct West (MPW) exiting to Moorebank Avenue). Similarly, for the BMD site office (eastern) leg approach to the roundabout, consideration should be given to restricting travel to a single lane.	Medium	Traffic management & operations / Intersections	LOGOS	<p>Noted; Required lane closure is outside BMD's LoW and forwarded to LOGOS for review and action.</p> <p>Logos – we will ask Knight Frank (who is responsible for this area) to adjust.</p> <p><u>Previously the western approach to the roundabout has had the left and through lane blocked to access through the use of cones. We would suggest this would limit the potential issue. As speeds are currently limited to 40 km/h this will help mitigate any risk. For right turns there is still the opportunity to do a u-turn and we do not believe this is a significant safety issue</u></p>

PHOTO 1: For the Western Ring Road approach to the roundabout near the BMD site office, there are two lanes on the northbound approach with only single lane exit lanes from the roundabout. Moreover, pavement markings show a through / right-turn in the median lane when there is no right-turn available.

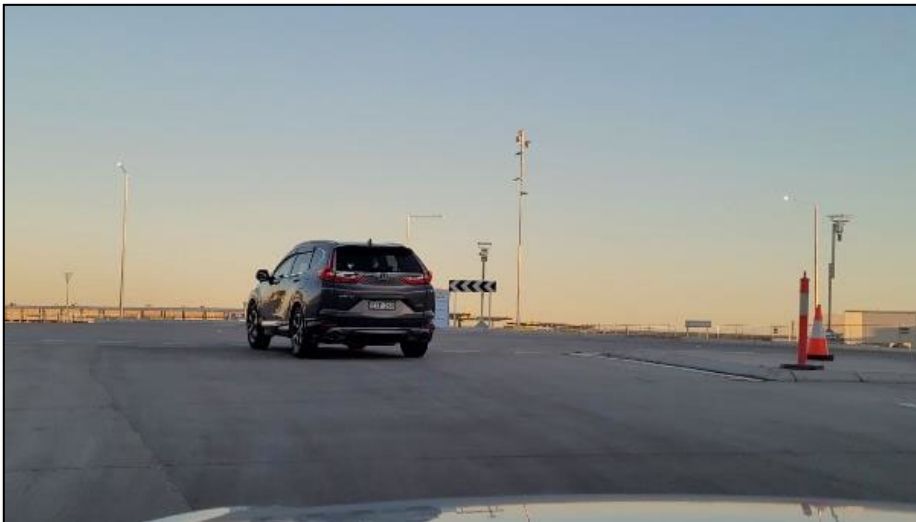
4.	For the southbound approach from Bapaume Road to the BMD site office / Western Ring Road roundabout, the 'roundabout control' signage is difficult to sight because it is located on the far left of the intersection entry leg – refer to <i>Photo 2</i> in <i>Appendix A</i> . Consideration should be given to providing an additional 'roundabout control' sign on the right side of the intersection approach within the median area (as per the other intersection leg treatments).	Low - Medium	Traffic signs	NOR THR OP	<p>Noted; Signs installed as per approved design. BMD will notify Designer Northrop for review.</p> <p>Logos – see Figure 11.2 of RTA Delineation Section 11 – Pavements markings at roundabouts. This shows signage to the right of approach.</p> <p>Delineation - Section 11 Pavement markings at roundabouts (nsw.gov.au)</p> <p>AS1742.2 Allows for the sign to be placed on either side of the roundabout, and additional signage placed as optional. We agree that due to the large size of the roundabout additional central island signage would be beneficial.</p>

PHOTO 2: For the southbound approach from Bapaume Road to the BMD site office / Western Ring Road roundabout, the 'roundabout control' signage is difficult to sight because it is located on the far left of the intersection entry leg.

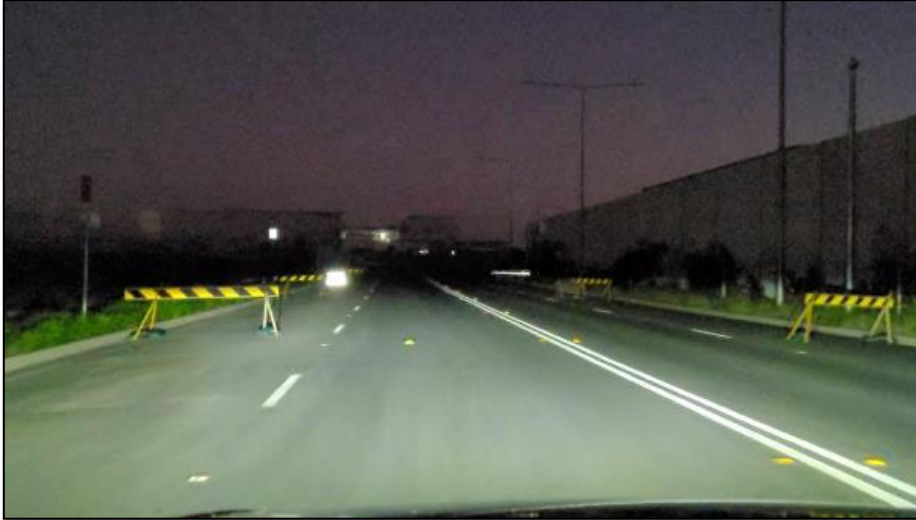
No.	Description of Road Safety Issue	Risk Rating	Road Safety Category	For completion by BMD	
				Action by	Response
5.	For travel along the Western Ring Road, the street lighting was not operational resulting in a darker section of road network in comparison with adjacent road sections – refer to <i>Photo 3</i> in <i>Appendix A</i> .	Low - Medium	Lighting	LOGOS	<p>Noted; It is outside BMD's LoW. BMD will notify LOGOS for review and action.</p> <p>Logos – This location is outside the extent of this RSA however we will advise maintenance and rectify.</p> <p>BMD to confirm lighting has been installed as per approved plans. Western ring road lighting should be provided once road is opened to public.</p>

PHOTO 3: For travel along the Western Ring Road, the street lighting was not operational resulting in a darker section of road network in comparison with adjacent road sections.

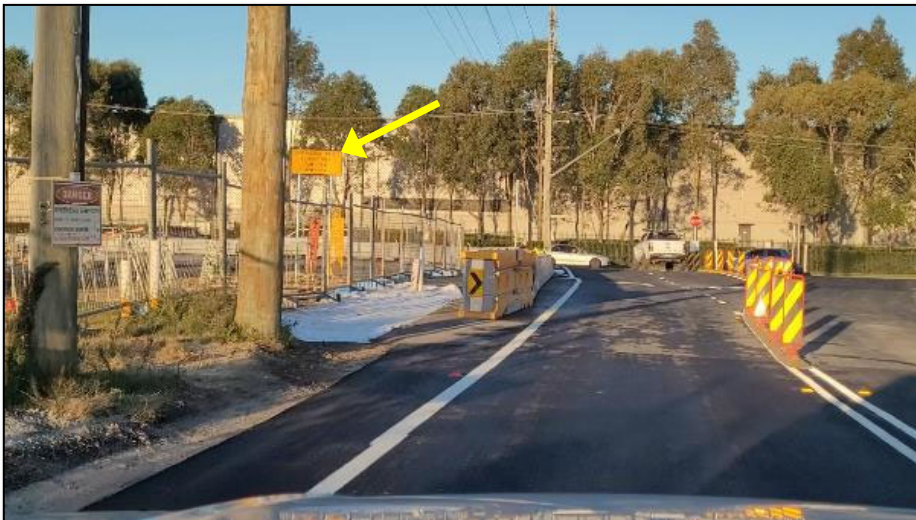
7.	For eastbound travel along Bapaume Road approaching Moorebank Avenue, the advisory right-turn restriction sign is located too far left of a driver's sightline, which focusses on the intersection ahead, and is difficult to fully read because of its relatively small size and its location beyond roadside power / street light poles – refer to <i>Photo 4</i> in <i>Appendix A</i> .	Low	Traffic signs	BMD	<p>Agreed; The sign has been relocated closer to travel path. Closed out: 07/05/2023</p> <p>Logos – no comment.</p>

PHOTO 4: For eastbound travel along Bapaume Road approaching Moorebank Avenue, the advisory right-turn restriction sign is located too far left of a driver's sightline and is difficult to fully read because of its relatively small size and its location beyond roadside power / street light poles.

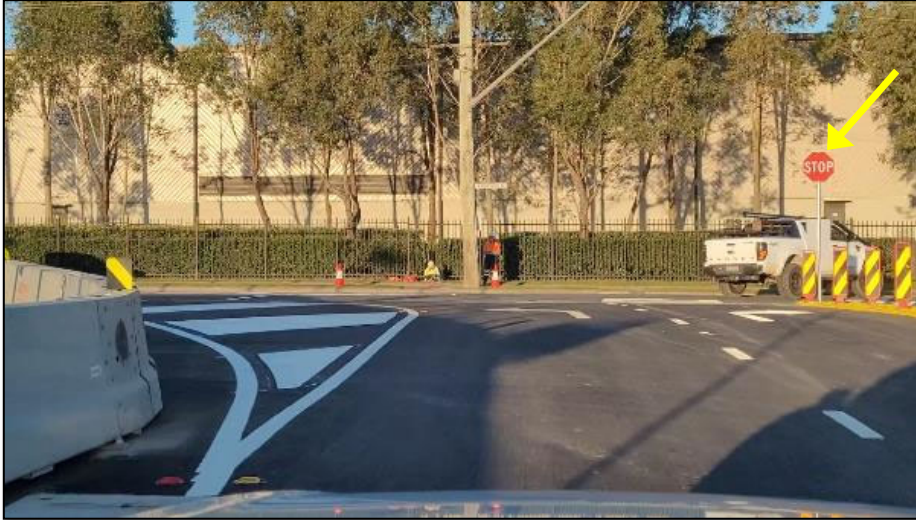
No.	Description of Road Safety Issue	Risk Rating	Road Safety Category	For completion by BMD	
				Action by	Response
8.	For the Bapaume Road approach to Moorebank Avenue, the 'Stop' control sign is located on the right side of the approach only, which is non-standard and undesirable, especially for the majority left-turning traffic – refer to <i>Photo 5</i> in <i>Appendix A</i> .	Low	Traffic signs	Northrop	<p>Noted; BMD will notify Designer Northrop for review.</p> <p>Logos – consider secondary sign on left.</p> <p>This has been rectified with the Stop sign being adjusted to provide additional offset to medians. An additional stop sign has been provided on the updated designs and advanced warnign sign provided on the left (MAAI-NRP-CP-DWG-4111_rev 11 drawing).</p>

PHOTO 5: For the Bapaume Road approach to Moorebank Avenue, the 'Stop' control sign is located on the right side of the approach only, which is non-standard and undesirable, especially for the majority left-turning traffic.

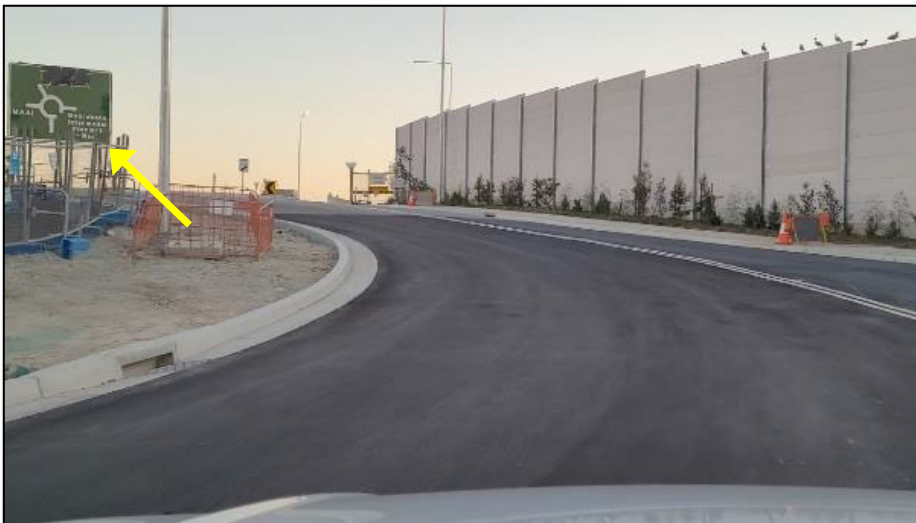
9.	For the southbound approach from Bapaume Road to the BMD site office / Western Ring Road roundabout, the advance direction signage is difficult to sight because it is on the inside of a left curved alignment – refer to <i>Photo 6</i> in <i>Appendix A</i> .	Low	Traffic signs	LOGOS	<p>Noted; The sign installed as per approved design provided by LOGOS. BMD will notify LOGOS for review.</p> <p>Logos – no comment.</p> <p>due to the large radius of the corner this was considered the most suitable location.</p>

PHOTO 6: For the southbound approach from Bapaume Road to the BMD site office / Western Ring Road roundabout, the advance direction signage is difficult to sight because it is on the inside of a left curved alignment.

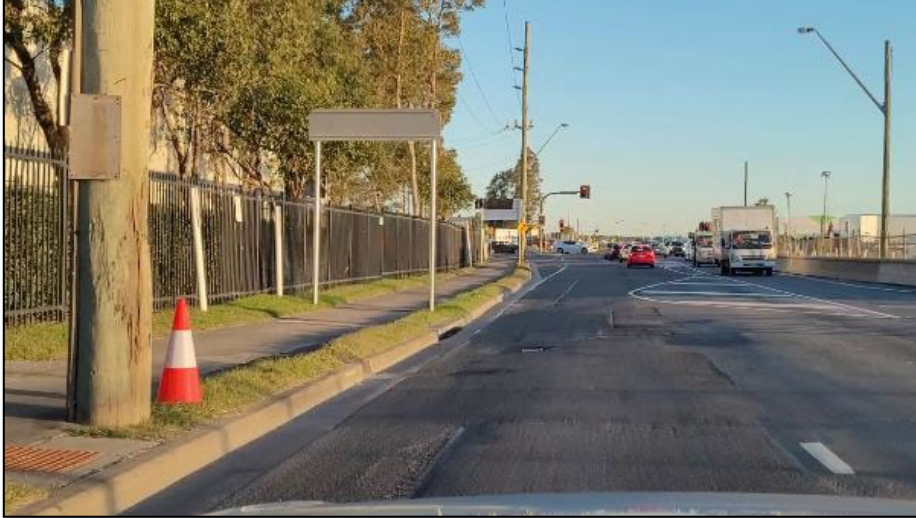
For completion by BMD	
No.	Description of Road Safety Issue	Risk Rating	Road Safety Category	Action by	Response
10.	For travel along Moorebank Avenue at the Bapaume Road intersection, there are sections of poor pavement resulting in sub-standard ride quality and delineation – refer to <i>Photo 7</i> in <i>Appendix A</i> .	Low	Road pavement	BMD	<p>Noted; It is existing road condition. BMD will notify LOGOS for review and required action.</p> <p>Logos – monitor, pavement will be redundant in a few months.</p> <p>We assume this comment relates to the existing condition of Moorebank Avenue and rectification of this will be undertaken in subsequent stages, this is outside the scope of upgraded works.</p>

PHOTO 7: For travel along Moorebank Avenue at the Bapaume Road intersection, there are sections of poor pavement resulting in sub-standard ride quality and delineation.
