# **Moorebank Precinct East – Stage 2 WSUD Independent Audit**

Report Prepared for:  
Department of Planning,  
Housing & Infrastructure

October, 2025  
Project No. 255

| Document title | Moorebank Precinct East Stage 2 – WSUD – 2025 Independent Audit Report | Project number<br>255 |

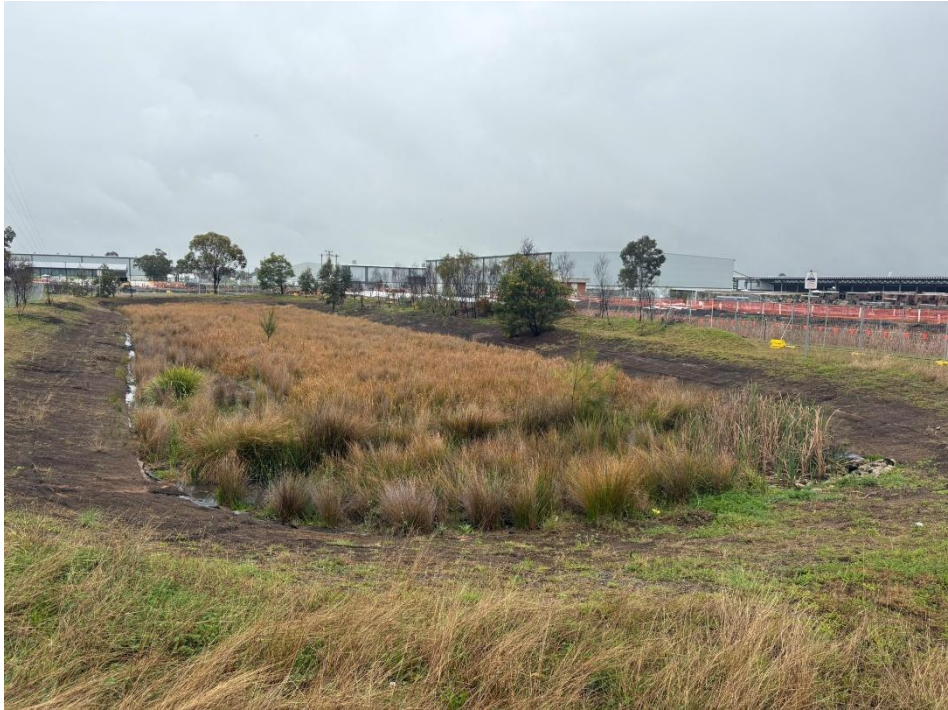
| Photo | Description |
|---|---|
| | <p>OSD 1 bioretention basin showing plant growth throughout the whole basin, denuded batters – batters recommended for planting pursuant to masterplan finalisation.</p> |

Based on the latest masterplan, it appears that OSD 1 remains unchanged in the masterplan, Assuming this to be correct, it is recommended then that the batters of OSD 1 be vegetated in accordance with the original design drawings.

Sheet 12 lists appropriate species and densities for the batters. It is recommended that prior to planting that a quality topsoil, compliant with AS4419 be placed to a minimum depth of 150mm on the batters.

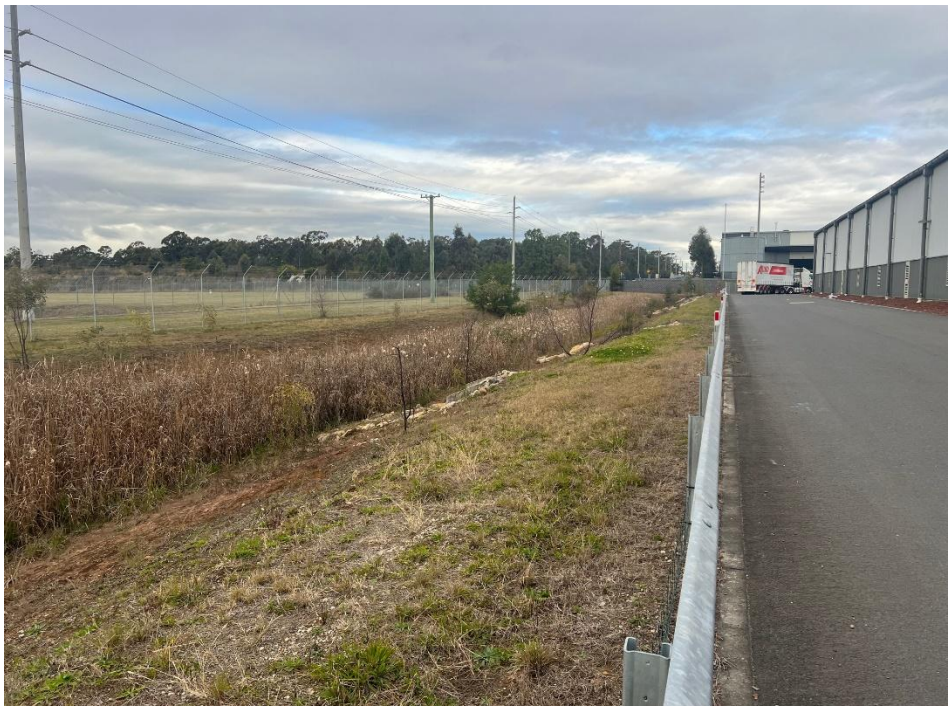
| Photo | Description |
|---|---|
| | <p>Swale adjacent to the OSD 1 in good condition – Previous bank stabilisation works successful and under guard rail shade cloth placement is preventing litter blowing in.</p> |

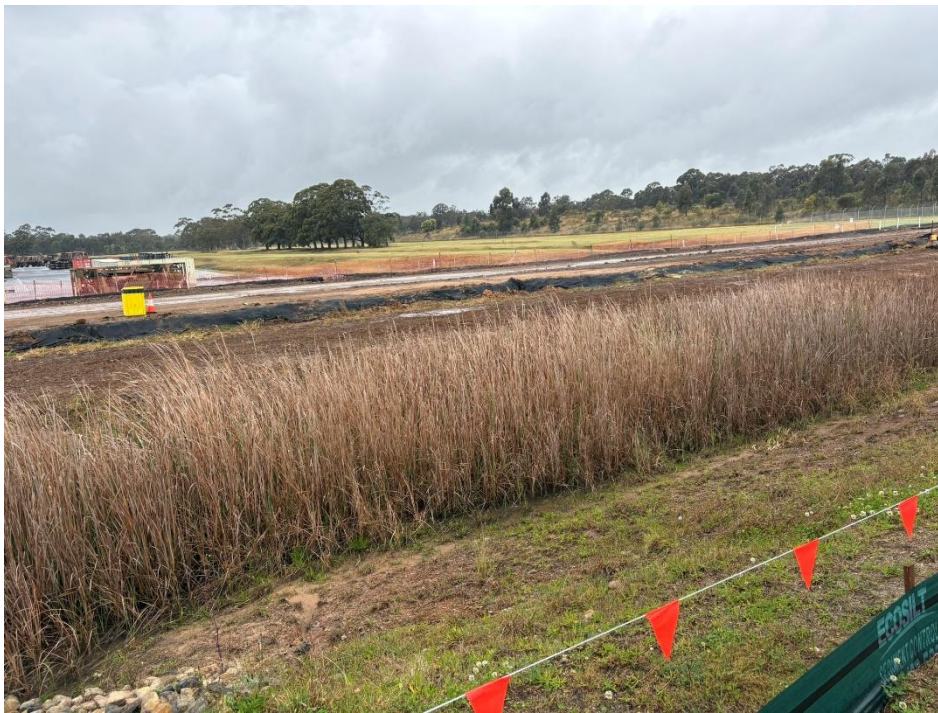
Swale adjacent to the OSD 1 in good condition – (limited access associated with Moorebank Avenue realignment construction works).

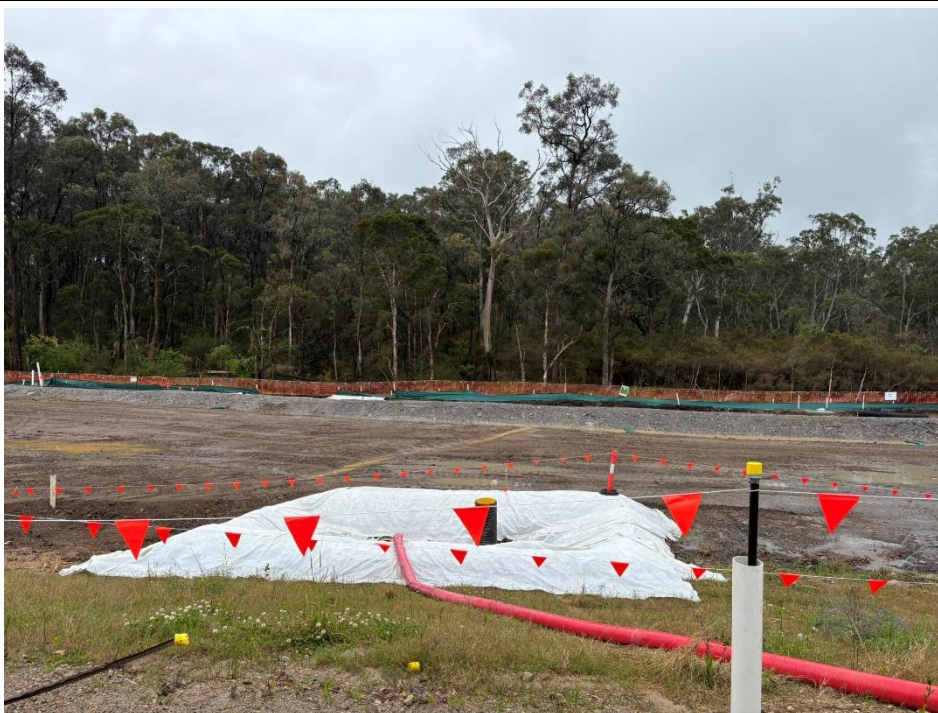
Near OSD2 (Moorebank Avenue deviation under construction in background) Red pipe is conveying inflows from OSD 2 pump station.

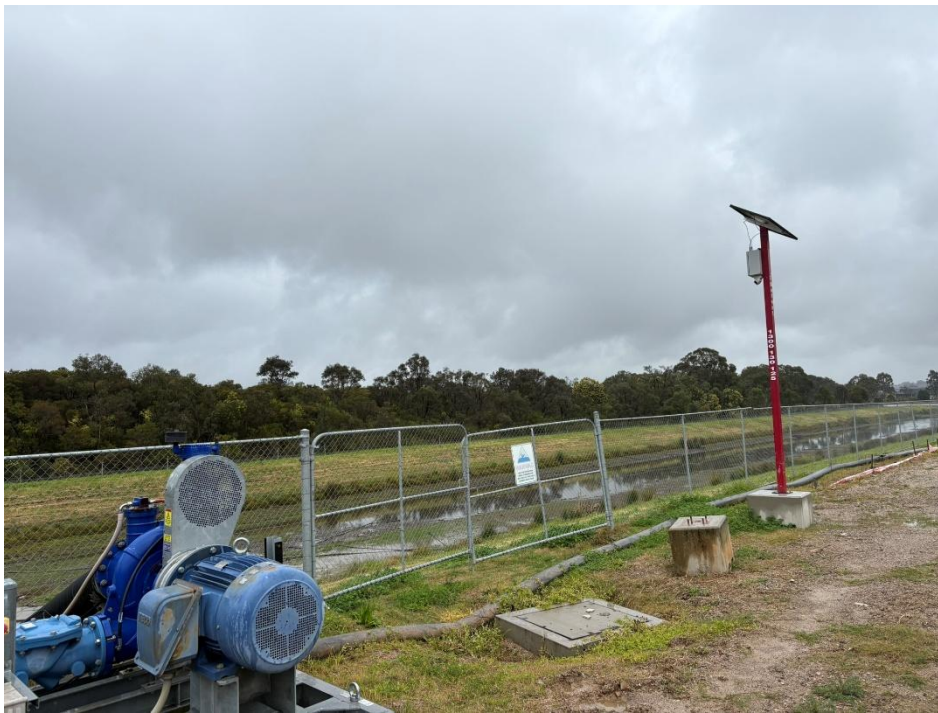
Pump to drain  
OSD2 which  
continues to  
operate as a  
pump out basin.

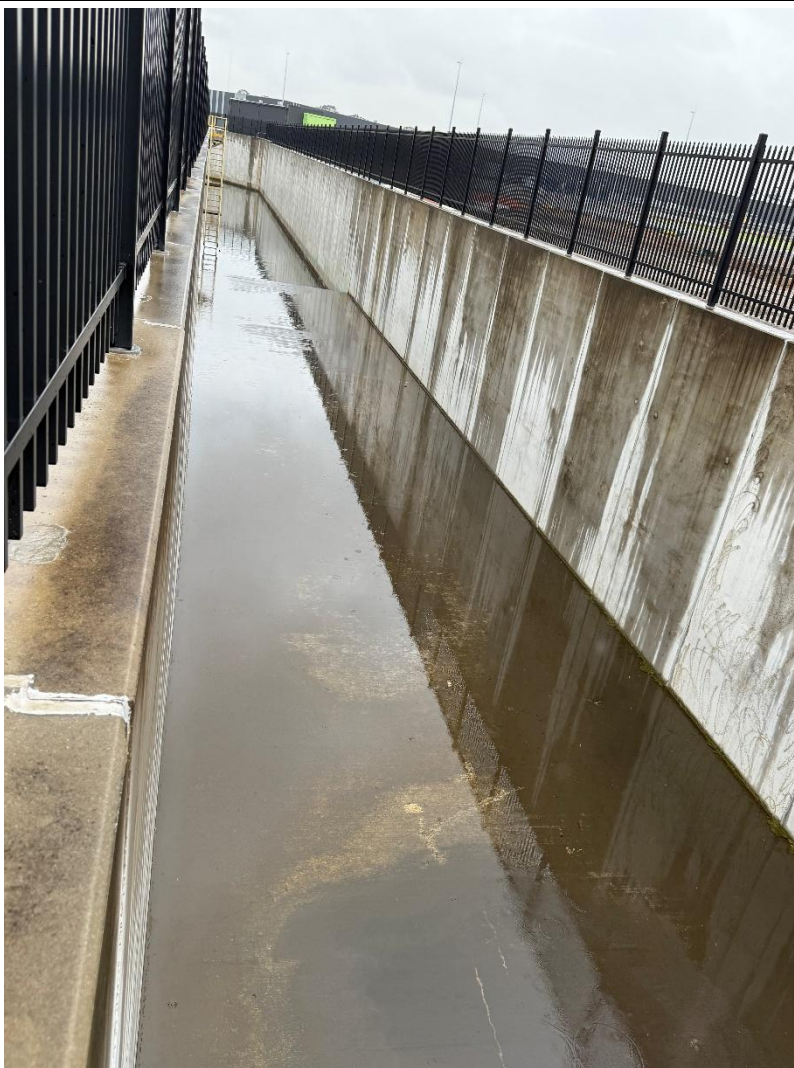
OSD 9 cleaned  
and well  
maintained.
