# Moorebank Precinct West – WSUD Independent Audit

Report Prepared for:  
Department of Planning,  
Housing & Infrastructure

October , 2025  
Project No. 255

| Project title | Moorebank Precinct West – Condition of Consent B36– Independent Audit | |

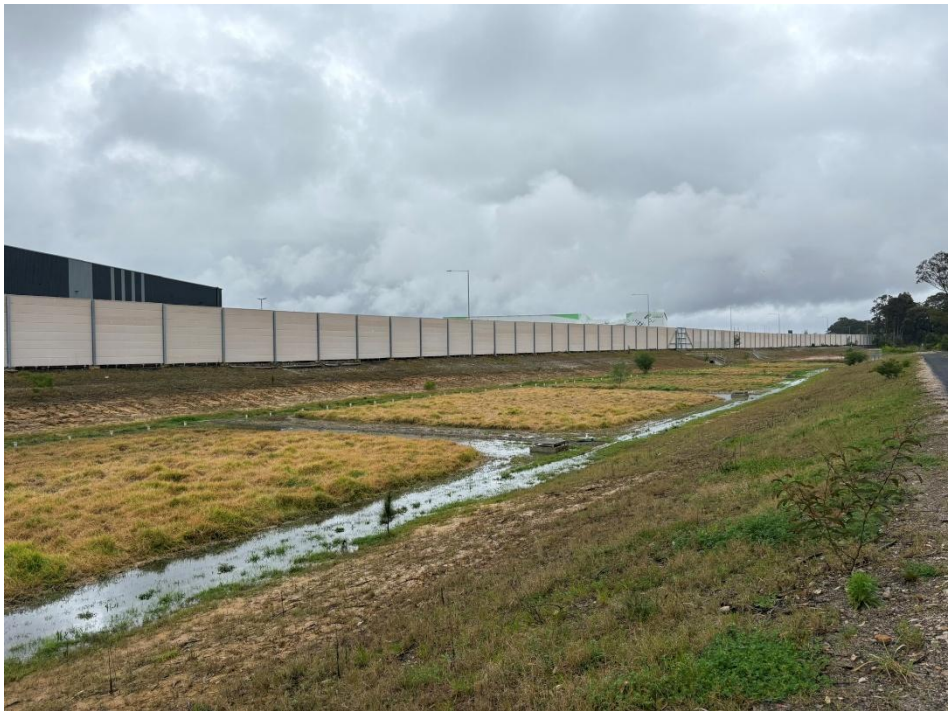
| Type | Details of item | Proposed or completed action | By whom and by when | Status |
|---|---|---|---|---|
| <b>Observation</b> | Grass cutting at OSD 5 has resulted in the borders being mown while the centre is unmown. This may be restricting the entry of water into the centre of the cells and reducing the volume of storage of the bioretention basin. It is noted we were unable to walk into the centre of the basin on the day of the site inspection due to wet weather. It may be that the longer grass in the centre is not at all precluding flows from entering the centre of the basin. | Grass cutting in centre of basin could further improve distribution of water across the basin. It is appreciated that longer grass would typically result in better water quality, in this context it may be resulting in reduced filtration prior to overflow occurring. | Maintenance Contractor | |

| <b>Observation</b> | Lack of vegetation on the sides of OSD Basin 5 will lead to ongoing erosion and deposition of silts and sands on the floor of the basin, especially in the distribution channel. This poses a risk of clogging the underlying transition drainage layer. | Ongoing monitoring and repairs during the sacrificial stage with work to establish a vegetated cover of the batter in accordance with design drawings.<br><br>It is appreciated this batter could be disturbed during the final stage 3 phase where the sacrificial grass is removed and replaced with permanent vegetation. | Maintenance Contractor | |

| Photo | Description |
|---|---|
| | <p>OSD 5 showing signs of erosion on basin sides due to lack of vegetation and a well vegetated basin floor.</p> <p>The photo also shows how the mowing regime may prevent water from flowing into the centre of the cells. Rather it is distributed around the basin perimeter which is likely to be getting a higher hydraulic loading.</p> |

- 1) Basin batters be topsoiled and vegetated in accordance with landscaping plans.
- 2) Basin 5 – more consistent mowing would allow for better distribution of the water across the grass cells in this large basin. There mowing more than the edges is recommended.

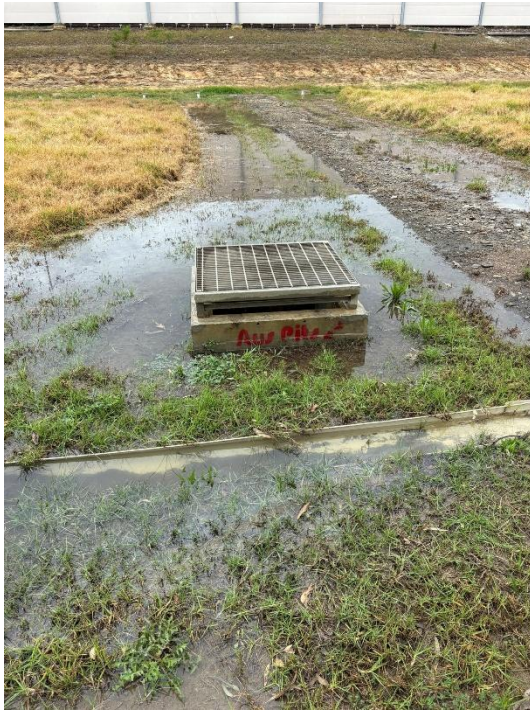
OSD 5 Poor vegetation coverage in places. Some sediment in the distribution pipeline most likely from erosion of the batter.

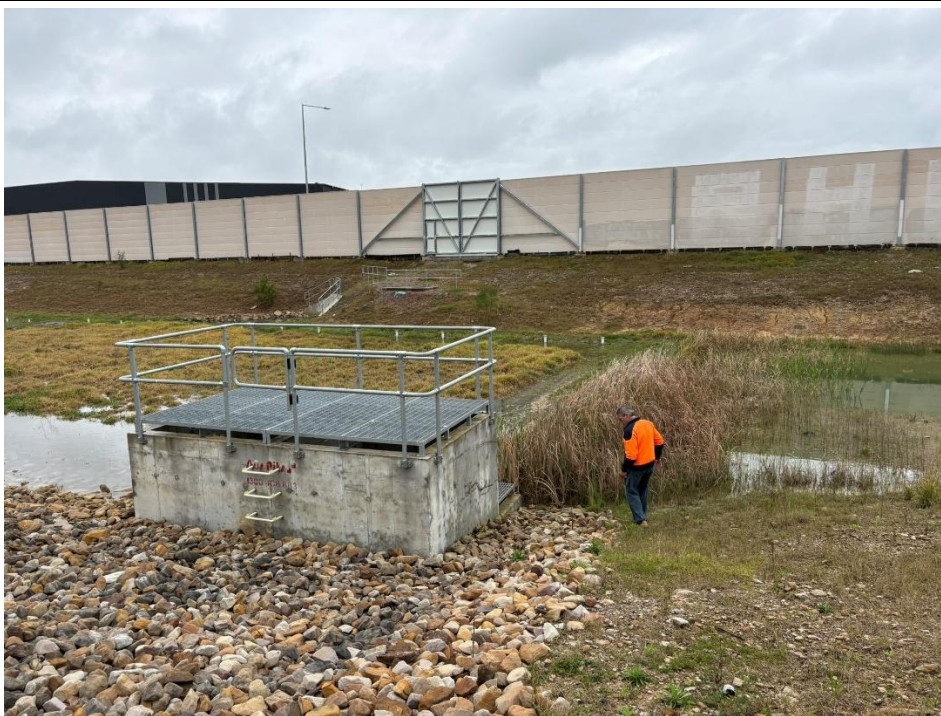
OSD 5 Basin outlet structure with rock armouring.

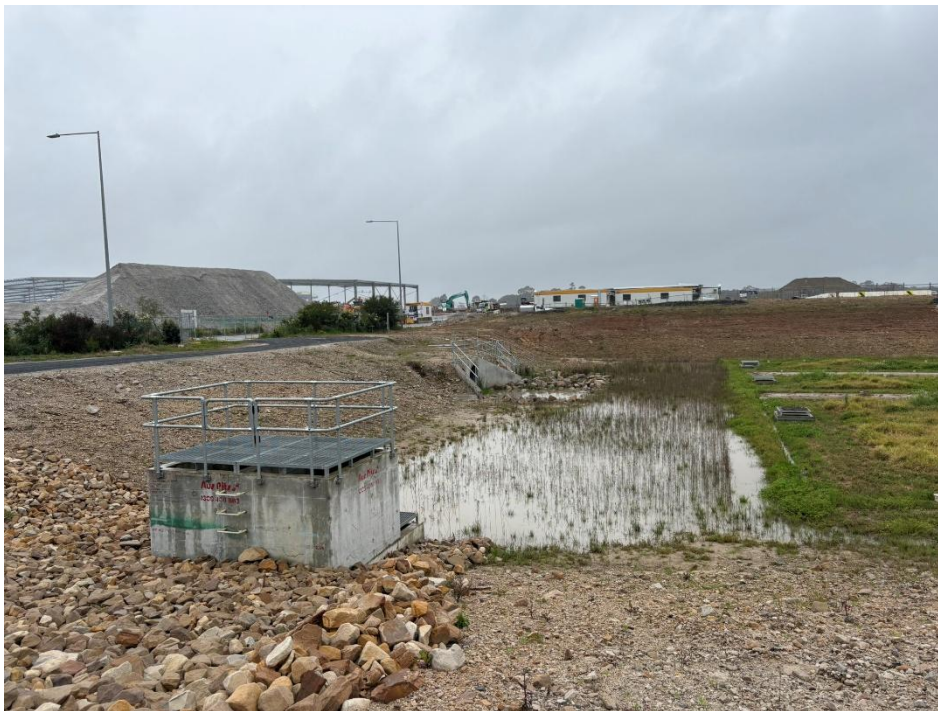
OSD 8 No  
topsoil or  
vegetation  
on the  
batters of  
the basins.

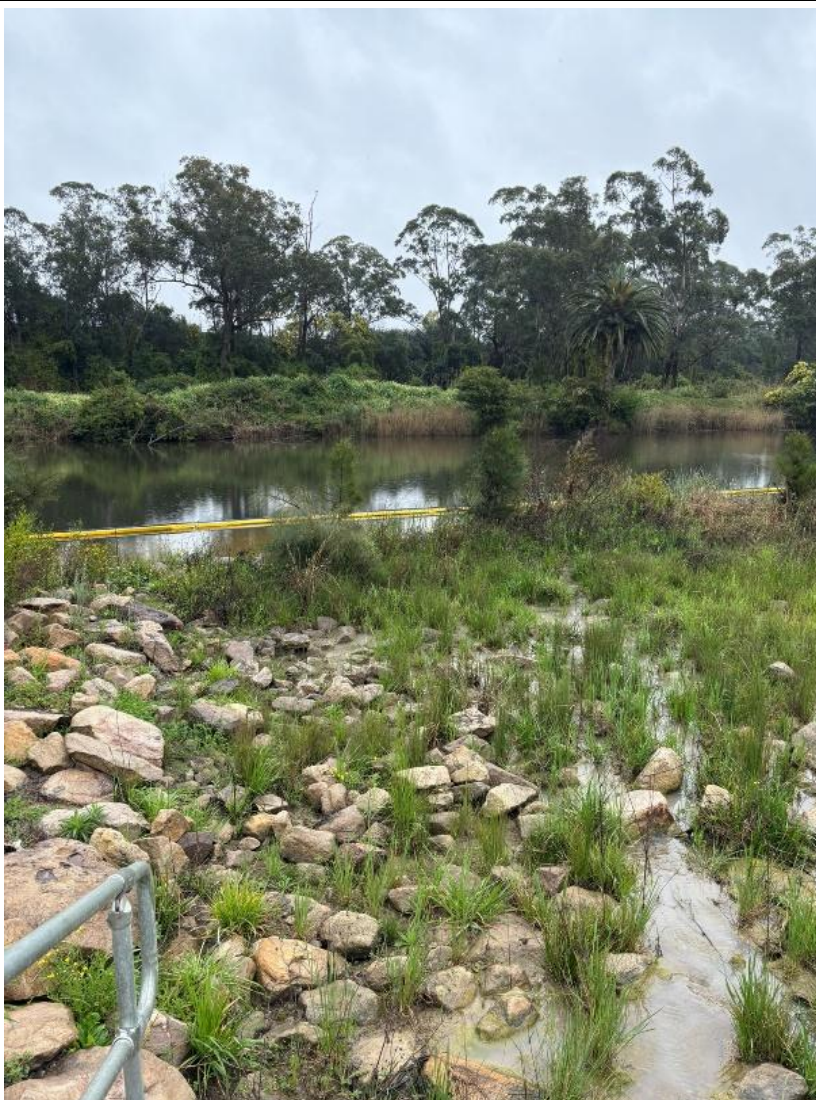
OSD 8  
Water  
quality at  
outlet does  
not appear  
to be  
impacting  
the  
George's  
River.

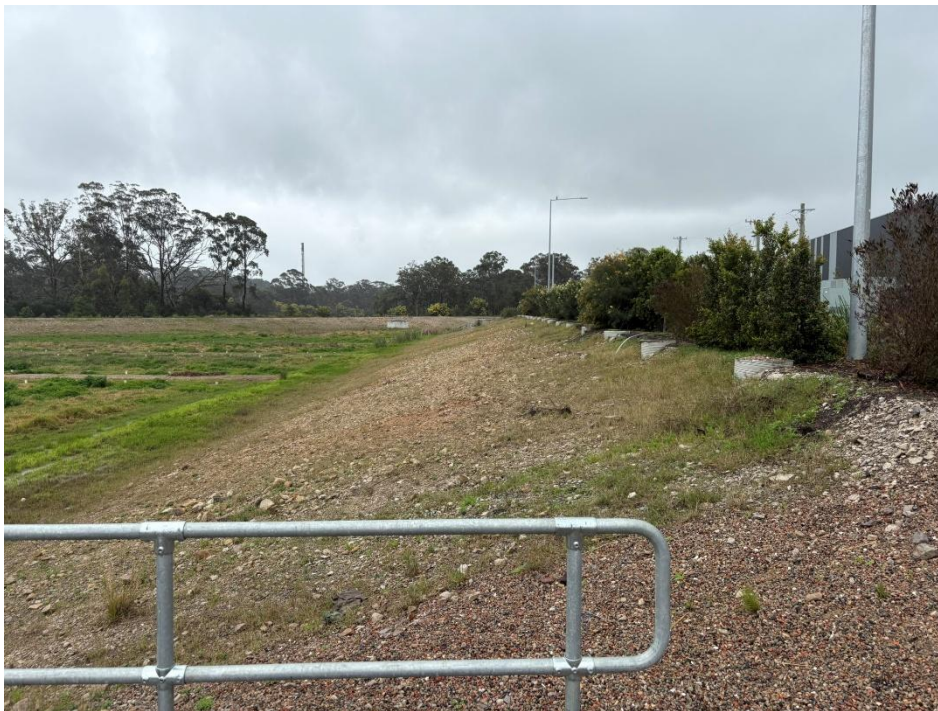
OSD 6  
showing  
batters  
without  
topsoil or  
vegetation.

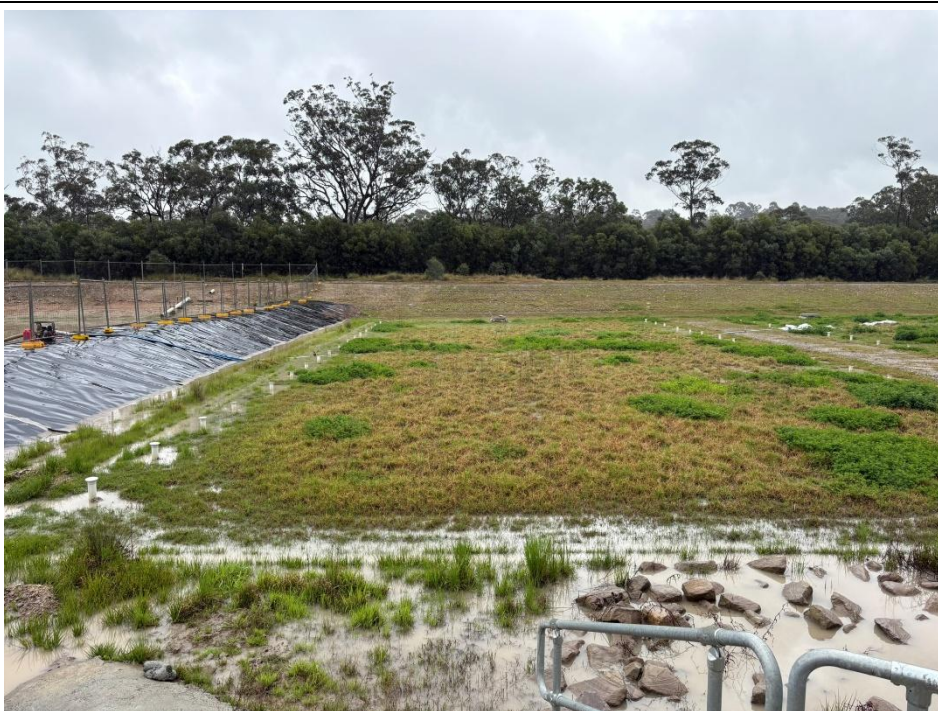
OSD 8  
Sacrificial  
state with  
HDPE lined  
batters and  
pump out  
operation  
from the  
adjacent  
sediment  
basin into  
the biocells.  
This basin  
also  
perimeter  
mowing  
with an  
appearance  
of  
diminished  
flow  
directed to  
centre of  
basin.
