APPENDIX G – WEED MONITORING REPORTS

MIP BI-MONTHLY WEED MONITORING REPORT – JUNE 2025

Arcadis has been commissioned to conduct bi-monthly weed monitoring surveys within the operational areas of Moorebank Precinct East (MPE) and Moorebank Precinct West (MPW). These areas together are known as the Moorebank Intermodal Precinct (MIP).

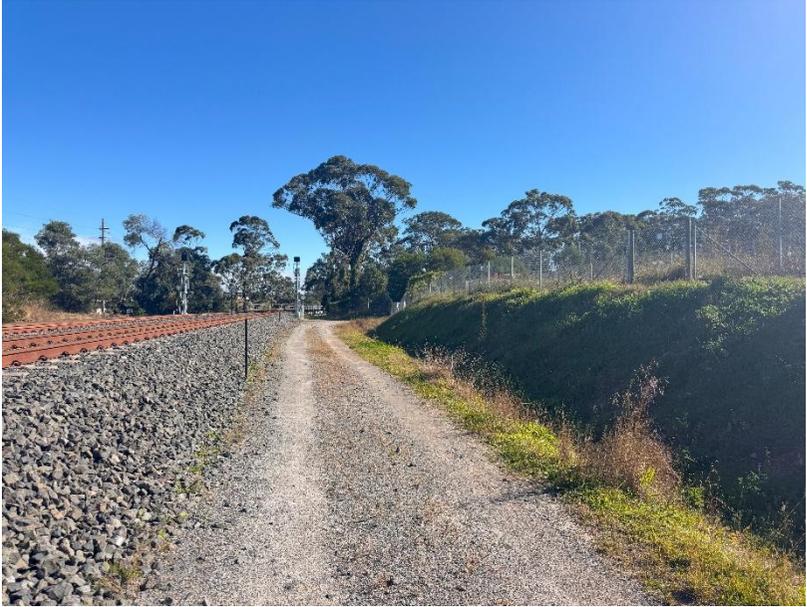
Inspection area	Weed abundances for current survey	Photo of inspection area
Moorebank Precinct East (MPE)		
Rail Access Land Package (RALP)	<ul style="list-style-type: none"> • <i>Chloris gayana</i> (Rhodes Grass) and small amounts of <i>Themeda quadrivalvis</i> (Grader Grass) were removed during this inspection • Some areas of <i>Lantana camara</i> (Lantana) were slashed along the fences adjacent to the Georges River BioBank site • The southern section of the RALP, in areas that have previously experienced significant batter erosion, were being colonised intensely by <i>Tagetes minuta</i> (Stinking Roger), and were slashed during this inspection (see adjacent photo).

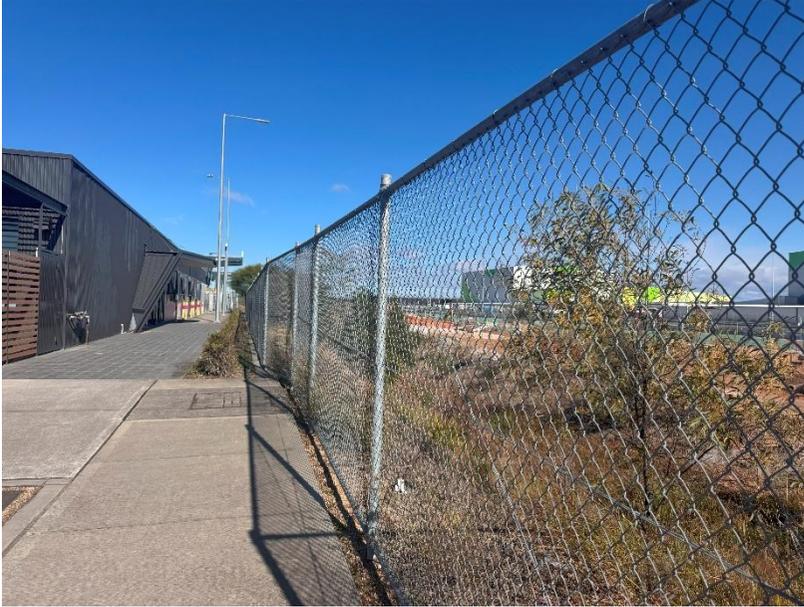
Inspection area	Weed abundances for current survey	Photo of inspection area
<p>IMEX building and adjacent drainage infrastructure</p>	<ul style="list-style-type: none">• <i>Acacia falcata</i> (Hickory Wattle) continue to grow unimpeded by weeds.

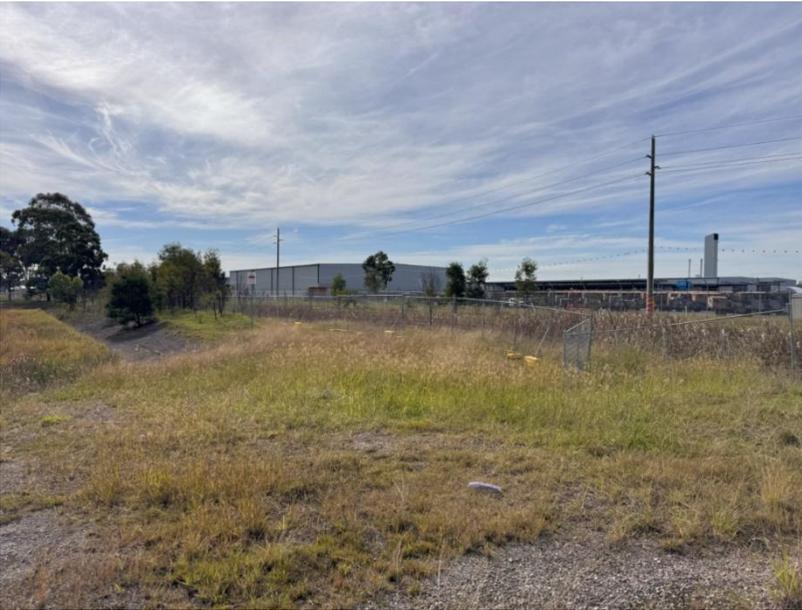
Inspection area	Weed abundances for current survey	Photo of inspection area
Warehouse areas	<ul style="list-style-type: none"> • Large areas of the native <i>Cynodon dactylon</i> (Couch Grass) are present across most of these areas and is generally outcompeting weed species. • Occurrences of weeds in the warehouse area and the adjacent drainage infrastructure is restricted to scattered individuals of <i>Senecio madagascariensis</i> (Fireweed), <i>Plantago lanceolata</i> (Plantain), <i>Trifolium arvense</i> (Clover) and exotic grasses like <i>Chloris gayana</i> (Rhodes Grass), <i>Sporobolus africanus</i> (Parramatta Grass), <i>Paspalum urvillei</i> (Giant Paspalum) and <i>Ehrharta erect</i> (Panic Veldtgrass) • Majority of this area has now been claimed by the Moorebank Avenue Upgrade project.

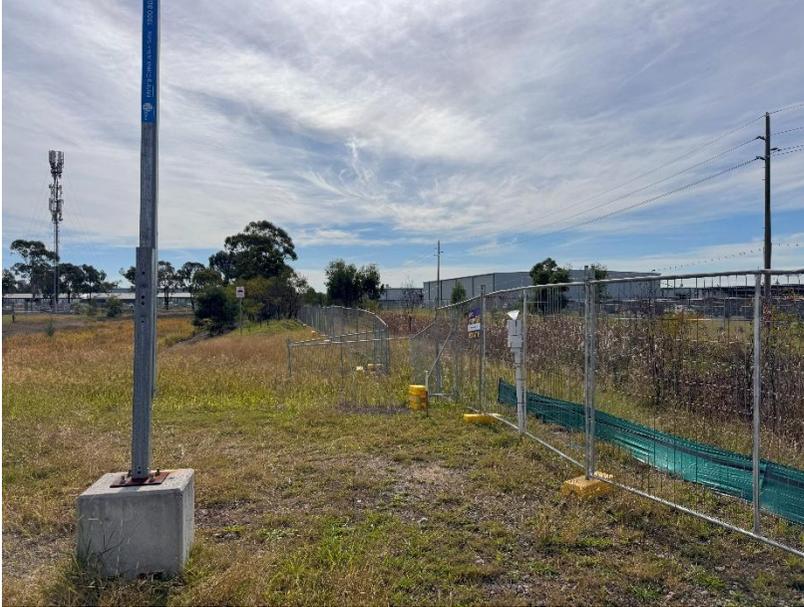
Inspection area	Weed abundances for current survey	Photo of inspection area
<p>Eastern boundary drainage infrastructure</p>	<ul style="list-style-type: none"> • Drainage infrastructure dominated by <i>Bulboschoenus fluviatilis</i> (Marsh club-rush) whilst other are dominated by <i>Typha orientalis</i> (Bulrush). Where space is present between stands of these native emergent species small clumps of <i>Panicum polyanthemum</i> (Slender Knotweed), <i>Daviesia ulicifolia</i>, <i>Ficinia nodosa</i> (Knotted Club-rush), <i>Carex tereticaulis</i> and <i>Juncus usitatus</i> are present. Other native species such as <i>Imperata cylindrica</i> and <i>Lomandra longifolia</i> were observed in the drainage channels. • Areas of erosion still present.

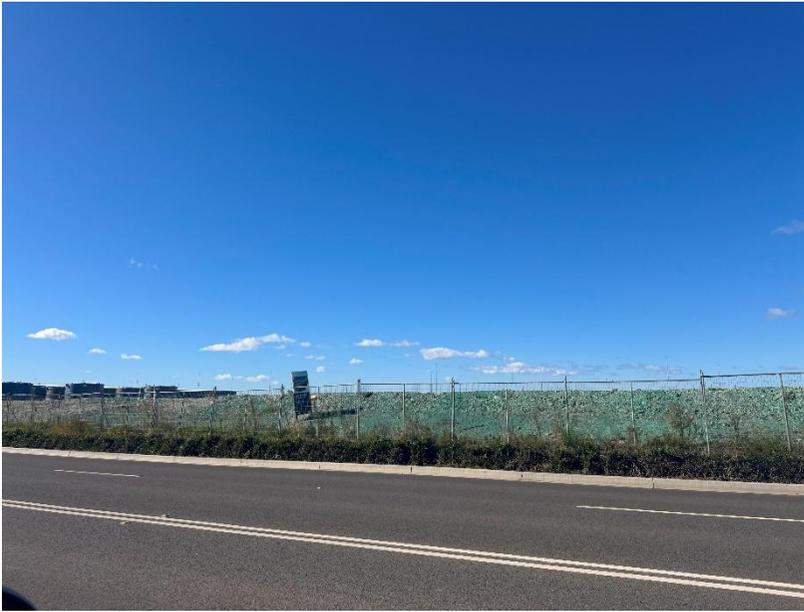
Inspection area	Weed abundances for current survey	Photo of inspection area
Moorebank Precinct West (MPW)		
<p>Landscaped areas along Bushmasters Avenue</p>	<ul style="list-style-type: none"> • Landscapes vegetation is in good condition, with minor weed incursions • Weed species present include <i>Sonchus oleraceus</i> (Common Sowthistle), <i>Chloris virgata</i> (Rhodes Grass), <i>Bidens pilosa</i>, <i>Conyza bonariensis</i> (Fleabane), <i>Cyclosporum leptophyllum</i> (Slender Celery), and <i>Tagetes minuta</i> (Stinking Roger). • Areas with limited to no landscaped vegetation are particularly susceptible to weed incursion from cleared areas (see adjacent photo)

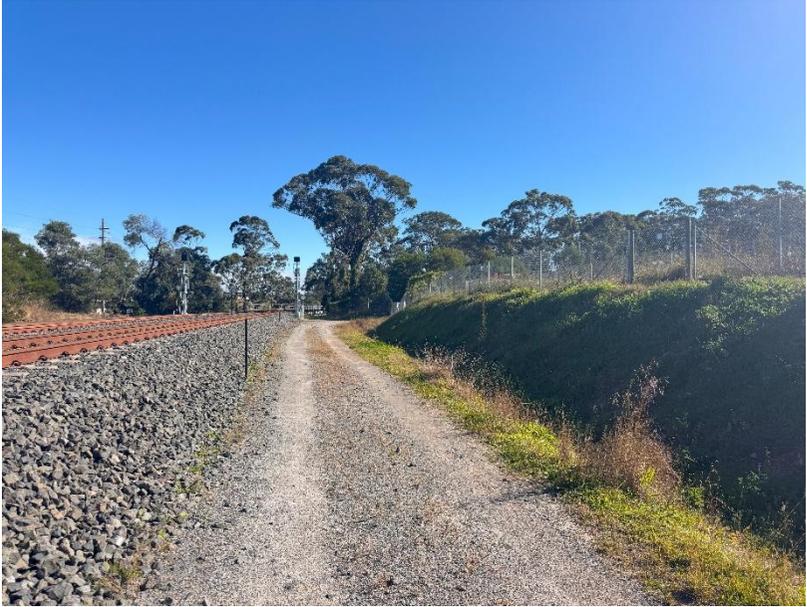
Inspection area	Weed abundances for current survey	Photo of inspection area
Moorebank Precinct East (MPE)		
Rail Access Land Package (RALP)	<ul style="list-style-type: none"> • Weed growth has been slow since June 2025 inspection • Small instances of Fireweed slashed • Steep areas along berms are being avoided for slashing due to safety concerns. Additionally, the small amounts of exotic vegetation are currently stabilising these berms, and will be targeted once construction is finalised in the MPW areas.

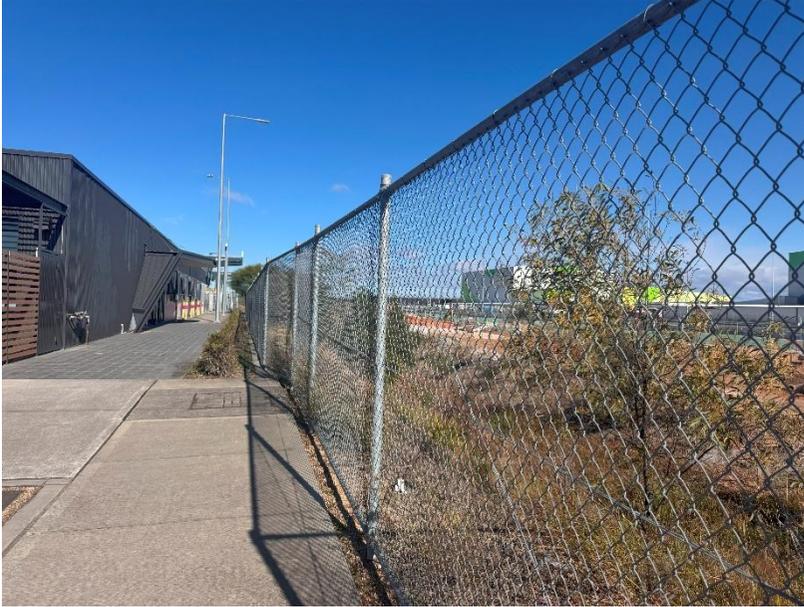
Inspection area	Weed abundances for current survey	Photo of inspection area
<p>IMEX building and adjacent drainage infrastructure</p>	<ul style="list-style-type: none">• <i>Acacia falcata</i> (Hickory Wattle) continue to grow unimpeded by weeds.

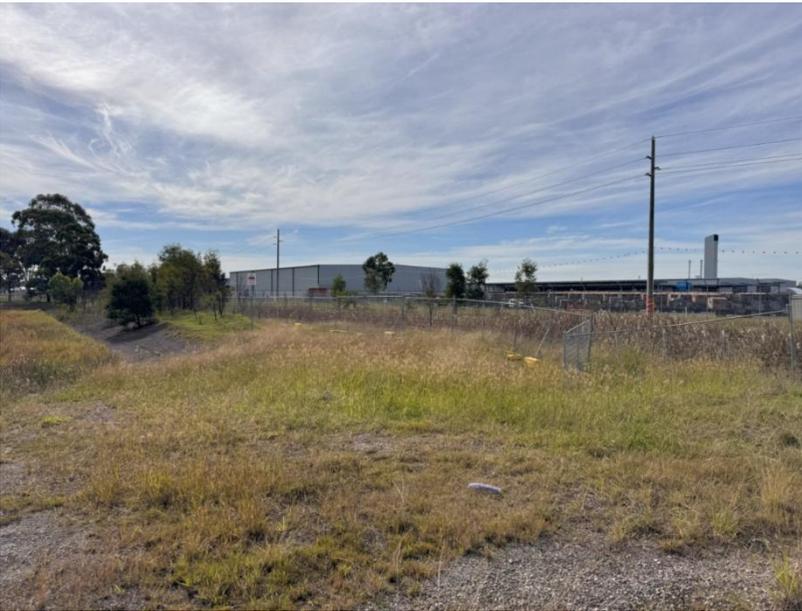
Inspection area	Weed abundances for current survey	Photo of inspection area
Warehouse areas	<ul style="list-style-type: none"> • Large areas of the native <i>Cynodon dactylon</i> (Couch Grass) are present across most of these areas and is generally outcompeting weed species. • Occurrences of weeds in the warehouse area and the adjacent drainage infrastructure is restricted to scattered individuals of <i>Senecio madagascariensis</i> (Fireweed), <i>Plantago lanceolata</i> (Plantain), <i>Trifolium arvense</i> (Clover) and exotic grasses like <i>Chloris gayana</i> (Rhodes Grass), <i>Sporobolus africanus</i> (Parramatta Grass), <i>Paspalum urvillei</i> (Giant Paspalum) and <i>Ehrharta erect</i> (Panic Veldtgrass) • Majority of this area has now been claimed by the Moorebank Avenue Upgrade project.

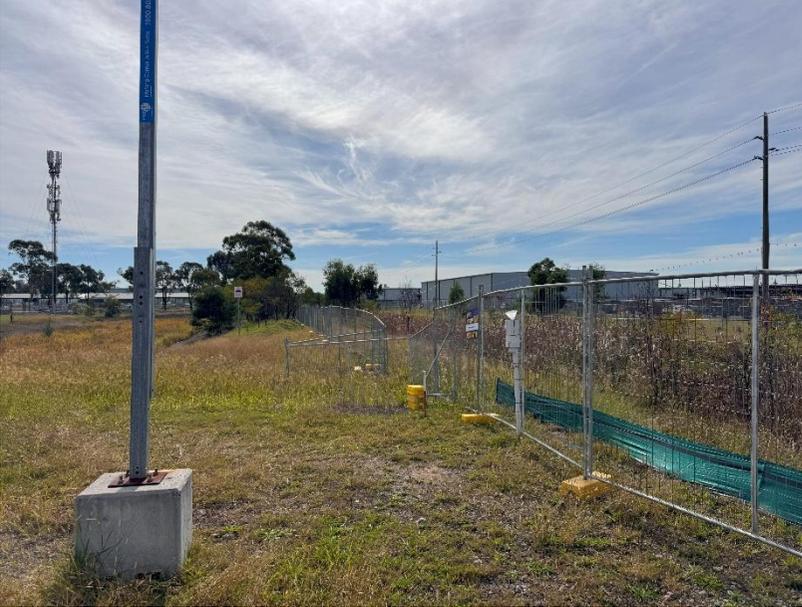
Inspection area	Weed abundances for current survey	Photo of inspection area
Eastern boundary drainage infrastructure	<ul style="list-style-type: none">• Drainage infrastructure dominated by <i>Bulboschoenus fluviatilis</i> (Marsh club-rush) whilst other are dominated by <i>Typha orientalis</i> (Bulrush). Where space is present between stands of these native emergent species small clumps of <i>Pericaria decipiens</i> (Slender Knotweed), <i>Daviesia ulicifolia</i>, <i>Ficinia nodosa</i> (Knotted Club-rush), <i>Carex tereticaulis</i> and <i>Juncus usitatus</i> are present. Other native species such as <i>Imperata cylindrica</i> and <i>Lomandra longifolia</i> were observed in the drainage channels.• Areas of erosion still present.

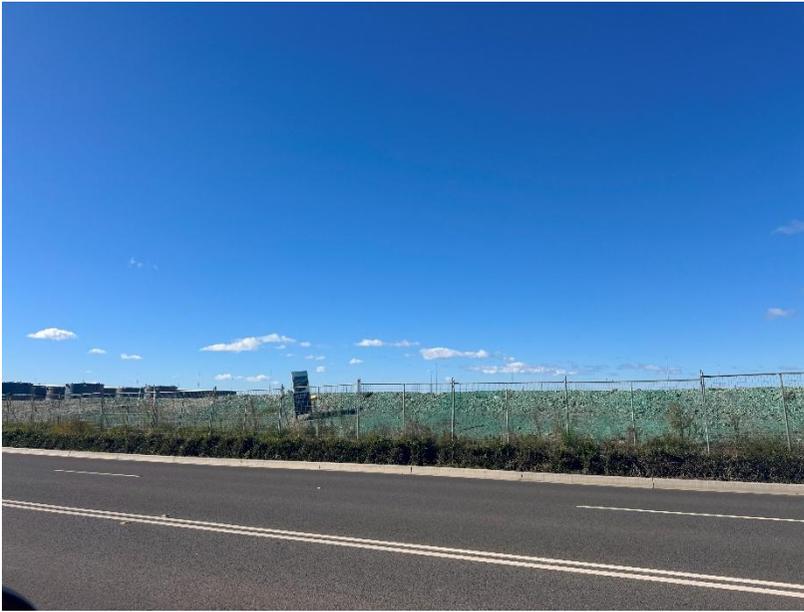
Inspection area	Weed abundances for current survey	Photo of inspection area
Moorebank Precinct West (MPW)		
<p>Landscaped areas along Bushmasters Avenue</p>	<ul style="list-style-type: none"> • Landscapes vegetation is in good condition, with minor weed incursions • Weed species present include <i>Sonchus oleraceus</i> (Common Sowthistle), <i>Chloris virgata</i> (Rhodes Grass), <i>Bidens pilosa</i>, <i>Conyza bonariensis</i> (Fleabane), <i>Cyclosporum leptophyllum</i> (Slender Celery), and <i>Tagetes minuta</i> (Stinking Roger). • Areas with limited to no landscaped vegetation are particularly susceptible to weed incursion from cleared areas (see adjacent photo)

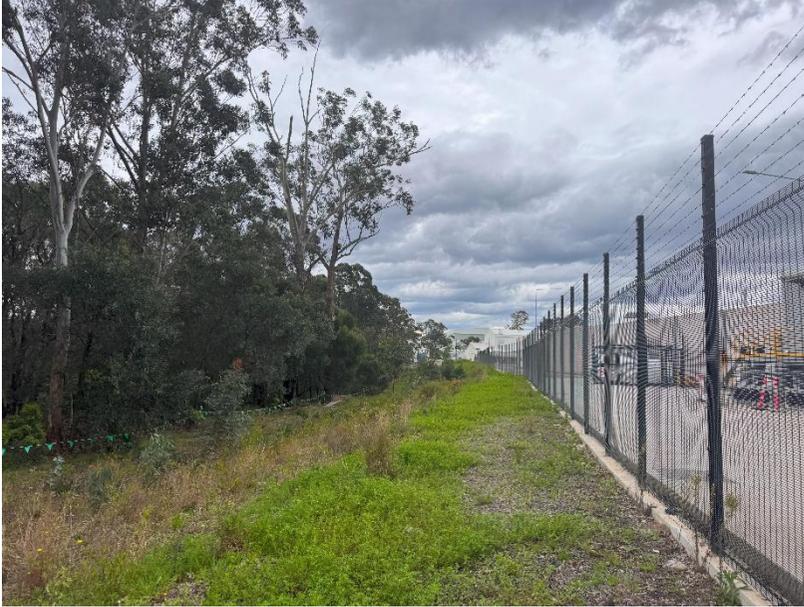
Inspection area	Weed abundances for current survey	Photo of inspection area
APZ area – northern MPW	<ul style="list-style-type: none">• Suppression of <i>Medicago</i> and other herbaceous weeds occurring in this area (<i>Sonchus oleraceus</i> (Common Sowthistle), <i>Cirsium vulgare</i>)• Methods include slashing and hand removal around native species

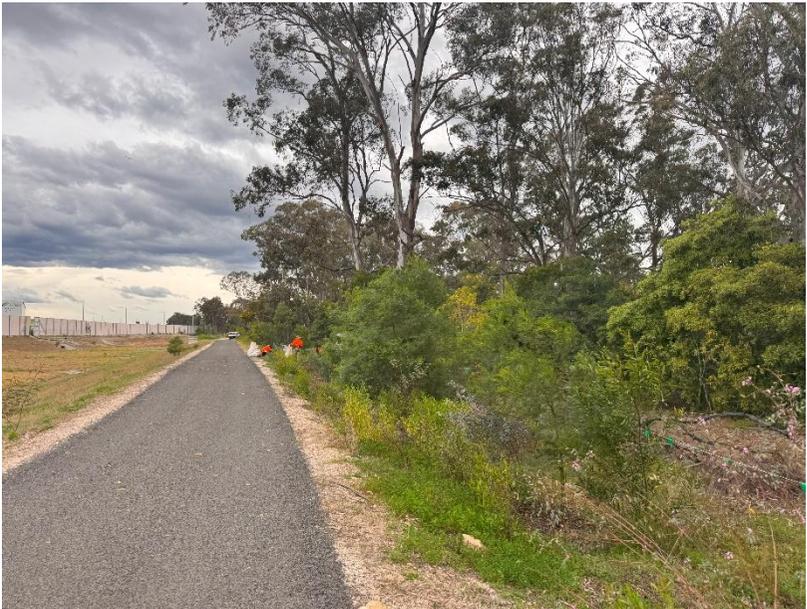
Inspection area	Weed abundances for current survey	Photo of inspection area
<p>Sediment basins adjacent to BioBank site</p>	<ul style="list-style-type: none">• Spot spraying, and hand pulling of weeds occurring along boundary of basins and BioBank site

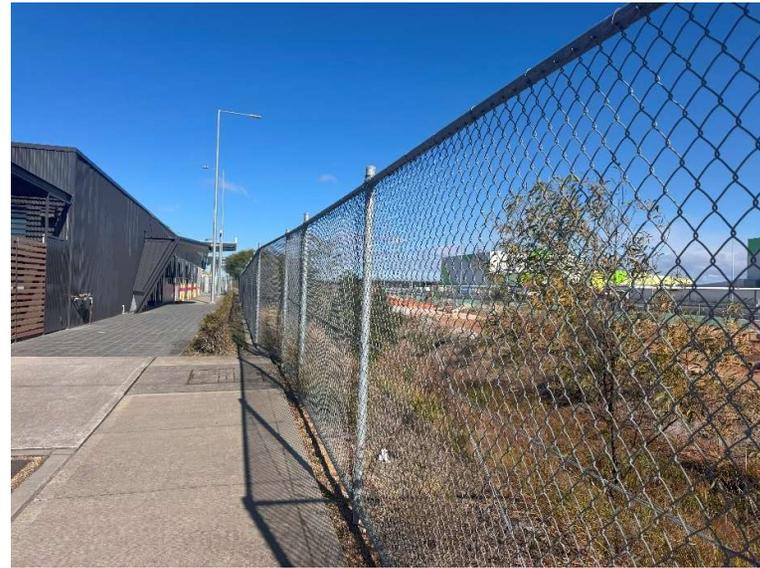
- *Acacia falcata* (Hickory Wattle) continue to grow unimpeded by weeds.

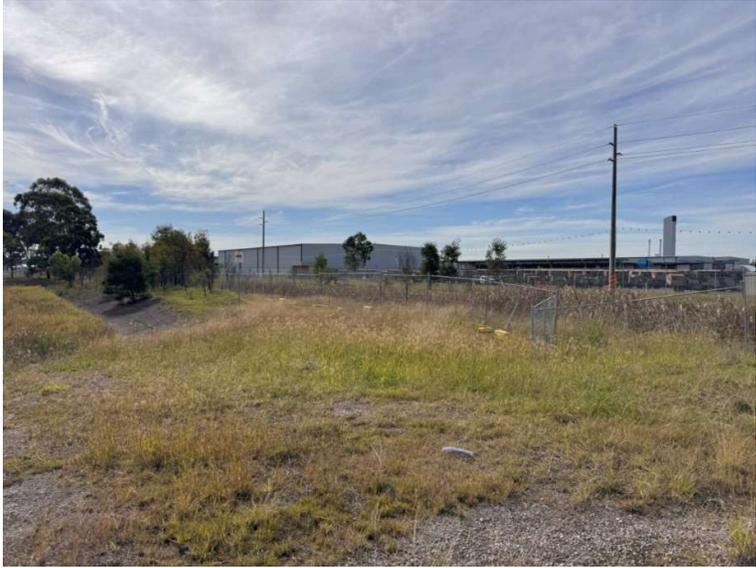
Inspection area	Weed abundances for current survey	Photo of inspection area
Warehouse areas	<ul style="list-style-type: none"> Majority of this area has now been claimed by the Moorebank Avenue Upgrade project and is unable to be surveyed adequately Occurrences of weeds in the warehouse area and the adjacent drainage infrastructure is restricted to scattered individuals of <i>Senecio madagascariensis</i> (Fireweed), <i>Plantago lanceolata</i> (Plantain), <i>Trifolium arvense</i> (Clover) and exotic grasses like <i>Chloris gayana</i> (Rhodes Grass), <i>Sporobolus africanus</i> (Parramatta Grass), <i>Paspalum urvillei</i> (Giant Paspalum) and <i>Ehrharta erect</i> (Panic Veldtgrass).

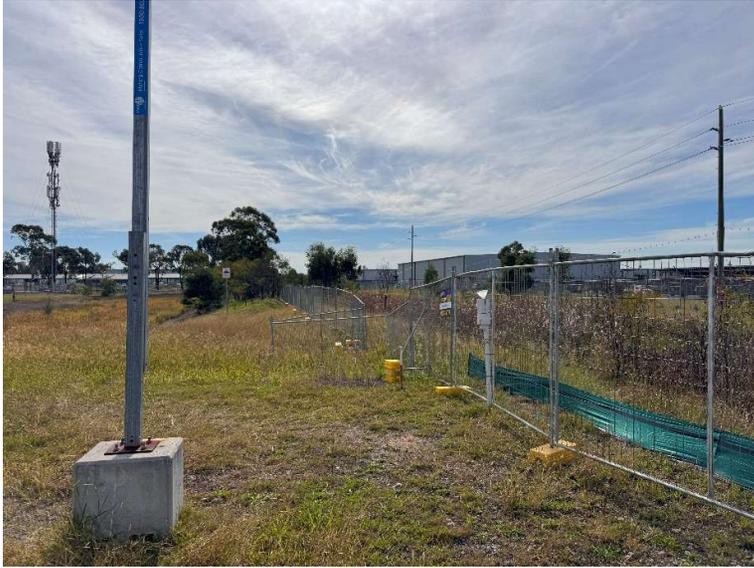
Inspection area	Weed abundances for current survey	Photo of inspection area
Eastern boundary drainage infrastructure	<ul style="list-style-type: none"> Majority of this area has now been claimed by the Moorebank Avenue Upgrade project and is unable to be surveyed adequately Drainage infrastructure dominated by <i>Bulboschoenus fluviatilis</i> (Marsh club-rush) whilst other are dominated by <i>Typha orientalis</i> (Bulrush). Where space is present between stands of these native emergent species small clumps of <i>Persicaria decipiens</i> (Slender Knotweed), <i>Daviesia ulicifolia</i>, <i>Ficinia nodosa</i> (Knotted Club-rush), <i>Carex tereticaulis</i> and <i>Juncus usitatus</i> are present. Other native species such as <i>Imperata cylindrica</i> and <i>Lomandra longifolia</i> were observed in the drainage channels. Areas of erosion still present.

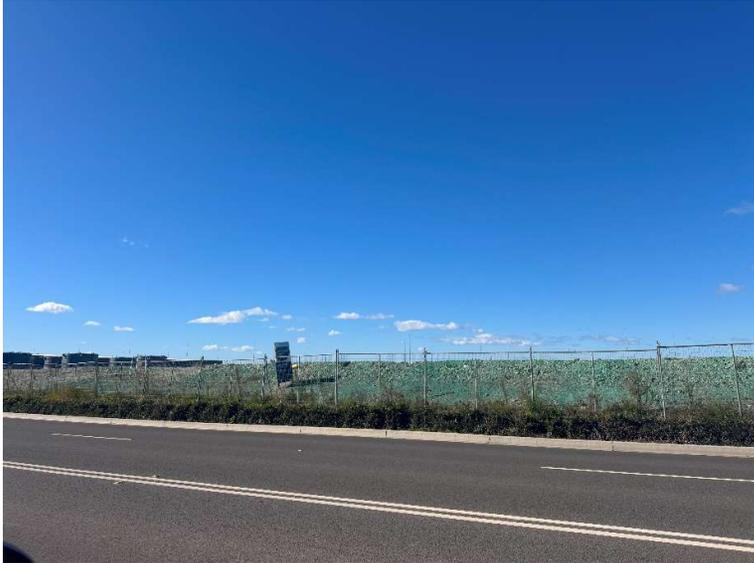
Inspection area	Weed abundances for current survey	Photo of inspection area
Moorebank Precinct West (MPW)		
<p>Landscaped areas along Bushmasters Avenue</p>	<ul style="list-style-type: none"> • Landscapes vegetation is in good condition, with minor weed incursions • Weed species present include <i>Sonchus oleraceus</i> (Common Sowthistle), <i>Chloris virgata</i> (Rhodes Grass), <i>Bidens pilosa</i>, <i>Conyza bonariensis</i> (Fleabane), <i>Cyclosporum leptophyllum</i> (Slender Celery), and <i>Tagetes minuta</i> (Stinking Roger). • Areas with limited to no landscaped vegetation are particularly susceptible to weed incursion from cleared areas (see adjacent photo)

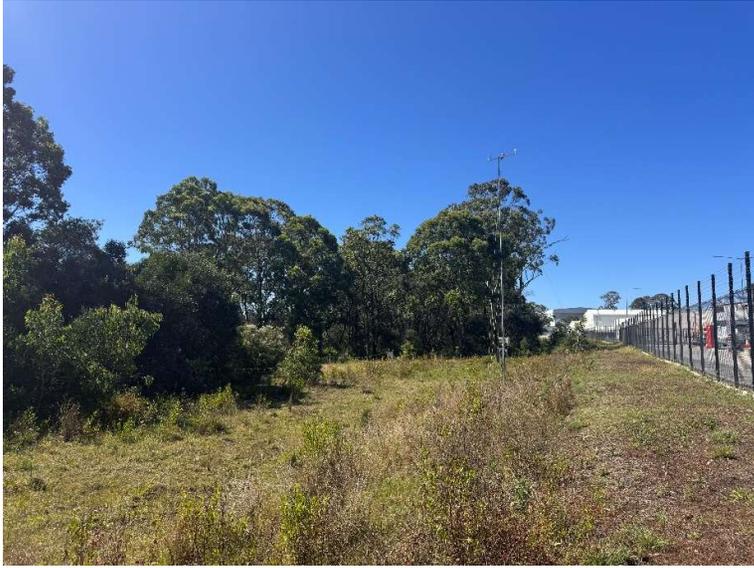
Inspection area	Weed abundances for current survey	Photo of inspection area
APZ area – northern MPW	<ul style="list-style-type: none">• Suppression of <i>Medicago polymorpha</i> and other herbacious weeds occuring in this area (<i>Sonchus oleraceus</i> (Common Sowthistle), <i>Cirsium vulagre</i>)• Methods include slashing and hand removal around native species• Large stands of the native shrub <i>Dodonea viscosa</i> are growing unimpeded.

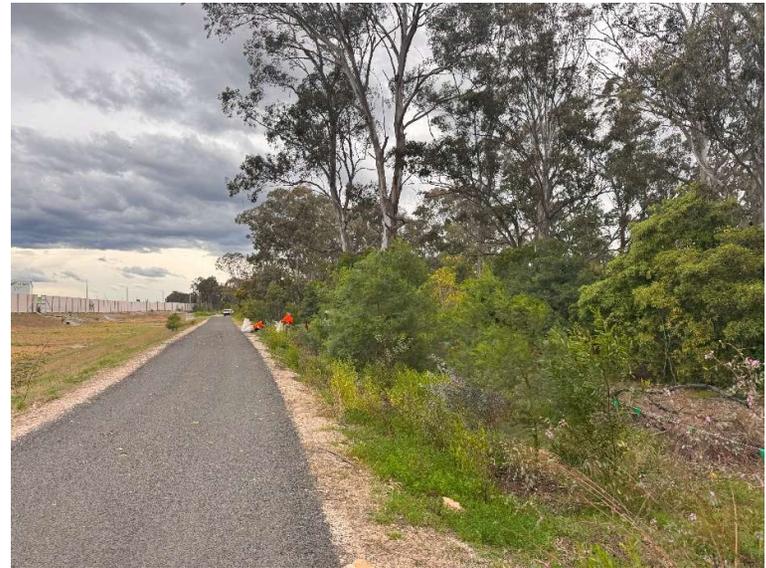
Sediment basins adjacent to BioBank site

- Spot spraying, and hand pulling of weeds occurring along boundary of basins and BioBank site
- No significant increases in weed coverage were observed around the basin outlet points

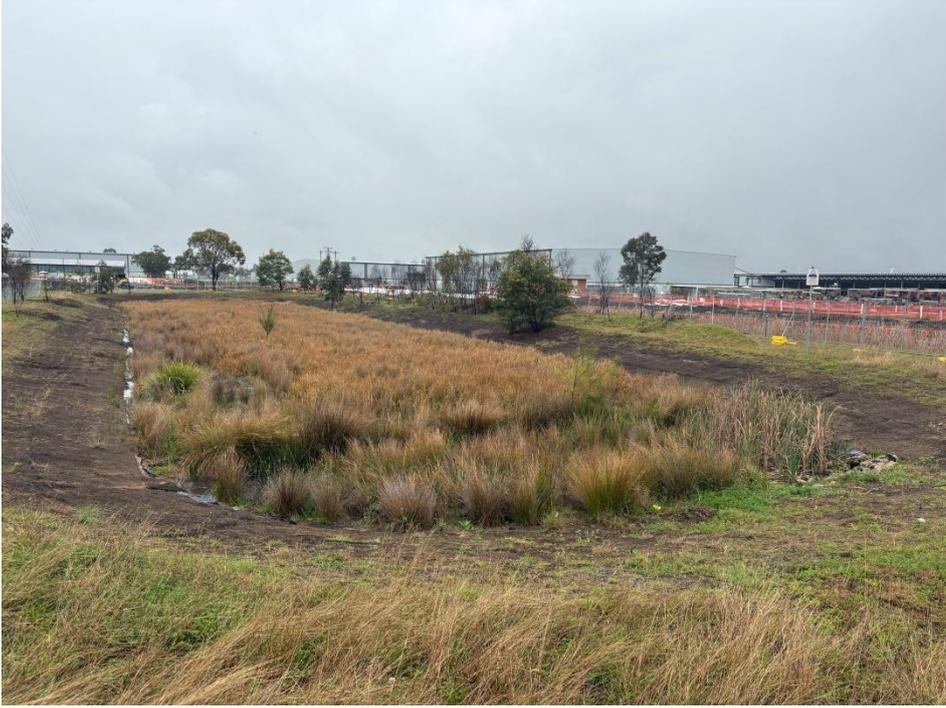
<p>OSD 1 bioretention basin showing plant growth throughout the whole basin, denuded batters – batters recommended for planting pursuant to masterplan finalisation.</p>

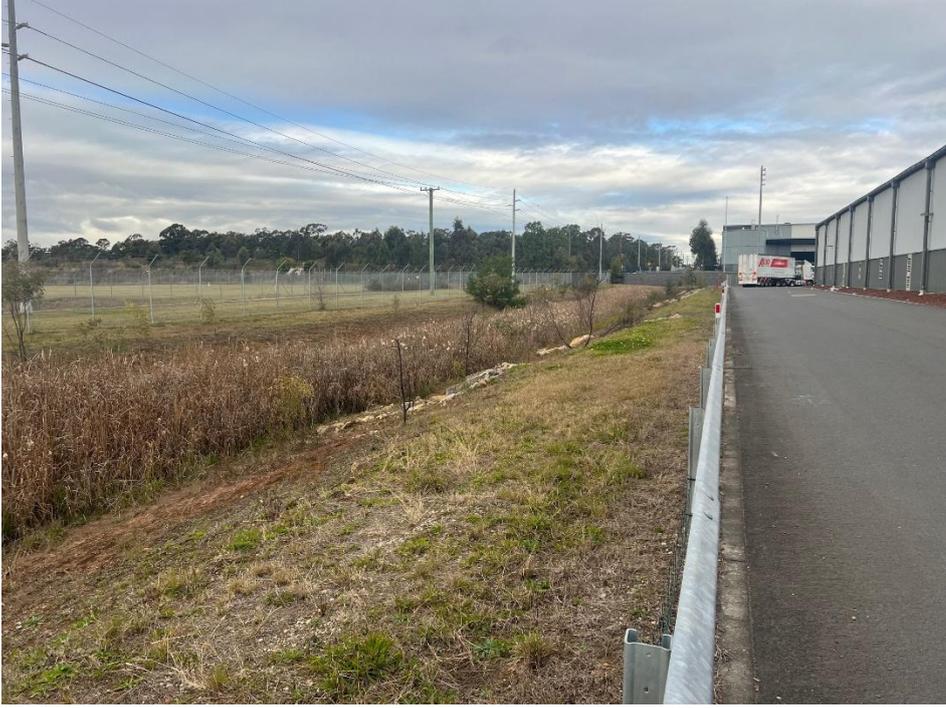
<p>Swale adjacent to the OSD 1 in good condition – Previous bank stabilisation works successful and under guard rail shade cloth placement is preventing litter blowing in.</p>

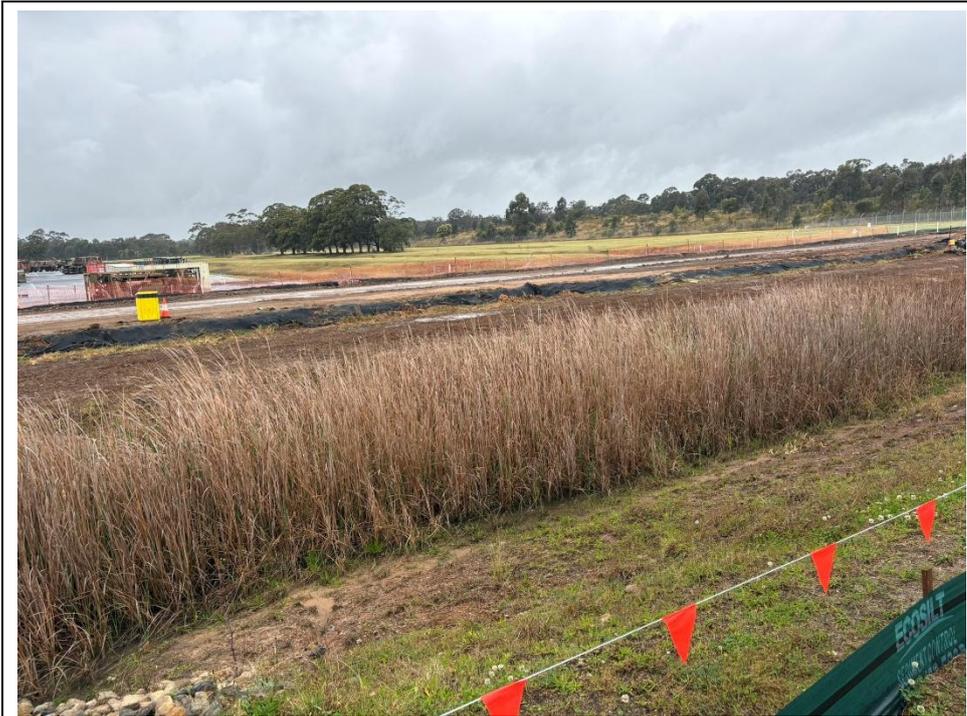
Swale adjacent to the OSD 1 in good condition – (limited access associated with Moorebank Avenue realignment construction works).

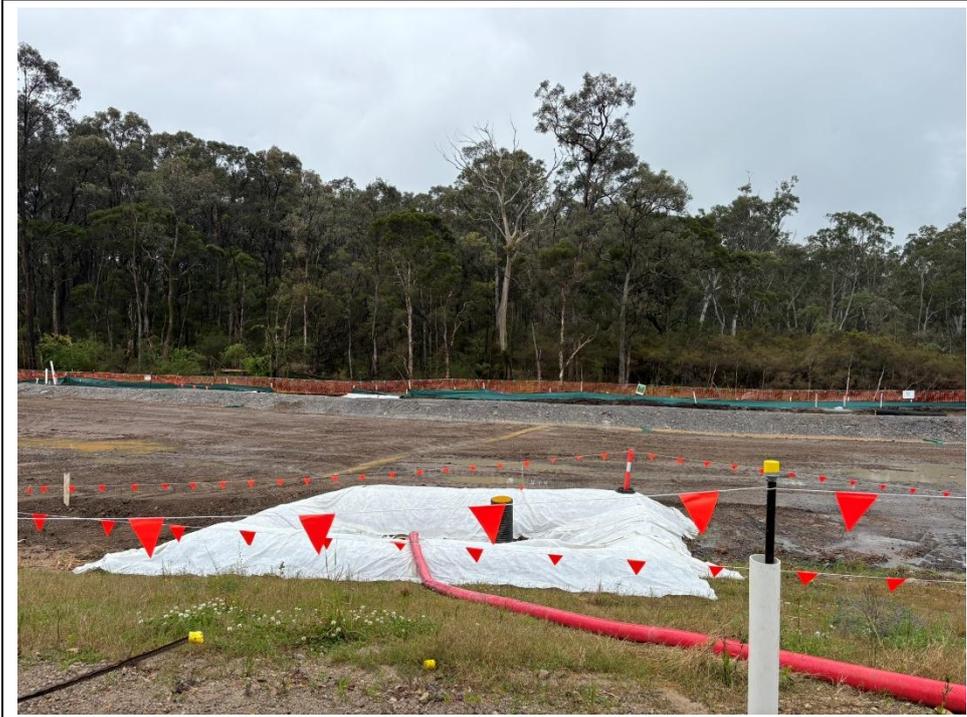
Near OSD2 (Moorebank Avenue deviation under construction in background) Red pipe is conveying inflows from OSD 2 pump station.

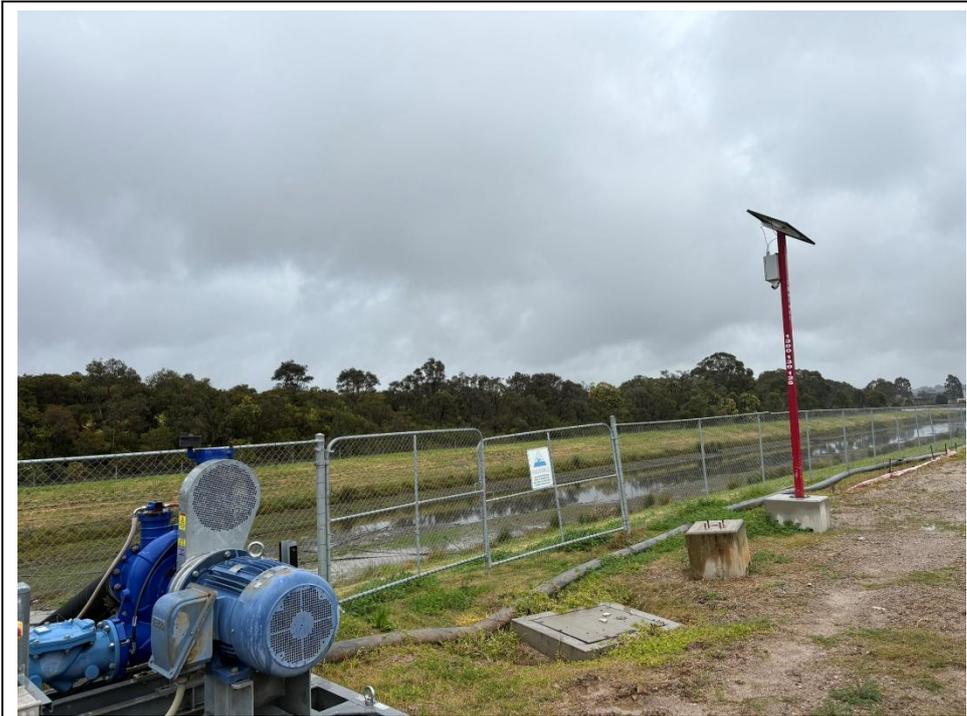
Pump to drain OSD2 which continues to operate as a pump out basin.

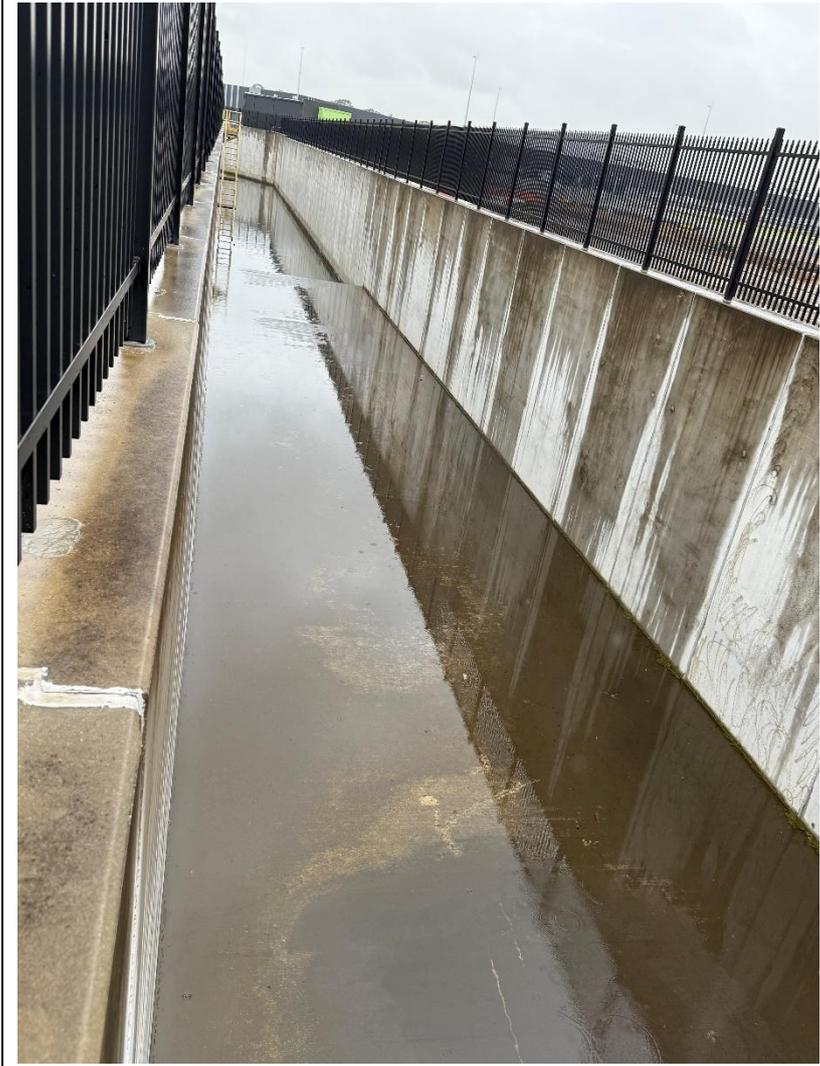
OSD 9 cleaned and well maintained.

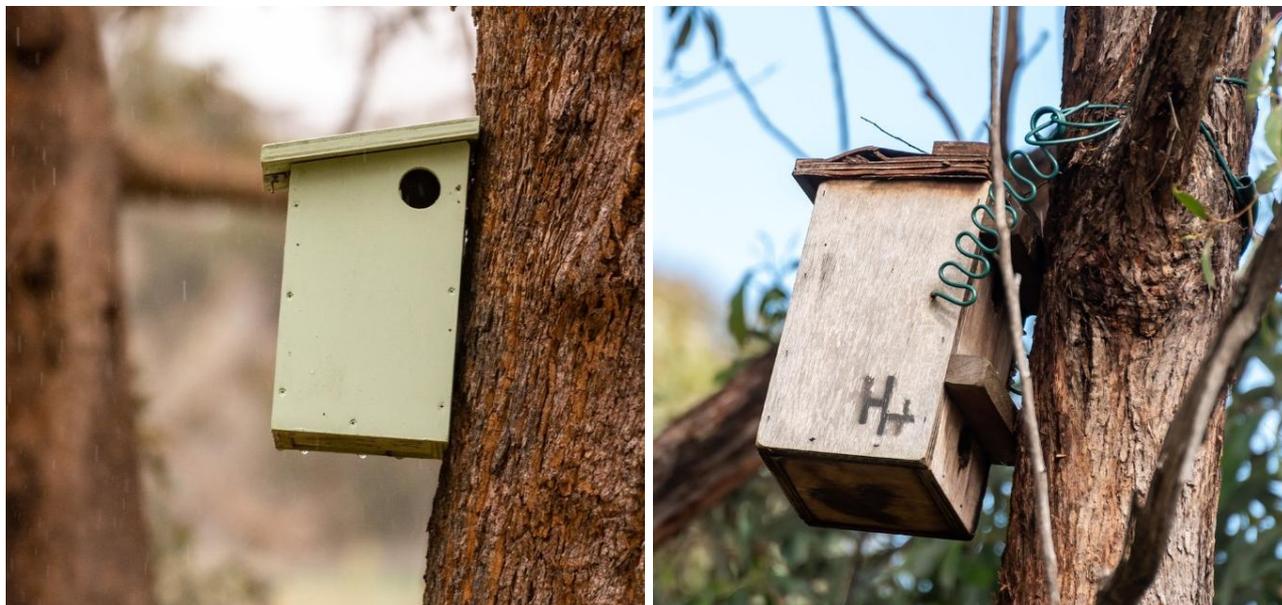
Plate 6-2. Commercially available nest boxes (left) often do not consist of appropriate water proofing and water will begin to damage the roof and back of the boxes. Lacquer wears very quickly on nest boxes and will need to be reapplied. In contrast, nest boxes painted (right) with a high-quality exterior paint such as Dulux Weathershield will last much longer.

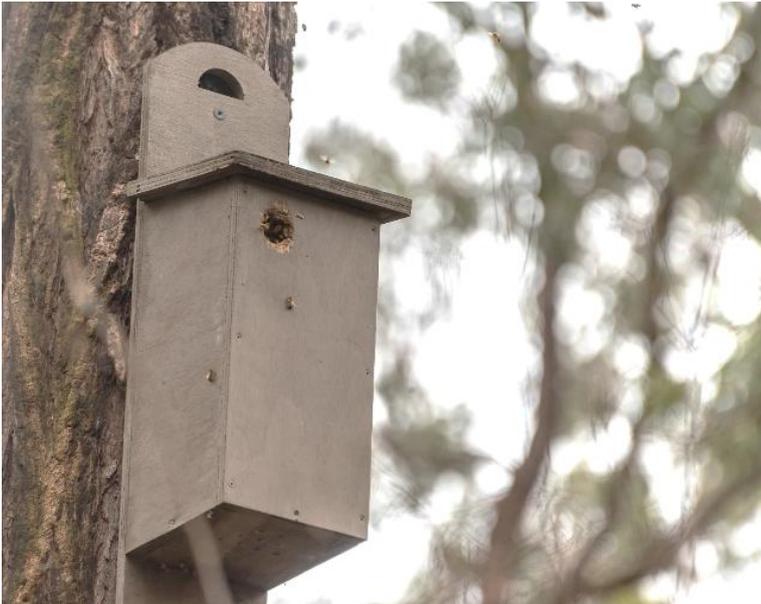
Plate 6-4. European honeybees have been found in nest boxes at Moorebank.
