Moorebank Precinct East - Stage 2

B106 - Baseline Aquatic
Ecological Monitoring
Report and Biodiversity
Monitoring Strategy
(SSD 7628)

Moorebank Precinct East Stage 2: Baseline Aquatic Ecological Monitoring Report and Biodiversity Monitoring Strategy Autumn 2018

8 June 2018

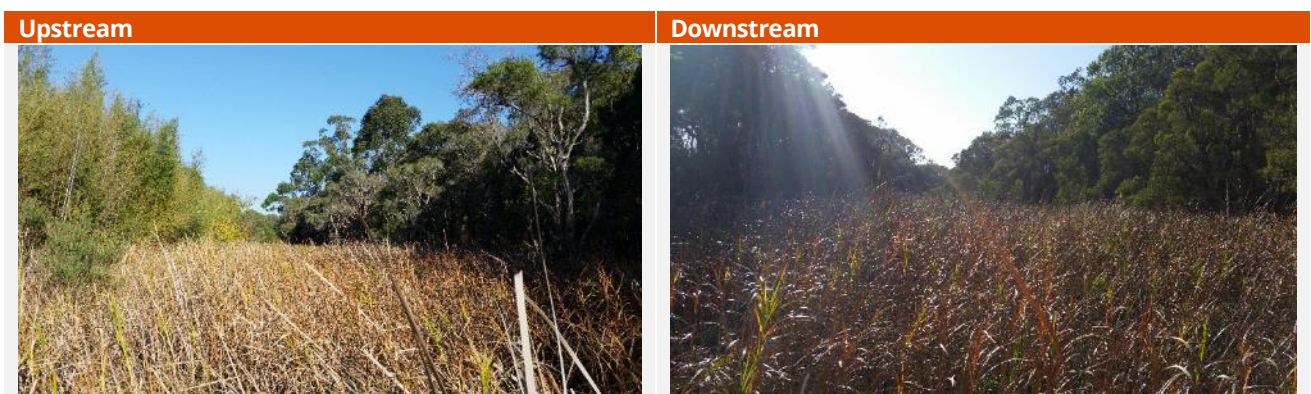
Site AQ1 was dry at the time of survey. Soils beneath the instream root layer were dry to a depth of at least 30 centimetres, with scattered woody perennials establishing in the active channel zone. The active channel zone averages approximately four metres width at this section of Anzac Creek. This site featured a dense and continuous coverage of instream emergent macrophytes dominated by reed-like structural forms. The most common species were the Native Rush *Typha* sp., Marsh Club-rush *Bolboschoenus fluviatilis*, with the exotic understory species Alligator Weed *Alternanthera philoxeroides* also occurring in patches. Dieback of these macrophytes, presumably a result of dry conditions, was observed at the time of survey. The presence of these macrophytes indicates that a degree of water is periodically held within the channel zone. The riparian vegetation was relatively intact, save for a cluster of exotic Bamboo that has established on the right bank and the presence of access tracks.

The dense coverage of instream emergent macrophytes in addition to the relatively intact woody riparian vegetation has resulted in a stable watercourse, with a wide and shallow channel geometry.

Plate 1 Views upstream and downstream of site AQ1

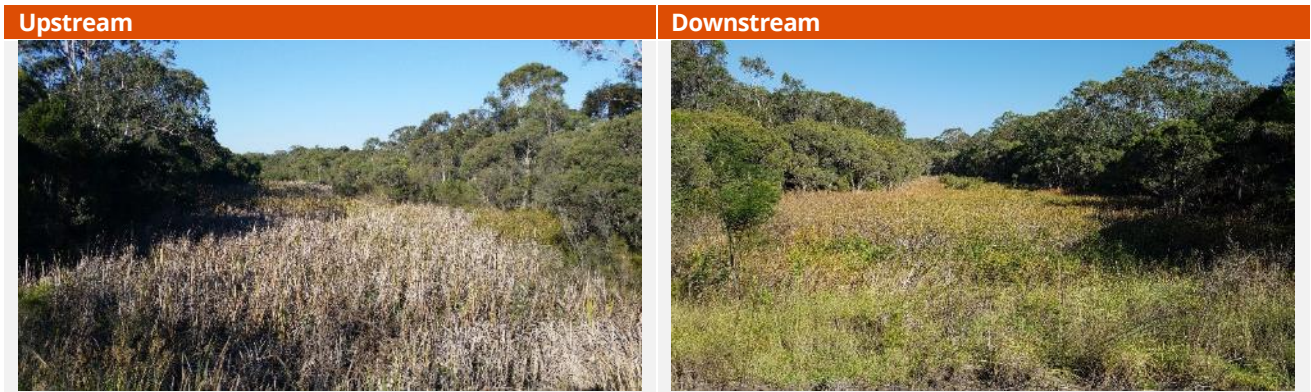
Site AQ2 was dry at the time of survey, with soils beneath the instream root layer dry to a depth of at least 30 centimetres. Anzac Creek is intersected at this site by a large culvert supporting rail tracks. The Creek widens slightly at this site, with the active channel zone averaging approximately five metres width. This site featured a dense and continuous coverage of instream emergent macrophytes. The instream vegetation within site AQ2 was consistent with site AQ1, dominated by tall reed-like structural forms. Dieback of these macrophytes, presumably a result of dry conditions, was observed to increase slightly at this site, in comparison to upstream. The presence of these macrophytes indicates that a degree of water is periodically held within the channel zone. The riparian vegetation was relatively intact, except for a gap on both banks where rail tracks intersect Anzac Creek.

The dense coverage of instream emergent macrophytes in addition to the relatively intact woody riparian vegetation has resulted in a stable watercourse, with a wide and shallow channel geometry.

Plate 2 Views upstream and downstream of site AQ2

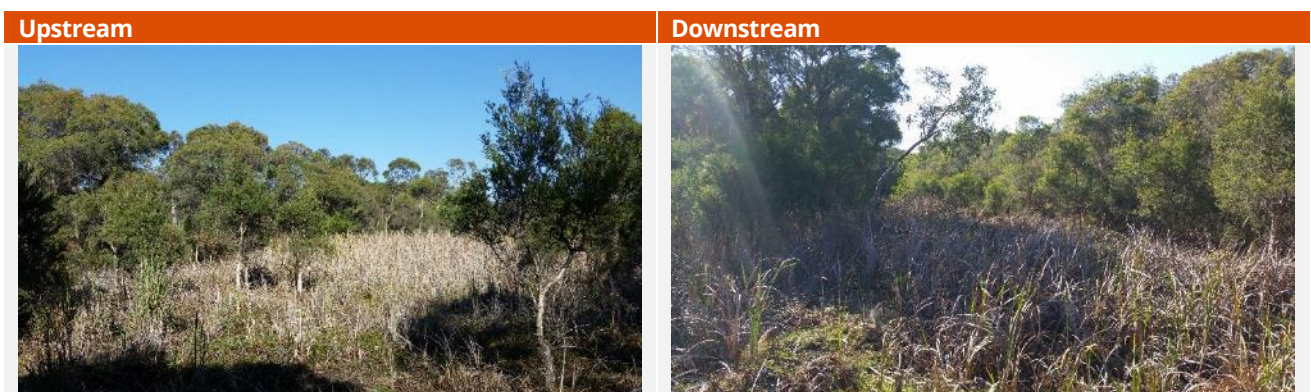
Site AQ3 was dry at the time of survey, with an increase in scattered woody perennials observed establishing in the active channel zone in comparison to upstream sections. A greater degree of the channel bed surface was exposed at the time of survey. The channel width narrows slightly at this point, to approximately three metres. The riparian and instream vegetation composition was generally consistent with sites AQ1 and AQ2, although the increase in bare stream substrate and instream occurrence of woody perennials indicate reduced water availability at this site.

The dense coverage of instream emergent macrophytes in addition to the relatively intact woody riparian vegetation has resulted in a stable watercourse, with a wide and shallow channel geometry.

Plate 3 Views upstream and downstream of site AQ3

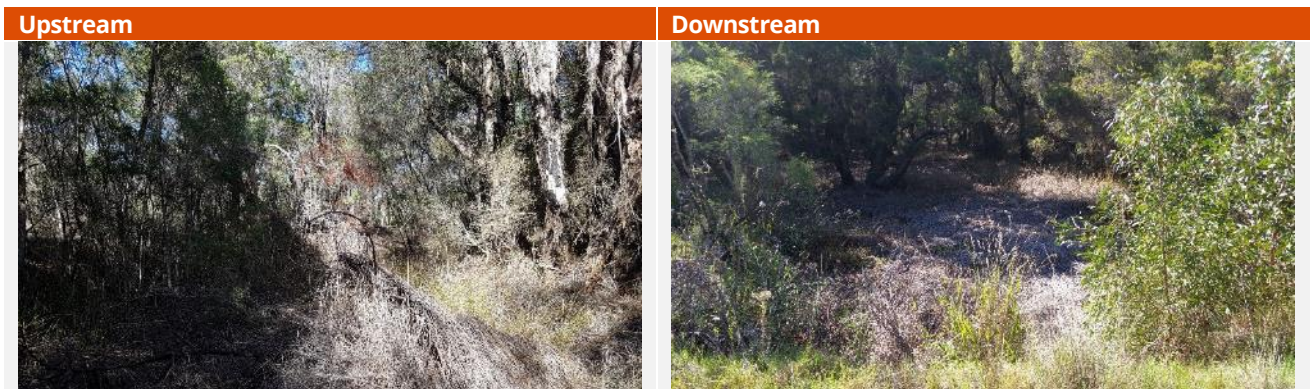
Site AQ4 was dry at the time of survey. Anzac Creek narrows at this site to a width of approximately three metres flowing through a culvert along a power line easement. The width depth ratio of Anzac Creek also decreases at this site. *Casuarina* species become the dominant riparian canopy species. Instream vegetation was almost entirely absent at the time of survey, however a dense coverage of dried leaf litter (coarse particulate organic matter) and dried macrophytes was observed within the channel zone. A small number Spike Rush (*Eleocharis* sp.) macrophytes, were observed within the channel. Indicating that water is periodically held within the channel zone, supporting dense plant growth.

The lack of instream vegetation, decrease in width depth ratio and exposure of some bank material indicates that this section of Anzac Creek is more susceptible to erosion than the upstream reaches. However no

indicators of significant erosional impacts were observed, indicating that Anzac Creek remains relatively stable at this site.

Plate 4 Views upstream and downstream of site AQ4

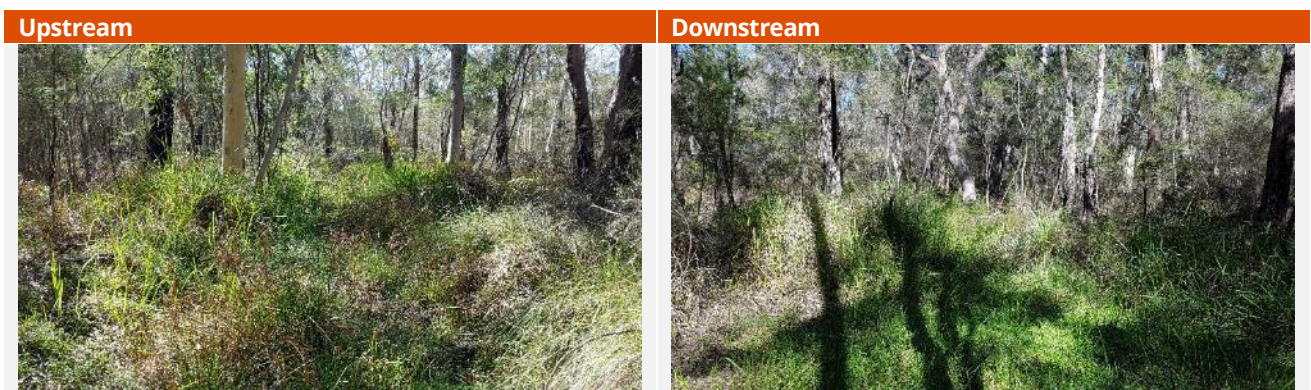
Site AQ5 was dry at the time of survey. However the presence of a variety of lush emergent macrophytes and terrestrial groundcover species within the channel indicate a greater availability of sub-surface water. Grass, tussock, branched and unbranched structural forms were all recorded within the active channel zone. The channel narrows significantly at this point, to approximately one and a half metres width. Channel shading also increases at this site, with *Casuarina* species decreasing in abundance. Riparian vegetation is almost entirely intact at this site, with native woody canopy species dominating. Scattered deposits of coarse woody debris were observed within the channel zone.

The presence of dense woody riparian vegetation, continuous instream macrophyte cover and coarse woody debris provide erosion resistance. No significant erosional processes were observed at this section of Anzac Creek.

Plate 5 Views upstream and downstream of site AQ5

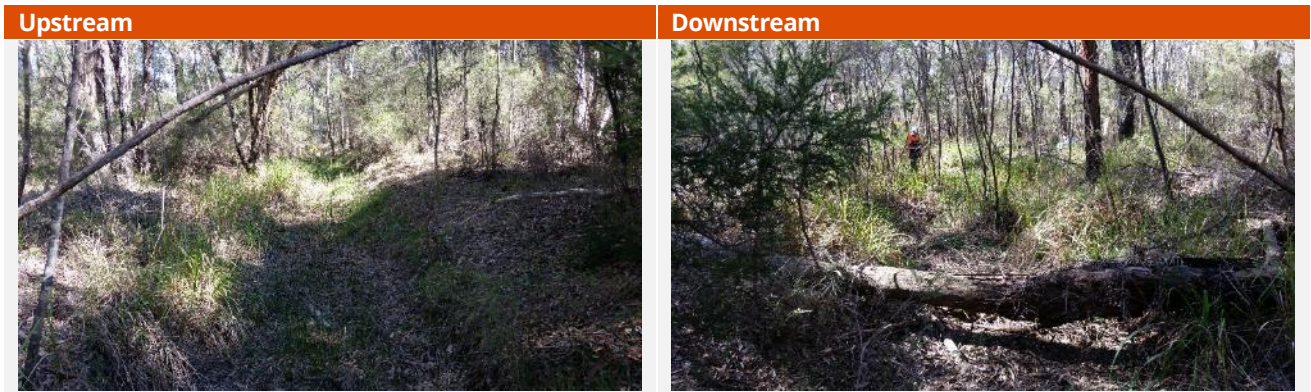
Site AQ5.1 is a small unmapped tributary of Anzac Creek and was dry at the time of survey. Given the straight planform of this tributary, it is likely to have been constructed to facilitate drainage into Anzac Creek. The majority of the stream substrate is covered by leaf litter, with scattered Spike Rush occurring within the stream bed.

The presence of dense woody riparian vegetation and intact vegetated banks suggest that this is a stable channel and is not subject to significant erosional processes.

Plate 6 Views upstream and downstream of site AQ5.1

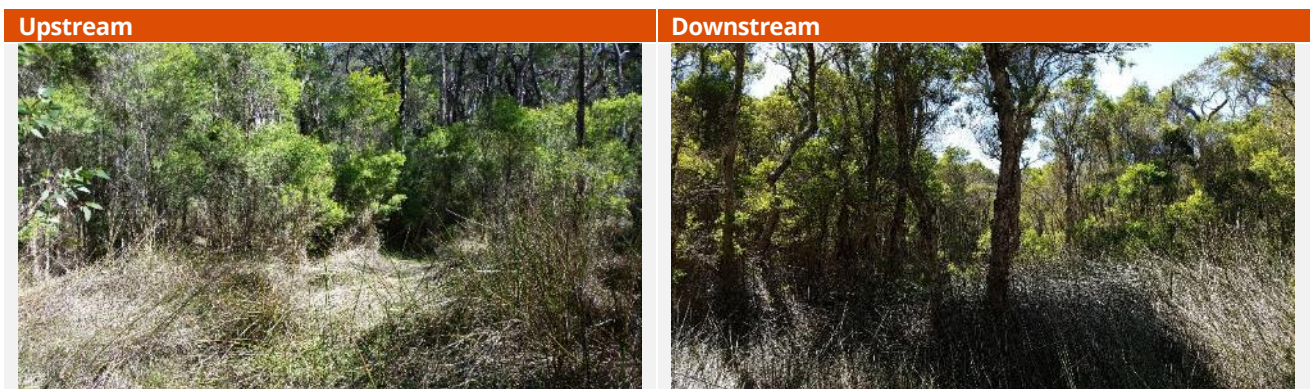
Anzac Creek becomes discontinuous at site AQ6, with the vegetation transitioning to a swamp-like understory species composition. The vegetation is characterised by tussocks of rush and sedge species, with an open canopy. The riparian vegetation surrounding site AQ6 remains intact and is dominated by native woody species. The site was dry at the time of survey.

The discontinuous nature of Anzac Creek at this site and presence of dense riparian vegetation suggest Anzac Creek is highly stable at this point.

Plate 7 Views upstream and downstream of site AQ6

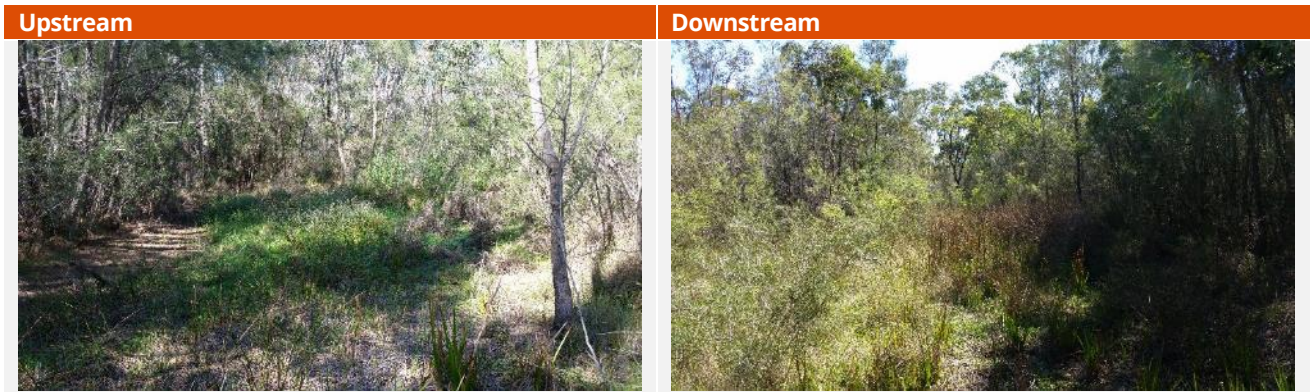
Site AQ7 consists of an access track depression, potentially directing flow into Anzac Creek during heavy rainfall events. The depression has been colonised by aquatic vegetation in the form of emergent macrophytes in numerous sections, with beds of Spike Rush macrophytes occurring in the deepest pools.

Plate 8 Views upstream and downstream of site AQ7

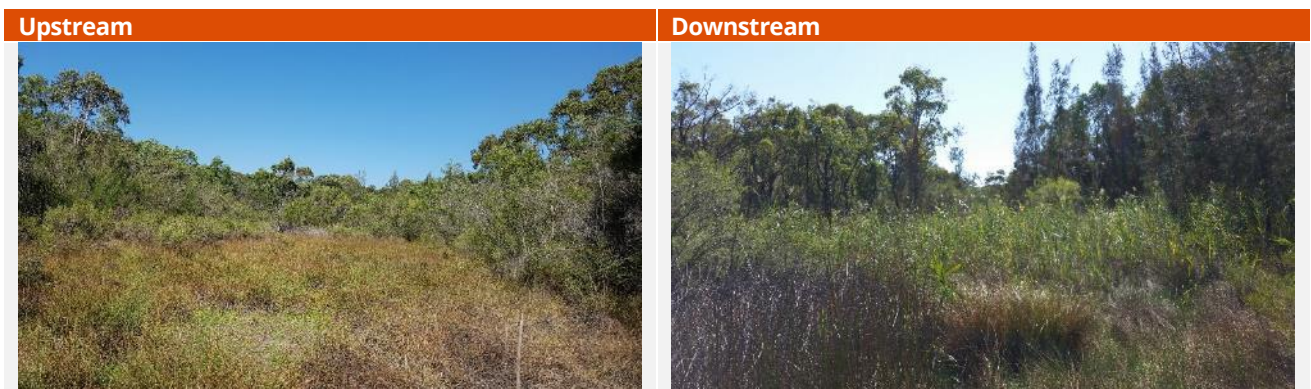
Site AQ8 along Anzac Creek marks a return to the wide shallow channel geometries recorded upstream of site AQ4, from the more discontinuous form observed at AQ6. Instream vegetation in the upstream section of AQ8 is comprised of low growing rush species. With the downstream section being dominated by the Reed like structural forms, predominantly the Common Reed. *Casuarina* species also become the more dominant riparian species as the Common Reed increases in abundance downstream. A large access track has been cut and maintained at this section of Anzac Creek disturbing riparian vegetation on the left bank.

Plate 9 Views upstream and downstream of site AQ8

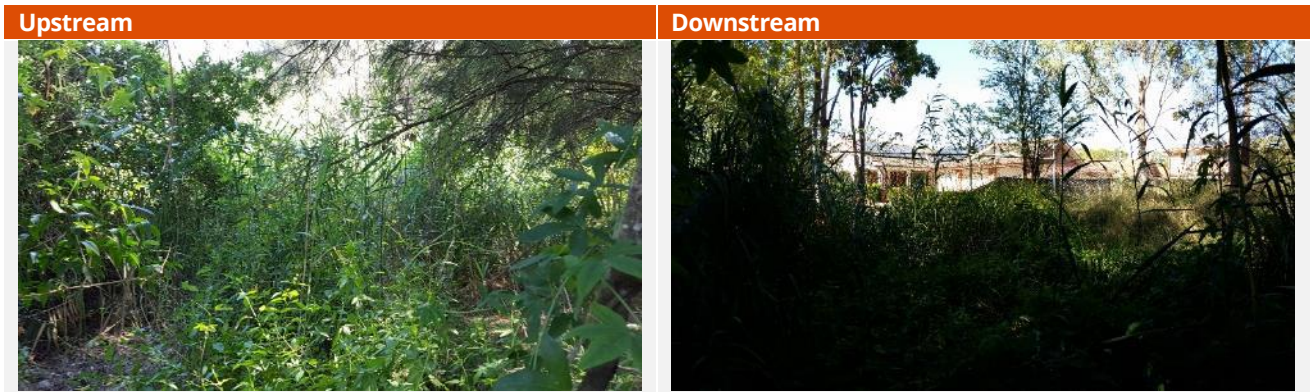
Site AQ9 is a small drainage channel facilitating runoff from residential areas to the east into Anzac Creek. The site is subject to edge effects and weed ingress due to its proximity to housing. Instream vegetation within the channel is dominated by exotic terrestrial species, with woody exotic species, such as large leaf privet *Ligustrum lucidum* also present.

Plate 10 Views upstream and downstream of site AQ9

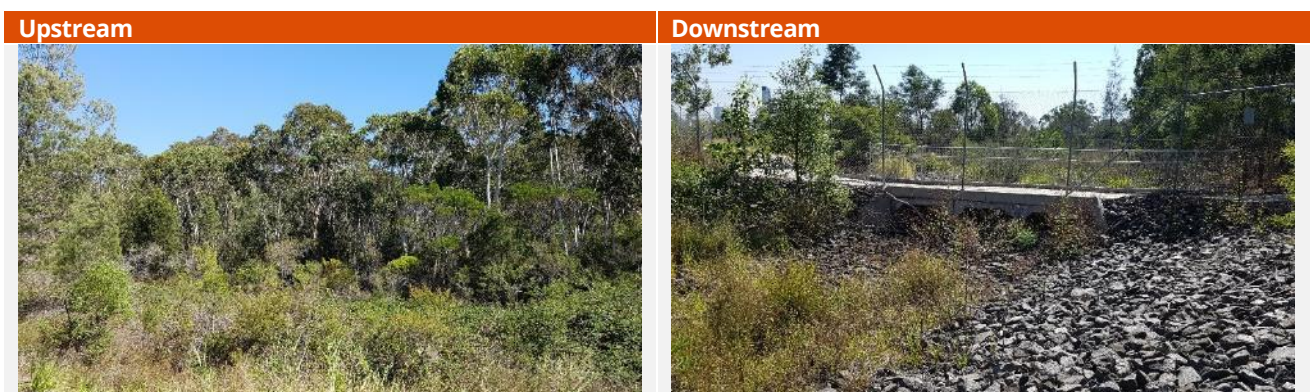
Site AQ10 was dry at the time of survey. This section of Anzac Creek displays a high degree of modification. The riparian vegetation on the right bank is displaced by residential housing, with a stormwater drain draining from the residential area also occurring on the right bank. Anzac Creek passes through a culvert at this section, with cobble sized rocks placed on the bed and banks as an erosion protection measure. Site AQ10 is highly edge affected with exotic terrestrial species dominating the channel and right bank. The dominance of terrestrial species indicates that water is held infrequently at this site. Downstream of the culvert Anzac Creek exhibits the same morphology and bed armouring measures. The riparian vegetation continues to decline in extent downstream, with dense beds of Common Reed occurring within the channel zone.

The reduction in instream and riparian vegetation, combined with the proximity to increased impervious surface areas and storm water inputs also suggests that AQ10 is subject to a greater degree of erosion than the upstream sections of Anzac Creek. The erosion protection measure of bed and bank armouring with rocks indicates that AQ10 is somewhat susceptible to erosional processes. Despite this, no significant indicators of erosion were observed at AQ10.

Plate 11 Views upstream and downstream of site AQ10

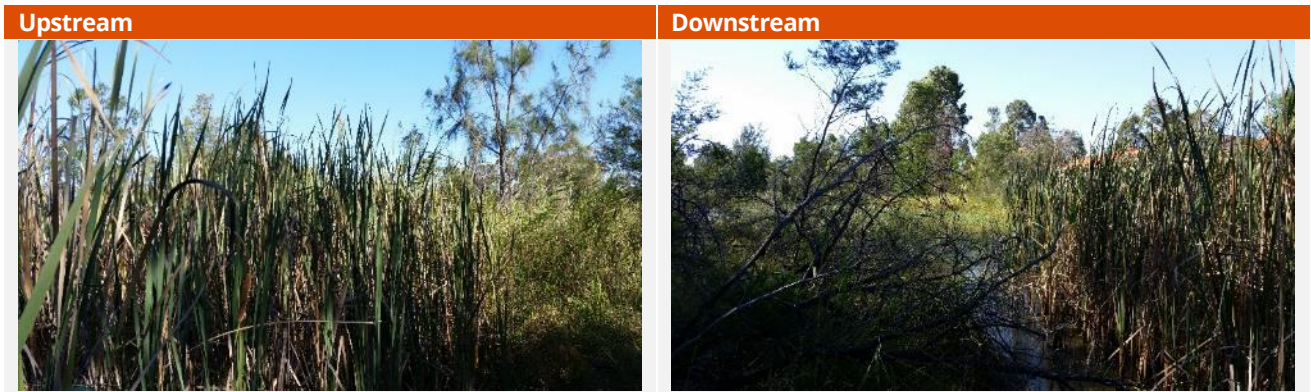
Site AQ11 occurs just upstream of the large refuge pool at AQ12 and held a small amount of water at the time of survey. Dense beds of Native Rush and Common Reed occur within the active channel zone, with riparian vegetation decreasing significantly in extent and condition in comparison to that of the "Boot land".

The channel geometry at this section is relatively wide and shallow, with vegetated and cohesive banks. As such this section of Anzac Creek is considered stable.

Plate 12 Views upstream and downstream of site AQ11

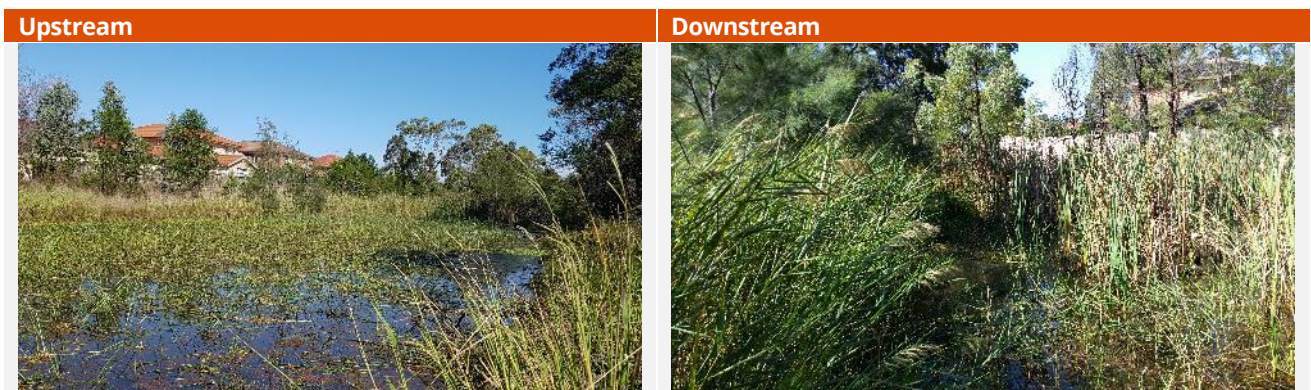
Site AQ12 features a large refuge pool approximately ten metres wide with an average depth of at least one metre. It is considered likely that this refuge pool holds water year round. Submerged macrophytes were observed throughout the pool, with floating and emergent macrophytes also present in large amounts around the pool margins. The upstream and downstream edges of the pool are covered by dense beds of Common Reed. These macrophytes provide significant epifaunal cover. The riparian vegetation continues to decline in extent and condition at site AQ12.

The amount of tall instream vegetation upstream of site AQ12, submerged vegetation within the refuge pool and vegetation root binding along the banks suggest Anzac Creek is stable at site AQ12. This is despite the reduction in woody riparian vegetation present at this site.

Plate 13 Views upstream and downstream of site AQ12

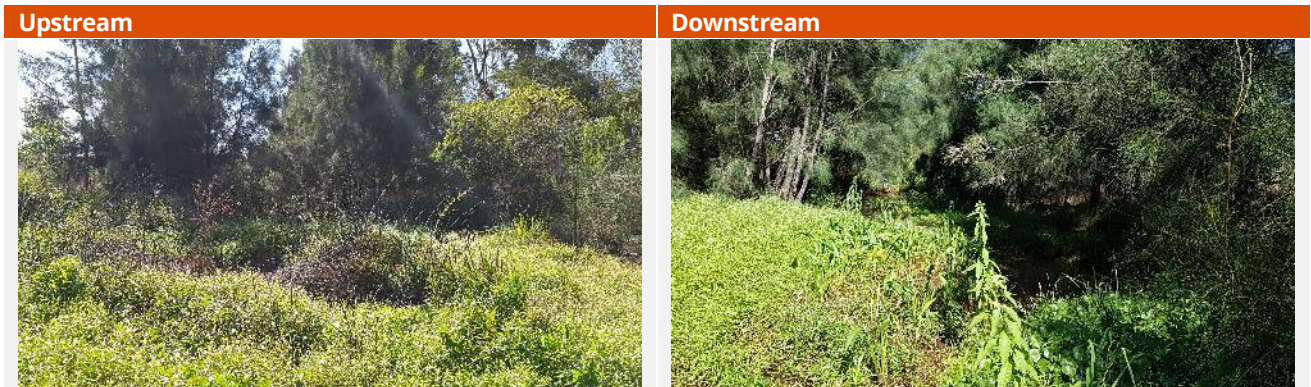
Anzac Creek between AQ13 and the overflow channel exhibits a wide shallow channel geometry, with dense low growing emergent macrophytes covering all instream surfaces. A very minor amount of standing water was observed at this section of Anzac Creek. Riparian vegetation increased in terms of condition and extent at

this section, with *Casuarina* species established along both banks to a greater degree, compared to the upstream and downstream sections.

Plate 14 Views upstream and downstream, between the overflow channel and site AQ13

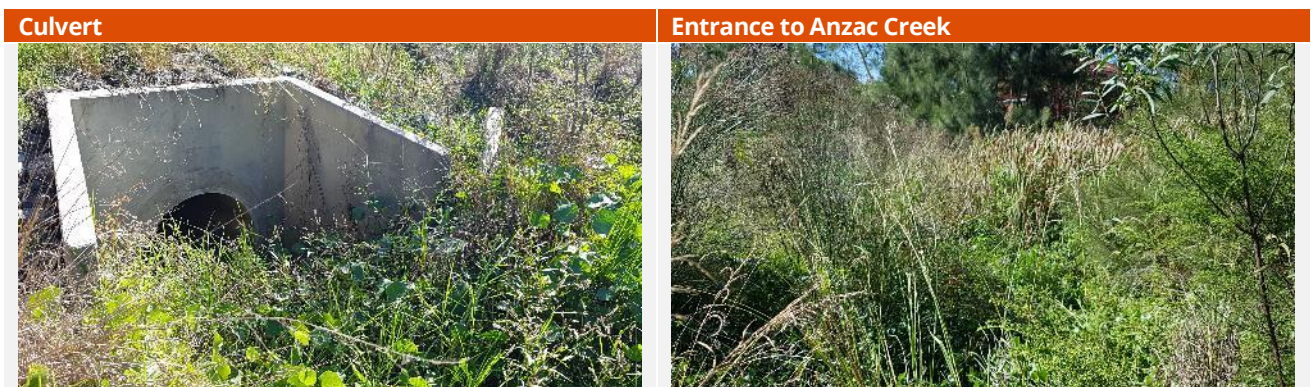
Site AQ13 site was completely dry at time of survey. Woody riparian vegetation is highly reduced along the left bank at AQ13, with terrestrial shrubs becoming more common. A thin strip of *Casuarina* species occur along the right bank. The riparian vegetation along the left bank and within the culvert entrance is highly edge affected, being dominated by exotic terrestrial grasses and understory species. Native species dominate within the active channel zone with dense beds of Native Rush present.

Plate 15 Plates of the culvert and entrance to Anzac Creek at site AQ13

This section of Anzac Creek is potentially more susceptible to erosion due to the presence of additional inputs from both the overflow channel and culvert. However, both site AQ13 and the section of Anzac creek between AQ13 and the overflow channel exhibit a considerable degree of channel stability. This is due to the dense coverage of instream vegetation, as well as the wide and shallow channel morphology.

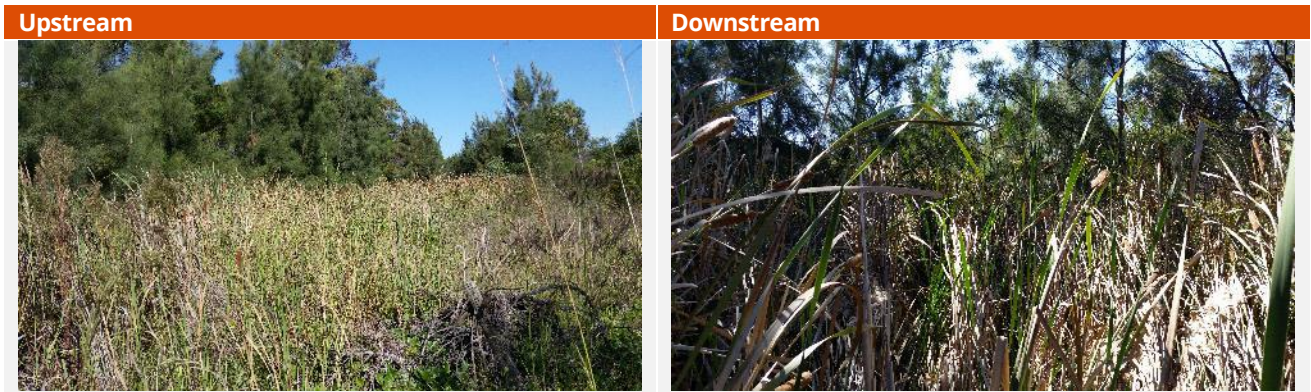
Site AQ14 is the most downstream site assessed. The site was dry at the time of survey. Dense beds of Native Rush occur within the active channel zone, with the extent and condition of riparian vegetation being consistent with sites AQ12 and AQ13.

The channel geometry at this section is relatively wide and shallow, with dense instream vegetation and vegetated banks. As such this section of Anzac Creek is considered stable.

Plate 16 Views upstream and downstream at site AQ14
