MIP BI-MONTHLY WEED MONITORING REPORT – OCTOBER 2025

Project title	Moorebank Precinct West – Condition of Consent B36– Independent Audit	
Document title	Moorebank Precinct West – WSUD – 2025 Independent Audit Report	Project number 255
Description		
Client Contact	Mark Howley

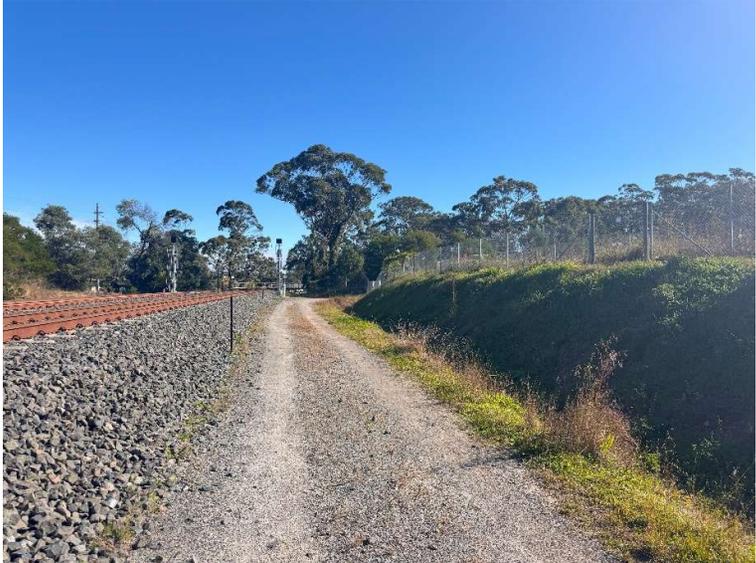
Inspection area	Weed abundances for current survey	Photo of inspection area
Moorebank Precinct East (MPE)		
Rail Access Land Package (RALP)	<ul style="list-style-type: none"> • Weed growth continuous to be suppressed, particularly in the areas immediately adjacent to the BioBank site. Large instances of native grasses (<i>Themeda triandra</i>) are growing substantially • Steep areas along berms are being avoided for slashing due to safety concerns. Additionally, the small amounts of exotic vegetation are currently stabilising these berms, and will be targeted once construction is finalised in the MPW areas.

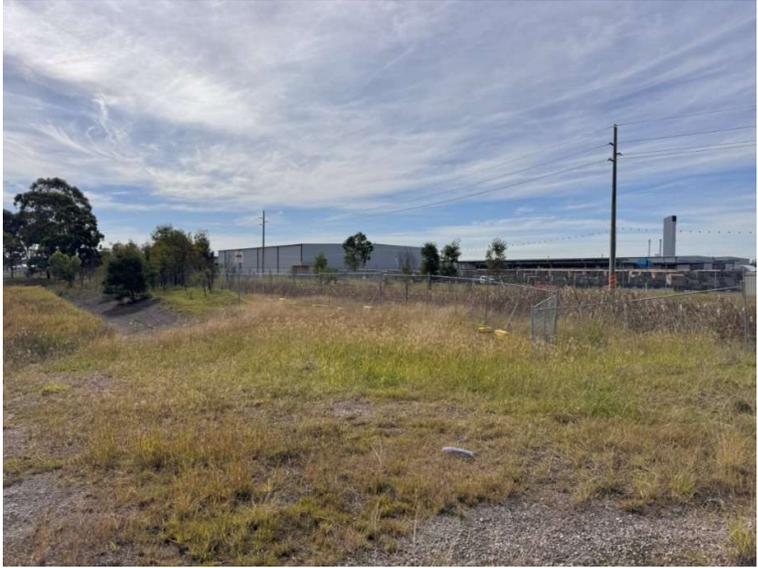
Inspection area	Weed abundances for current survey	Photo of inspection area
Warehouse areas	<ul style="list-style-type: none"> Majority of this area has now been claimed by the Moorebank Avenue Upgrade project and is unable to be surveyed adequately Occurrences of weeds in the warehouse area and the adjacent drainage infrastructure is restricted to scattered individuals of <i>Senecio madagascariensis</i> (Fireweed), <i>Plantago lanceolata</i> (Plantain), <i>Trifolium arvense</i> (Clover) and exotic grasses like <i>Chloris gayana</i> (Rhodes Grass), <i>Sporobolus africanus</i> (Parramatta Grass), <i>Paspalum urvillei</i> (Giant Paspalum) and <i>Ehrharta erect</i> (Panic Veldtgrass).

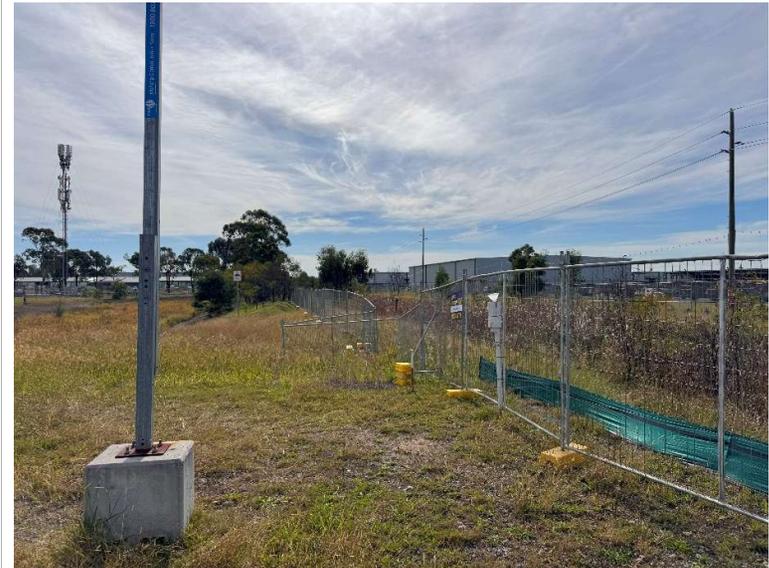
Eastern boundary
drainage infrastructure

- Majority of this area has now been claimed by the Moorebank Avenue Upgrade project and is unable to be surveyed adequately
- Drainage infrastructure dominated by *Bulboschoenus fluviatilis* (Marsh club-rush) whilst other are dominated by *Typha orientalis* (Bulrush). Where space is present between stands of these native emergent species small clumps of *Persicaria decipiens* (Slender Knotweed), *Daviesia ulicifolia*, *Ficinia nodosa* (Knotted Club-rush), *Carex tereticaulis* and *Juncus usitatus* are present. Other native species such as *Imperata cylindrica* and *Lomandra longifolia* were observed in the drainage channels.
- Areas of erosion still present.

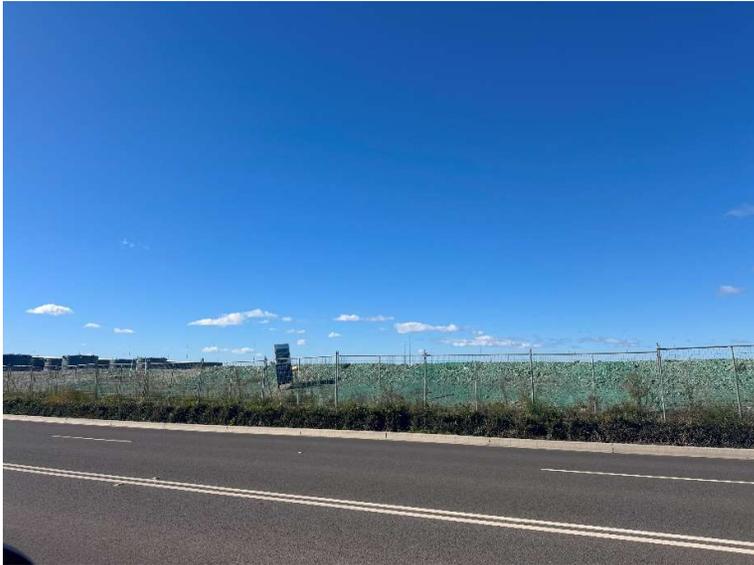
Inspection area	Weed abundances for current survey	Photo of inspection area
Moorebank Precinct West (MPW)		
<p>Landscaped areas along Bushmasters Avenue</p>	<ul style="list-style-type: none"> • Landscapes vegetation is in good condition, with minor weed incursions • Weed species present include <i>Sonchus oleraceus</i> (Common Sowthistle), <i>Chloris virgata</i> (Rhodes Grass), <i>Bidens pilosa</i>, <i>Conyza bonariensis</i> (Fleabane), <i>Cyclosporum leptophyllum</i> (Slender Celery), and <i>Tagetes minuta</i> (Stinking Roger). • Areas with limited to no landscaped vegetation are particularly susceptible to weed incursion from cleared areas (see adjacent photo)

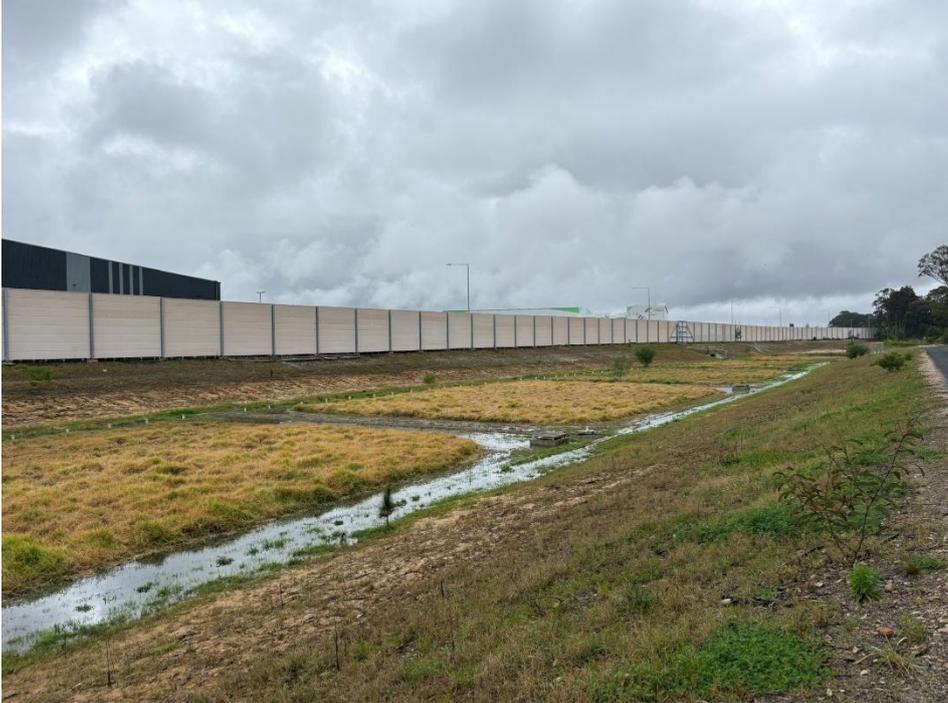
<p>OSD 5 showing signs of erosion on basin sides due to lack of vegetation and a well vegetated basin floor.</p> <p>The photo also shows how the mowing regime may prevent water from flowing into the centre of the cells. Rather it is distributed around the basin perimeter which is likely to be getting a higher hydraulic loading.</p>

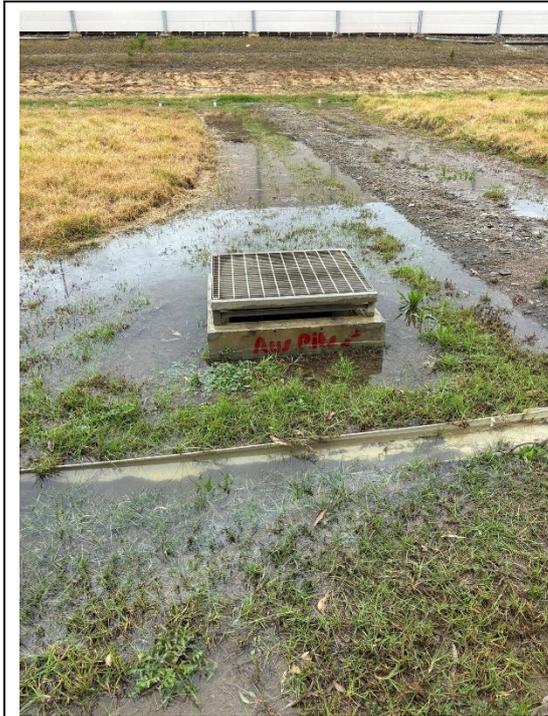
OSD 5 Poor vegetation coverage in places. Some sediment in the distribution pipeline most likely from erosion of the batter.

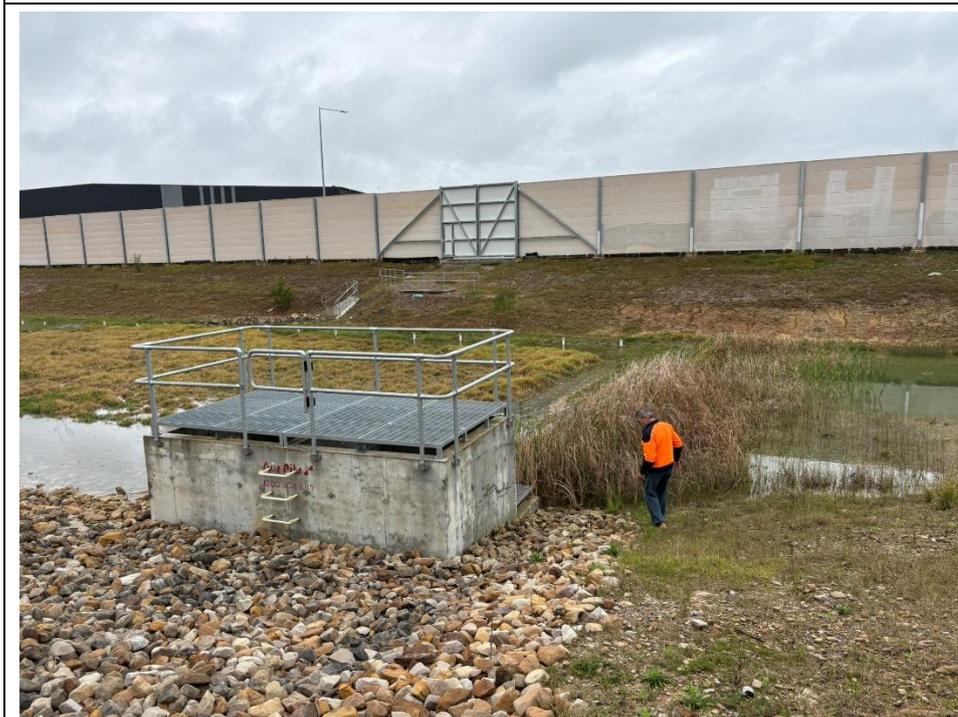
OSD 5 Basin outlet structure with rock armouring.

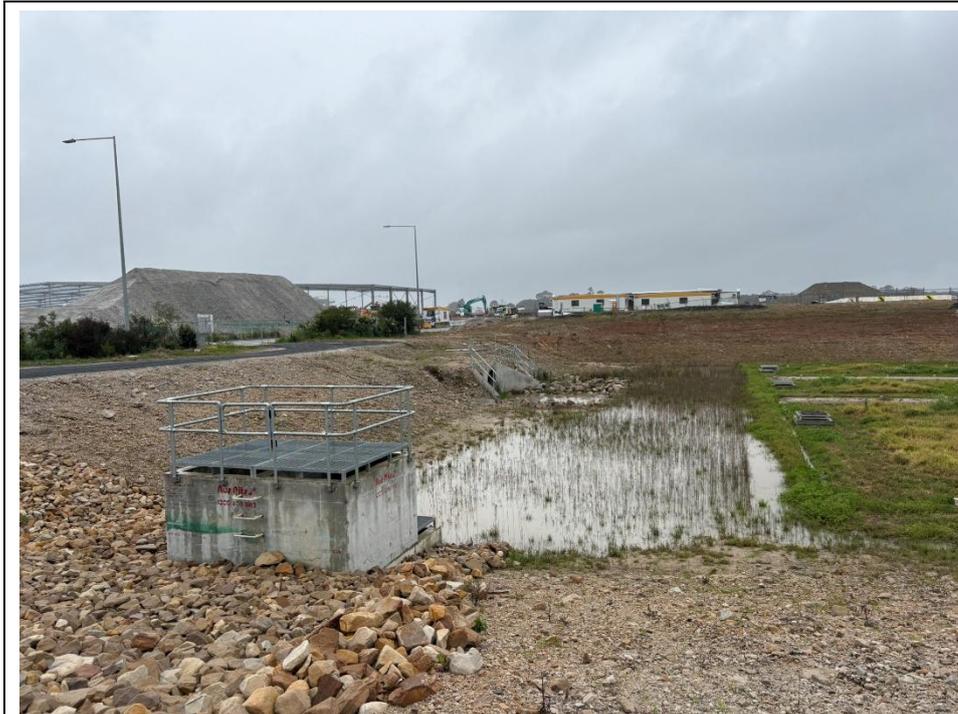
OSD 8 No topsoil or vegetation on the batters of the basins.

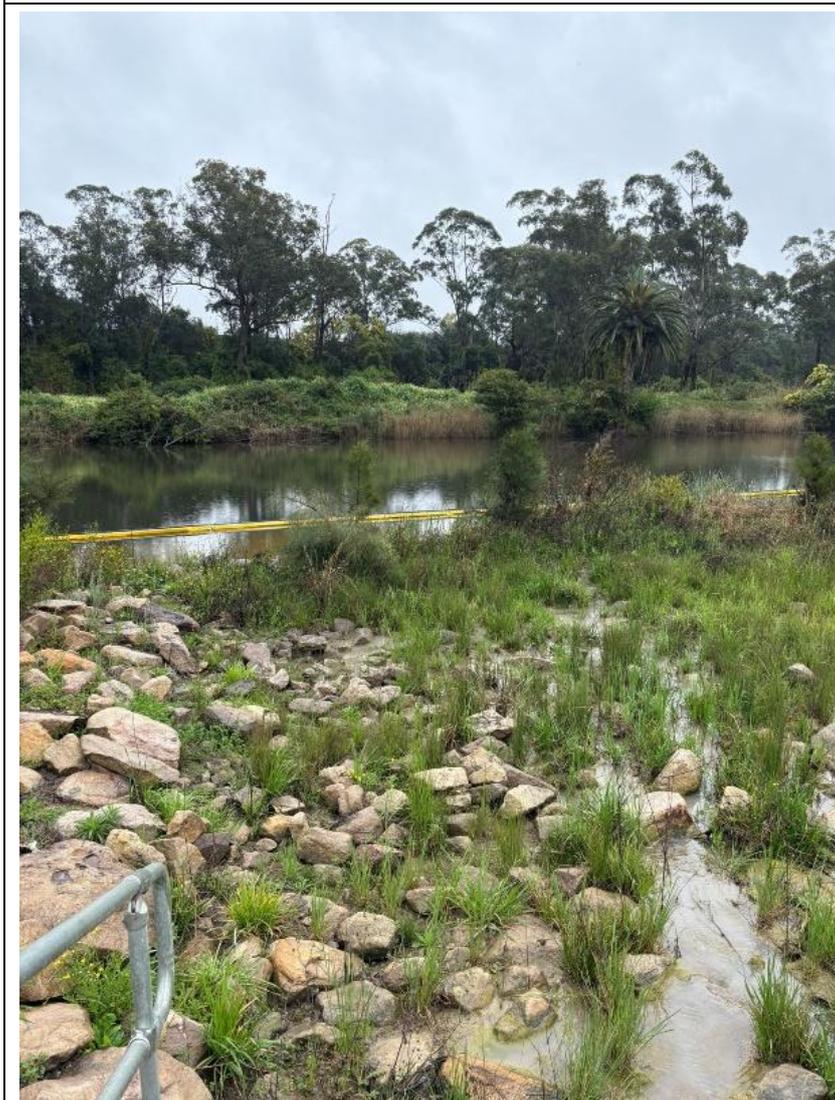
OSD 8
Water quality at outlet does not appear to be impacting the George's River.

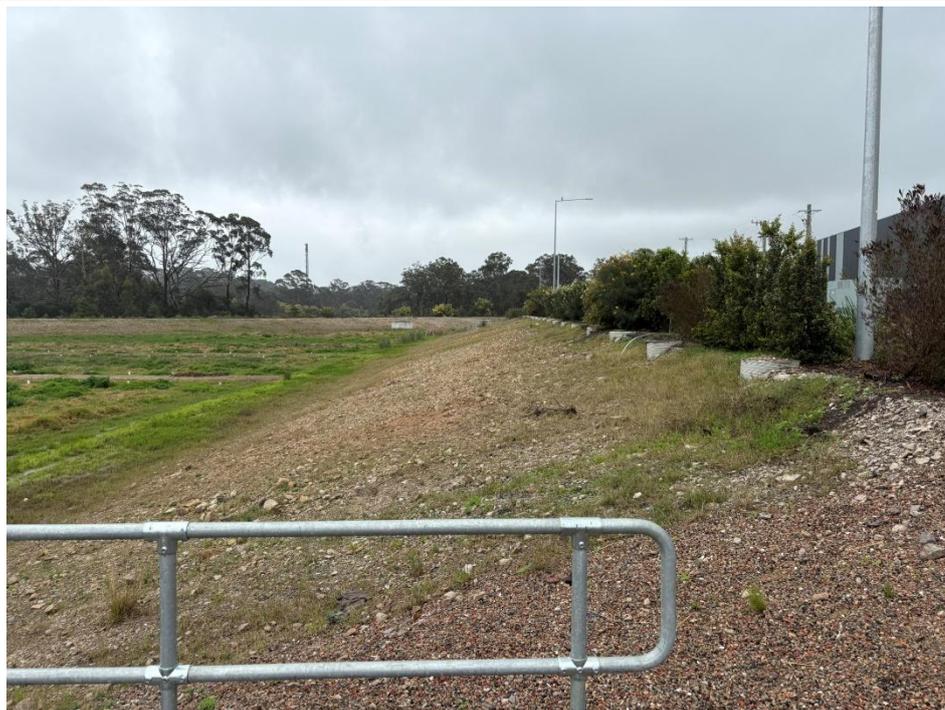
OSD 6 showing batters without topsoil or vegetation.

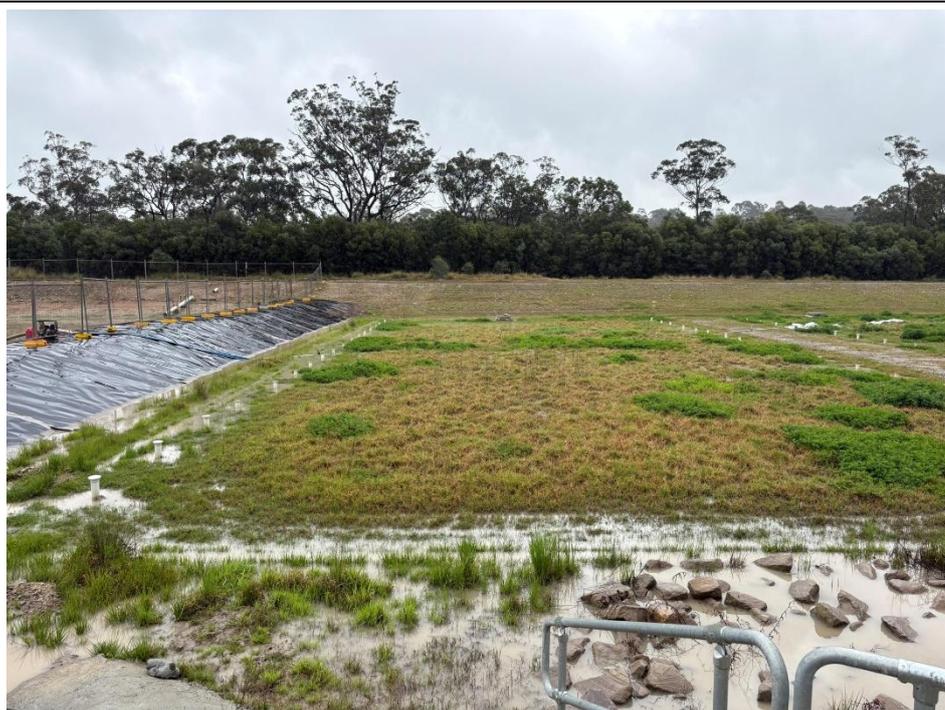
OSD 8 Sacrificial state with HDPE lined batters and pump out operation from the adjacent sediment basin into the biocells. This basin also perimeter mowing with an appearance of diminished flow directed to centre of basin.
