Annual EPBC Offset Site Monitoring (2024-25)

Arcadis were commissioned by Tactical Group on behalf of LOGOS to conduct the annual spring nest box monitoring survey within the Moorebank Logistics Park (MLP). The spring 2024 monitoring event marks the seventh year that Arcadis has monitored nest boxes installed within the Bootland and Georges River corridor to offset the removal of hollow-bearing trees for the construction of the MLP development. As a requirement of the State Conditions of Consent and Commonwealth Conditions of Approval and to guide the replacement of hollows removed during construction, a Nest Box Management Strategy (CPB, 2017) was prepared. This project document also included the requirement for monitoring of nest boxes. This memorandum has been prepared to document the findings of the 2024 nest box monitoring survey.

## Addendum to the Moorebank Annual Flora and Fauna Monitoring Report

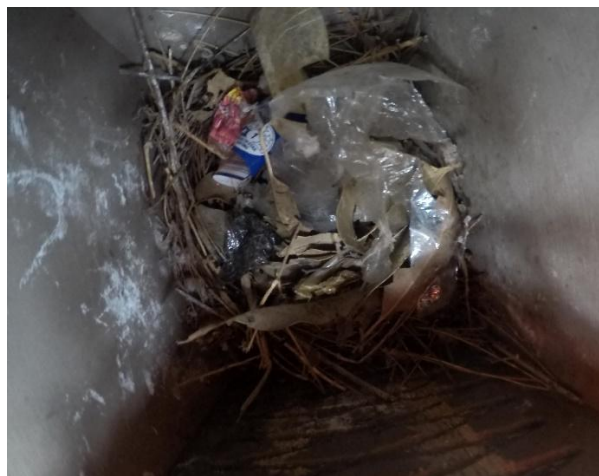
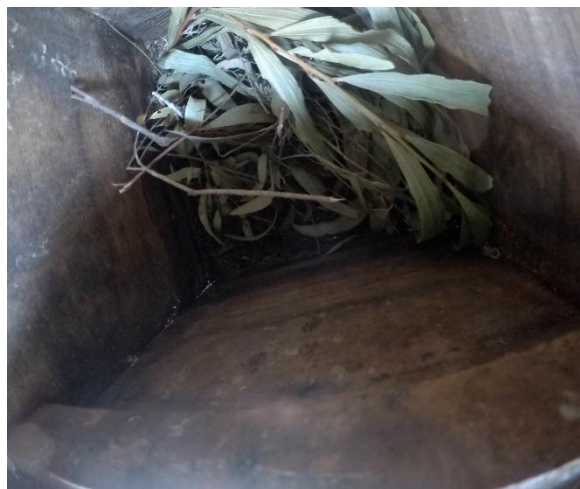
Plate 3: Examples of nest boxes utilised by fauna – Invasive Indian Myna nesting material (left) and native Sugar glider nesting material (right)

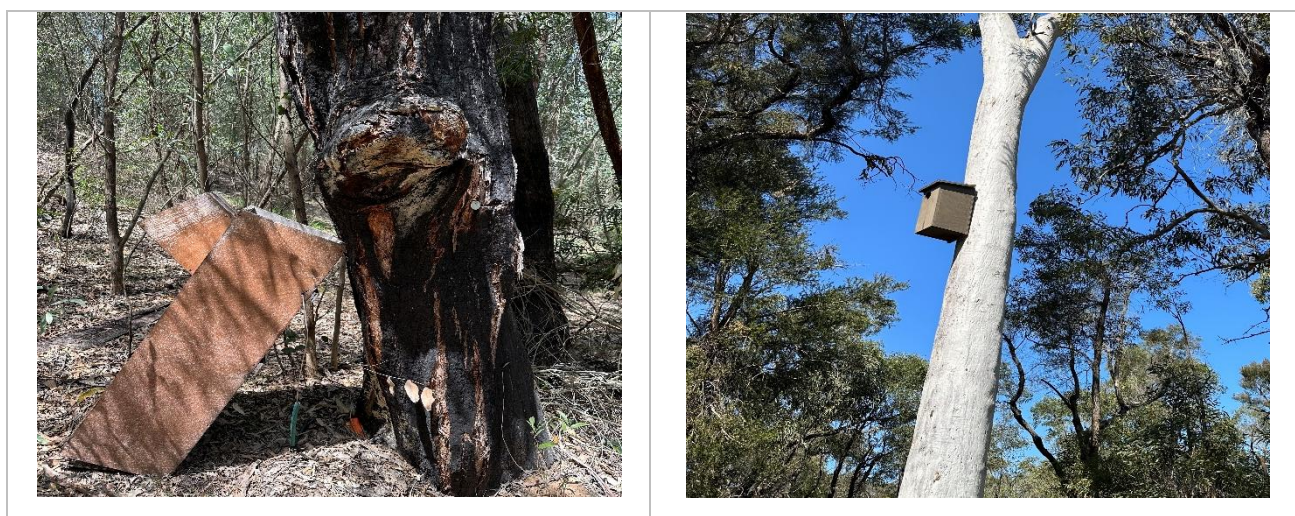
- A total of 26 were nest boxes identified as damaged and in poor condition for use by fauna. Damages included missing bottoms and lids and lack of drainage for pooling water. Three nest boxes were found to have fallen from the tree.
- Nest box installed at a height above 10 metres: Ten nest boxes were installed too high and were unable to be internally inspected due to the camera being unable to reach the box.
- Seven nest boxes were unable to be accessed due to dense *Lantana camara* blocking access.
- Nest box unstable on the tree due to incorrect mounting: A total of two nest boxes were loose on the tree.
- Nest box installed in an inappropriate location (i.e., no shade): One nest box was found to have little shade cover and had potentially resulted in a fauna fatality.

Plate 4: Examples of nest boxes with management issues – fallen nest box (left), nest box with full sun exposure (right)

Table 8 summarises nest boxes identified as requiring maintenance action. Maintenance works have been undertaken in March 2022, May 2023 and June 2024 to repair and reinstall nest boxes across the site, however, the number of failing nest boxes continues to increase annually as the boxes approach the end of their expected lifespan. As per the NBS (CPB 2018), nest boxes that are not functional to fauna are to be classified as requiring urgent repair. The 27 nest boxes identified as not providing habitat to fauna should therefore be repaired and reinstalled as soon as possible.

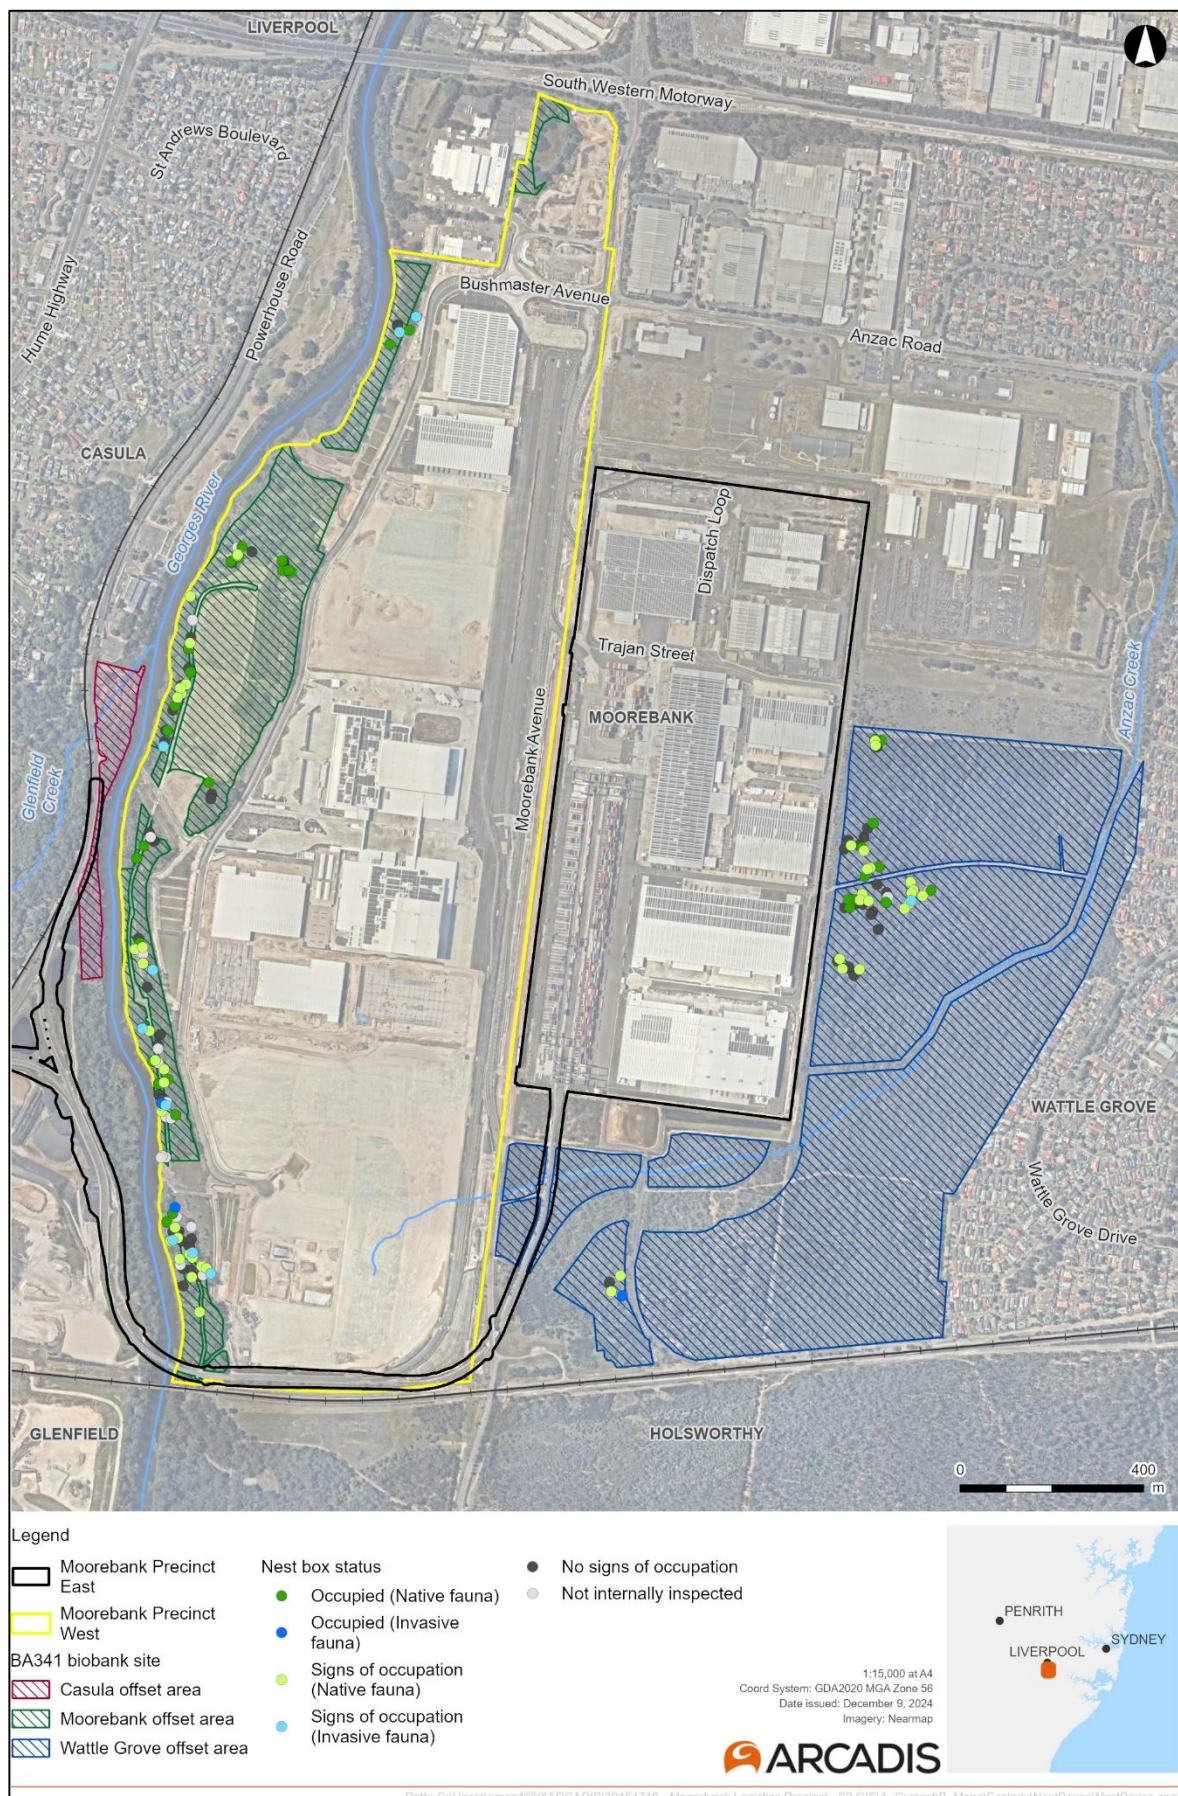
Figure 1: Results of the 2024 nest boxes monitoring survey

A summary of the utilisation and condition of nest boxes from the spring 2024 monitoring period is discussed below and presented in Figure 1.

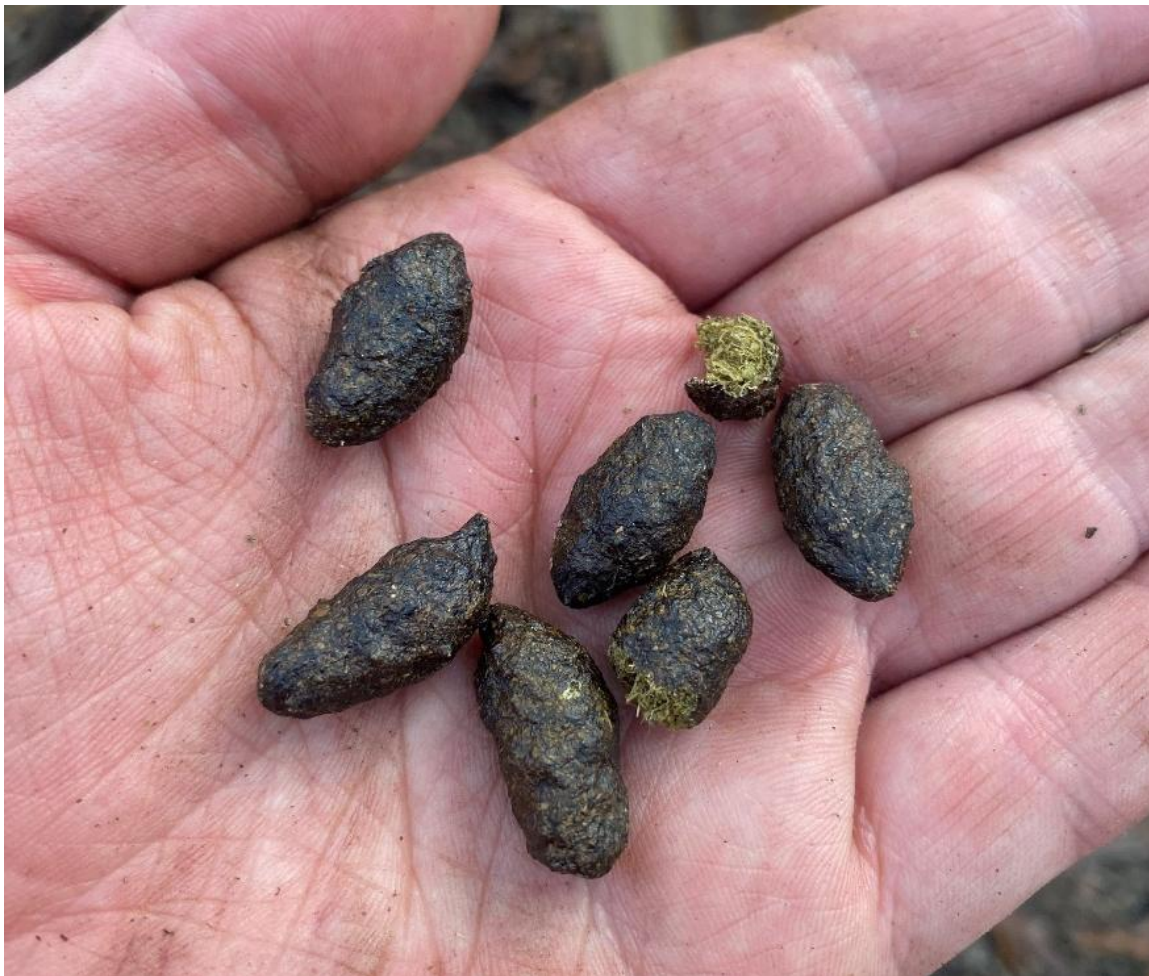
Plate 5-1. Example Koala scats found at the base of a *E. racemosa* not far from where the species was observed the following evening during spotlighting. Deep scratches on the tree were also observed.

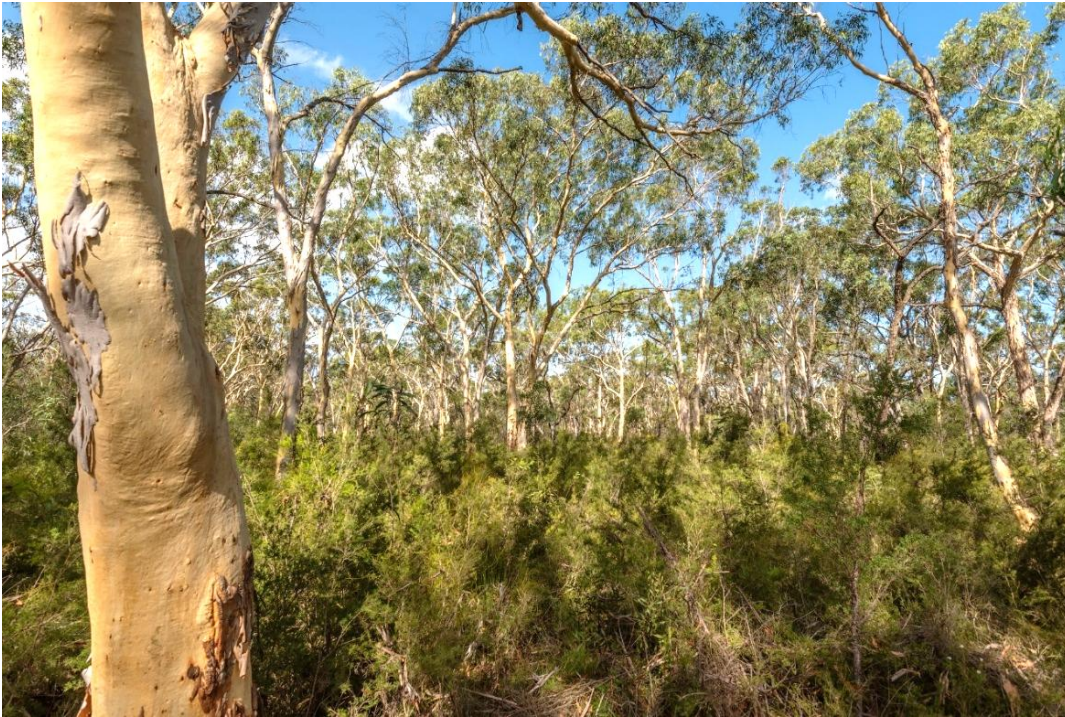
*Plate 3-6 Wattle Grove sites typically consisted of a dominant canopy of Scribbly Gum (a listed preferred Koala Feed Tree), but the dense undergrowth may impede Koala movement in the areas.*

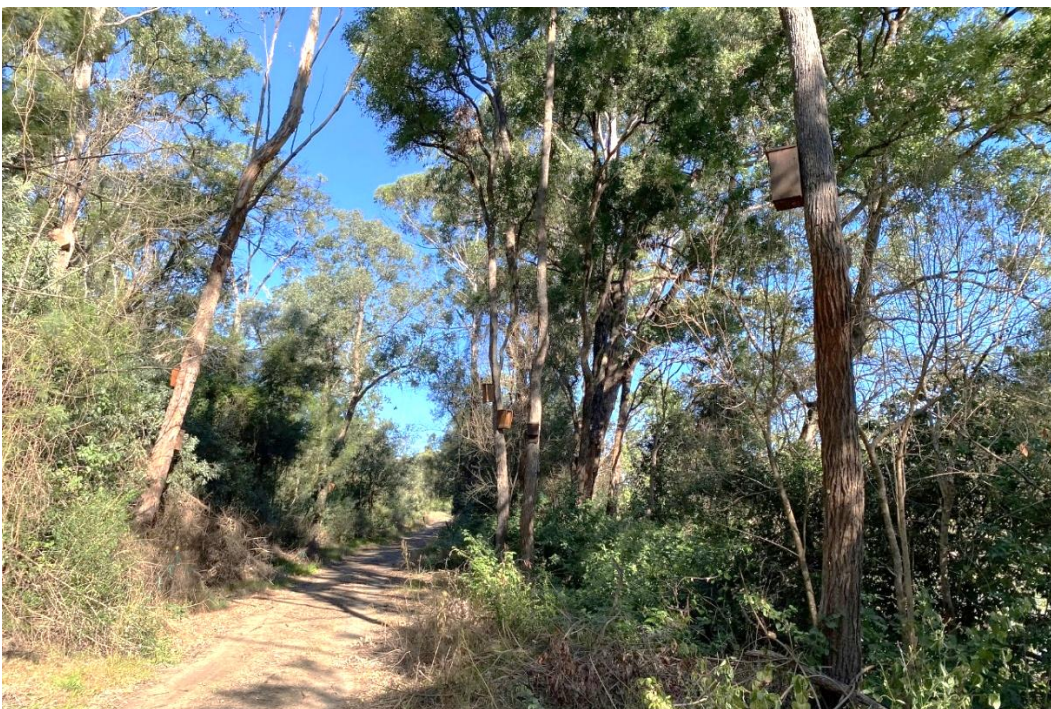
*Plate 3-9 The Georges River contains less suitable habitat for Koalas, with areas of dense undergrowth of Lantana.*
