Phase 1 ESA – Central Rail Access Option

Phase 1 Environmental Site Assessment, Moorebank Intermodal Terminal

Central Rail Access Option

9 July 2014

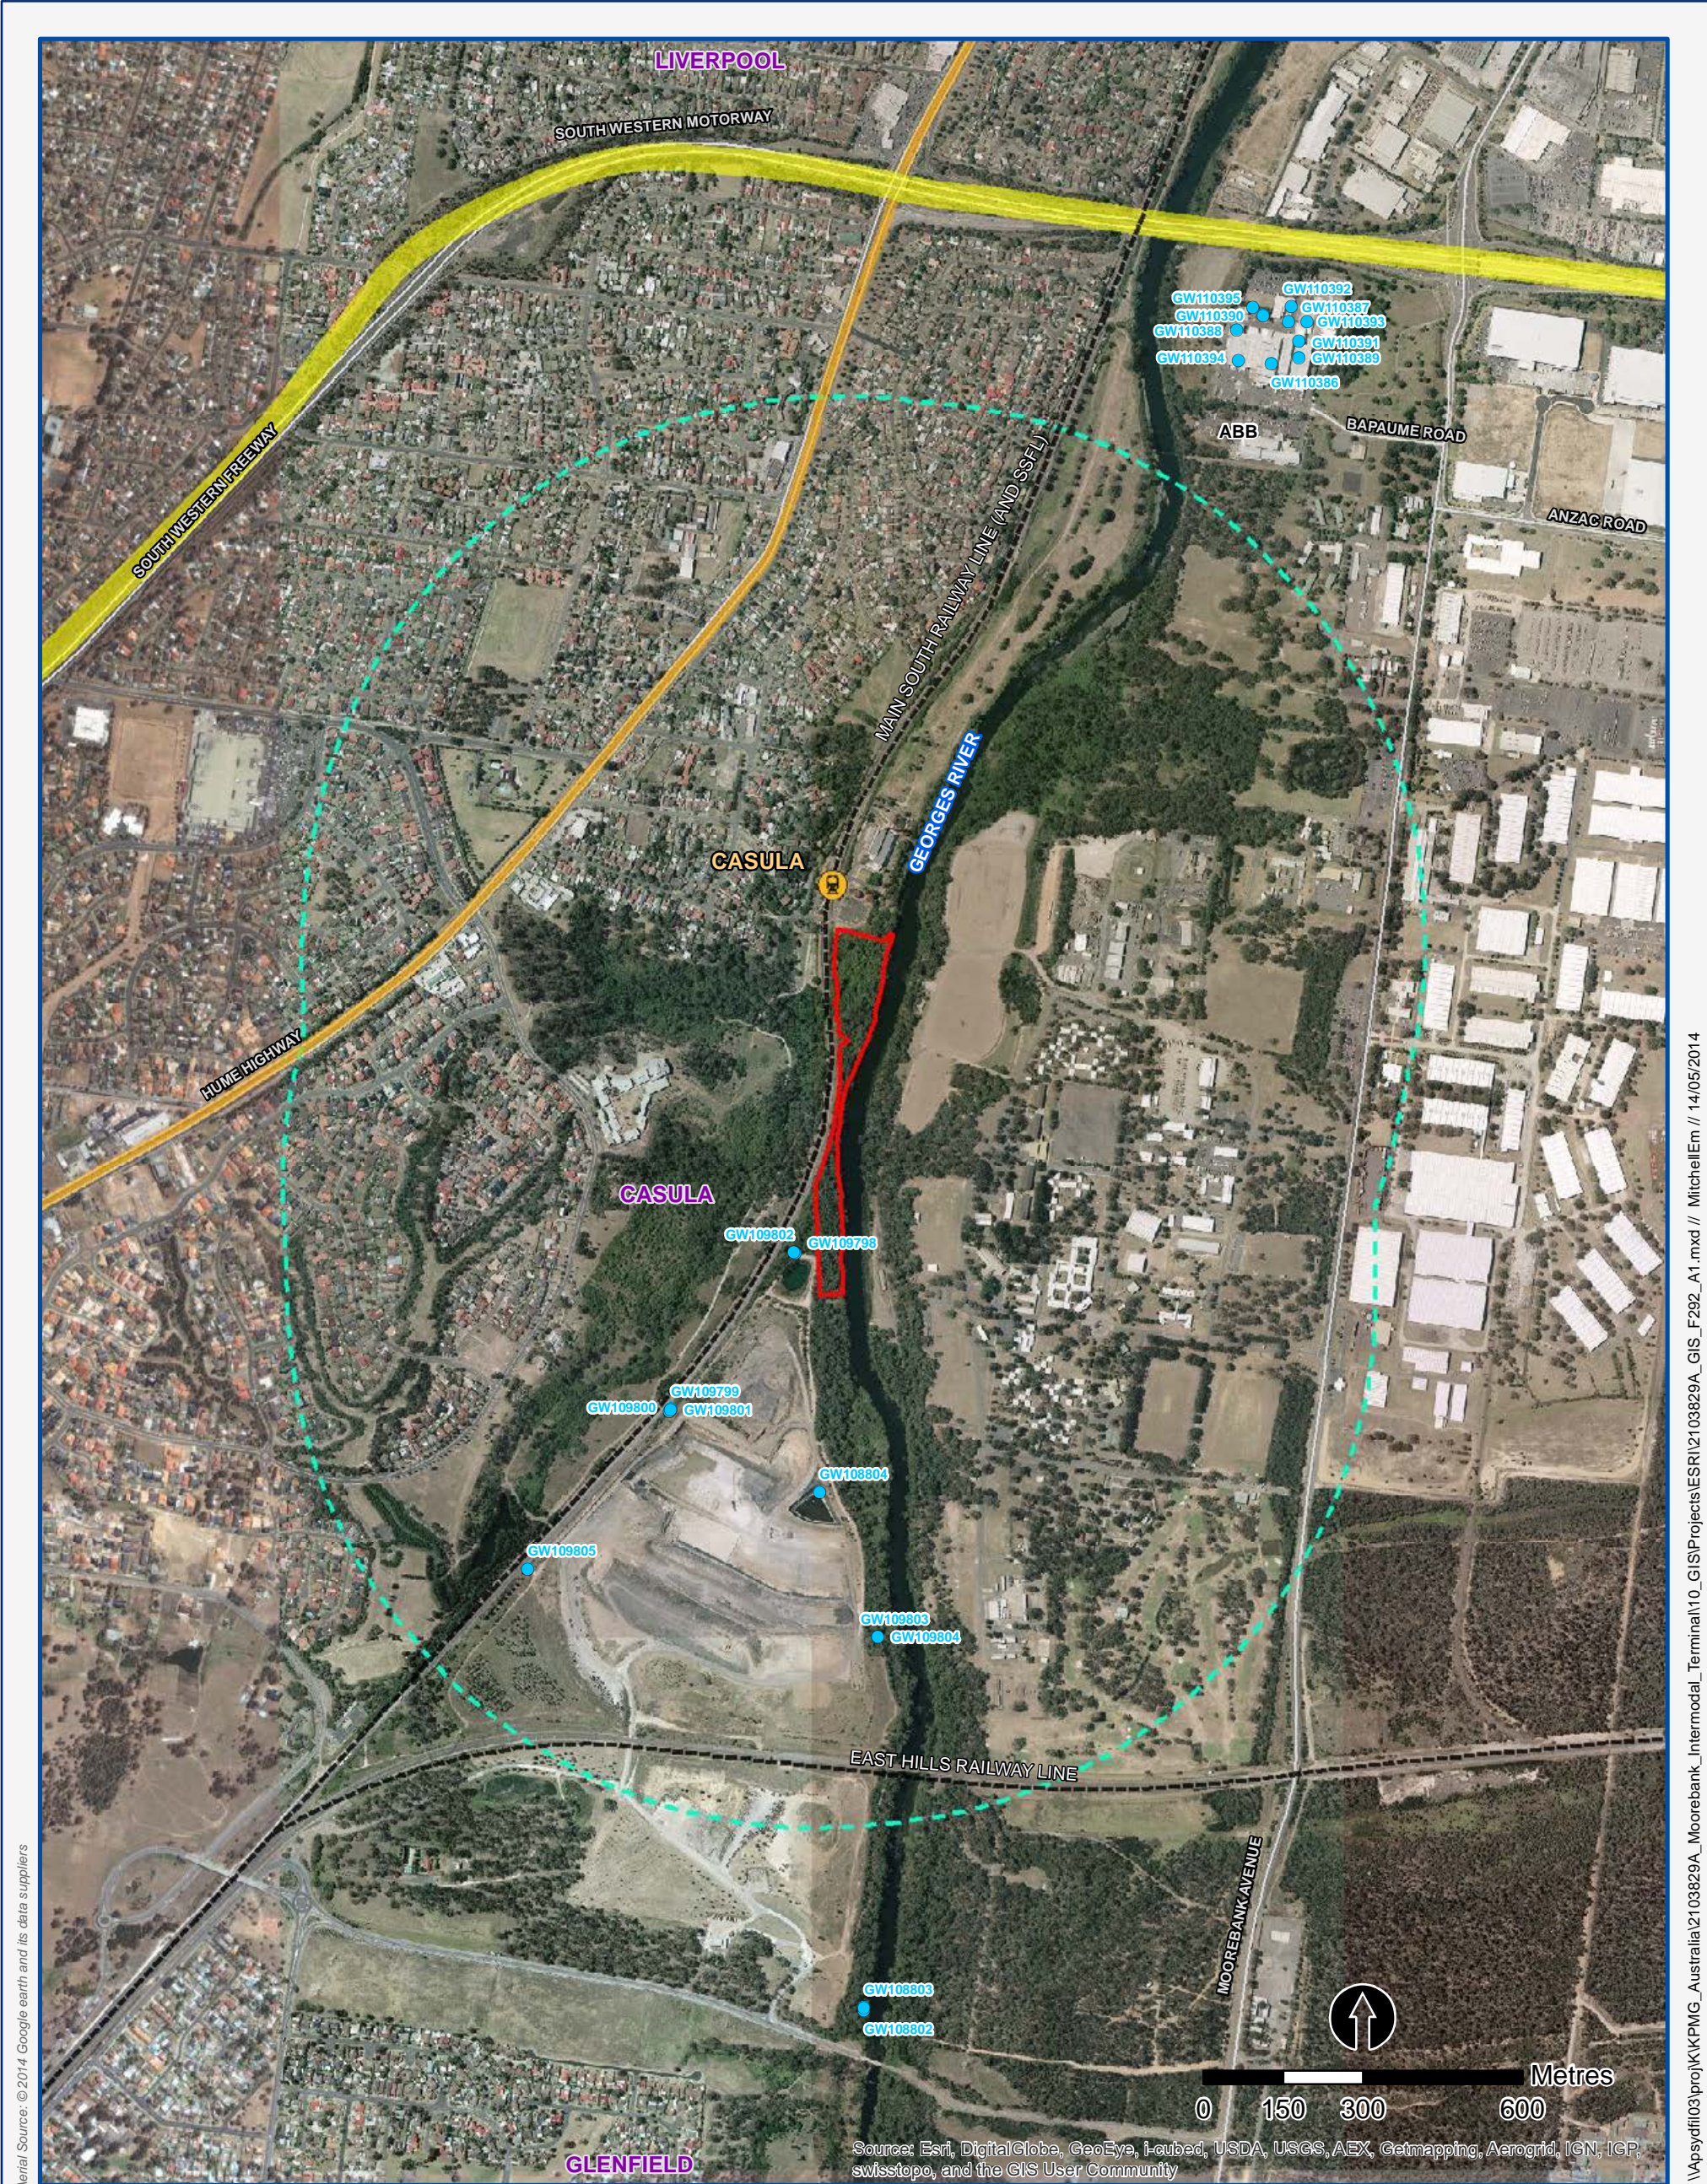
Figure 2: Central rail alignment option

Aerial Source: © 2014 Google earth and its data suppliers

The site and surrounding features are shown in Figure 2, section 8.

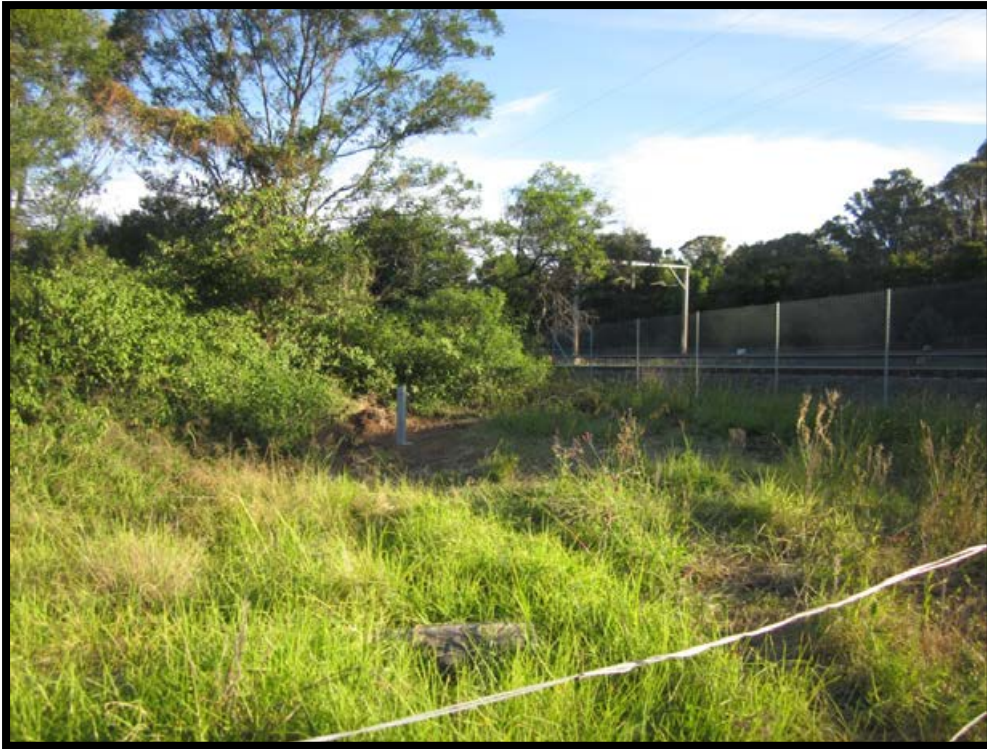
Photograph 1 View south west from northern boundary of the site taken from Casula Powerhouse showing rail corridor and existing groundwater monitoring well.

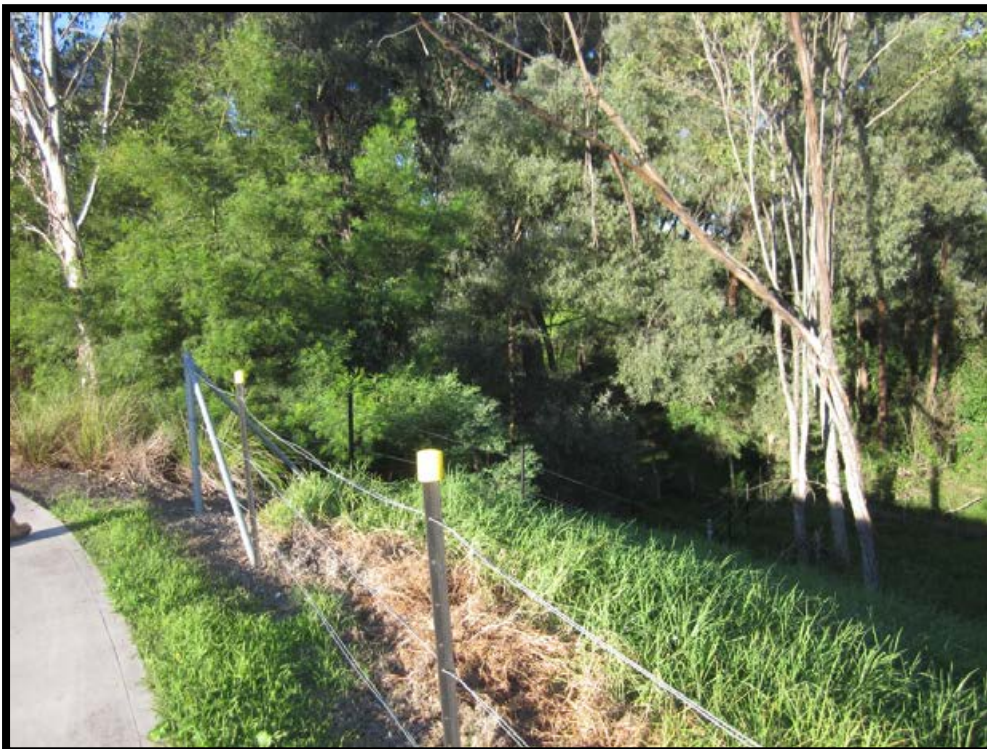
Photograph 2 View south east from northern boundary of the site taken from Casula Powerhouse, showing steep slope to the southern end of the site.

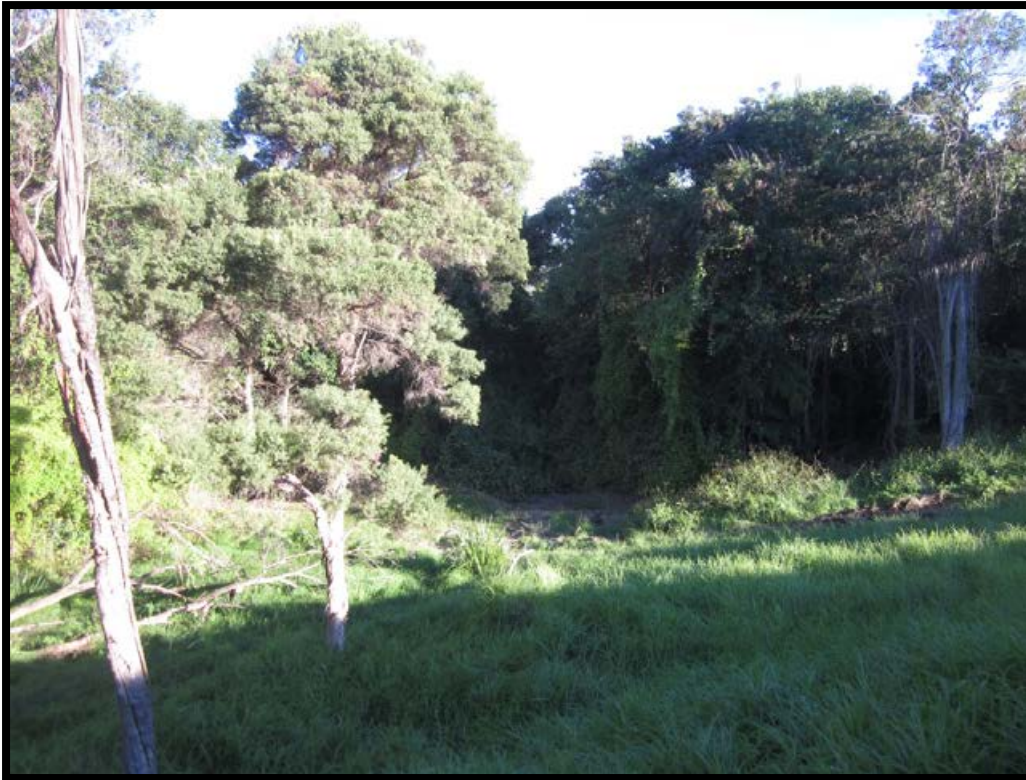
Photograph 3 View looking south from northern boundary of the site showing dense vegetation cover.

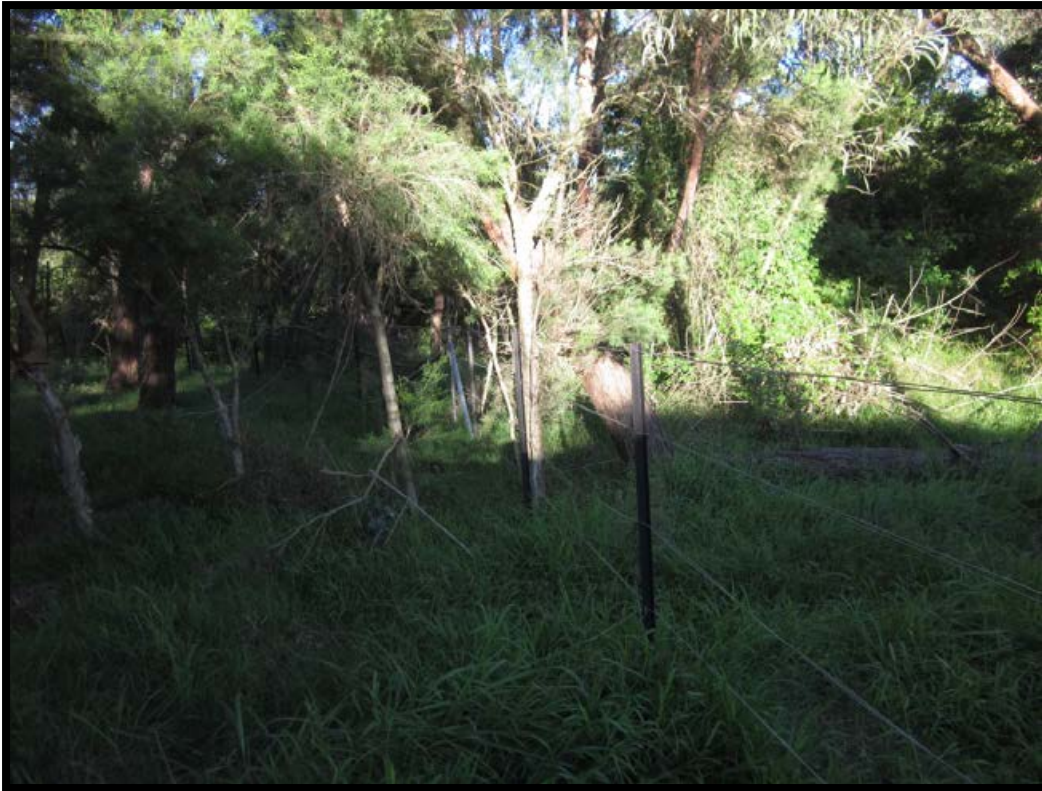
Photograph 5 Northern boundary of the site fenced from Casula Powerhouse car park, no access to the site from the northern end.
