# MOOREBANK LOGISTICS PARK

## Moorebank Precinct East: Six-Monthly Operations Compliance Report

Report: #4

Period: November 2021 – May 2022

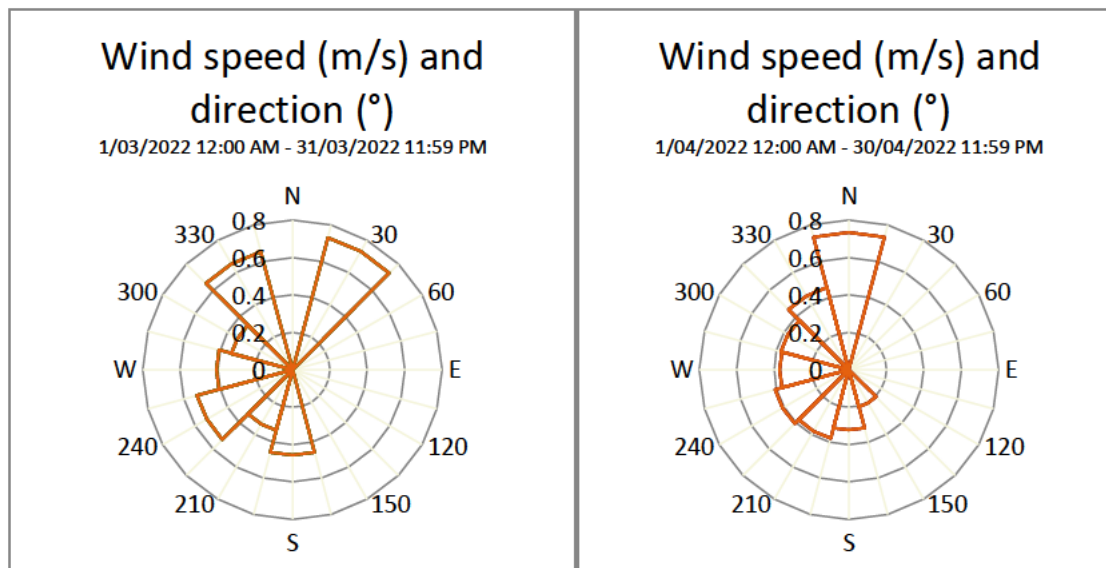
Figure 3-1: Wind roses (March and April 2022)

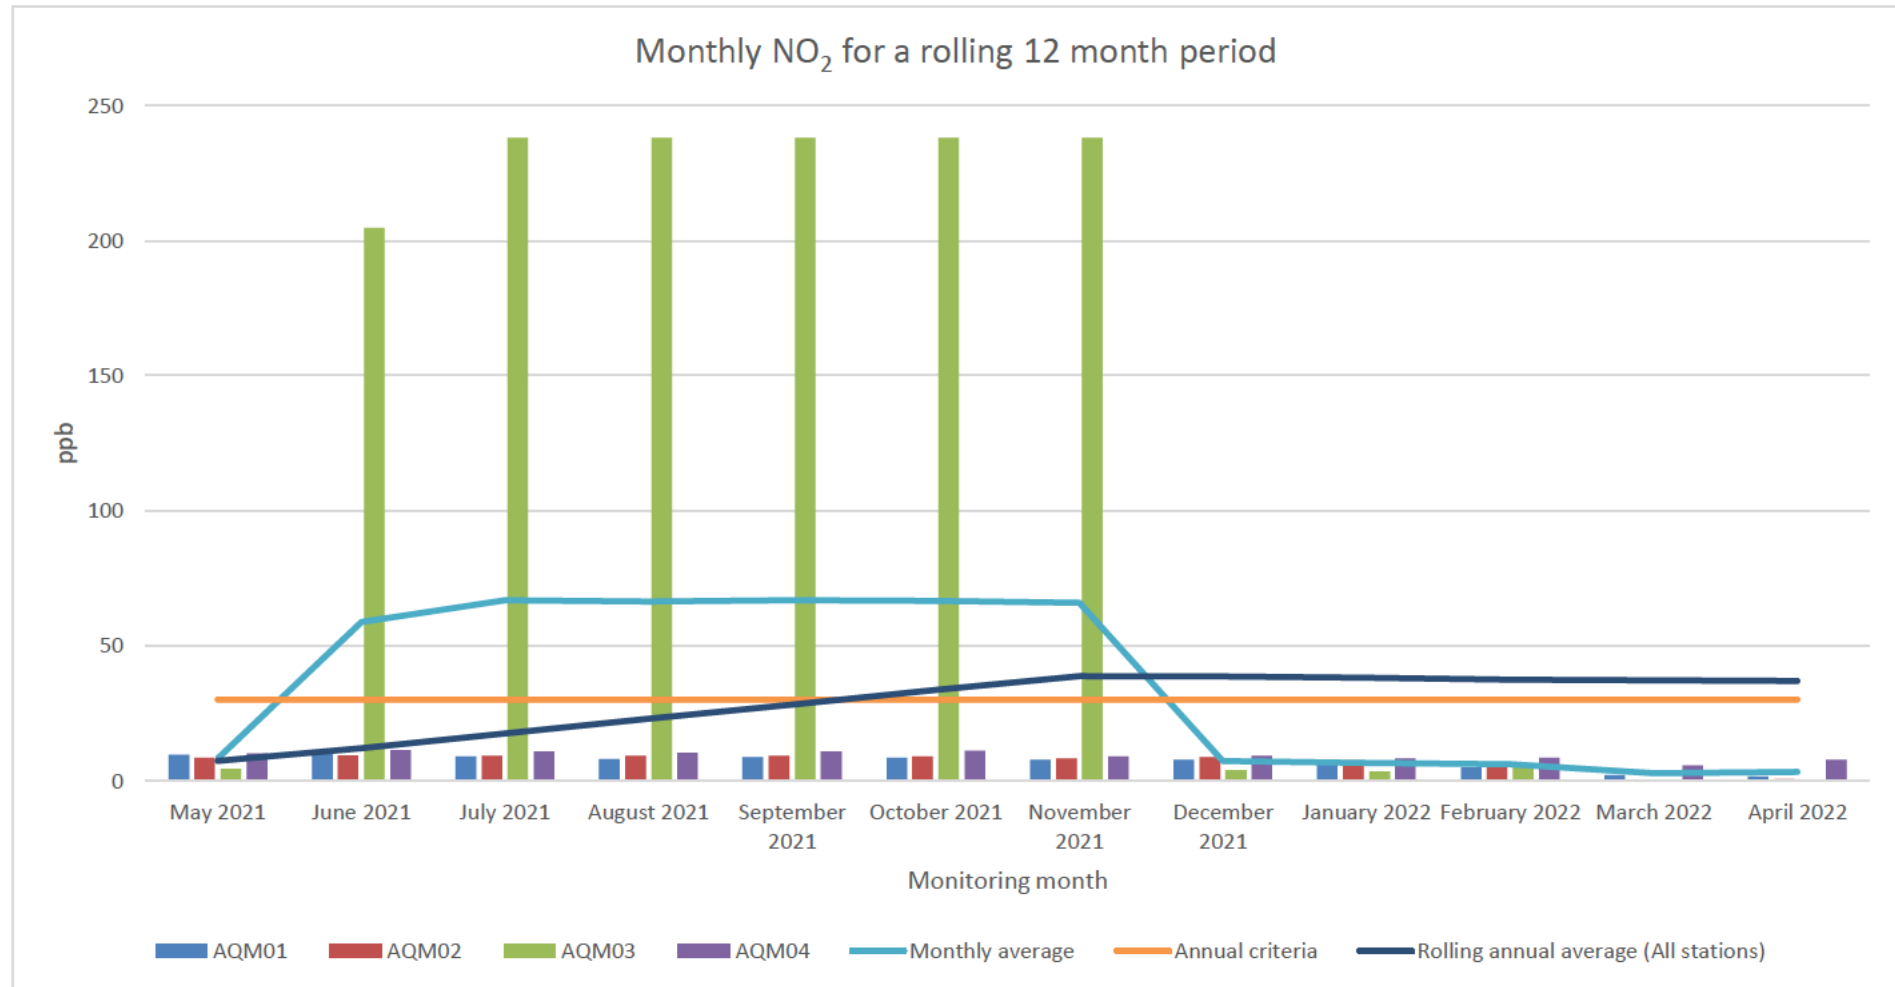
- No out of hours deliveries for MPW Stage 2 occurred on the observed exceedance days.
- The annual average criteria for NO<sub>2</sub> (0.03 ppm) was consistently exceeded from June 2021 to November 2021 (inclusive) at AQM03 and as of 30 April 2022 the rolling 12-month annual average for this monitor is 0.13 ppm. As discussed in Section 2.4, this monitor has had a low availability throughout this reporting period. The NO<sub>2</sub> data in November 2021 and also during the previous five months has also been significantly higher than in previous reporting period. This has resulted in a rolling NO<sub>2</sub> annual average of 0.037 ppm for all stations, which marginally exceeds the annual criteria of 0.03 ppm. The monitor was taken off site for maintenance and recalibration in November 2021 and when returned in December 2021, after which the recordings appeared to be more normal.

Monthly NO<sub>2</sub> over 12 months including the 6-months for this report

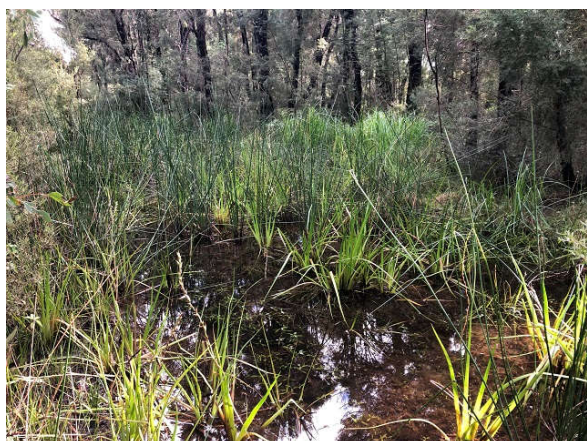
Plate 3: AQ4 – View upstream (11/06/21)

The active channel zone, composed of fine sediments, was up to approximately 4 m wide (Plates 3&4). No indicators of significant erosion were observed suggesting that Anzac Creek continues to be relatively stable at this site (Appendix 2).

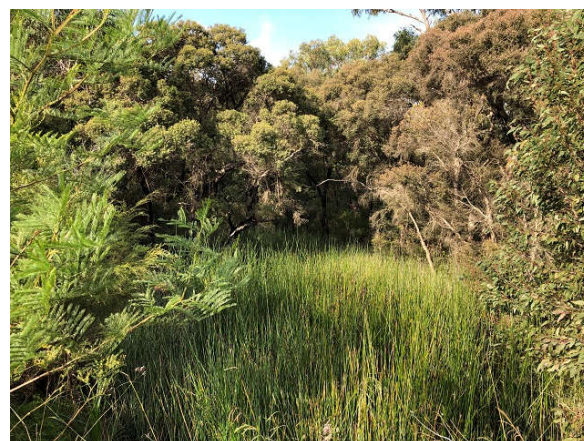
Plate 4: AQ4 – View downstream (28/04/21)

Since the baseline survey, stands of the emergent macrophyte, Jointed Twig Rush (*Baumea articulata*) and Twig Rush (*Baumea rubiginosa*) have formed across the downstream reaches of stream channel (Plate 4). Jointed Twig Rush, Slender Knotweed and Frog's Mouth (*Philydrum lanuginosum*) are common in the upstream reaches (Plate 4).

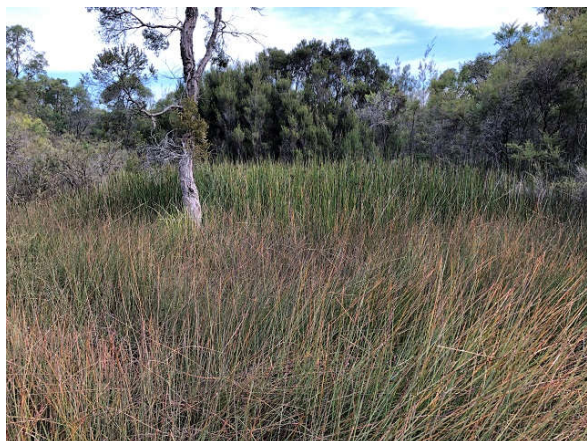
Plate 5: Site AQ8 – view upstream (28/04/21)

The stream channel at Site AQ8 (up to approximately 20 m wide) continues to be classified as stable, mostly due to dense cover by emergent macrophytes in addition to a relatively intact, woody riparian zone (Appendix 2).

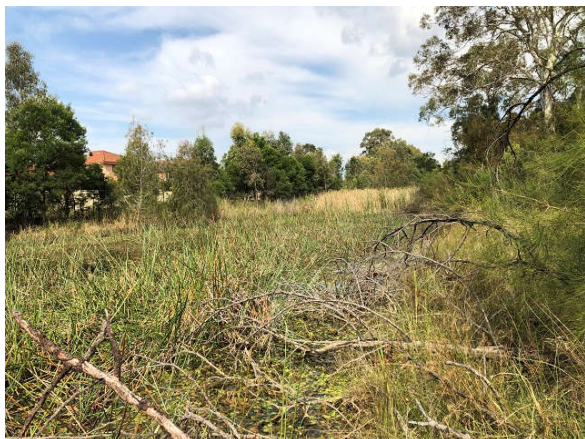
Plate 7: Site AQ12 – view upstream (28/04/21)

The submerged macrophyte species, Ribbonweed (*Vallisneria* sp.) and *Potamogeton ochreatus* were common, in addition to Slender Knotweed and dense stands of Typha, Phragmites and Tall Spike Rush (Plate 7). *Nymphoides geminata* (Entire Marshwort), with mostly floating leaves, was common close to the shore.

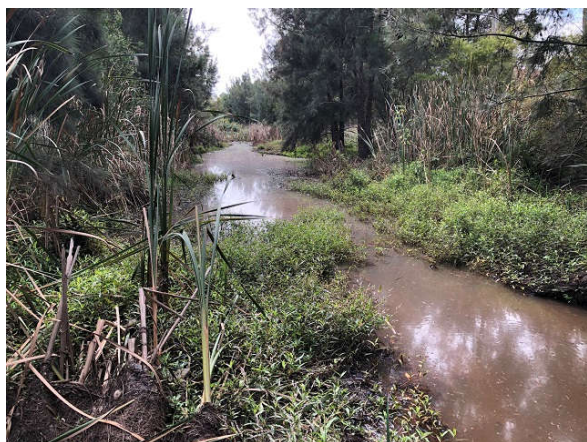
Plate 9: Site AQ13 – view downstream (28/04/21)

A large proportion of the stream channel and edges were colonised by Typha and Slender Knotweed. River Clubrush (*Schoenoplectus validus*) and Whorled Pennywort/Shield

Pennywort (*Hydrocotyle cf verticillata*) were also common. The stream channel appeared stable (Appendix 2).

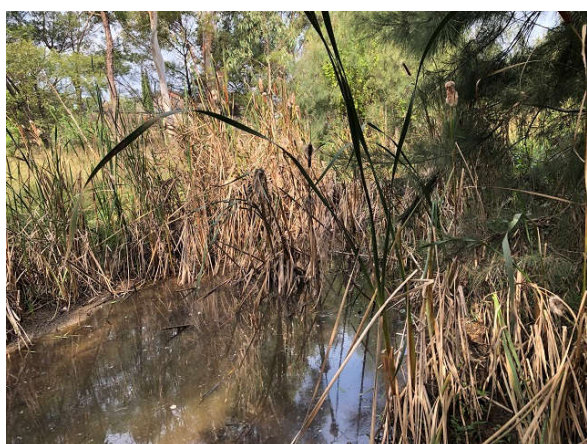
Plate 11: Site AQ14 – view upstream (28/04/21)

Typha, Slender Knotweed, River Clubrush and Whorled Pennywort/Shield Pennywort were common (Plates 11&12). This section of Anzac Creek remains mostly stable due to dense instream vegetation and vegetated banks (Appendix 2).

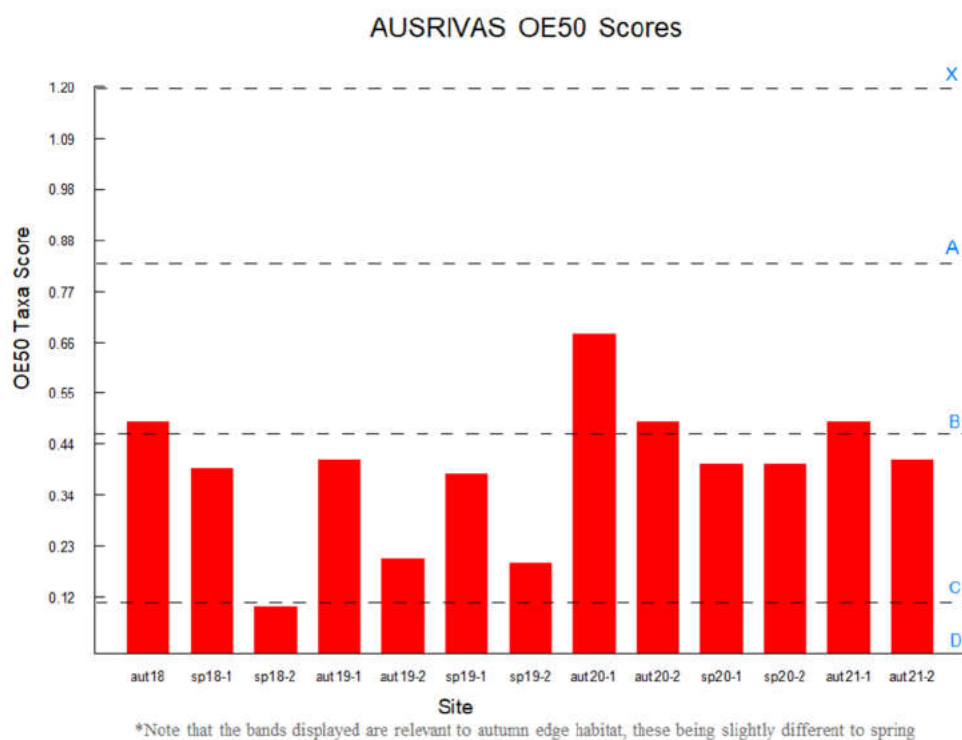
**Figure 3.** OE50 Taxa Scores and their respective Band Scores (B-D) for AUSRIVAS samples collected from edge habitat at Site AQ12 since autumn 2018.

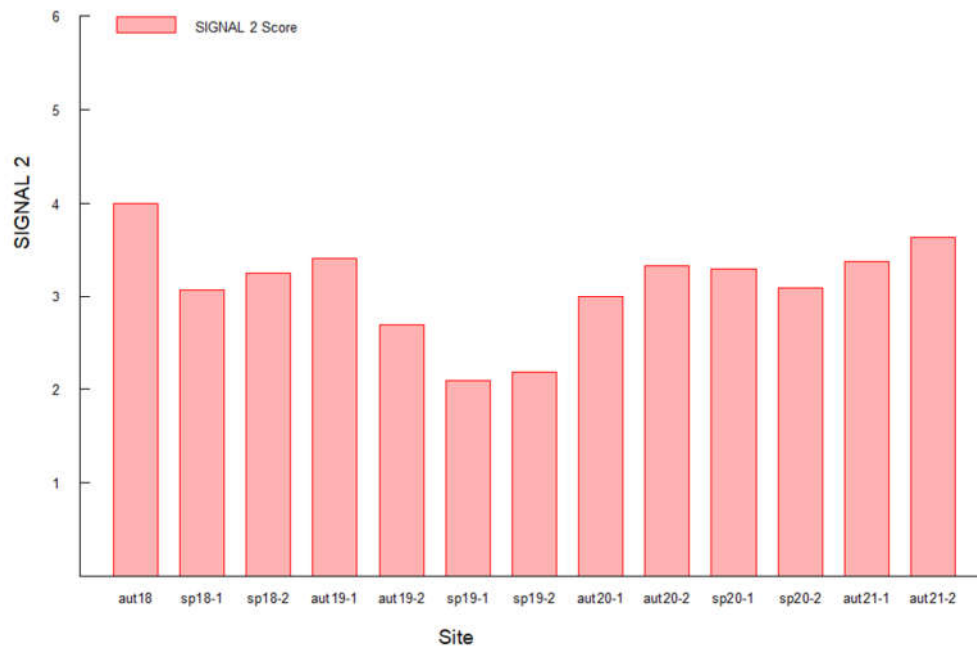
**Figure 4. Quadrant diagram showing SIGNAL 2 results for Site AQ12 sampled in Anzac Creek since autumn 2018.**

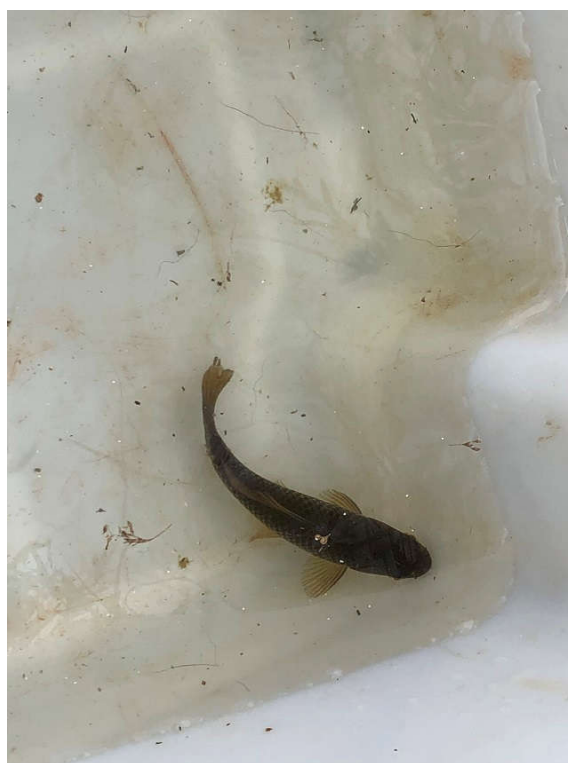
**Plate 13:** Juvenile Goldfish collected at Site AQ12 (28/04/2021).

Four species of fish (including two introduced species) were observed while electro-fishing at Site AQ12 in autumn 2021 (Table 10). *Gambusia* (*Gambusia holbrooki*) were common and also caught in dip nets used to sample aquatic macroinvertebrates in autumn 2021 (Table 6). Short-finned eels (*Anguilla australis*) (<30 cm in length), a Long-finned eel (*Anguilla reinhardtii*) (<40cm in length) and one individual of the introduced species, Goldfish (*Carassius auratus*) were also collected (Table 10).
