# **MOOREBANK LOGISTICS PARK**

## **Moorebank Precinct East: Six-Monthly Operations Compliance Report**

Report: #6

Period: November 2022 – May 2023

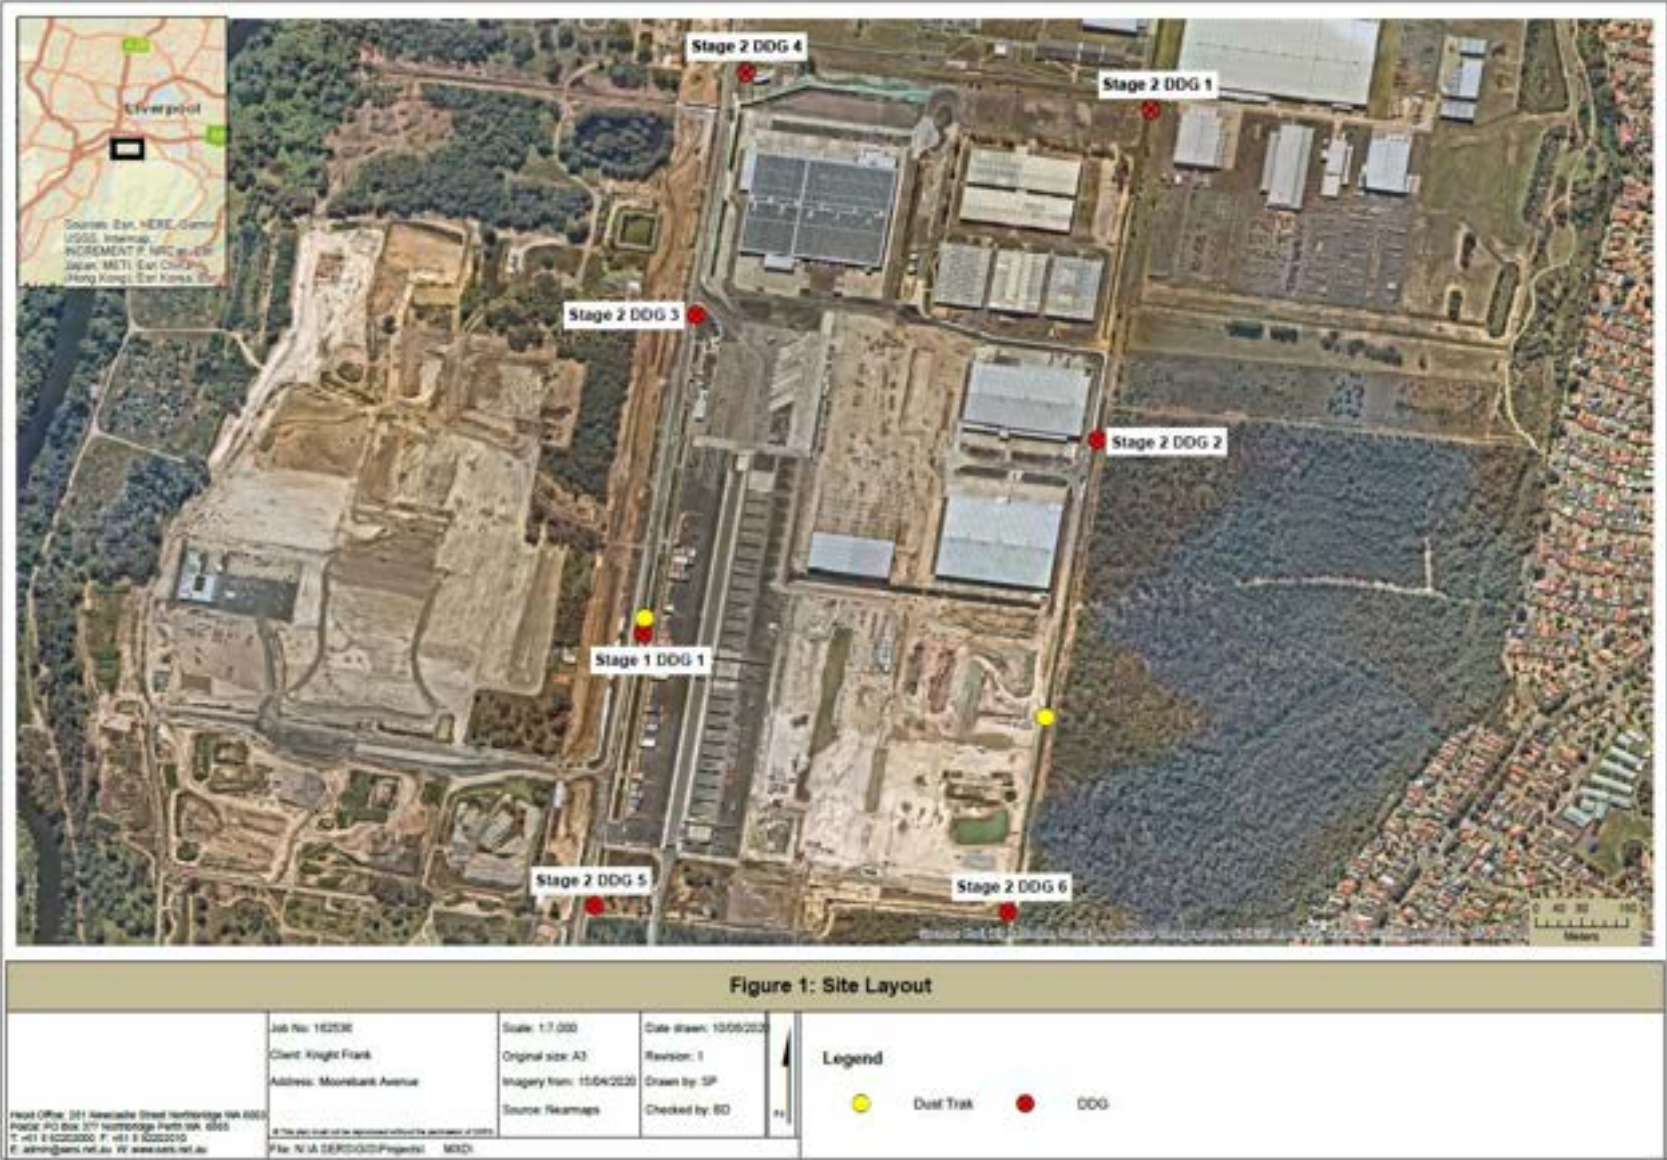
Figure 2-2: Location of Dust Deposition Gauges (Source: SERS, June 2023)

DDG locations were also chosen so that a true representation of dust generated from site operation activity of MEP could be established and to a slightly lesser extent, the construction activities of MWP Stage 2.

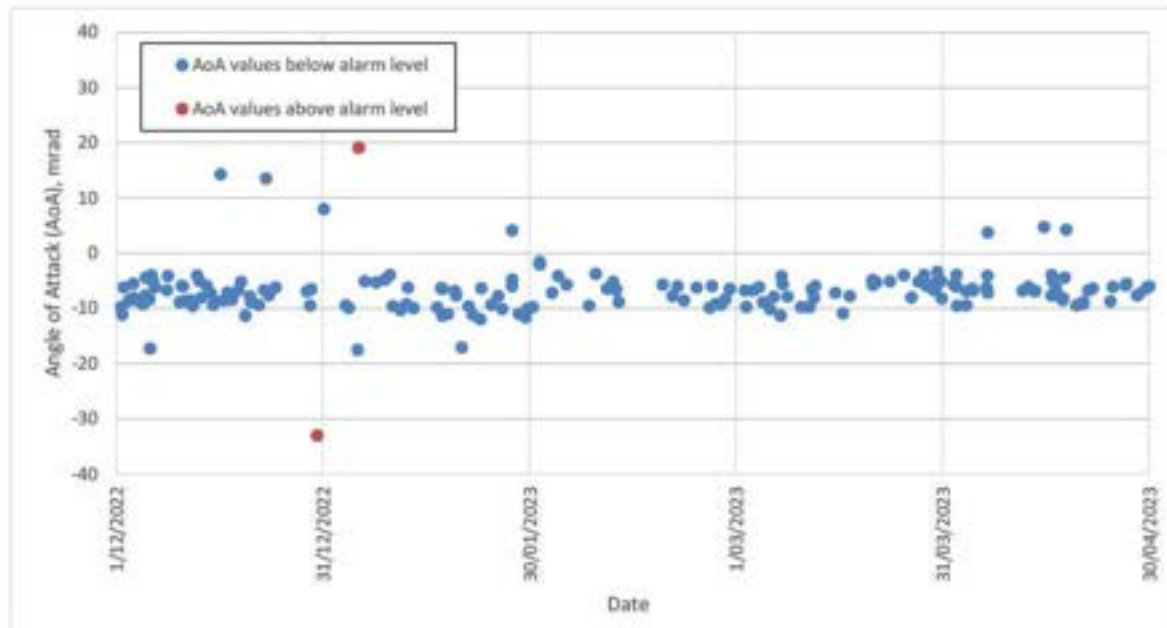
**Figure 5** Maximum AoA value for each train - 1 December 2022 and 30 April 2023

None of these AoA alarm events resulted in elevated noise levels at the permanent noise monitoring location (refer Section 5.1). Exceedances of the AoA alarm levels were viewed as one-off instances, occurring irregularly.

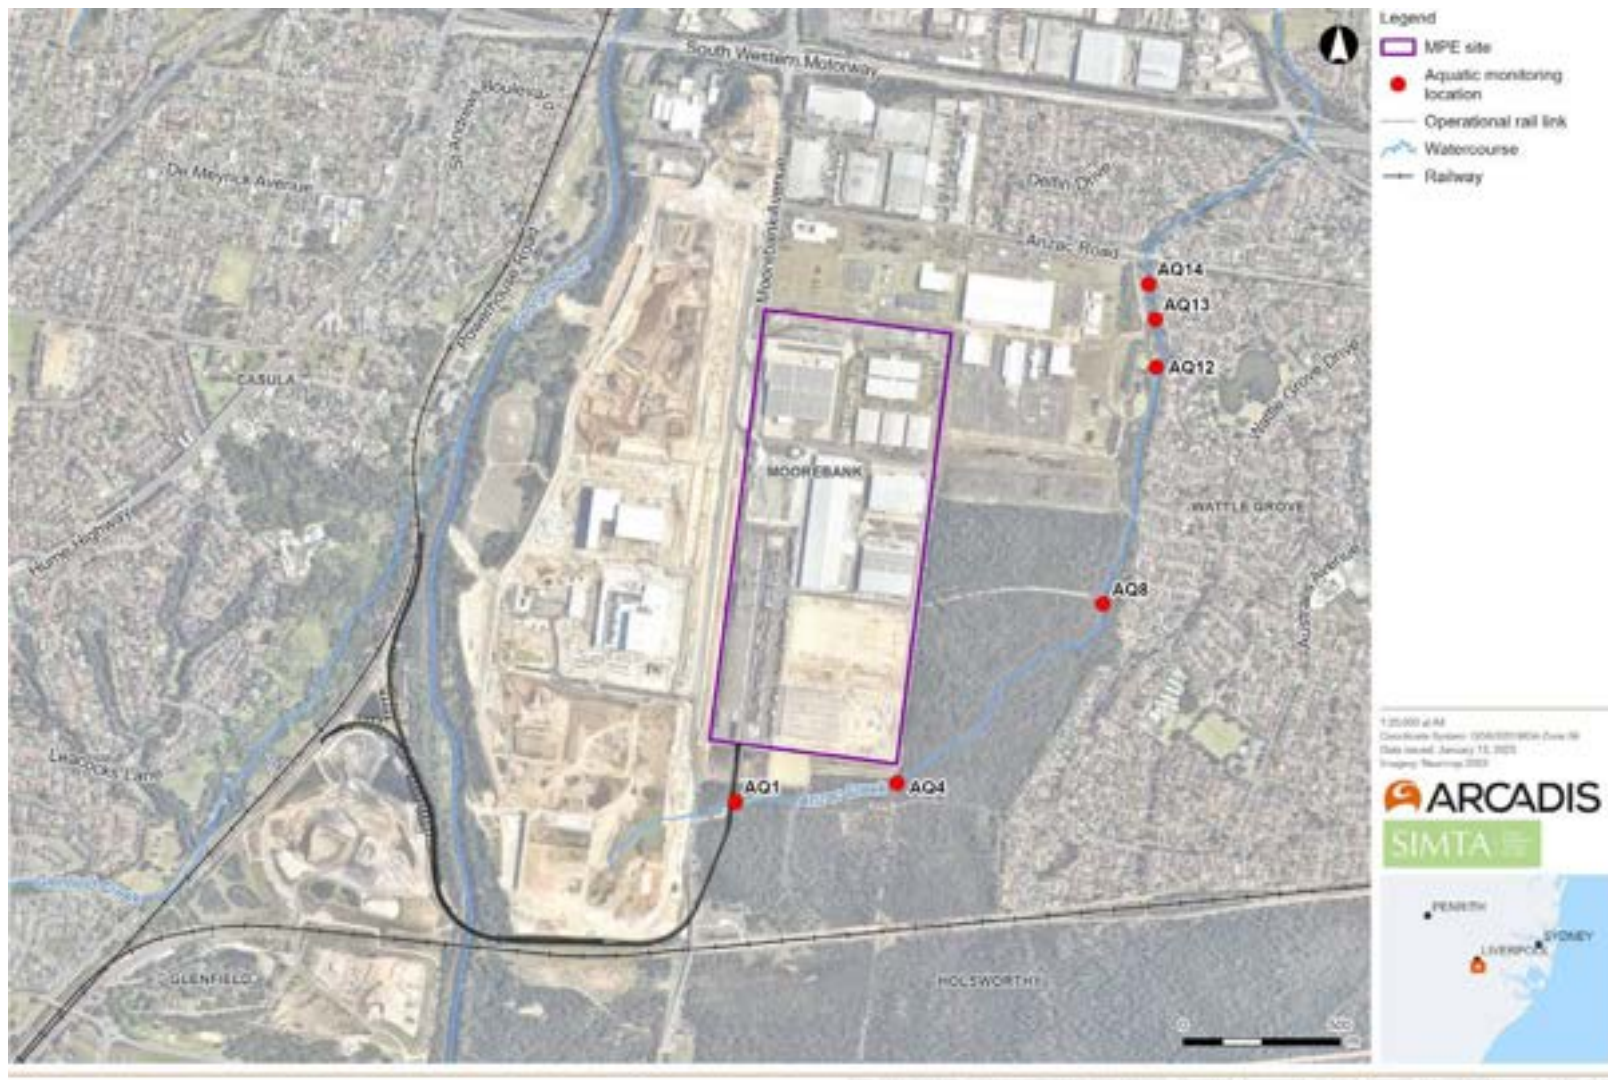
Figure 1. Project Location

Surface water from the MPES2 site is expected to enter Anzac Creek as licensed discharge between Site AQ4 and AQ8 (Figure 1). It was also considered likely that runoff from some areas of the MPES2 site would be collected by a vegetated dam situated within Commonwealth Department of Defence land (Biosis, 2018). Flow from this dam enters Anzac Creek upstream of Site AQ14 via a culvert (Figure 1).

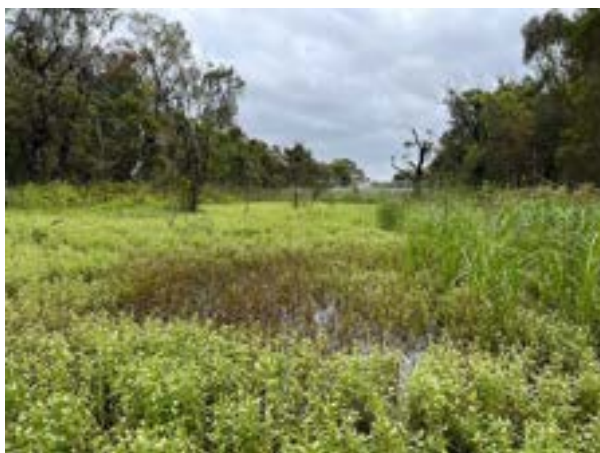
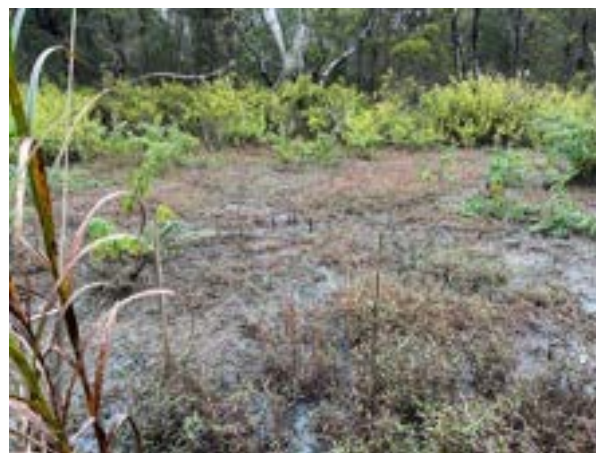
Since the spring 2022 survey, there had been a considerable decline in water and cover of Alligator Weed (*Alternanthera philoxeroides*) at Site AQ1 (Plates 1&2). Alligator weed litter and accumulations of filamentous green algae were observed decaying on the surface of the creek bed. The channel bed consisted of fine sediment, the upper layers of which were anoxic.

The active channel zone at this site (up to approximately 5 m wide) remains stable (i.e., no signs of active erosion), due to the absence of flow, cover of remaining aquatic plants and the relatively intact woody riparian vegetation (Appendix 2). Native plant species included Slender knotweed (*Persicaria decipiens*), Marsh Club-rush (*Bolboschoenus fluviatilis*) and Typha (*Typha* sp.). *Myriophyllum variifolium* Hook.f., a species of water milfoil native to eastern Australia, was also present. The tree canopy was mostly comprised by *Melaleuca* spp. and *Eucalyptus* spp. (Plates 1&2).

Plate 1: AQ1 – View across stream (30/11/22)

Plate 2: AQ1 – View across stream (18/05/23)

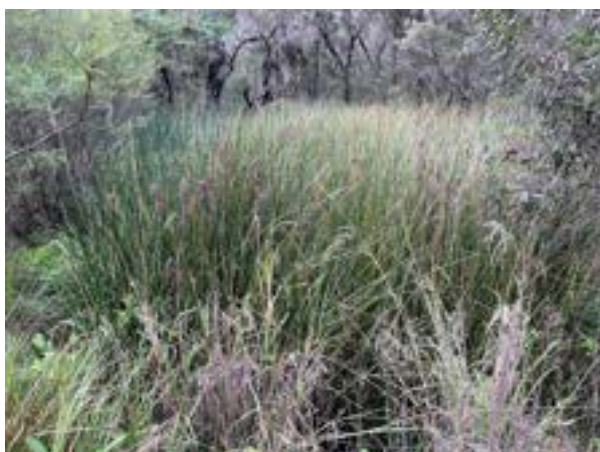
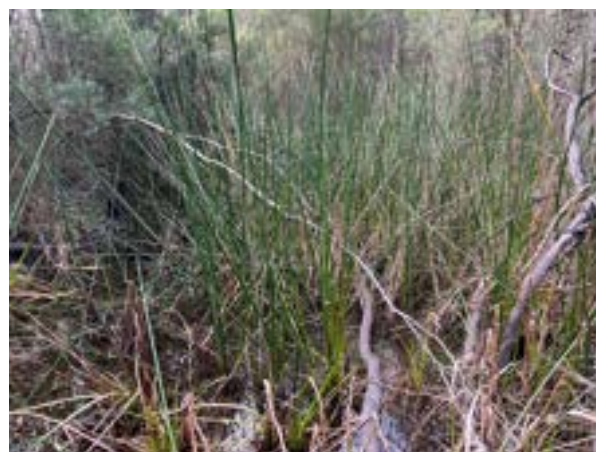
Since the baseline survey, stands of the emergent macrophyte, Jointed Twig Rush (*Baumea articulata*) and Twig Rush (*Baumea rubiginosa*) have colonised a large proportion of the stream channel (Plates 3&4). Jointed Twig Rush, Slender Knotweed and Frog's Mouth (*Philydrum lanuginosum*) continue to be common in the upstream reaches (Plate 4).

The active channel zone, composed of fine sediments, is up to approximately 4 m wide (Plates 3&4). No indicators of significant erosion were observed suggesting that Anzac Creek continues to be relatively stable at this site, particularly since colonisation of the stream channel by emergent macrophytes and reduced flow within the creek since spring 2022 (Plate 3&4, Appendix 2).

Plate 3: AQ4 – View downstream (18/05/23)

Plate 4: AQ4 – View upstream (3/07/23)

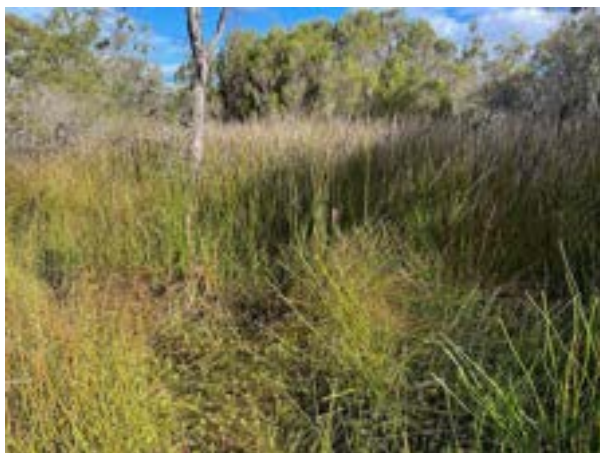
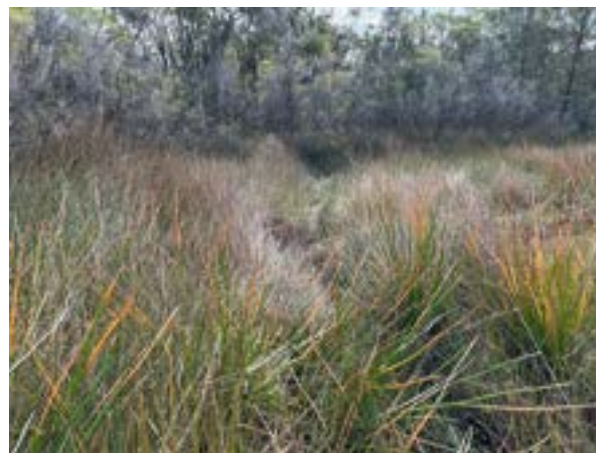
Most notably, taller species of emergent macrophyte, including Jointed Twig Rush and Tall Spikerush (*Eleocharis sphacelata*) have encroached upon habitat previously dominated by Heron Bristle Sedge (*Chorizandra cymbaria*) (Plates 5&6). Other shorter plants, including Frogsmouth (*Philydrum lanuginosum*), Slender Knotweed and the introduced species, Umbrella Sedge (*Cyperus eragrostis*), were also less common than observed by the spring 2022 surveys. Riparian vegetation continues to be dominated by *Casuarina* trees. Common Reed/Phragmites (*Phragmites australis*) was present at the downstream end of the site.

The stream channel at Site AQ8 (up to approximately 20 m wide) continues to be classified as stable, mostly due to the dense cover by emergent macrophytes in addition to a relatively intact, woody riparian zone (Appendix 2).

Plate 5: Site AQ8 – view upstream (18/05/23)

Plate 6: Site AQ8 – view across stream (3/07/23)

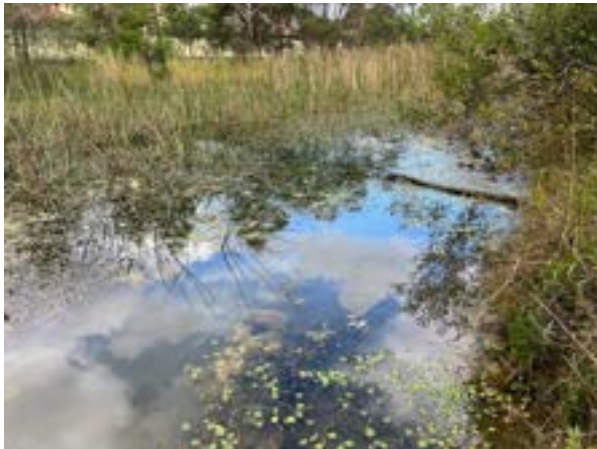
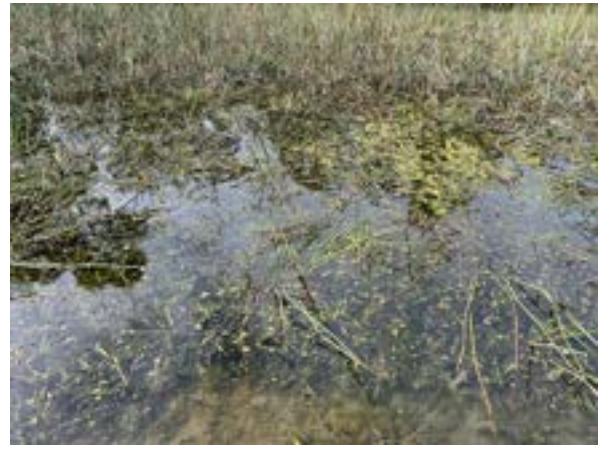
The submerged macrophyte species, Ribbonweed (*Vallisneria* sp.) and *Potamogeton ochreatus* were common, in addition to Slender Knotweed and dense stands of Typha, Phragmites and Tall Spike Rush (Plate 7). *Nymphoides geminata* (Entire Marshwort), with mostly floating leaves and accumulations of green filamentous algae were abundant in areas close to the shore (Plates 7&8). Also noted during spring 2022 and autumn 2023 was the native perennial, *Utricularia* sp., which occur on wet soil and in freshwater as terrestrial or aquatic species. *Egeria* (*Egeria densa*), which was collected close to the left-bank (facing downstream) of the pool in spring 2020, has not been observed subsequently.

Riparian vegetation included Casuarina, Eucalyptus and Melaleuca trees and Spiny-head Mat-rush/Basket Grass (*Lomdandra longifolia*) (Plates 7&8).

Plate 7: Site AQ12 – view upstream (18/05/23)

Plate 8: Site AQ12 – view across stream (3/07/23)

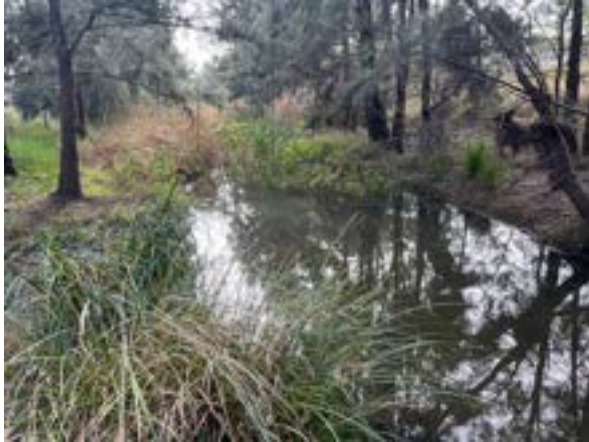
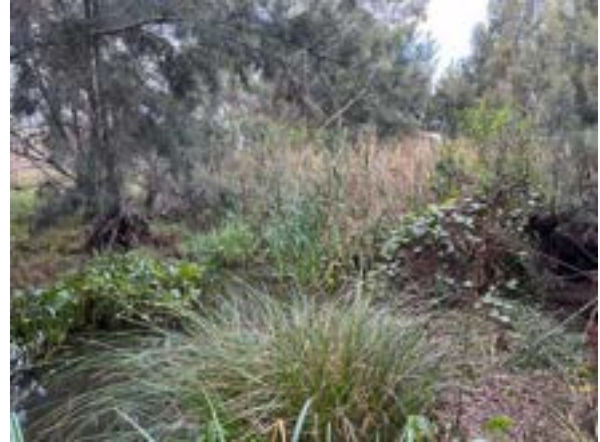
A large proportion of the stream channel and edges were colonised by Typha and Slender Knotweed. River Clubrush (*Schoenoplectus validus*) was also common. Recent surveys have noted the establishment of the aquatic weed, *Sagittaria platyphylla* (*Sagittaria*). The stream channel appeared stable (Appendix 2).

Plate 9: Site AQ13 – view downstream (3/07/23)

Plate 10: Site AQ13 – view upstream (18/05/23)

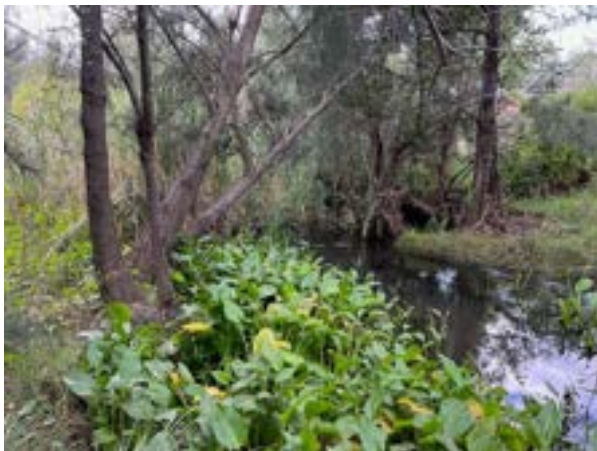
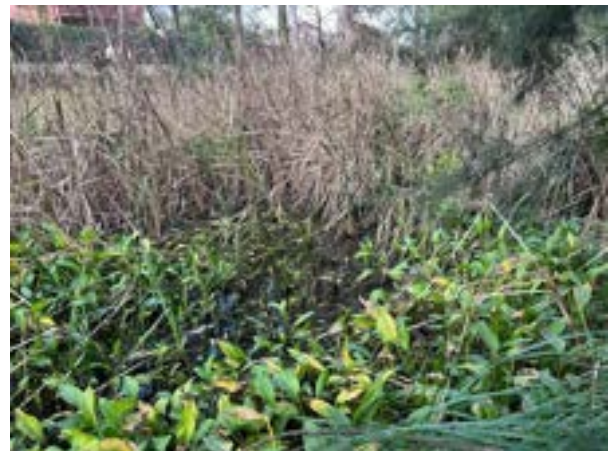
Site AQ14 is situated approximately 150 m downstream of Site AQ13 and immediately downstream of the culvert that links the dam within Commonwealth Department of Defence Lands to Anzac Creek (Figure 1). Flow was not apparent at the time of both autumn 2023 surveys (Plates 11&12).

Typha, Slender Knotweed, River Clubrush and Whorled Pennywort/Shield Pennywort continue to be common (Plates 11&12). Stands of Sagittaria were also noted. This section of Anzac Creek remains mostly stable due to dense instream vegetation and vegetated banks (Appendix 2). Water visibility was ‘good’ at the time of both surveys (Plates 11&12).

Plate 11: Site AQ14 – view downstream (30/11/22)

Plate 12: Site AQ14 – view upstream (3/07/23)

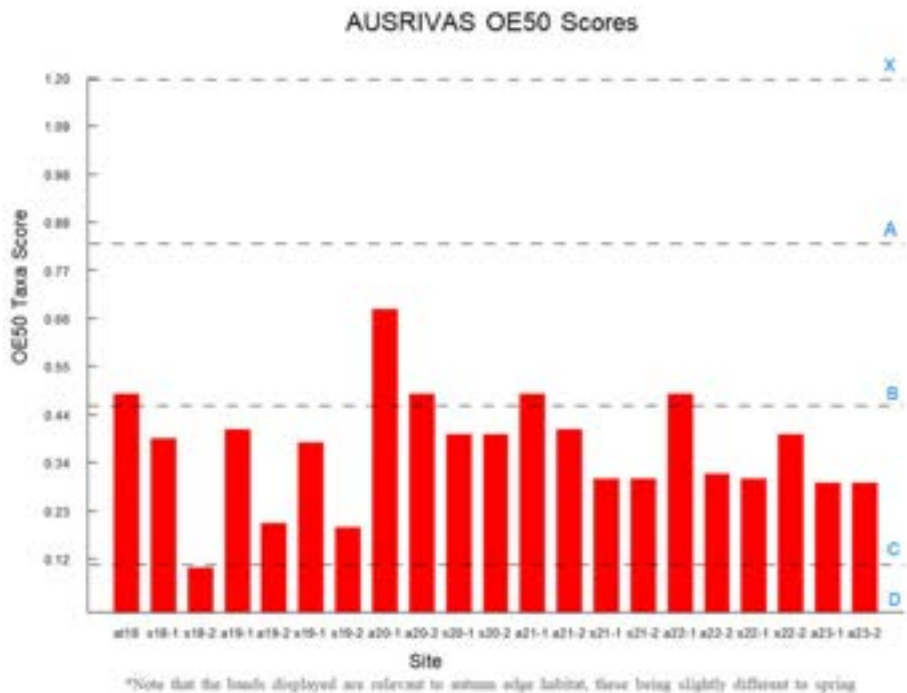
**Figure 3. OE50 Taxa Scores and their respective Band Scores (B-D) for AUSRIVAS samples collected from edge habitat at Site AQ12 since autumn 2018.**
