Long-Term Environmental Management Plan

Northern Ring Road, Service Pad and Loop Road,
Moorebank Precinct West, 400 Moorebank Avenue,
Moorebank, NSW

Prepared for: Logos Property Pty Ltd c/- Tactical Group Pty Ltd

EP1489.008_v4 14 September 2022

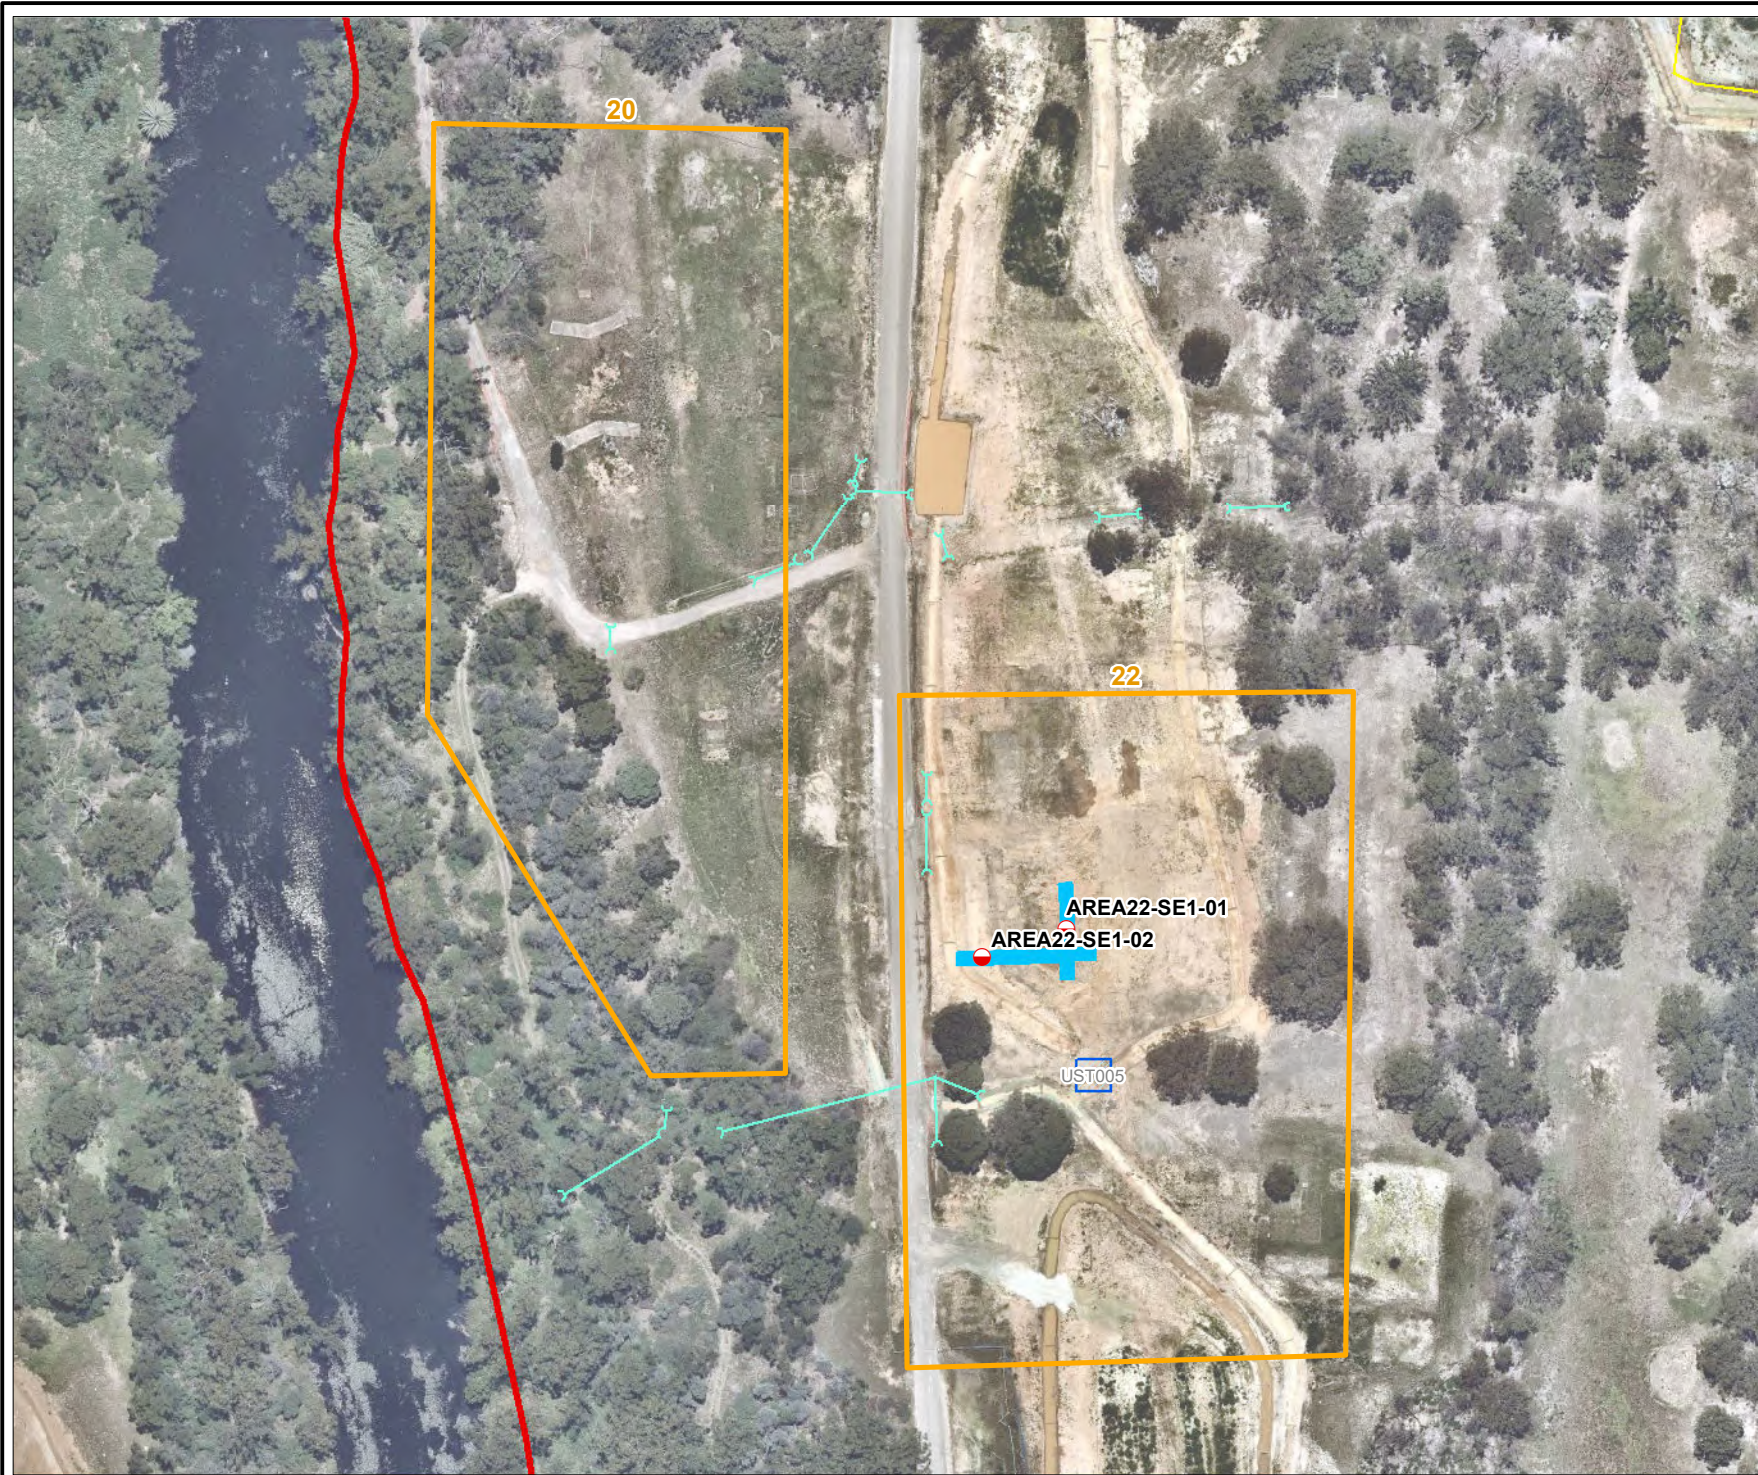
- ▭ Approximate Site Boundary
- ▭ Areas Of Potential Concern
- ▭ Services Excavation
- ▭ UST
- Stormwater
- Sewerage
- Sample Location

JBS&G (2022) noted the presence of one (1) groundwater monitoring well at the Site which is to be sampled as part of the requirements within the MPE LTEMP (EP Risk 2020a) and subsequent LTEMP for the land. Requirements for groundwater and surface water monitoring are provided within **EMP 11** and **EMP 12** respectively. The location of the groundwater monitoring well is provided within **Figure 6**.

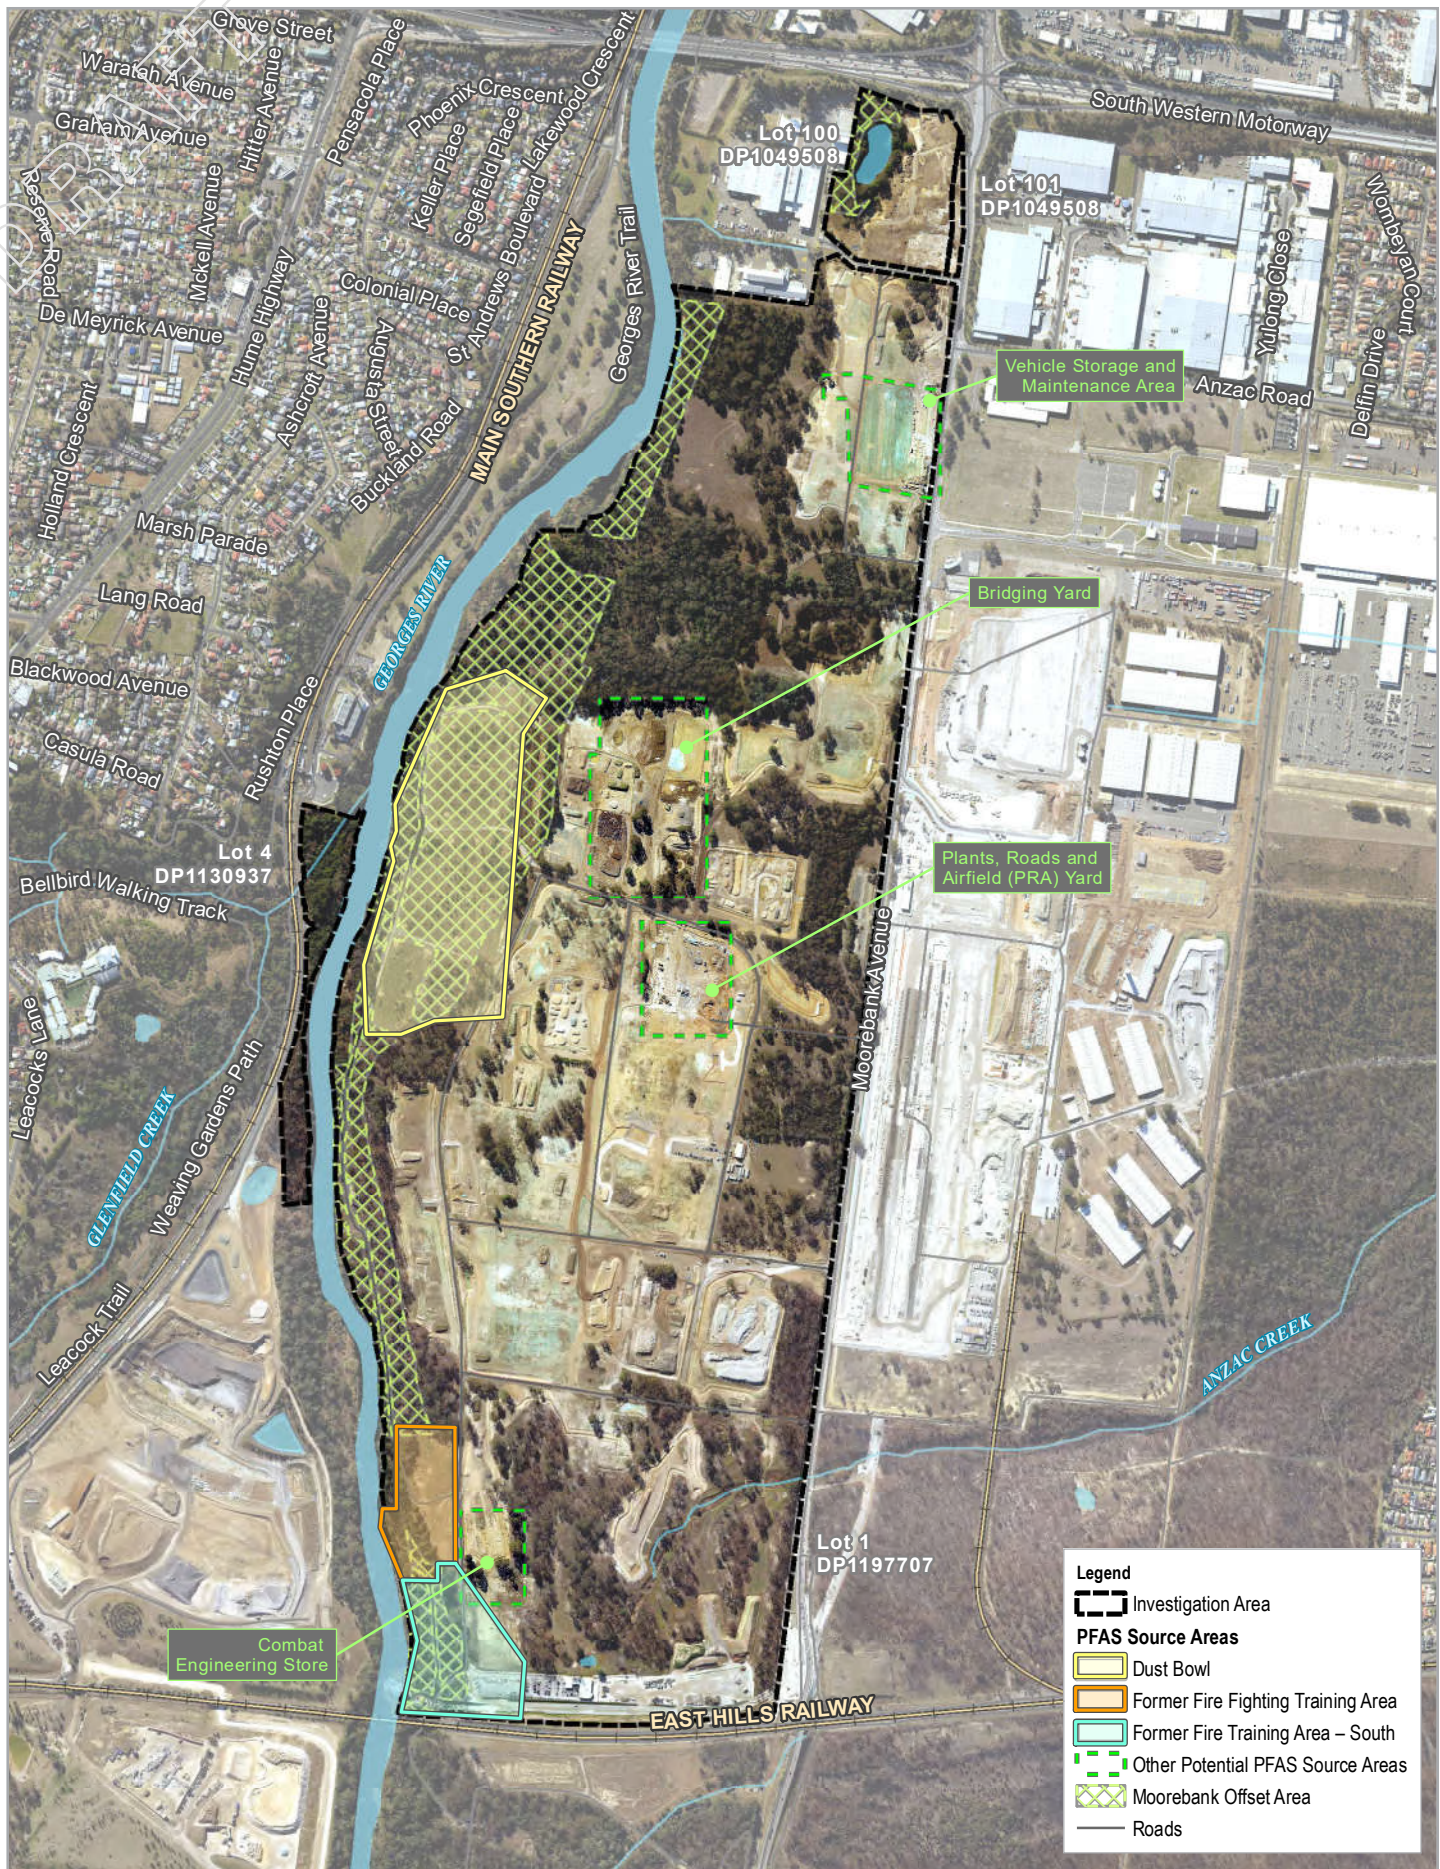
FIGURE 3

- Investigation Area
- PFAS Source Areas**
- Dust Bowl
- Former Fire Fighting Training Area
- Former Fire Training Area – South
- Other Potential PFAS Source Areas
- Moorebank Offset Area
- Roads

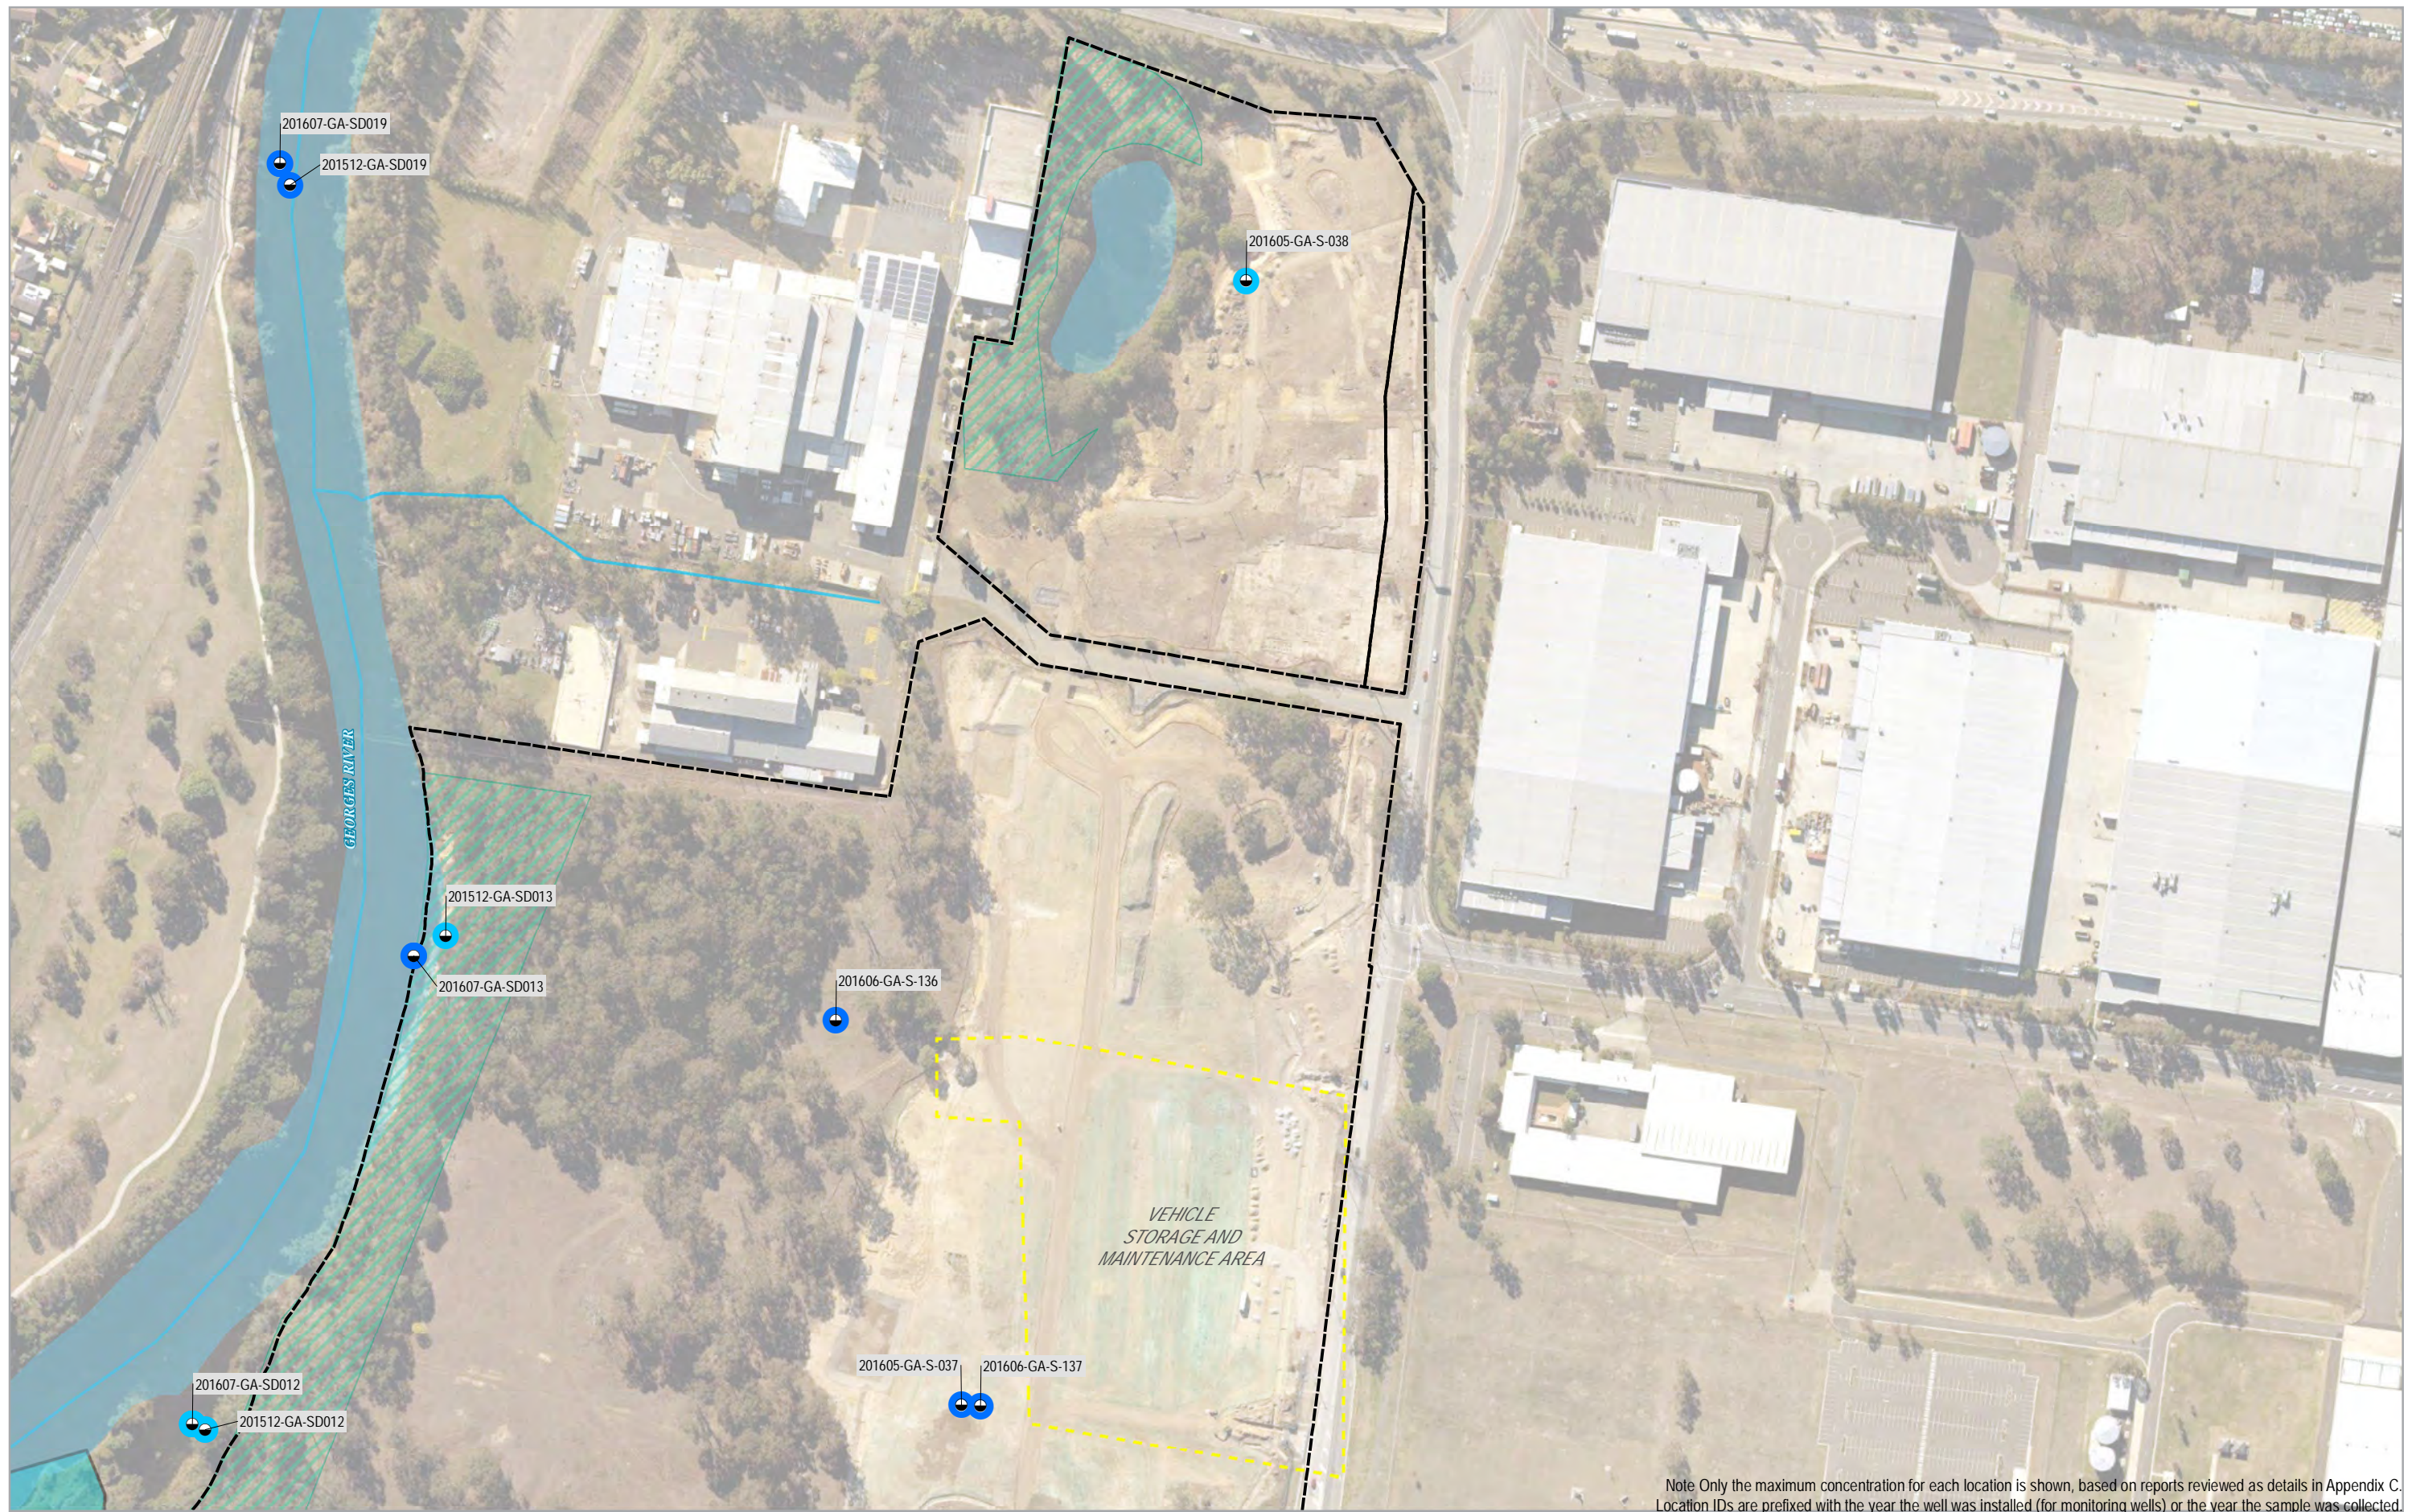
FIGURE 7B

Note: Only the maximum concentration for each location is shown, based on reports reviewed as details in Appendix C. Location IDs are prefixed with the year the well was installed (for monitoring wells) or the year the sample was collected.

- LEGEND**
- Investigation Area
 - Other Potential PFAS Source
 - Moorebank Offset
 - Drainage Basin (Approximate)
 - Sediment Sample
- Max PFOS + PFHxS Concentration (mg/kg)**
- >1
 - >5
 - >10
 - No PFAS Data
 - <LOR
 - LOR - 0.01
 - >0.01

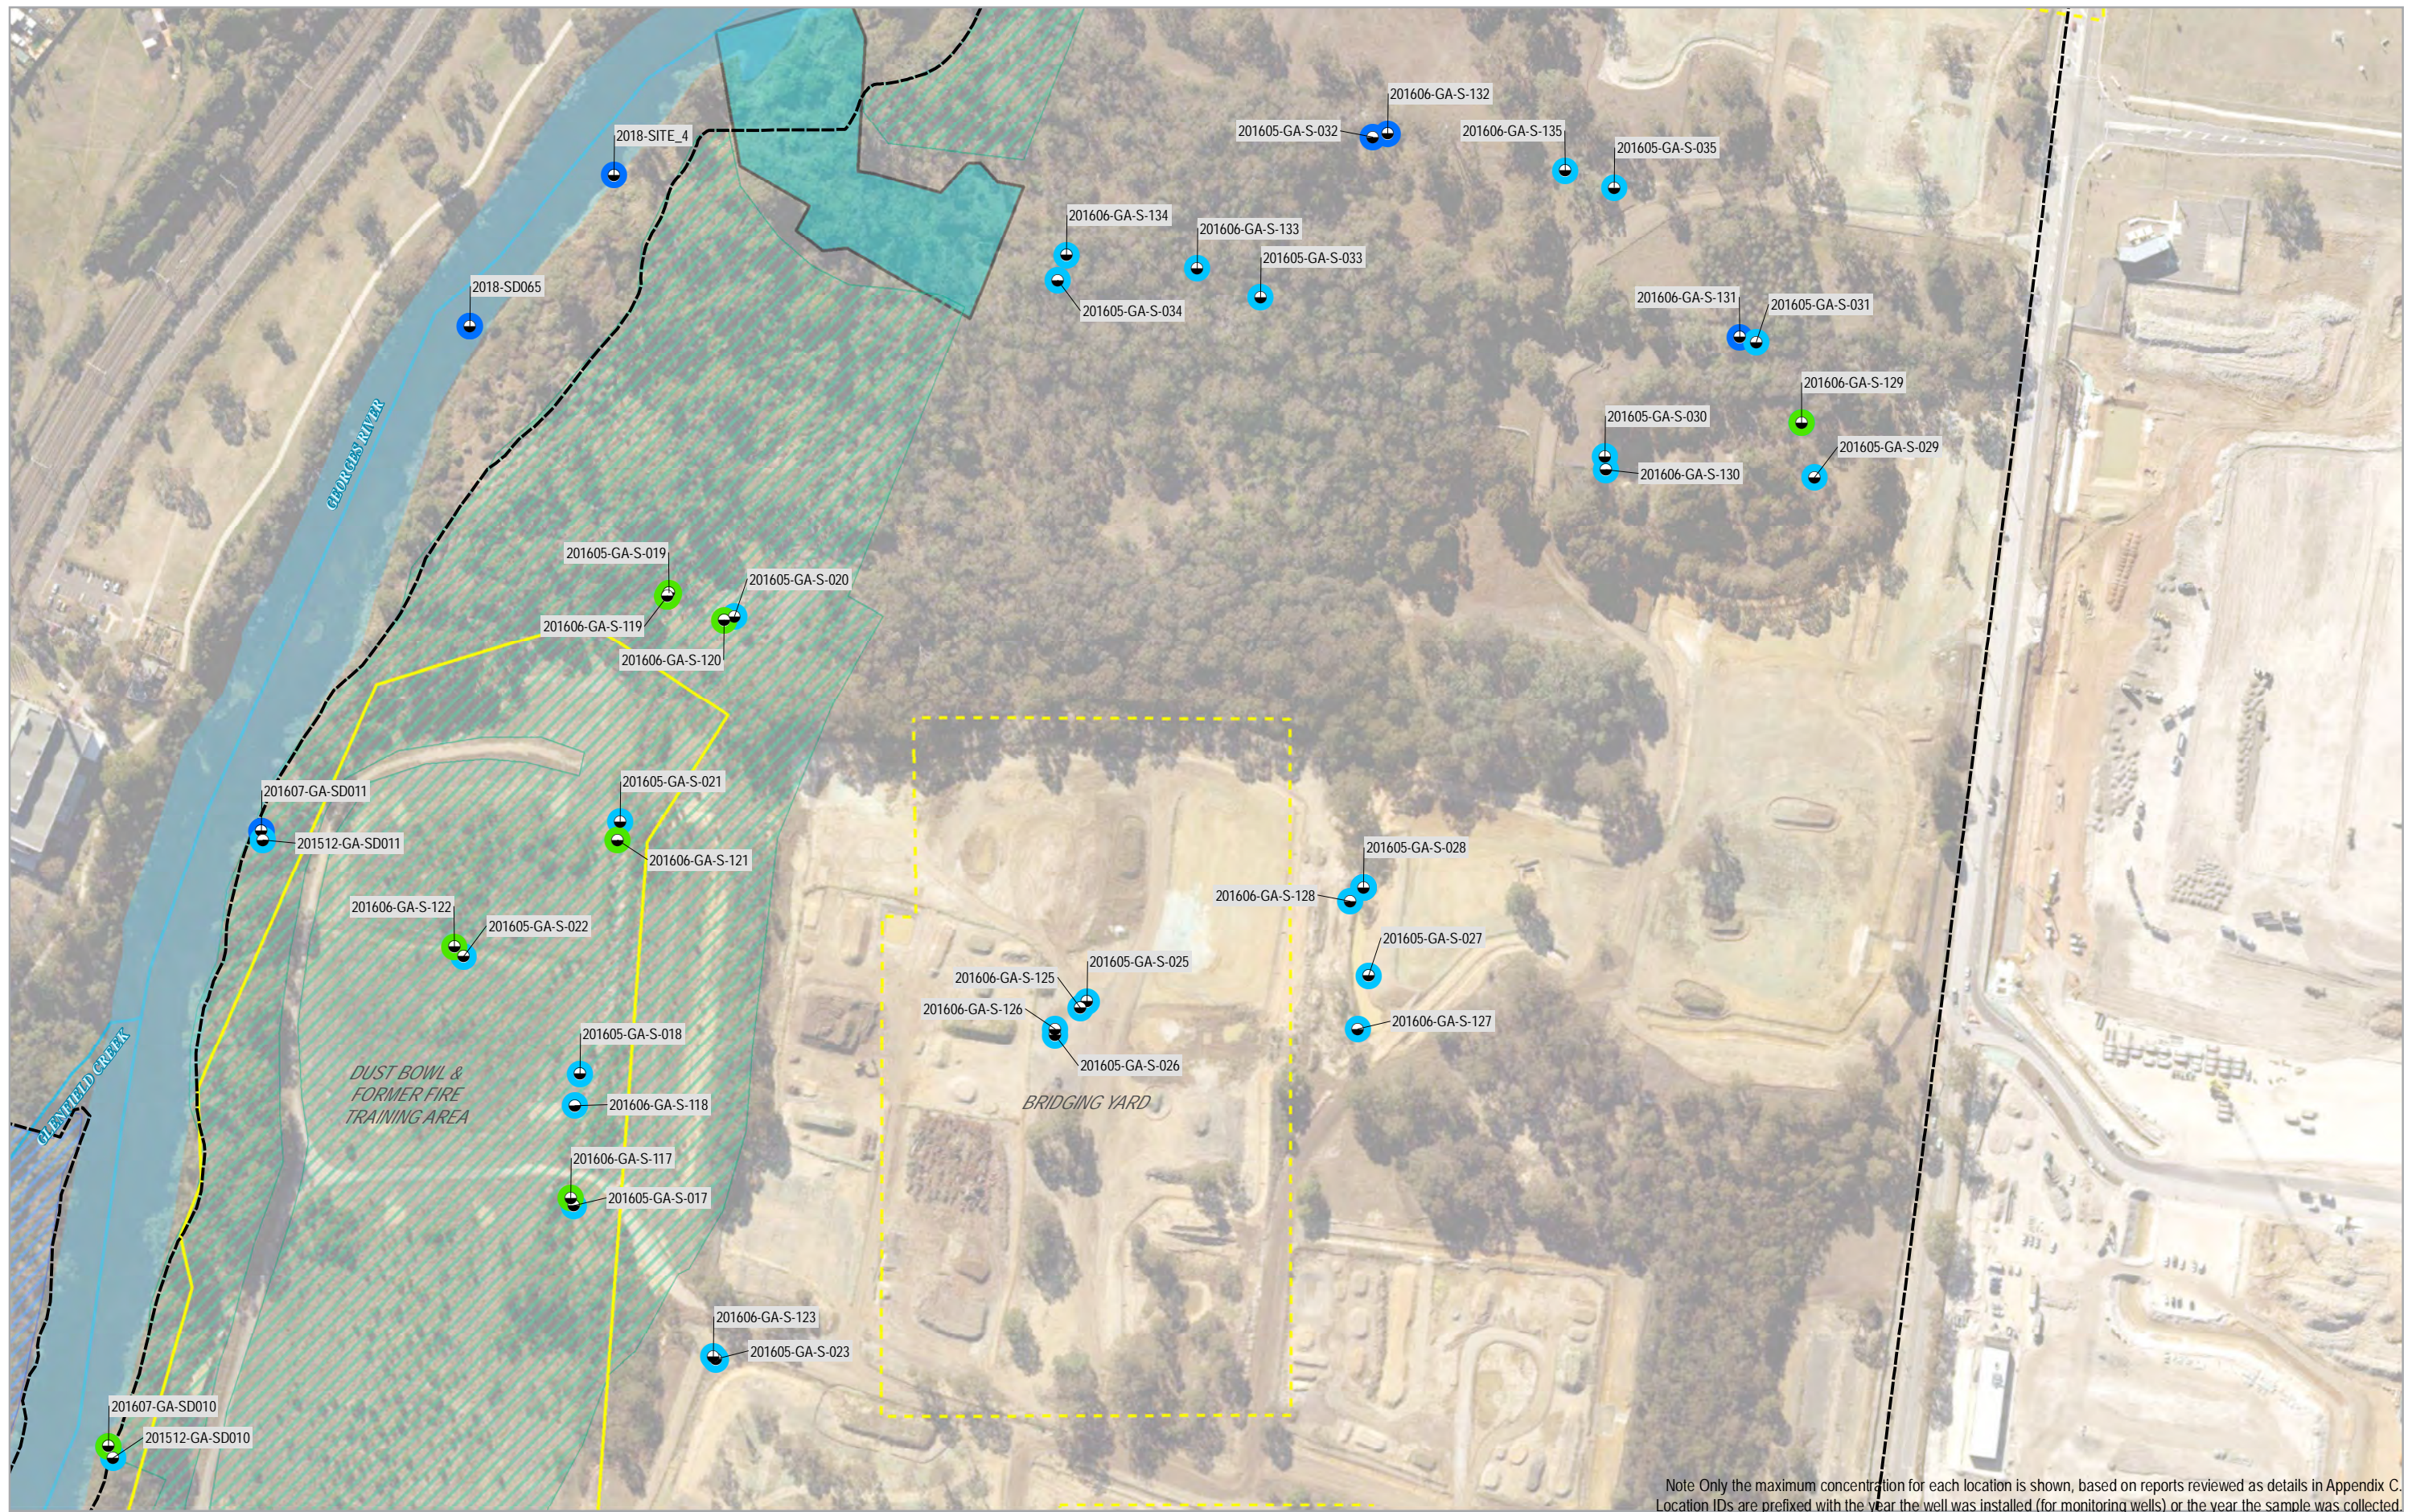
Note Only the maximum concentration for each location is shown, based on reports reviewed as details in Appendix C. Location IDs are prefixed with the year the well was installed (for monitoring wells) or the year the sample was collected.

- LEGEND**
- Investigation Area
 - Key PFAS Source
 - Other Potential PFAS Source
 - Casula (Hourglass) Offset Biobank Site
 - Moorebank Offset
 - Drainage Basin (Approximate)
 - Sediment Sample
 - Max PFOS + PFHxS Concentration (mg/kg) <LOR
 - LOR - 0.01
 - >0.01
 - >1
 - >5
 - >10
 - No PFAS Data

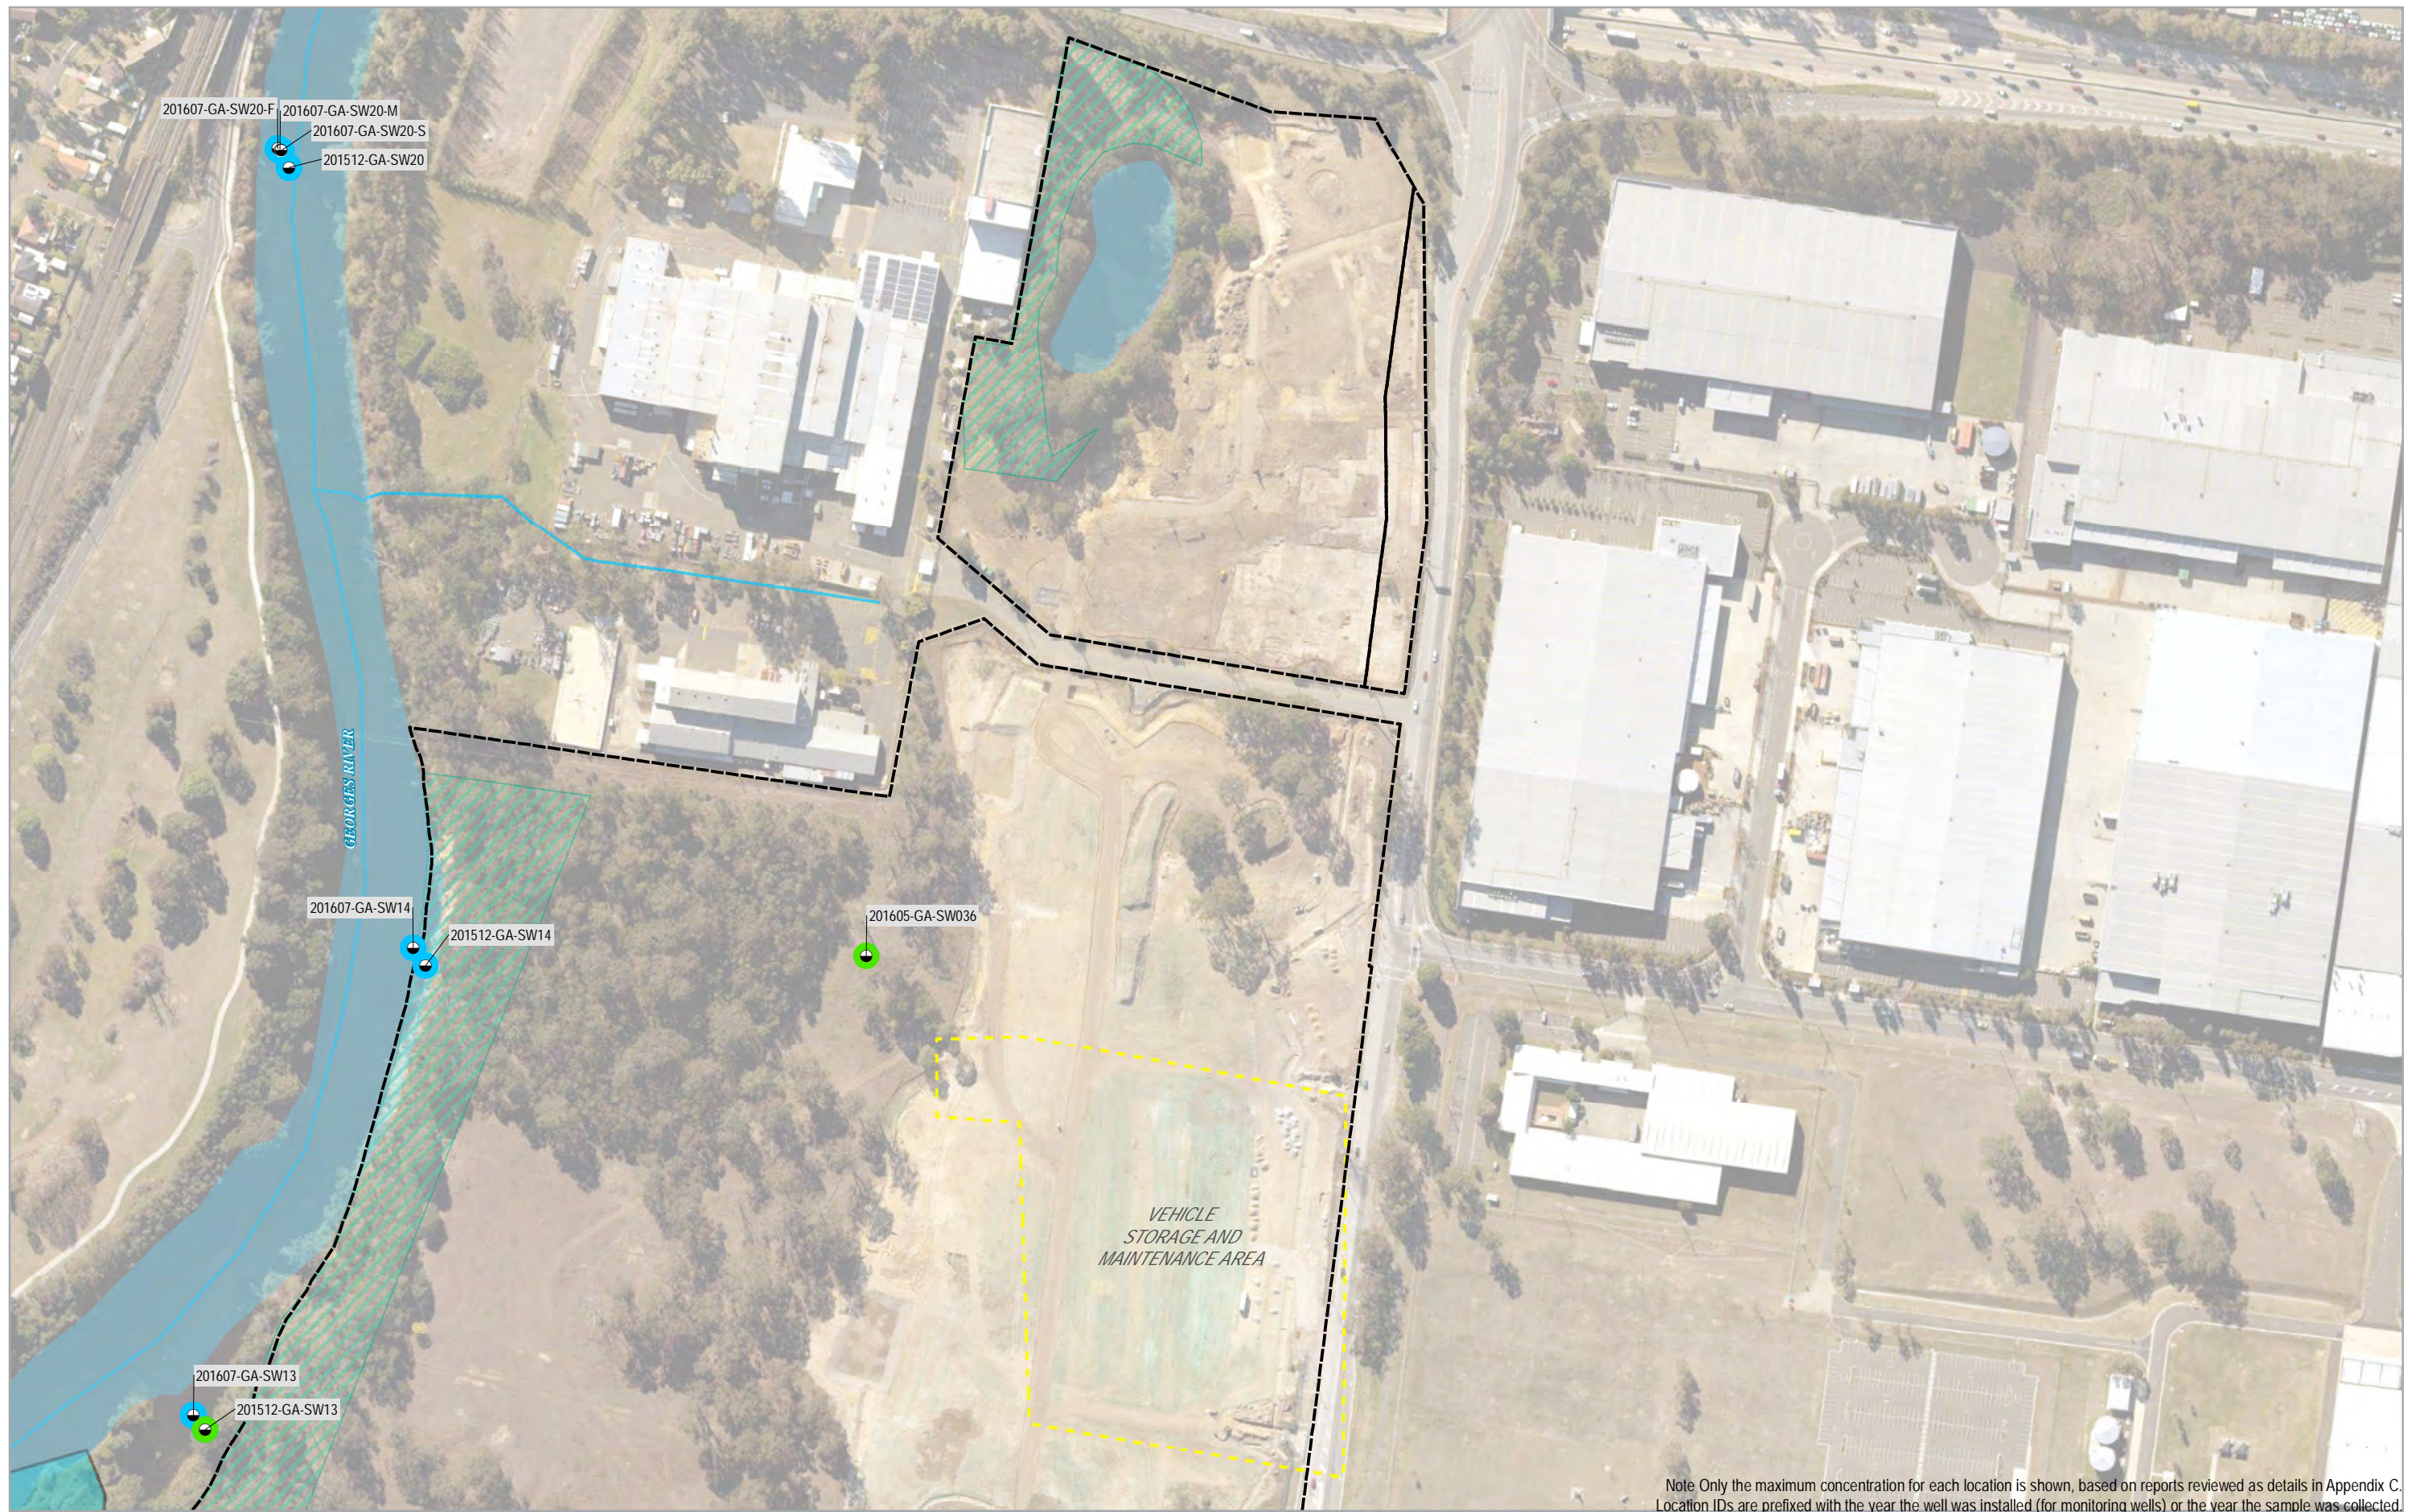
FIGURE 8B

Note Only the maximum concentration for each location is shown, based on reports reviewed as details in Appendix C. Location IDs are prefixed with the year the well was installed (for monitoring wells) or the year the sample was collected.

- LEGEND**
- Investigation Area
 - Other Potential PFAS Source
 - Moorebank Offset
 - Drainage Basin (Approximate)
 - Surface Water
- Max PFOS + PFHxS Concentration (µg/L)**
- <LOR
 - LOR - 0.13
 - >0.13
 - >0.7
 - >10
 - >100
 - No PFAS Data

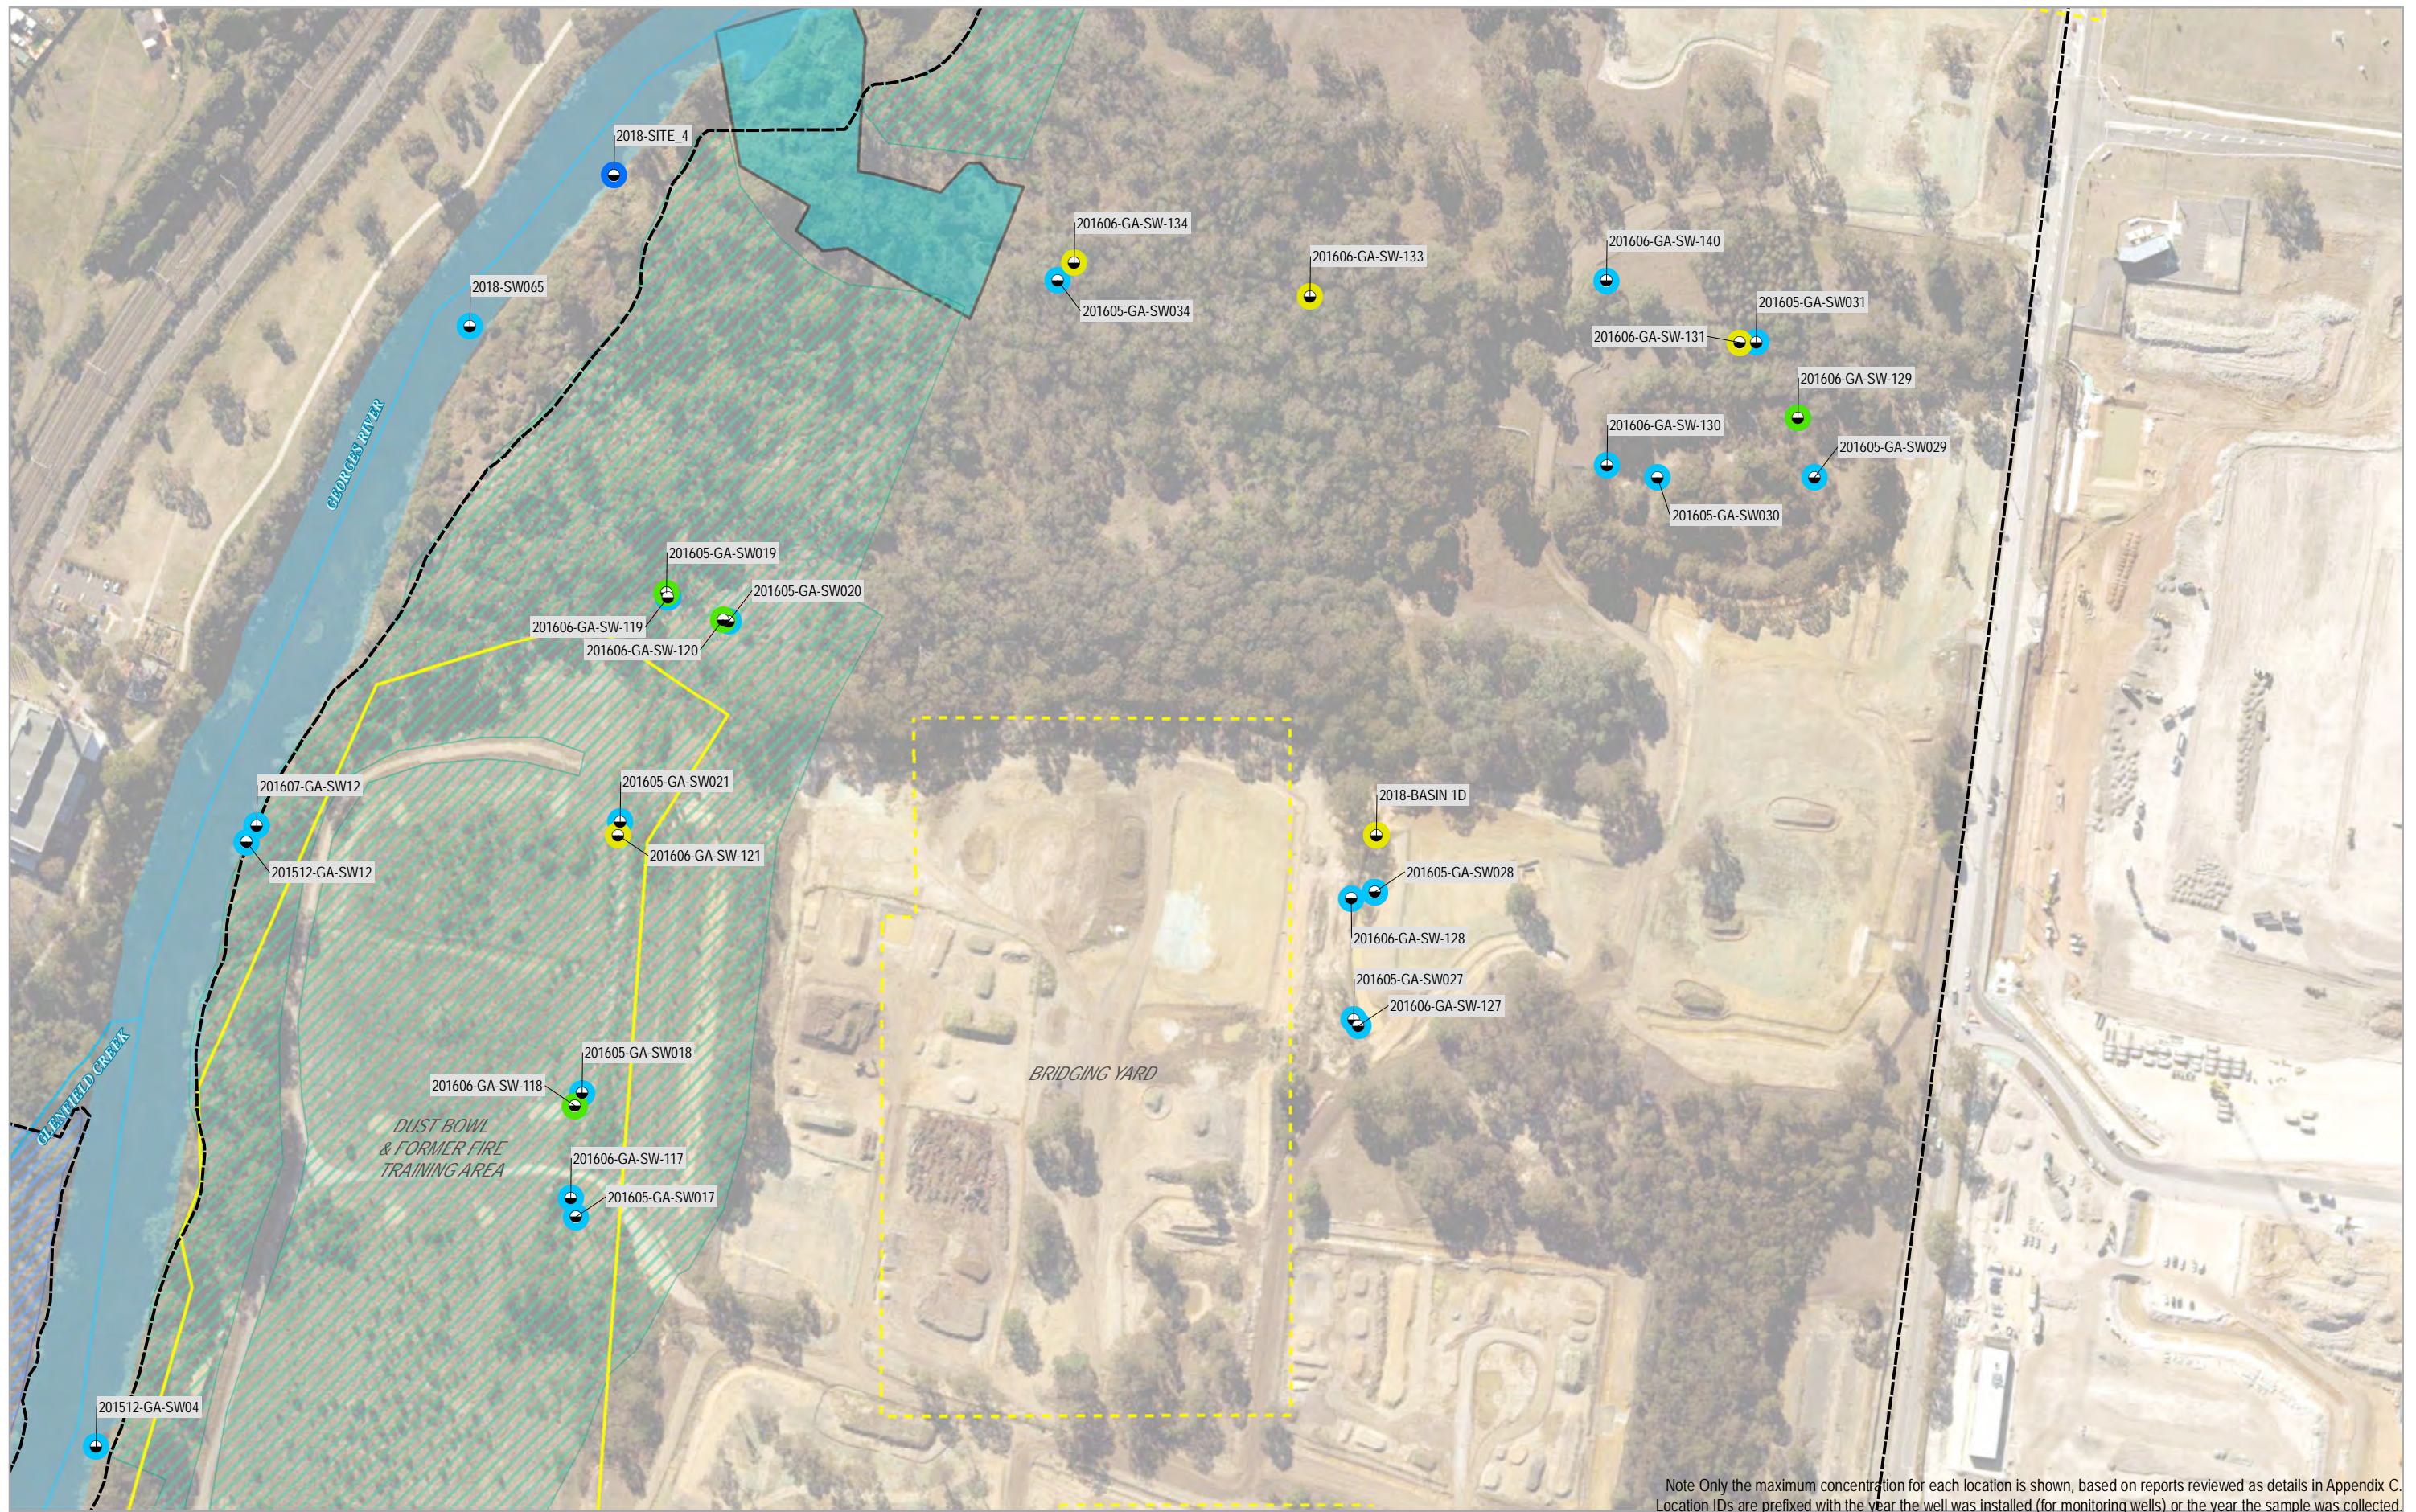
Note Only the maximum concentration for each location is shown, based on reports reviewed as details in Appendix C. Location IDs are prefixed with the year the well was installed (for monitoring wells) or the year the sample was collected.
