Long-Term Environmental Management Plan

Northern Ring Road, Service Pad and Loop Road,
Moorebank Precinct West, 400 Moorebank Avenue,
Moorebank, NSW

Prepared for: Logos Property Pty Ltd c/- Tactical Group Pty Ltd

EP1489.008_v4 14 September 2022

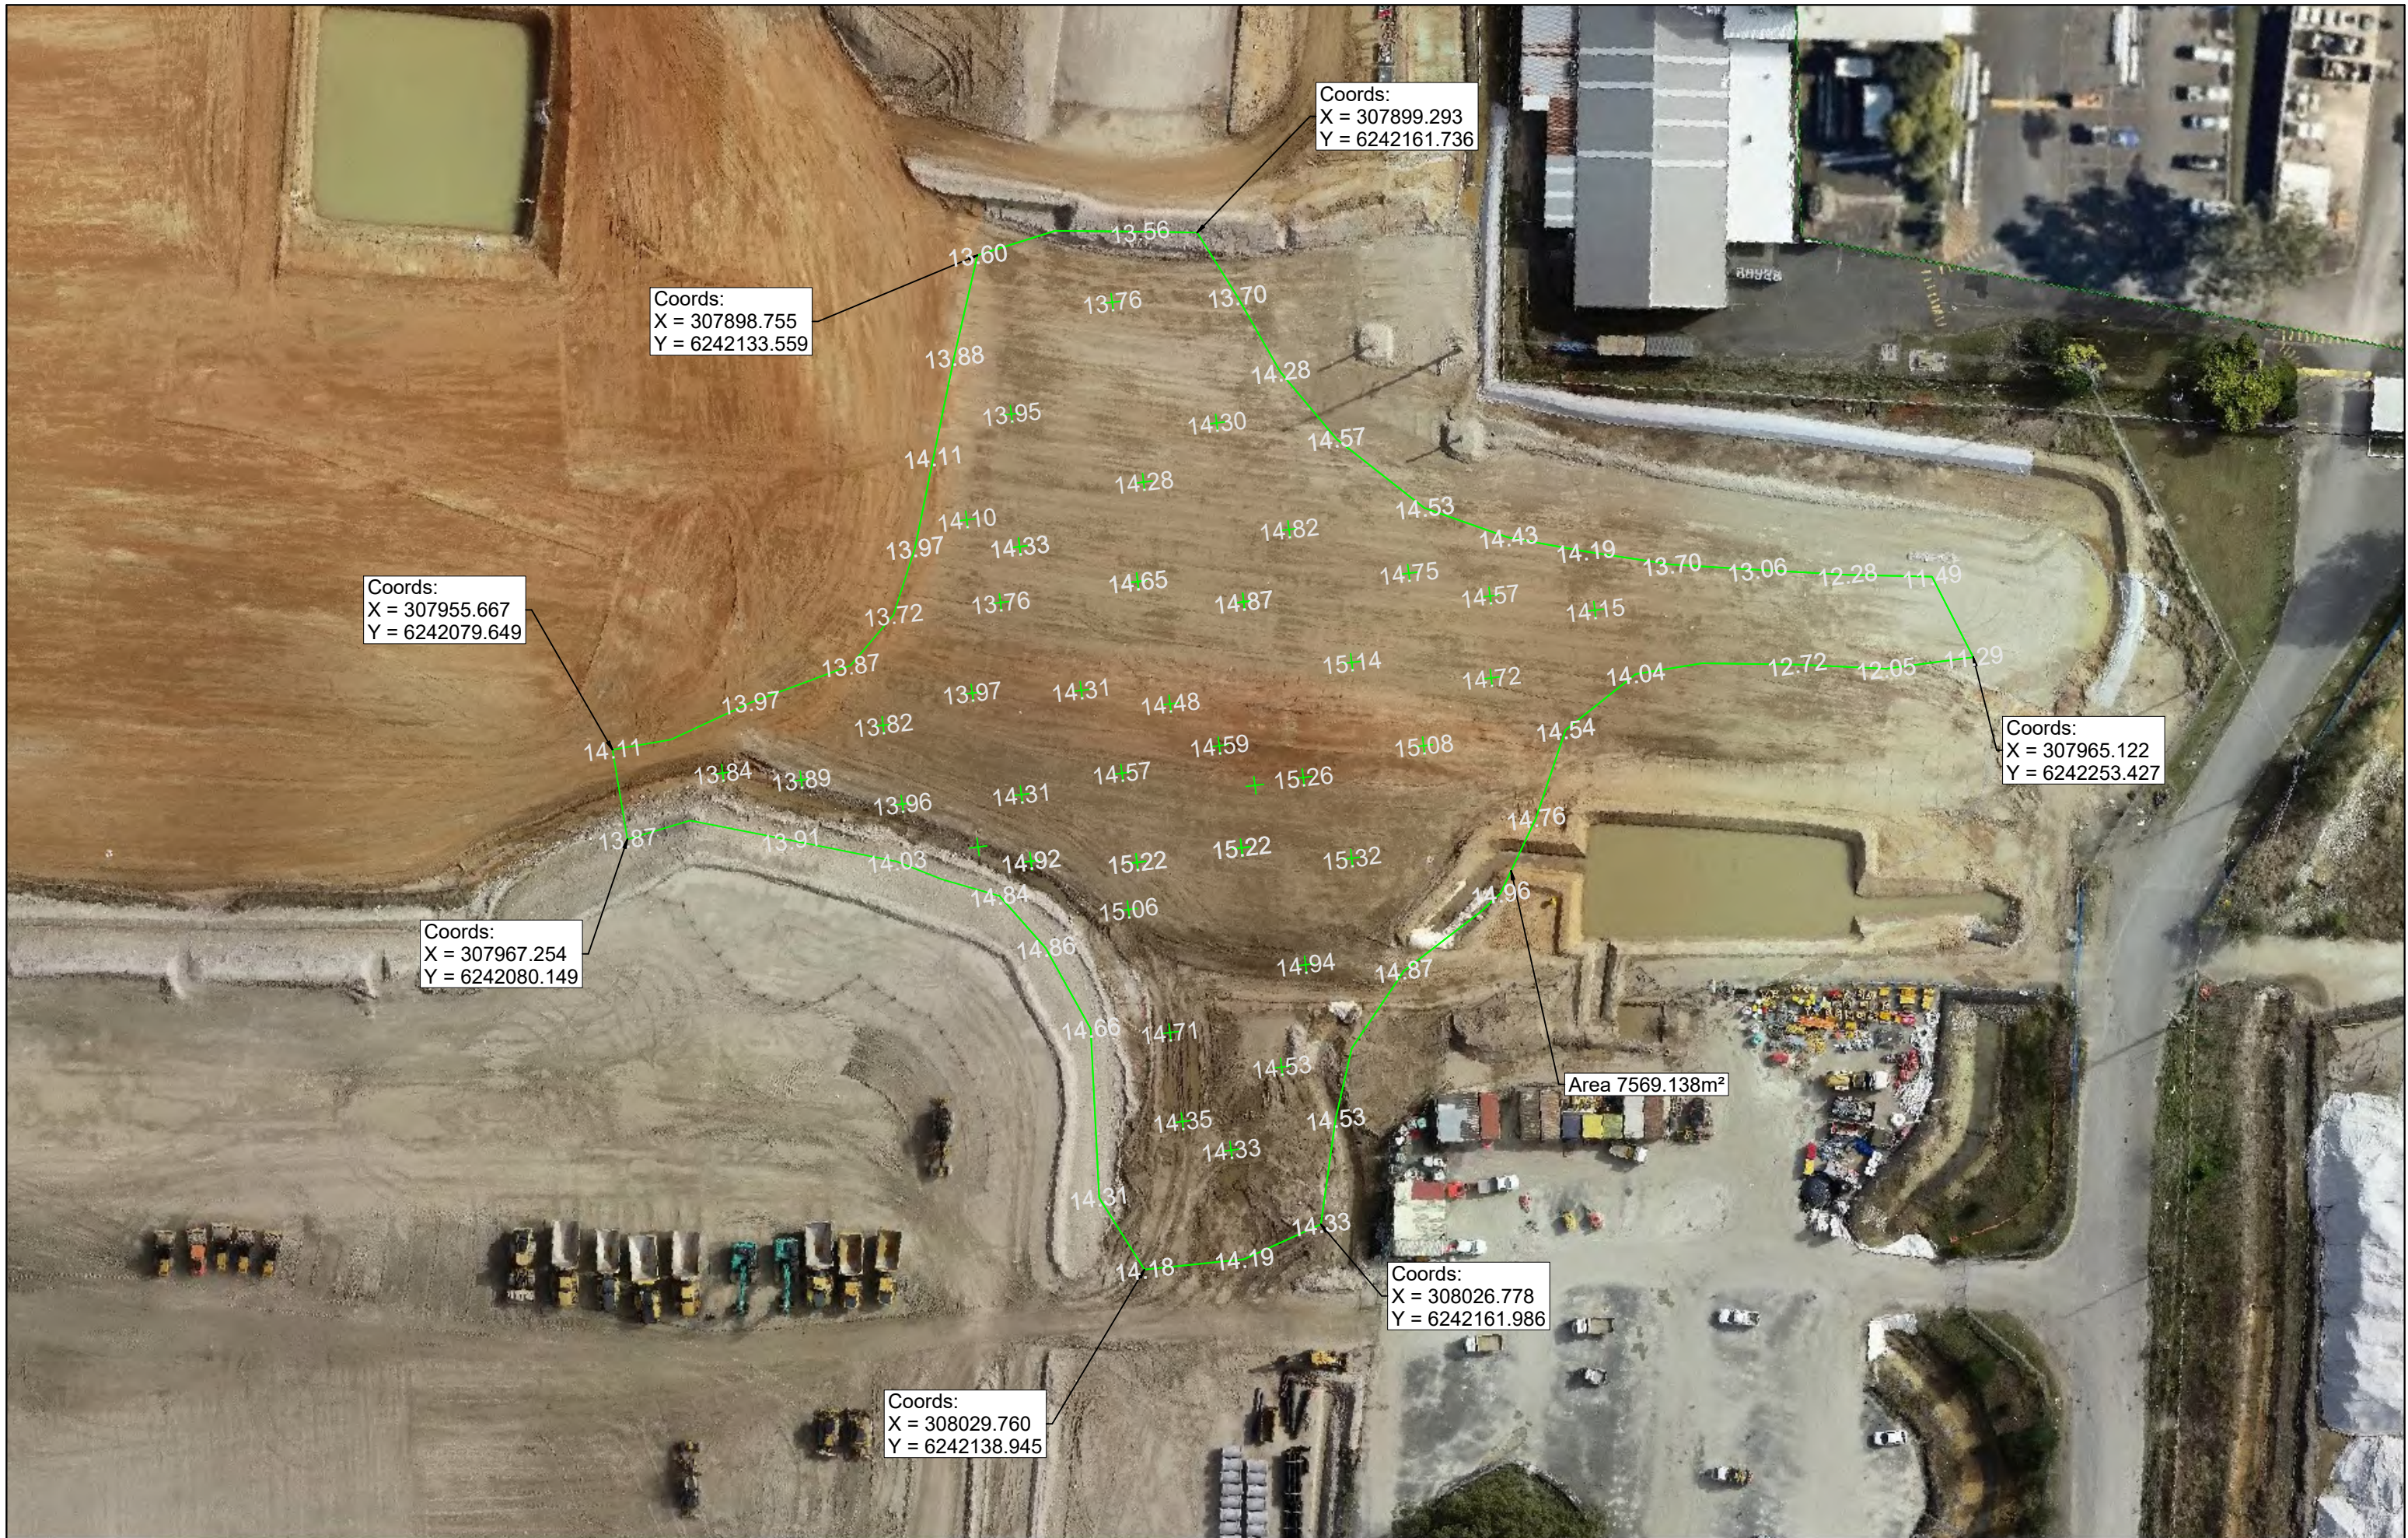
NOTES:
TOP OF ACM LAYER
SP 348
LOOP RD

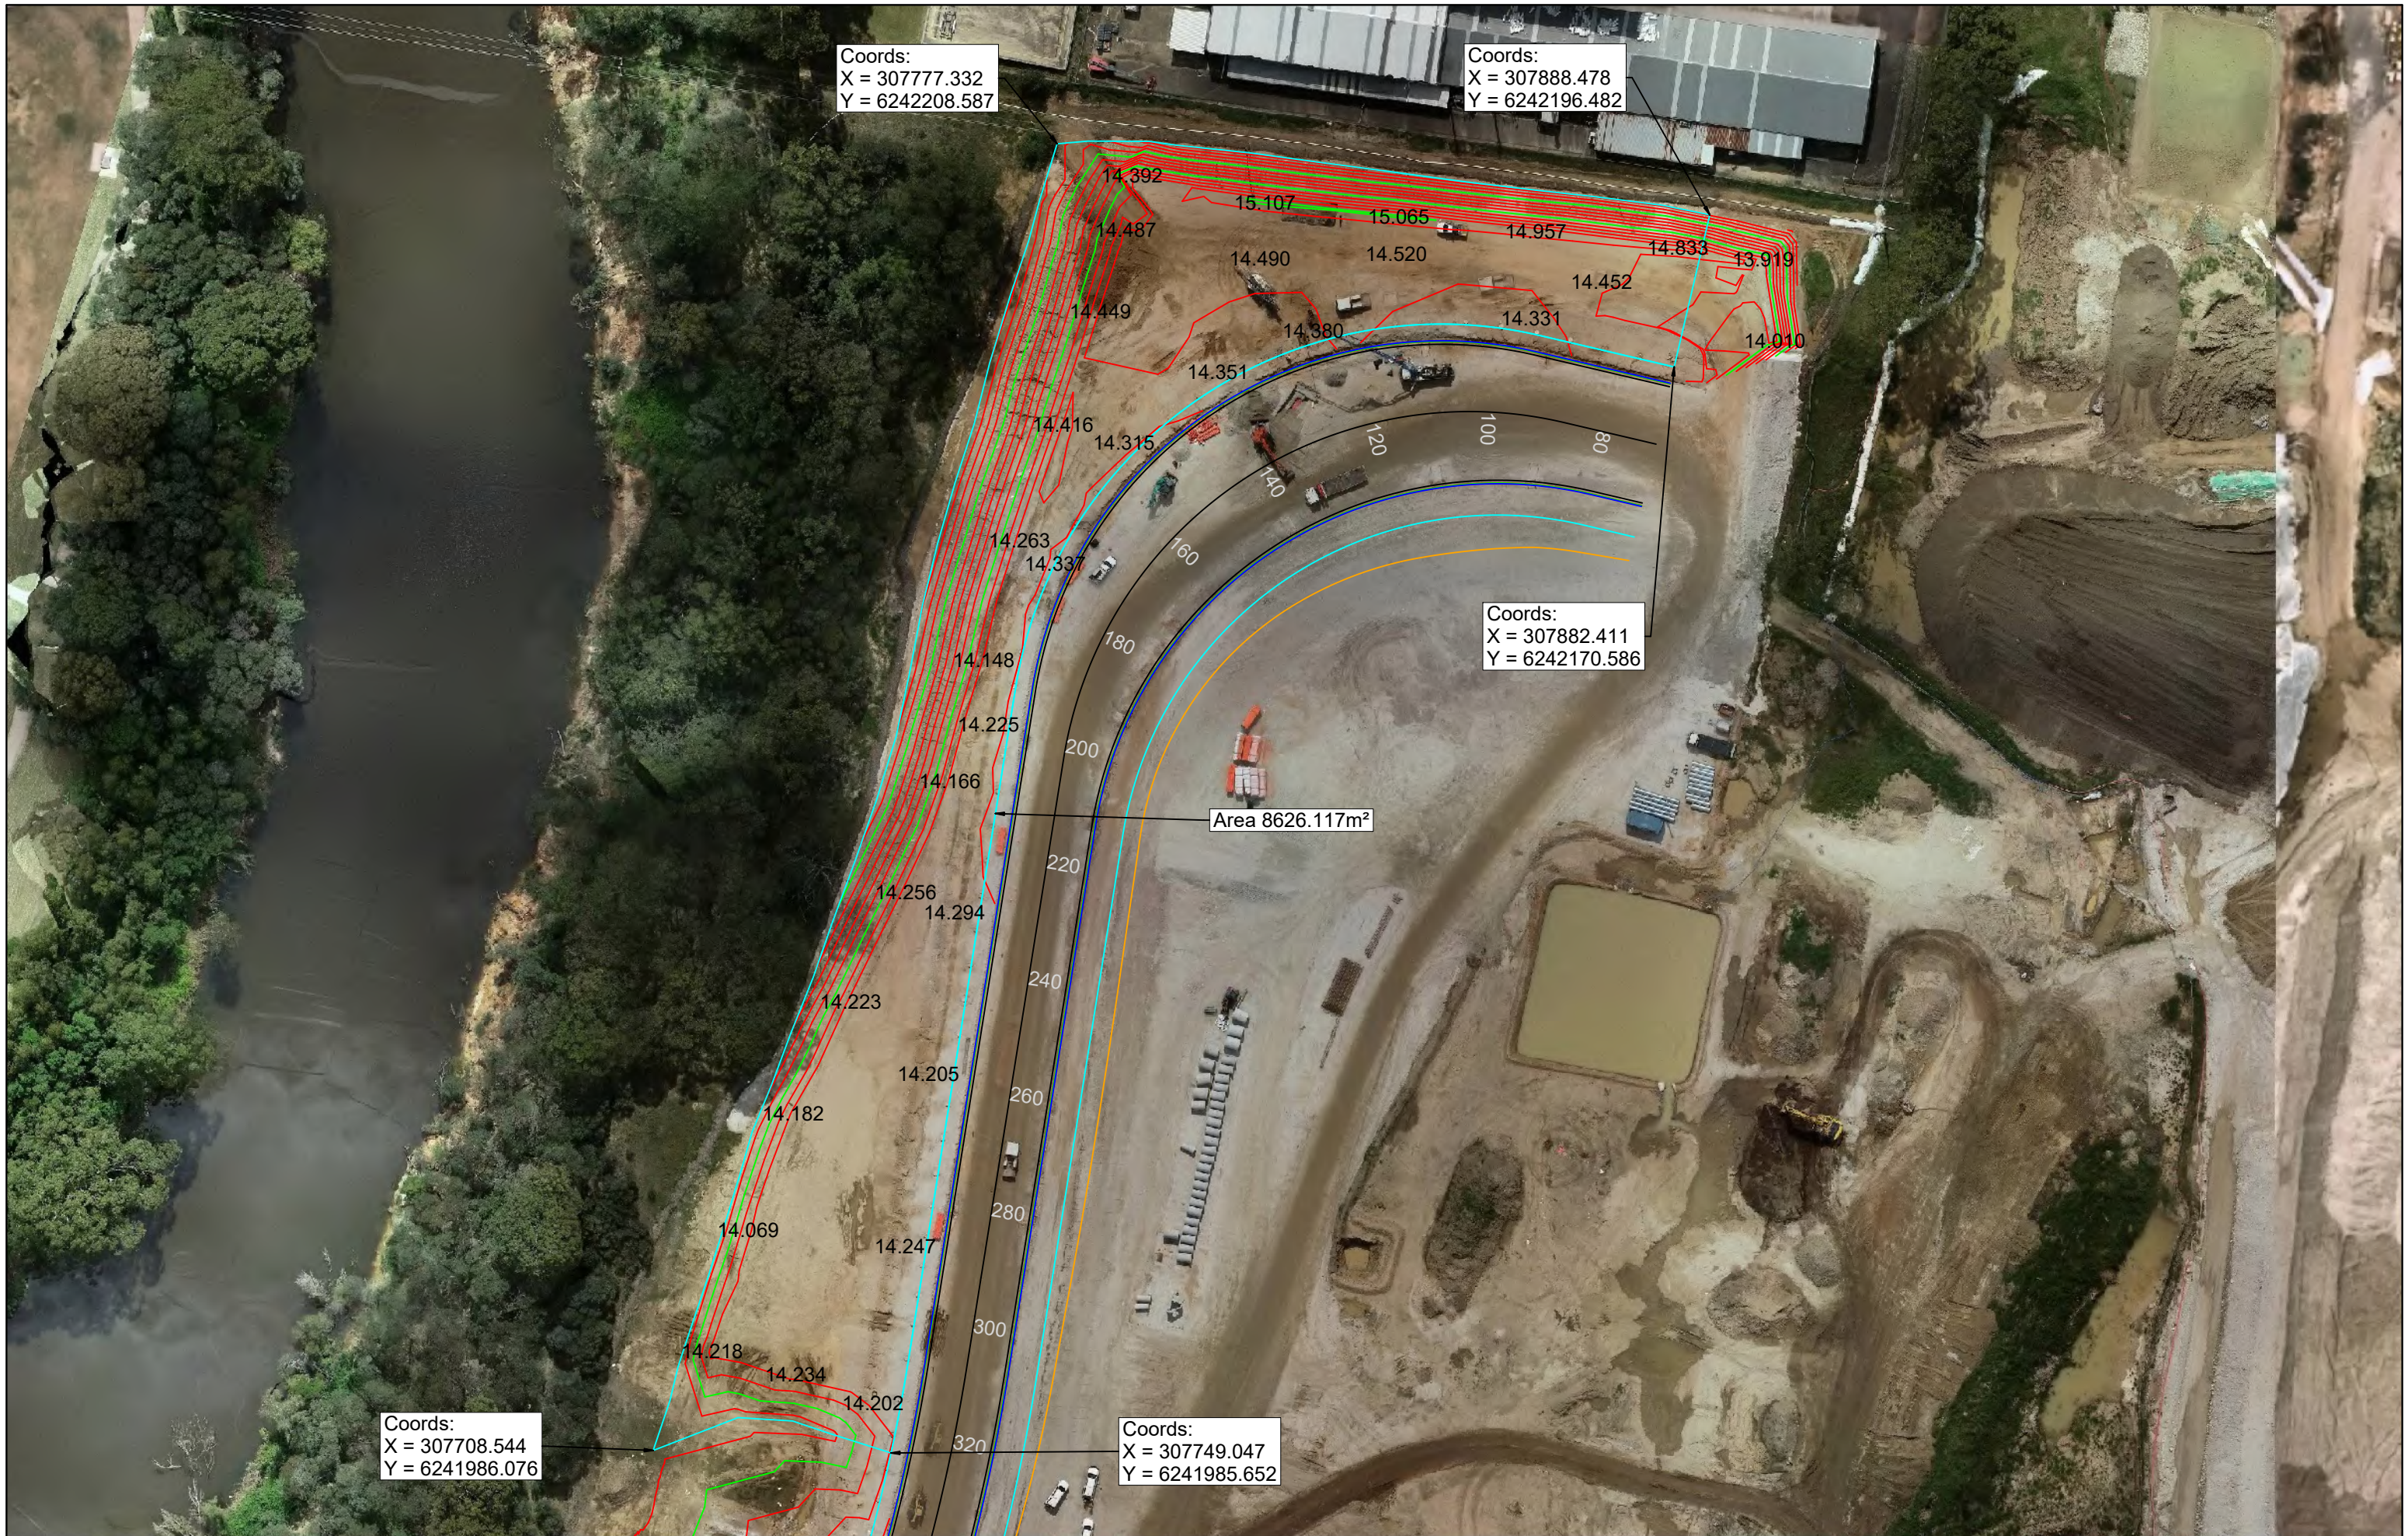
Legend: Approximate Site Boundary Northern Ring Road, Service Pad, Loop Road Audit Area SP348 Placement			MPW, Moorebank, NSW FINAL FINISHED SURVEY LEVEL OF PFAS REUSE AREA
Job No: 58753	Scale: 1:541		
Client: J Wyndham Prince	Coord. Sys. GDA 1994 MGA Zone 56		
Drawn By: EP	Checked By: LH	Version: R03 Rev C	Date: 31-Aug-2022
FIGURE 8
