**MOOREBANK PRECINCT EAST STAGE 2:  
BIODIVERSITY MONITORING IN ANZAC CREEK  
SPRING 2024 SURVEY**

**Final Report Prepared for  
ARCADIS**

**7 February 2025**

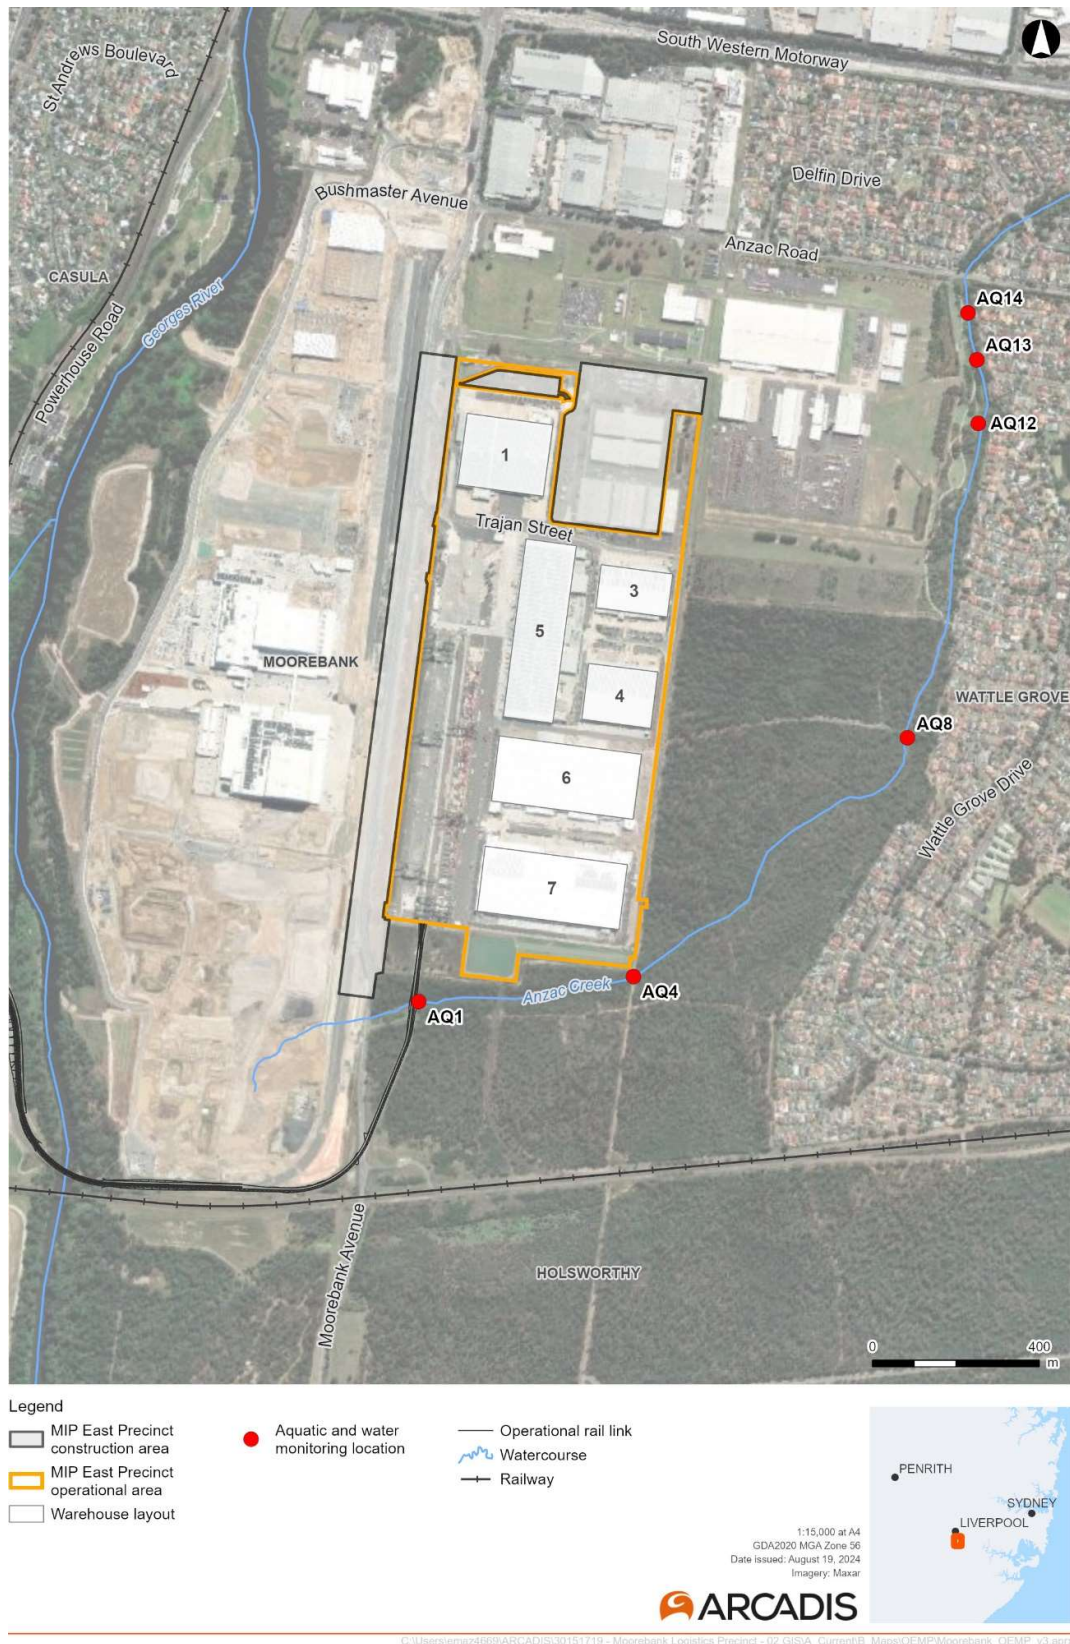
**Figure 1. Project Location**

Surface water from the MPES2 site was expected to enter Anzac Creek as a licensed discharge between Site AQ4 and AQ8 (Figure 1). It was also considered likely that runoff from some areas of the MPES2 site would be collected by a vegetated dam situated within Commonwealth Department of Defence land (Biosis, 2018). Flow from this dam enters Anzac Creek upstream of Site AQ14 via a culvert (Figure 1).

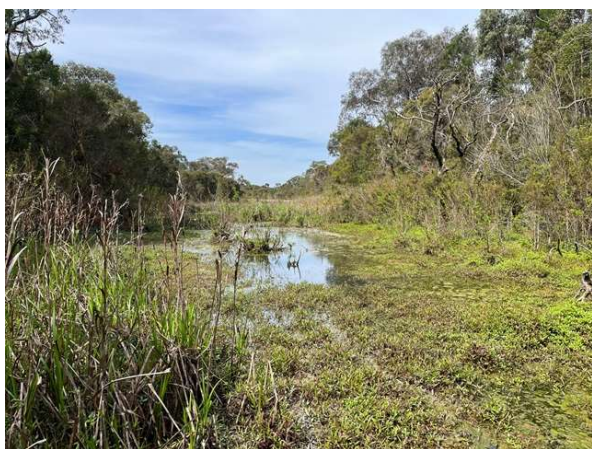
Plate 1: AQ1 – View downstream (24/09/24)

There was no flowing water at the time of the spring 2024 surveys, although the channel was almost full-to-bank (up to approximately 0.4 m deep) at the time of the second survey (Plates 1&2). The active channel zone at this site remains stable (i.e., no signs of active erosion), due to the absence of flow, cover of aquatic plants and the relatively intact woody riparian vegetation (Appendix 2). The channel bed consisted of fine sediment, the upper layers of which were anoxic.

There has been a notable increase in cover of the introduced wetland shrub, *Ludwigia peruviana* (Ludwigia), on either side of the stream channel since autumn 2024 (Plate 2). This plant is an introduced, fast-growing wetland shrub that grows to 3 m tall. Slender knotweed (*Persicaria decipiens*) occupied a large proportion of the stream channel and Alligator Weed (*Alternanthera philoxeroides*) is still common, particularly at the time of the second survey (Plates 1&2). Native plant species included Marsh Club-rush (*Bolboschoenus fluviatilis*), Typha (*Typha* sp.), and *Myriophyllum variifolium*. The tree canopy was mostly comprised of *Melaleuca* spp. and *Eucalyptus* spp. (Plates 1&2).

Also notable at Site AQ1 was the presence of the introduced aquatic weed, Ludwigia (*Ludwigia peruviana*), within the creek channel. Found mostly in creeks and wetland areas, Ludwigia is a fast-growing invasive aquatic plant that can form dense colonies in slow-moving and static waterways (Sainty and Jacobs, 2003). An upright perennial shrub, it can grow to 3 m tall. Its presence can change water flows and increase the risk of flooding,

- Sampling of the stream health monitoring programme to be repeated in autumn 2025;
- Land managers focus on containment and on-going suppression of Alligator Weed and Ludwigia within Anzac Creek and the riparian zone, particularly at Site AQ1, and the popular aquarium plant, *Egeria densa* (Egeria), commonly observed within the refuge pool.

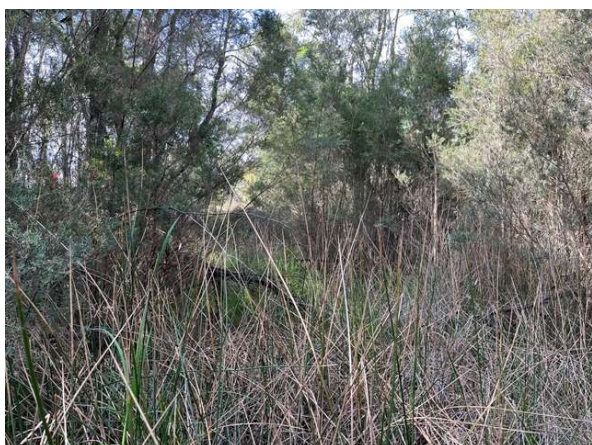
Plate 3: AQ4 – View across-stream (24/09/24)

Since the baseline survey, stands of the emergent macrophyte, Jointed Twig Rush (*Baumea articulata*) and Twig Rush (*Baumea rubiginosa*) have colonised a large proportion of the stream channel (Plates 3&4). Typha and Slender Knotweed were also present.

The active channel zone, composed of fine sediments, was up to approximately 4 m wide (Plates 3&4). No indicators of significant erosion were observed suggesting that Anzac Creek continues to be relatively stable at this site, particularly since colonisation by dense stands of emergent macrophytes and little flow along this section of the creek since spring 2022 (Plate 3&4, Appendix 2).

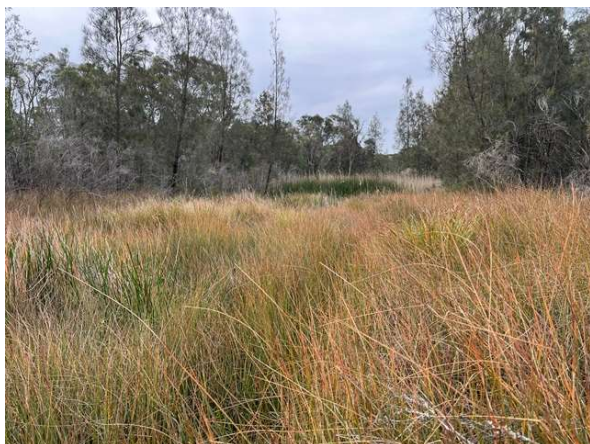
**Plate 5: Site AQ8 – view upstream (24/09/24)**

Most notably, taller species of emergent macrophyte, including Tall Spikerush (*Eleocharis sphacelata*) and Jointed Twig Rush and have encroached upon habitat previously dominated by Heron Bristle Sedge (*Chorizandra cymbaria*) (Plates 5&6). Other shorter plants, including Frogsmouth (*Philydrum lanuginosum*), Slender Knotweed and the introduced species, Umbrella Sedge (*Cyperus eragrostis*) have also declined in abundance. Riparian vegetation continues to be dominated by *Casuarina* trees. Common Reed/Phragmites (*Phragmites australis*) and Typha were present at the downstream end of the site. Blackberry (*Rubus fruticosus*), which is listed as a weed of national significance, has increased its distribution at the upstream end of this site.

The stream channel at Site AQ8 (up to approximately 20 m wide) continues to be classified as stable, mostly due to the dense cover by emergent macrophytes in addition to a relatively intact, woody riparian zone (Appendix 2). Very little aquatic habitat was present within the study channel at the time of the spring 2024 surveys.

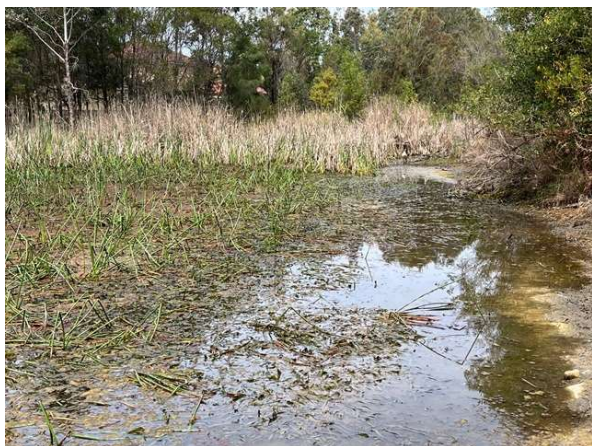
Plate 7: Site AQ12 – view upstream (24/09/24)

The submerged macrophyte, *Vallisneria* sp. (Ribbonweed), was common, in addition to Slender Knotweed and dense stands of Typha, Phragmites and Tall Spike Rush (Plate 7). *Nymphoides geminata* (Entire Marshwort), with mostly floating leaves continues to be abundant in areas close to the shore (Plates 7&8).

Also noted was the native perennial, *Utricularia* sp., which occurs on wet soil and in freshwater as terrestrial or aquatic species, and the small native fern, *Azolla*. *Egeria* (*Egeria densa*), which was collected close to the left-bank (facing downstream) of the pool in spring 2020, continues to be present. Riparian vegetation included Casuarina, Eucalyptus and Melaleuca trees and Spiny-head Mat-rush/Basket Grass (*Lomdandra longifolia*) (Plates 7&8).

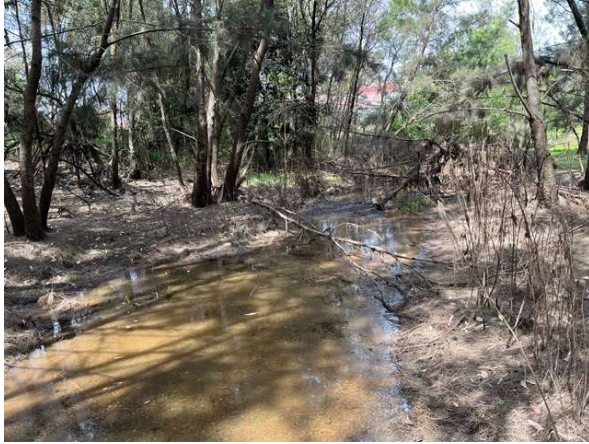
Plate 9: Site AQ13 – view upstream (24/09/24)

Site AQ13 was situated approximately 200 m downstream of Site AQ12 (Figure 1). This site was located approximately 150 m downstream from an overflow channel that enters the creek from Wattle Grove. Water to a depth of approximately 0.5 m was present at Site AQ13 at the time of the second survey and flow was apparent at the time of both surveys (Plates 9&10).

A large proportion of the stream channel and edges were colonised by Typha and Slender Knotweed. The aquatic weed, *Sagittaria platyphylla* (*Sagittaria*) continued to expand its distribution at the edges of the creek channel. River Clubrush (*Schoenoplectus validus*) was also common. The stream channel appeared stable (Appendix 2).

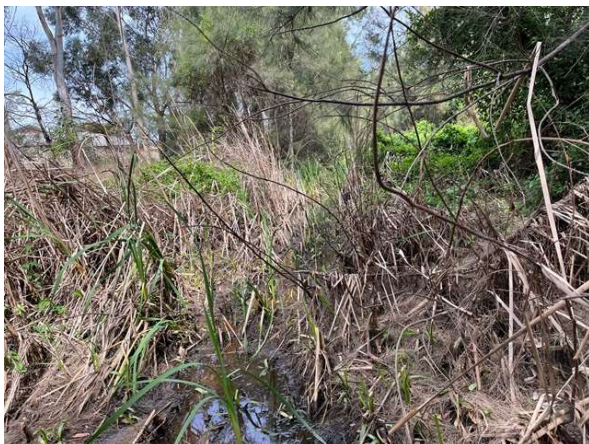
Plate 11: Site AQ14 – view downstream (24/09/24)

Site AQ14 was situated approximately 150 m downstream of Site AQ13 and immediately downstream of the culvert that links the dam within Commonwealth Department of Defence land to Anzac Creek (Figure 1). Flow was apparent at the time of both autumn 2024 surveys (Plates 11&12).

Typha, Slender Knotweed, River Clubrush and Whorled Pennywort/Shield Pennywort continue to be common (Plates 11&12). Sagittaria continued to expand its distribution within the channel of the creek (Plates 11&12). This section of Anzac Creek remains mostly stable due to dense instream vegetation and vegetated banks (Appendix 2). Water visibility was ‘good’ at the time of both surveys (Plates 11&12).

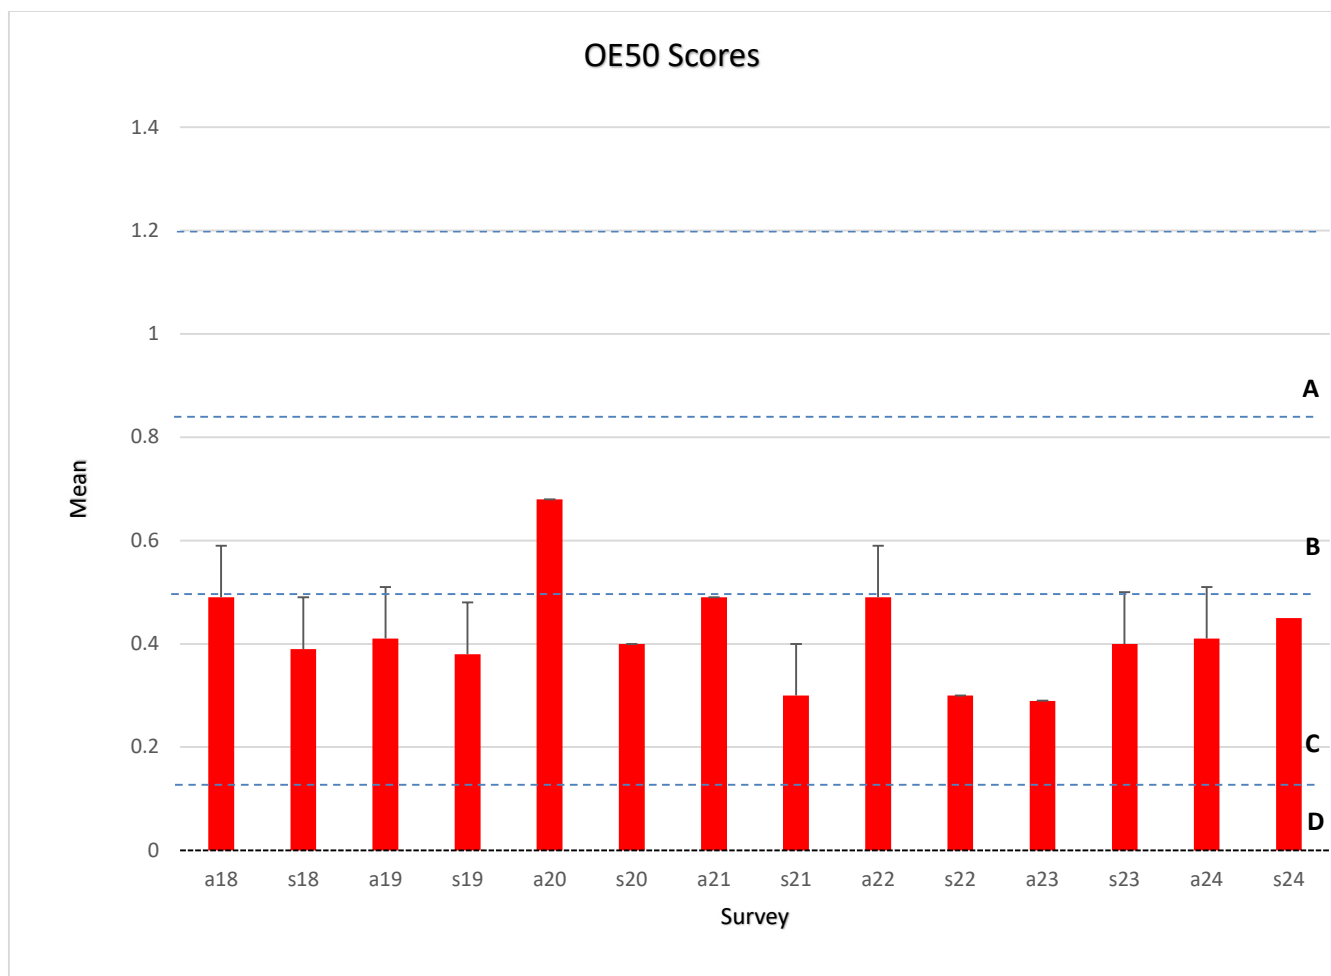
Autumn 2024 – Survey 2	8	4.00	0.29	C
Spring 2024 – Survey 1	9	3.94	0.40	C
Spring 2024 – Survey 2	12	3.71	0.50	C

**Figure 3. Mean (±SE) OE50 Taxa Scores and their respective Band Scores (B-D) for AUSRIVAS samples collected at Site AQ12 since autumn 2018.** NB Note that the bands displayed are relevant to autumn edge habitat, these being slightly different to spring.

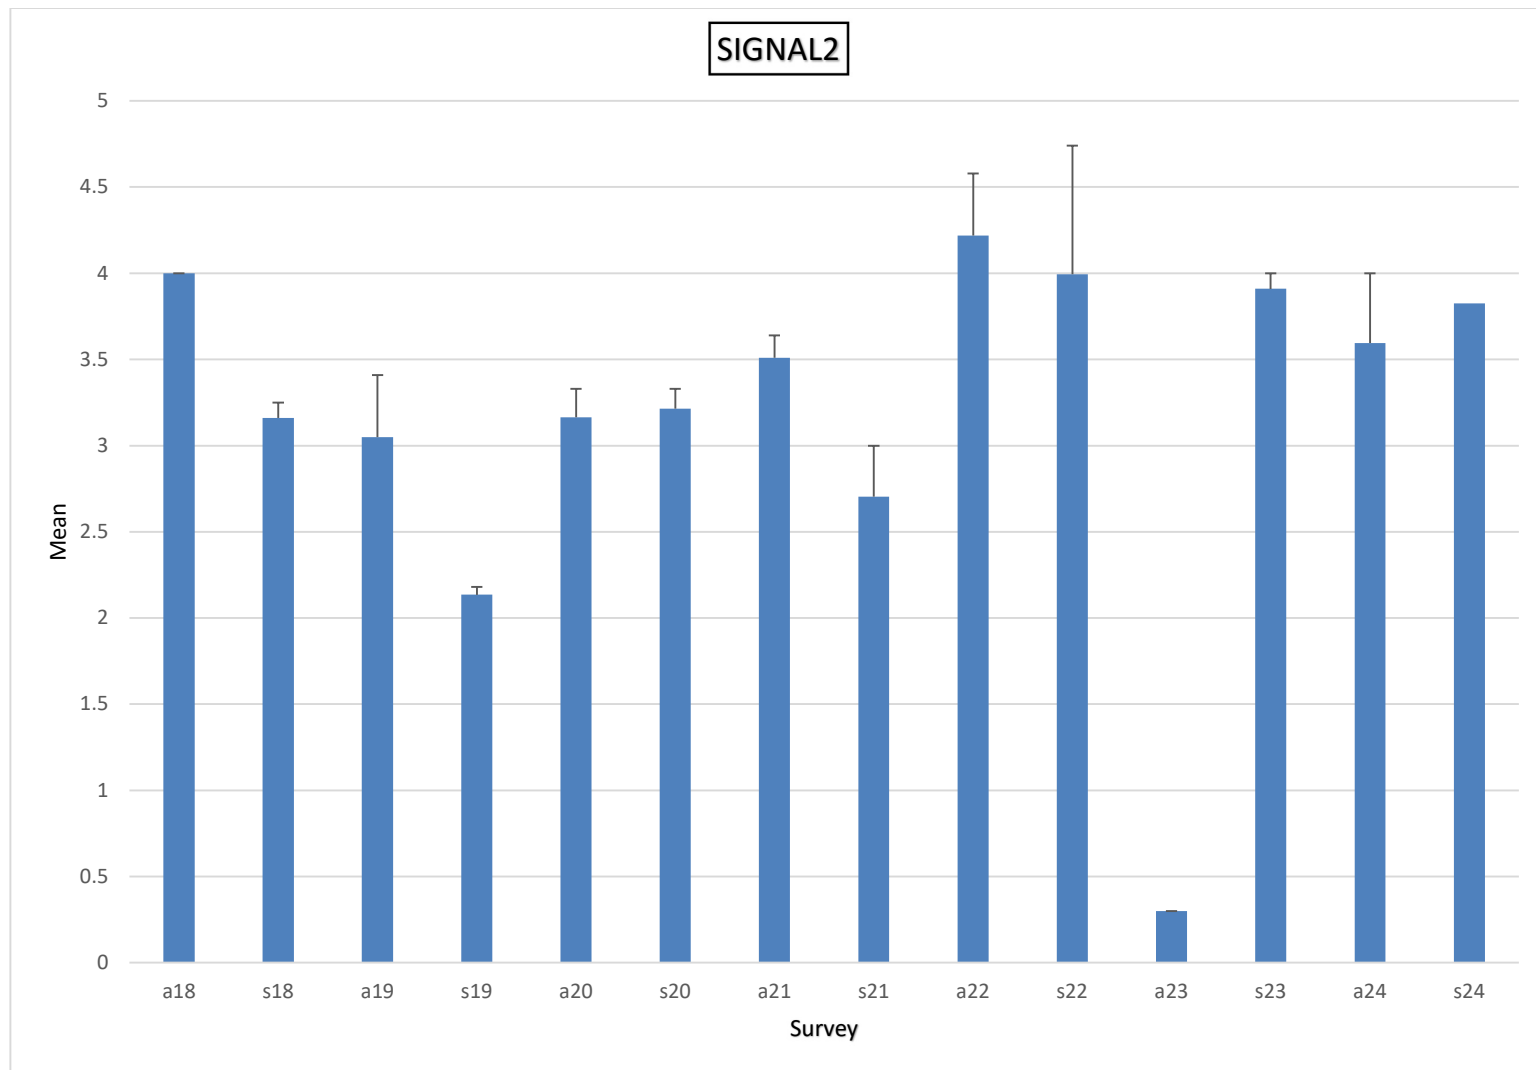
**Figure 4. Mean (±) SIGNAL 2 results for Site AQ12 sampled in Anzac Creek since autumn 2018.**

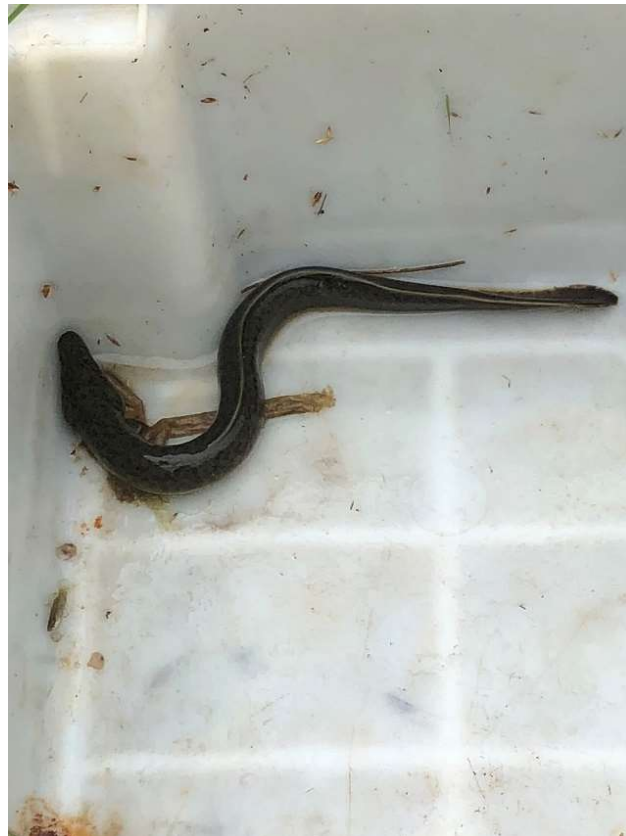
Four species of fish were collected while electro-fishing at Site AQ12 in spring 2024, including 3 individuals of Striped gudgeon (*Gobiomorphus australis*), one Long-finned eel (*Anguilla reinhardtii*) (20-30cm in length), a Firetail gudgeon (*Hypseleotris cf galii*) and numerous Gambusia (*Gambusia holbrooki*) (Table 10). A further species, Australian smelt (*Retropinna semoni*), was collected (1 individual) in net samples while collecting aquatic macroinvertebrates.

**Plate 13:** Juvenile Long-finned eel collected at Site AQ12 (spring 2024).
