MOOREBANK PRECINCT EAST STAGE 2: BIODIVERSITY MONITORING IN ANZAC CREEK

AUTUMN 2025 SURVEY

**Final Report Prepared for
ARCADIS**

3 October 2025

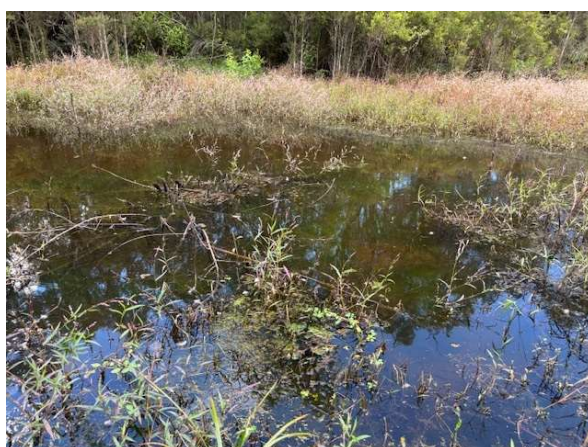
The active channel zone remains stable (i.e., no signs of active erosion) due to the absence of flow, dense cover of instream aquatic plants, including Slender Knotweed (*Persicaria decipiens*), Marsh Club-rush (*Bolboschoenus fluviatilis*) and Typha (*Typha* sp.), and the relatively intact woody riparian vegetation (Appendix 2).

Exotic species, including Alligator Weed (*Alternanthera philoxeroides*) and *Ludwigia peruviana* (Ludwigia), continue to be a common. The channel bed consisted of fine sediment, the upper layers of which were anoxic. The tree canopy was mostly comprised of *Melaleuca* spp. and *Eucalyptus* spp. (Plates 1&2).

Plate 1: AQ1 – View downstream (9/04/25)

Plate 2: AQ1 – View across stream (9/04/25)

- Sampling of the stream health monitoring programme to be repeated in spring 2025;
- Land managers focus on containment and on-going suppression of Alligator Weed and Ludwigia and within Anzac Creek and the riparian zone, particularly at Site AQ1, and the popular aquarium plant, *Egeria densa* (*Egeria*), commonly observed within the refuge pool;
- In areas where riparian vegetation has recently been cleared from adjacent to Anzac Creek (i.e. within the vicinity of Site AQ4), rehabilitation works are carried out to minimise sediments and contaminants becoming mobilized to the downstream environment.

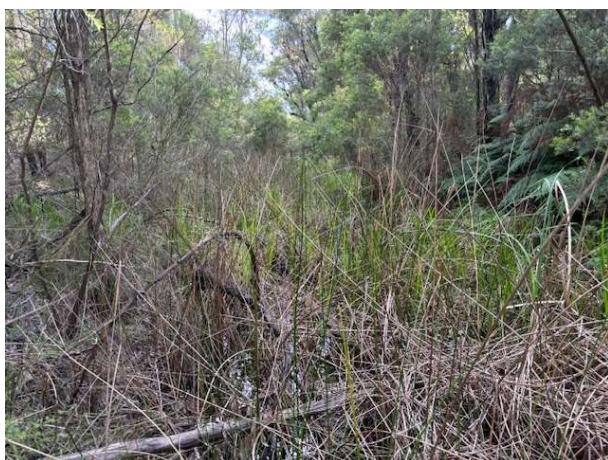
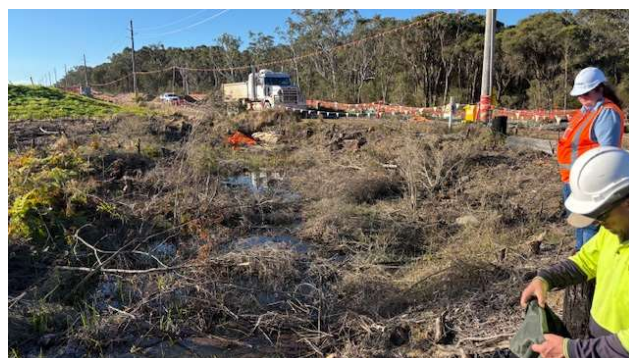
Occasional aquatic plants were still present, including Heron Bristle Sedge (*Chorizandra cymbaria*) and a species of *Utricularia* sp. (Bladderwort), which is a carnivorous plant that occurs on wet soil and in freshwater as terrestrial or aquatic species. Water quality was clear and free of sediment (Plate 3&4). Clearing of trees and riparian vegetation at this site will destabilise the stream channel.

Plate 3: AQ4 – View across-stream (9/04/25)

Plate 4: AQ4 – View downstream (23/06/25)

- stabilising areas of the stream bank recently cleared within the vicinity of Site AQ4, to minimise sediments and contaminants becoming mobilized to downstream environments;
- containment and on-going suppression of Alligator Weed and Ludwigia at Site AQ1, and the popular aquarium plant, *Egeria densa* (Egeria), within the refuge pool at Site AQ12. Signage and public information at popular points of entry by the public to the creek and other local waterways may reduce the chance of unintentional human-assisted introductions (e.g. by using live bait, or by being released by aquaria) of aquatic plants and fish.

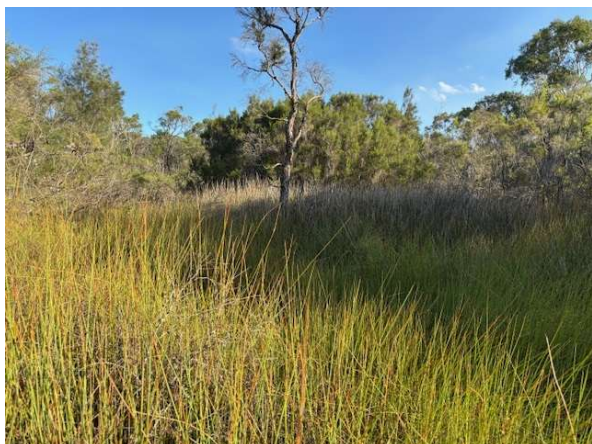
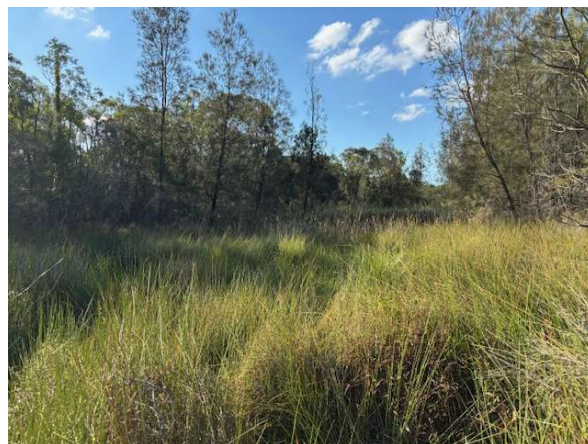
Stands of emergent macrophytes including Heron Bristle Sedge (*Chorizandra cymbaria*), Tall Spikerush (*Eleocharis sphacelata*) and Jointed Twig Rush occupied a large proportion of the stream channel (Plates 5&6). Other shorter plants, including Frogsmouth (*Philydrum lanuginosum*), Slender Knotweed and the introduced species, Umbrella Sedge (*Cyperus eragrostis*) have declined in abundance over the last two months, mostly likely due to shading by the taller species. Riparian vegetation continues to be dominated by *Casuarina* trees. Common Reed/Phragmites (*Phragmites australis*) and Typha were present at the downstream end of the site. Blackberry (*Rubus fruticosus*), which is listed as a weed of national significance, was present at the upstream section of this site.

The stream channel at Site AQ8 (up to approximately 20 m wide) continues to be classified as stable, mostly due to the dense cover by emergent macrophytes in addition to a relatively intact, woody riparian zone (Appendix 2). Very little aquatic habitat was present within the study channel at the time of the autumn 2025 surveys.

Plate 5: Site AQ8 – view upstream (9/04/25)

Plate 6: Site AQ8 – view downstream (9/04/25)

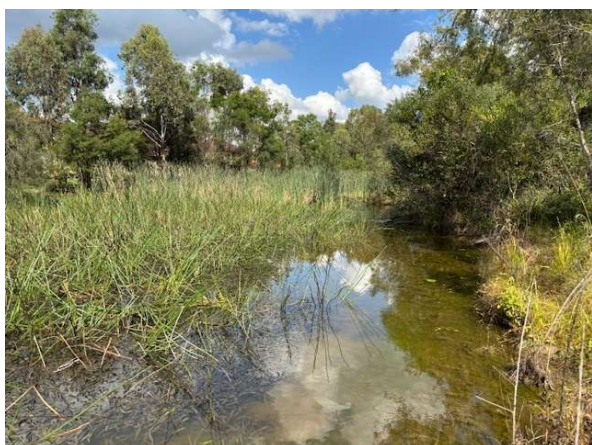
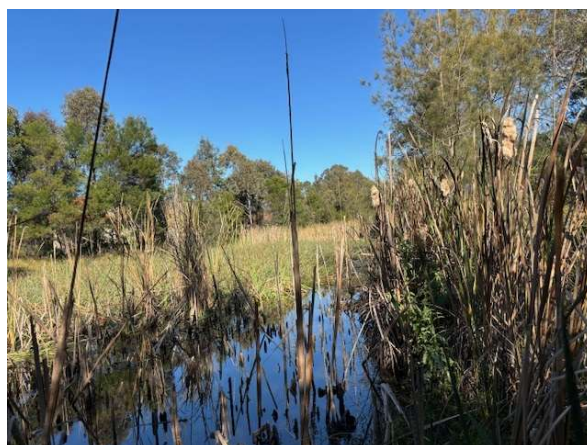
Also noted was the native perennial, *Utricularia* sp., and the small native fern, *Azolla*. *Egeria* (*Egeria densa*), which was collected close to the left-bank (facing downstream) of the pool in spring 2020, continues to be present. Riparian vegetation included Casuarina, Eucalyptus and Melaleuca trees and Spiny-head Mat-rush/Basket Grass (*Lomdandra longifolia*) (Plates 7&8).

Extensive cover of vegetation within the riparian zone contributes stability to the edges of the pool at Site AQ12. An area of active erosion has been apparent at the downstream end of the pool since autumn 2020, associated with heavy rainfall and bank overflows, including at the time of the autumn 2025 surveys.

Water level in the pool was up to approximately 0.8 m deep at the time of the second survey. The pool substratum was composed primarily of fine sediment with a considerable cover of detritus. Green filamentous macro-algae continue to be relatively abundant. Flow was apparent at the downstream end of the pool at the time of both surveys. Water clarity was considered good.

Plate 7: Site AQ12 – view upstream (9/04/25)

Plate 8: Site AQ12 – view across stream (23/06/25)

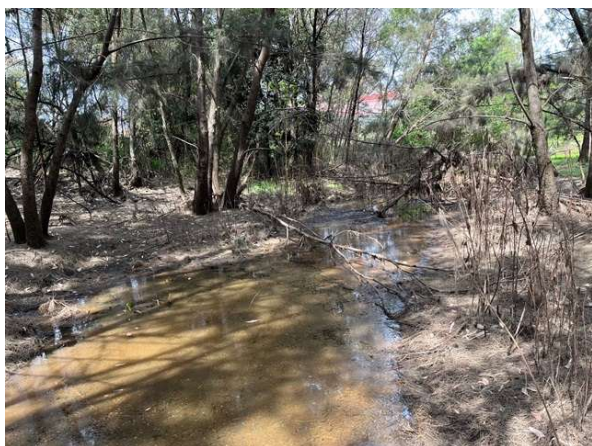
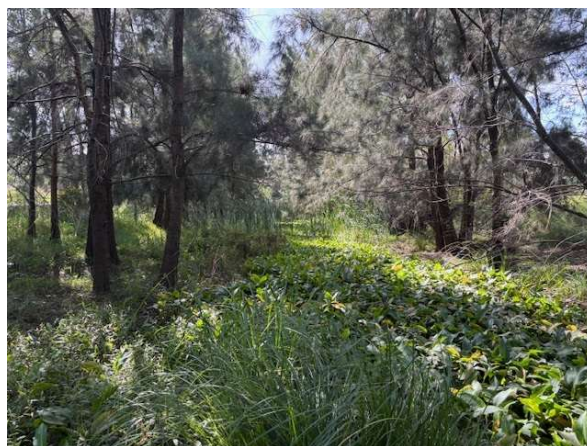
Site AQ13 was situated approximately 200 m downstream of Site AQ12 and approximately 150 m downstream from an overflow channel that enters the creek from Wattle Grove (Figure 1). A large proportion of the stream channel and edges had been recolonised by the aquatic weed, *Sagittaria platyphylla* (Sagittaria), since September 2024 (Plates 9&10). Slender Knotweed and Typha were also common. Water was present to a depth of approximately 0.5 m. The stream channel appeared stable (Plate 10; Appendix 2).

Plate 9: Site AQ13 – view upstream (24/09/24)

Plate 10: Site AQ13 – view downstream (23/06/25)

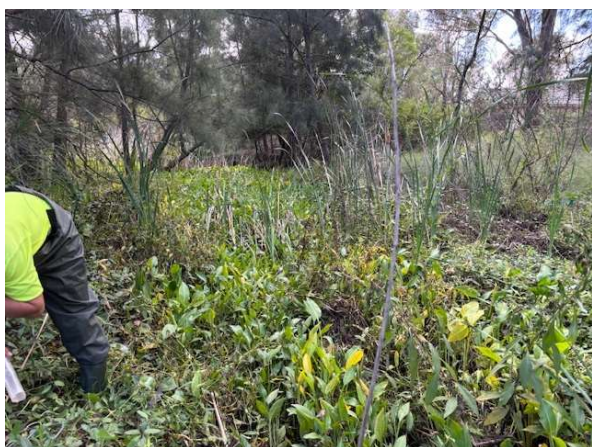
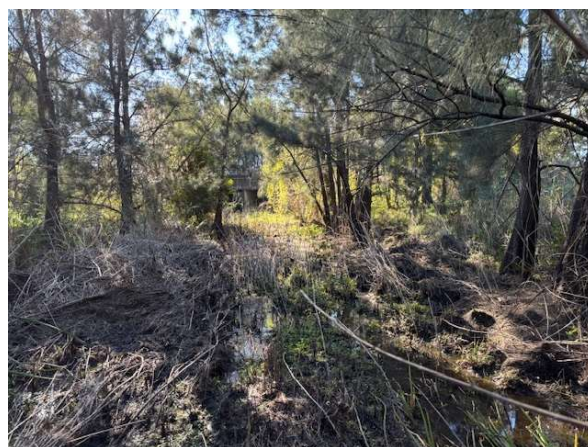
Typha, *Slender Knotweed*, *River Clubrush* and *Whorled Pennywort/Shield Pennywort* continue to be common (Plates 11&12). *Sagittaria* was common at the time of the first survey (Plate 11) but apparent high flows along the creek channel appear to have reduced aquatic plant distribution by the time of the second survey (Plates 11&12). Nevertheless, this section of Anzac Creek remains mostly stable due to the presence of instream vegetation and vegetated banks (Appendix 2). Water visibility was ‘good’ at the time of both surveys (Plates 11&12).

Plate 11: Site AQ14 – view downstream (9/04/25)

Plate 12: Site AQ14 – view downstream (23/06/25)

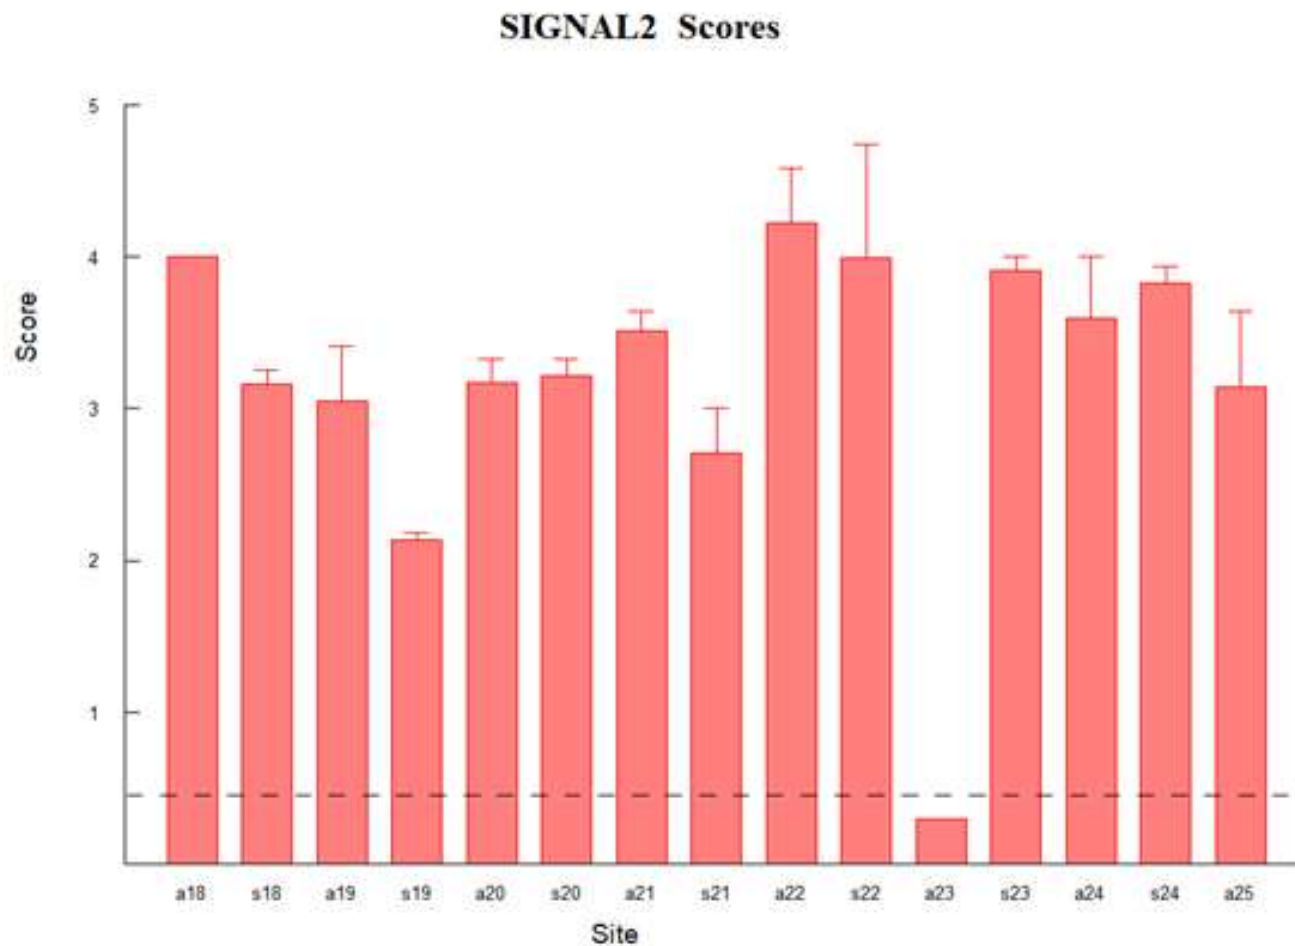
Figure 4. Mean (\pm) SIGNAL 2 results for Site AQ12 sampled in Anzac Creek since autumn 2018.

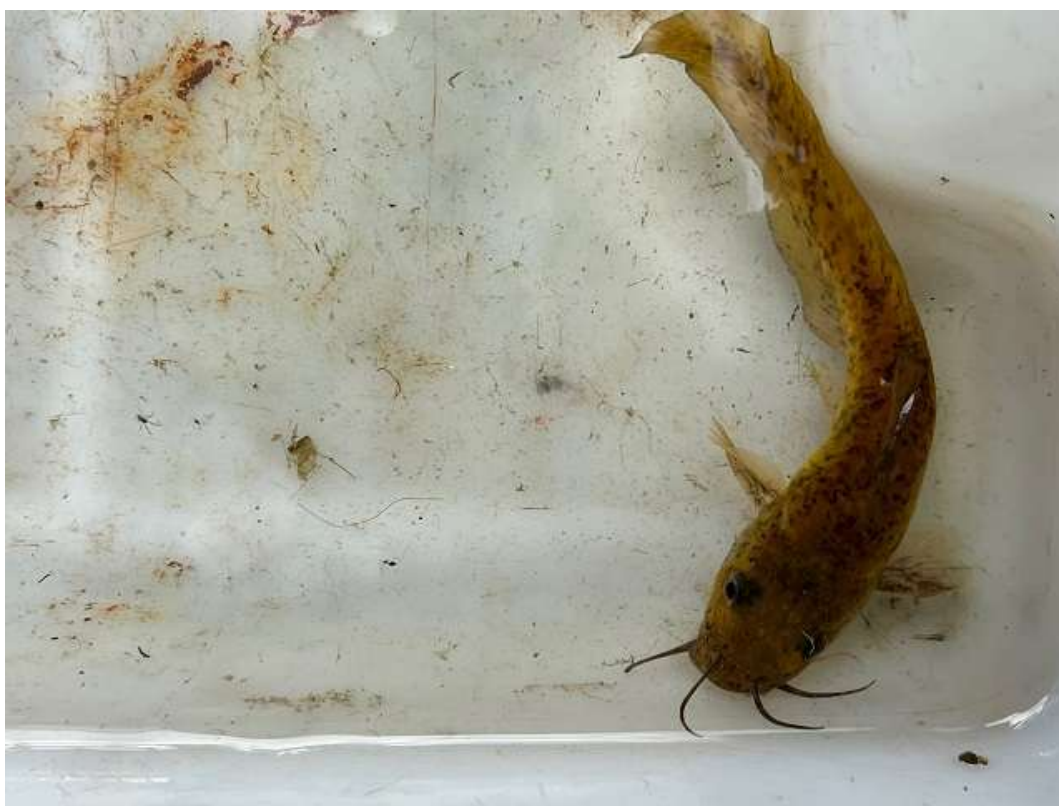
Plate 13: Juvenile Eel-tailed catfish collected at Site AQ12 (autumn 2023).
