Moorebank Logistics Park West Precinct

Basin 8 (OSD-8)

Autumn Stormwater Network Water Quality
Monitoring Data & Reporting November 2025

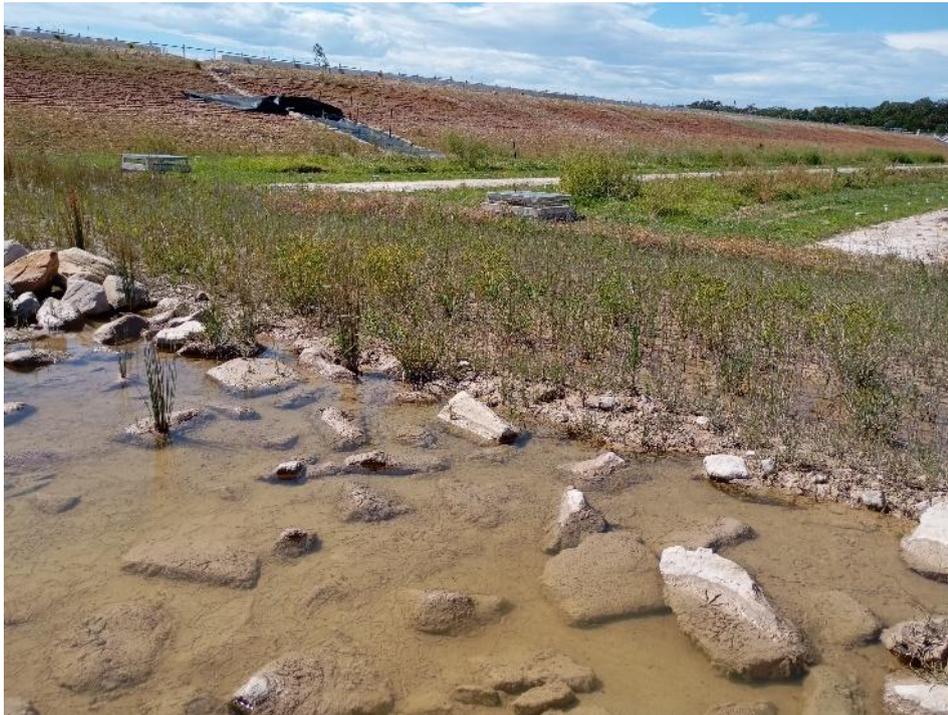
Collection Site (OSD-8) Inlet water source from SIOMP

B) 8 Outlet Results A) (OSD-8)

Measures	Results Nov 25	Results	Results
Date & Time	26/11/2025 – 9.54am		
Temperature	22.9		
Dissolved Oxygen %	101		
Dissolved Oxygen mg/L	8.7		
Salinity SPC ms/cm	0.003		
Salinity C-ms/cm	2.9		
TDS mg/L Total Dissolved Solids	2		
pH	6.3		
ORP mV Oxidation reduction potential	279		
NTU	152.80

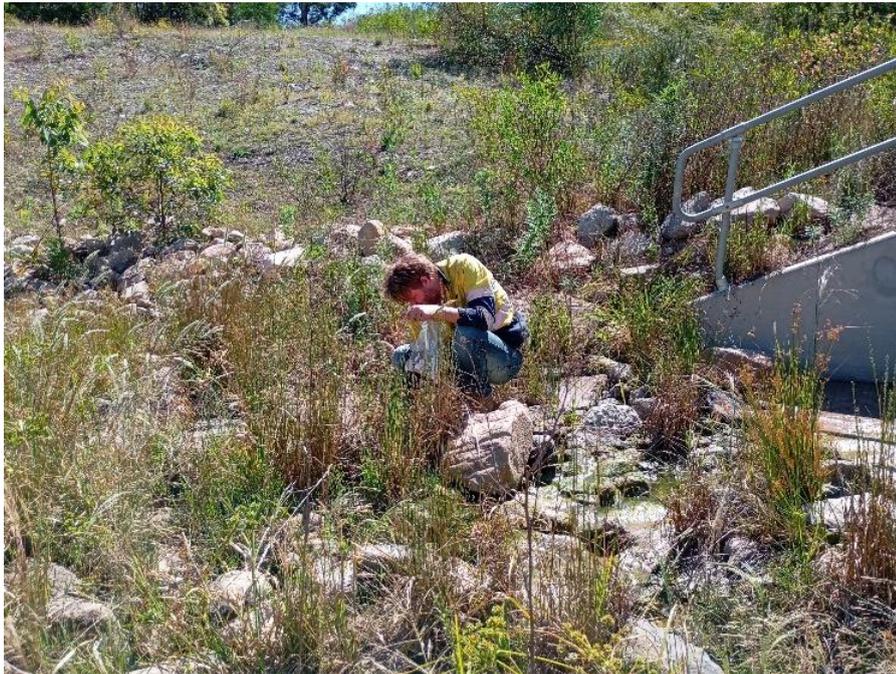
Collection Site (OSD-8) Basin Discharge to Georges River

B) 8 Outlet Results B) (OSD-8)

Measures	Results Nov 25	Results	Results
Date & Time	26/11/2025 – 9.54am		
Temperature	23.2		
Dissolved Oxygen %	101		
Dissolved Oxygen mg/L	8.6		
Salinity SPC ms/cm	0.003		
Salinity C-ms/cm	2.9		
TDS mg/L Total Dissolved Solids	2		
pH	5.91		
ORP mV Oxidation reduction potential	289.7		
NTU	155.34

pH value is very low compared to the previous reading at this sample location. The pH should be noted and be prioritised for reviewed again across the next sample period.

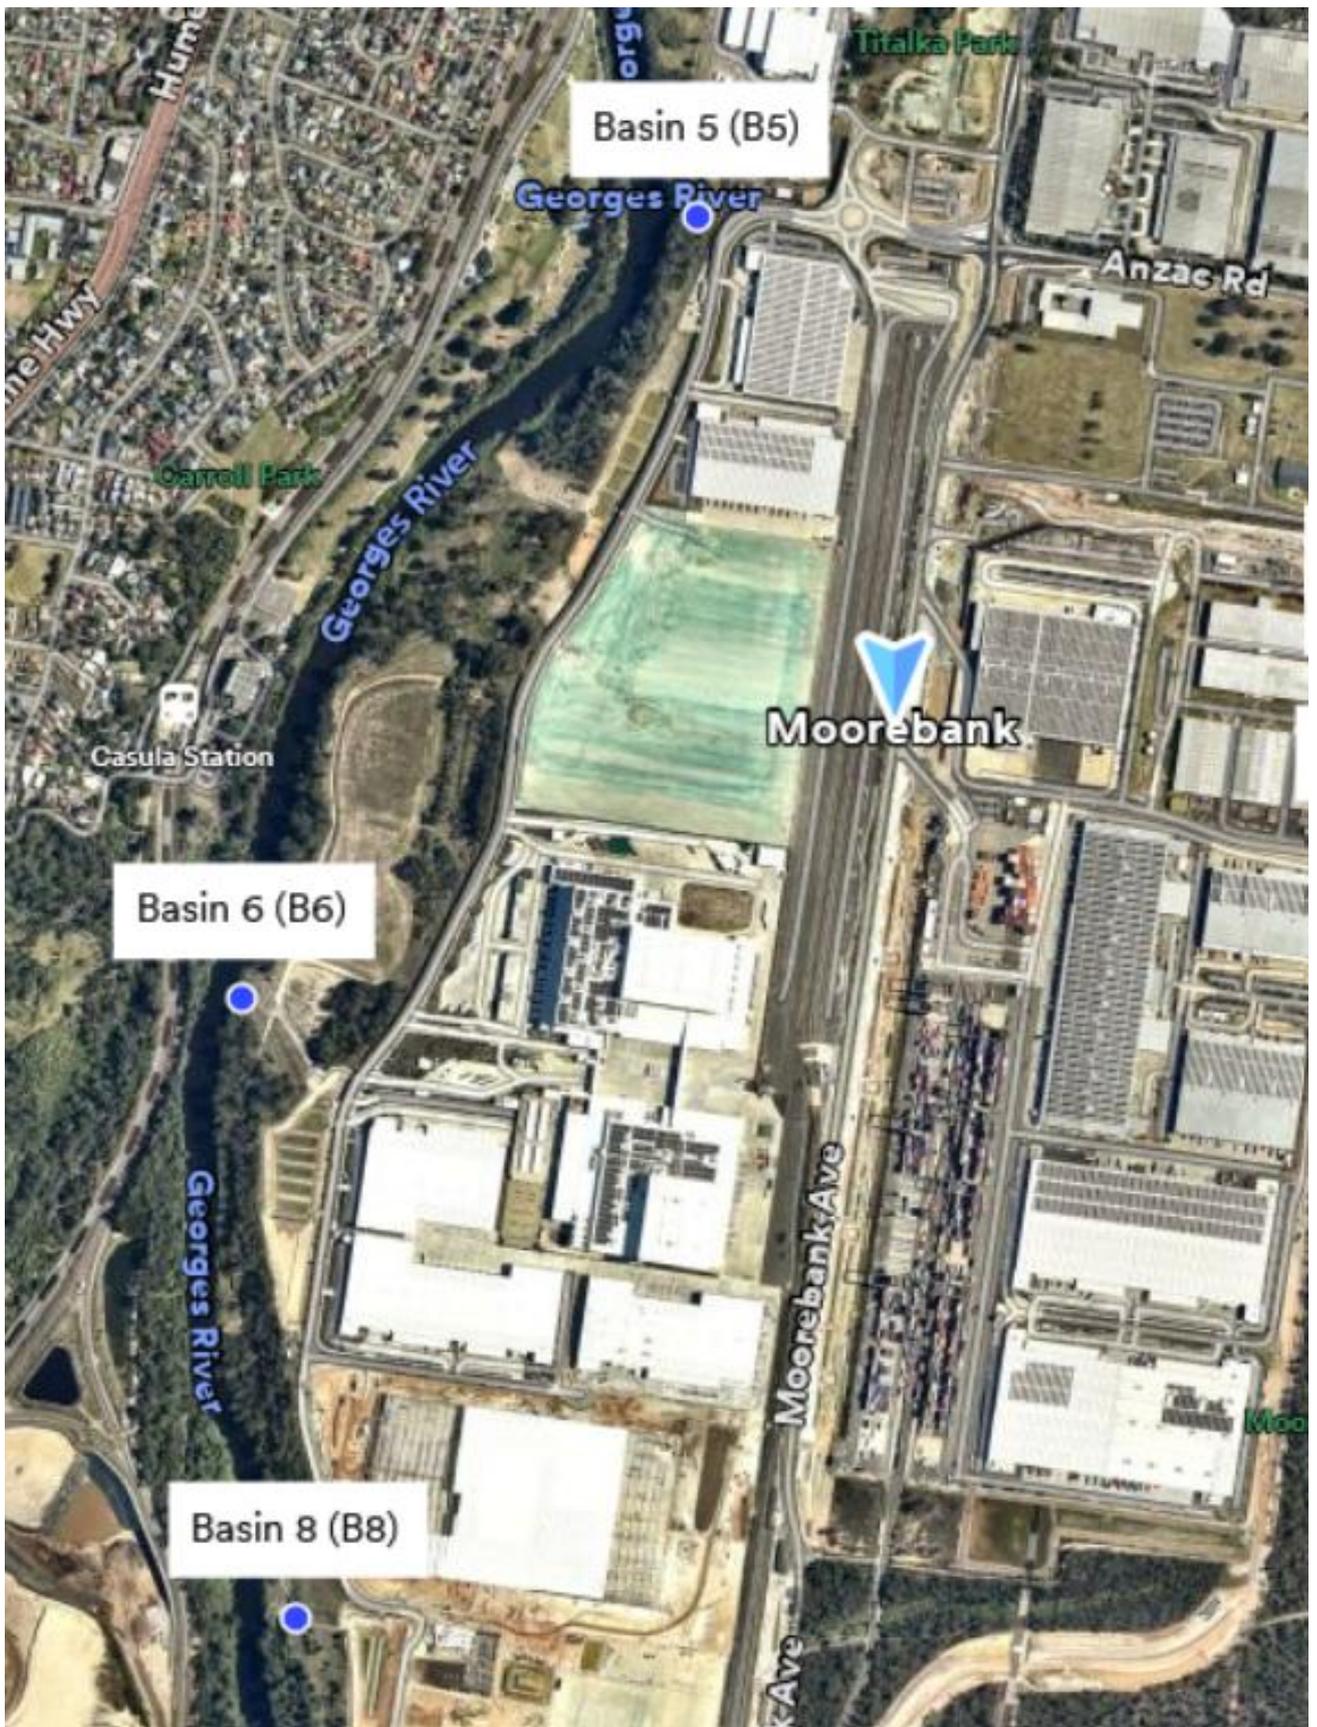
STORMWATER DISCHARGE TESTING SITE
BASIN 8 – OSD 8 INFLOW

Site image 1. Testing site Basin OSD-8 inflow water from the SIOMP network

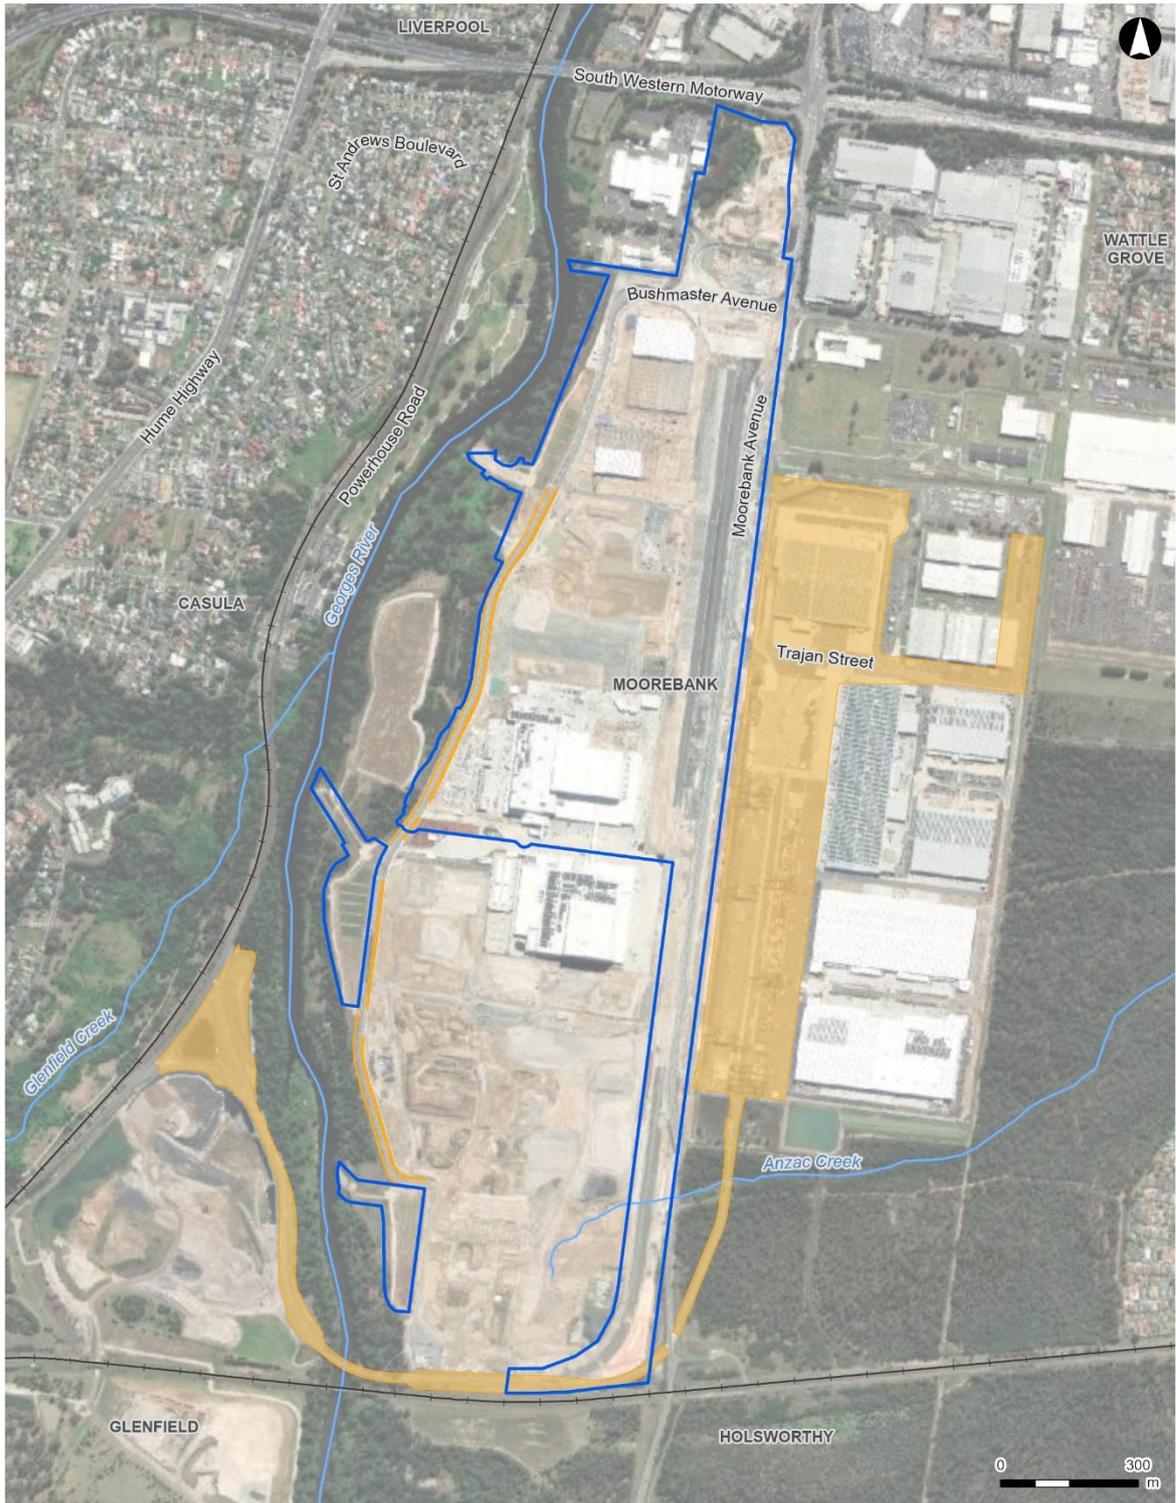
Figure 1. Survey extent within the MPI operational facility

Arcadis ecologist Kate Mauger attended the MIP operational area on 25 June 2025. Monitoring involved traversing the MIP operational facility on foot, surveying landscaped areas, stormwater infrastructure and soft batters adjoining the RALP for increases in weed abundance of the identified species in Appendix A and Appendix B. The areas surveyed are presented in Figure 1.

Monitoring of weeds was restricted to the operational facility; weeds were not assessed within the bounds of the active construction areas surrounding new warehouses.

Surveys were not undertaken in areas extending beyond the junction between the QUBE RALP and the Southern Sydney Freight Line (SSFL).

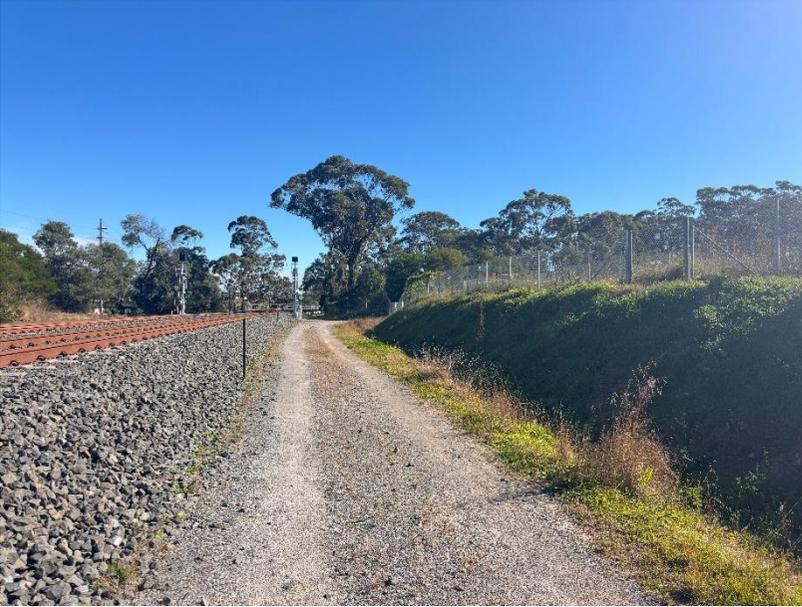
Inspection area	Weed abundances for current survey	Photo of inspection area
Moorebank Precinct East (MPE)		
Rail Access Land Package (RALP)	<ul style="list-style-type: none"> • <i>Chloris gayana</i> (Rhodes Grass) and small amounts of <i>Themeda quadrivalvis</i> (Grader Grass) were removed during this inspection • Some areas of <i>Lantana camara</i> (Lantana) were slashed along the fences adjacent to the Georges River BioBank site • The southern section of the RALP, in areas that have previously experienced significant batter erosion, were being colonised intensely by <i>Tagetes minuta</i> (Stinking Roger), and were slashed during this inspection (see adjacent photo).

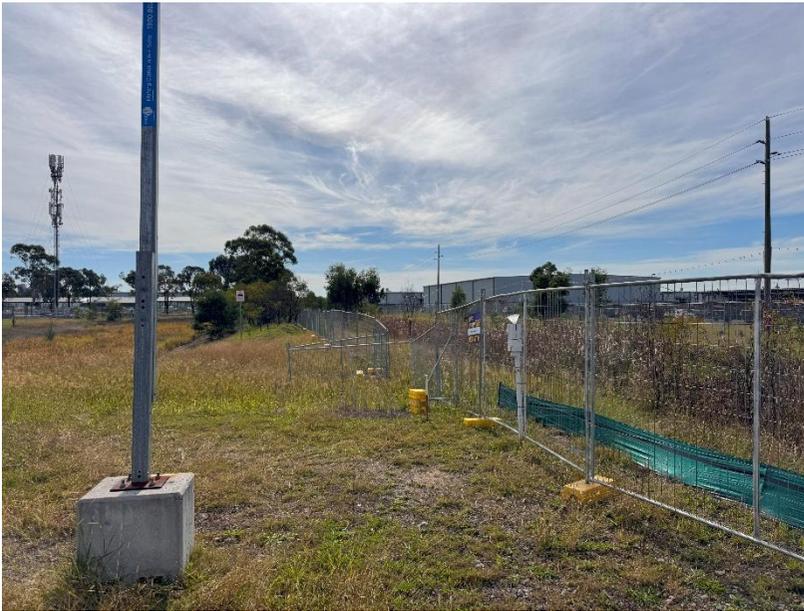
Inspection area	Weed abundances for current survey	Photo of inspection area
<p>Eastern boundary drainage infrastructure</p>	<ul style="list-style-type: none"> • Drainage infrastructure dominated by <i>Bulboschoenus fluviatilis</i> (Marsh club-rush) whilst other are dominated by <i>Typha orientalis</i> (Bulrush). Where space is present between stands of these native emergent species small clumps of <i>Pericaria decipiens</i> (Slender Knotweed), <i>Daviesia ulicifolia</i>, <i>Ficinia nodosa</i> (Knotted Club-rush), <i>Carex tereticaulis</i> and <i>Juncus usitatus</i> are present. Other native species such as <i>Imperata cylindrica</i> and <i>Lomandra longifolia</i> were observed in the drainage channels. • Areas of erosion still present.

<p>The photograph shows an outdoor drainage area. In the foreground, there is a concrete base for a utility pole. A metal fence runs across the middle ground, with a green safety netting attached to its base. The ground is covered with dry grass and some weeds. In the background, there are trees, a utility tower, and a cloudy sky.</p>
