**MOOREBANK PRECINCT EAST STAGE 2:
BIODIVERSITY MONITORING IN ANZAC CREEK**

SPRING 2025 SURVEY

**Final Report Prepared for
ARCADIS**

17 February 2026

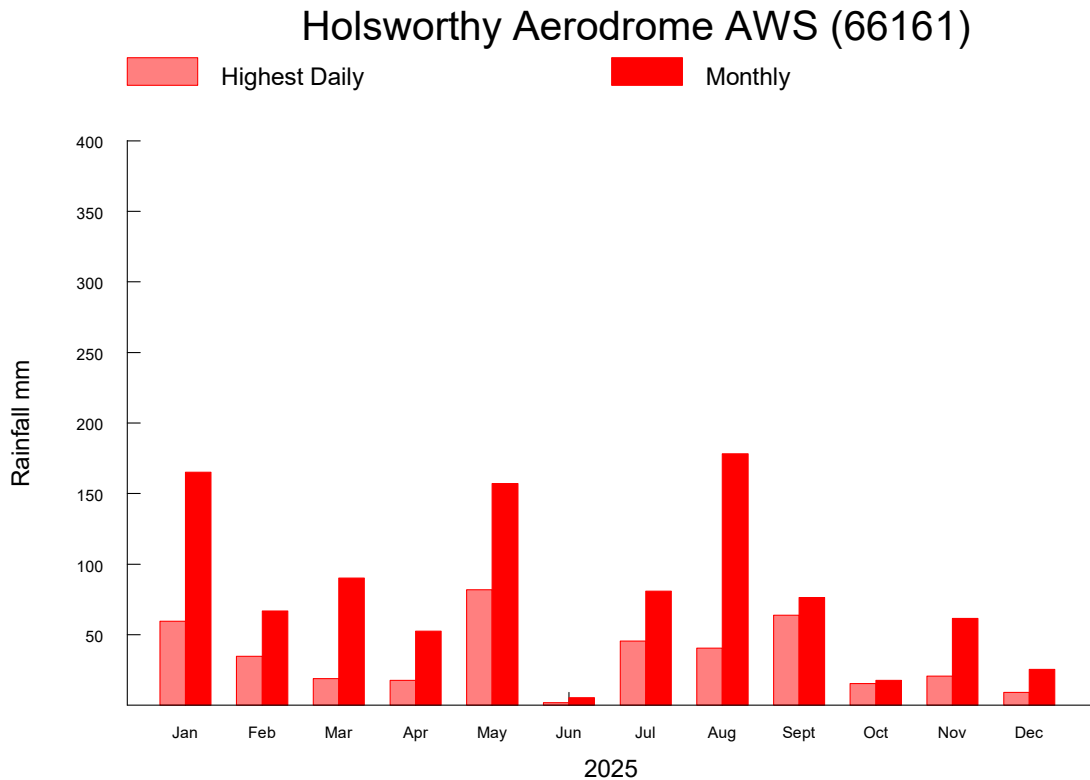
Within the two months prior to the 2025 spring Survey 1 (21 October 2025) and Survey 2 (1 December 2025), a total of 97.6 mm and 79.2 mm rainfall was recorded respectively by the meteorological station situated near Holsworthy Aerodrome AWS Rainfall Station (Station ID: 66161) (Figure 2).

Figure 2. Rainfall (mm) measured at Holsworthy Aerodrome AWS Rainfall Station (66161) between 1 January and 31 December 2025.

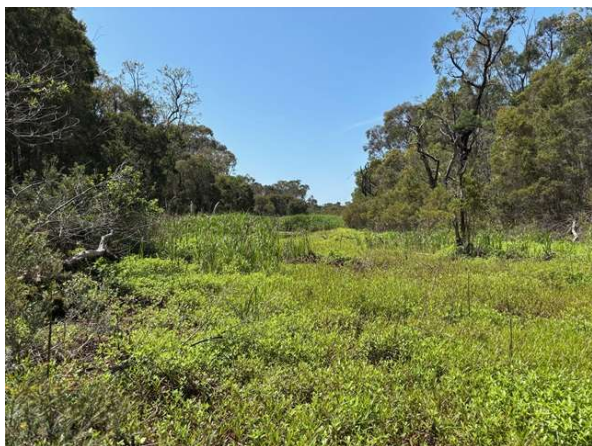
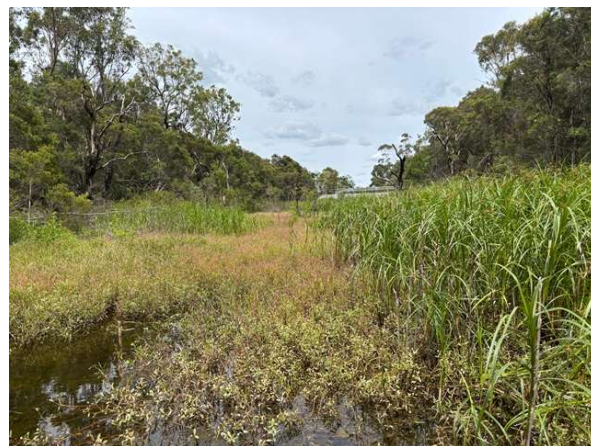
Plate 1: AQ1 – View upstream (21/10/25)

Water level was considerably lower at all sites sampled at the time of Spring 2025 Survey 1 compared to Survey 2 (Plates 1&2): isolated pools were present within the main channel at the time of Survey 1, whilst the channel was mostly submerged (to a depth of up to ~ 40 cm) at the time of Survey 2. *Gambusia (Gambusia holbrooki)* were observed.

The active channel zone remains stable (i.e., no signs of active erosion) due to dense cover of instream aquatic plants, including Slender Knotweed (*Pericaria decipiens*), Marsh Club-rush (*Bolboschoenus fluviatilis*) and Typha (*Typha* sp.), and the relatively intact woody riparian vegetation (Appendix 2).

Exotic species, including Alligator Weed (*Alternanthera philoxeroides*) and Ludwigia (*Ludwigia peruviana*), continue to be common at the edges of the channel. The channel bed consisted of fine sediment, the upper layers of which were anoxic: accumulations of green macroalgae were common at the time of Survey 2. The tree canopy was mostly comprised of *Melaleuca* spp. and *Eucalyptus* spp. (Plates 1&2).

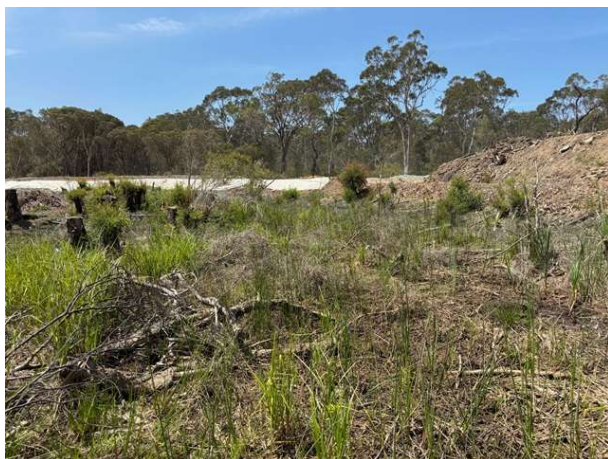
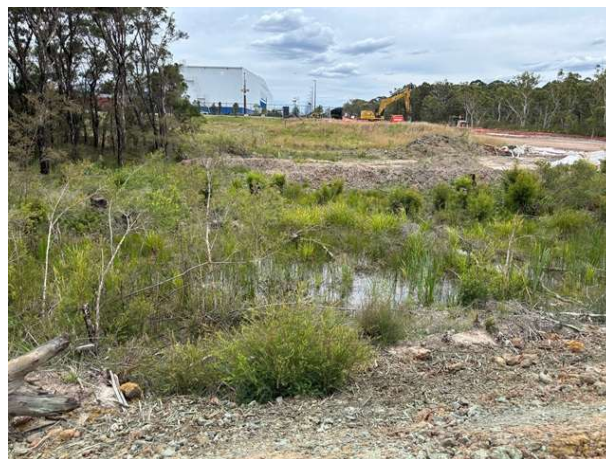
Plate 3: AQ4 – View downstream (21/10/25)

At the time of the Spring 2025 surveys, stands of *Baumea articulata* and *Baumea rubiginosa* continue to cover a large proportion of the stream channel and edges (Plates 3&4). Frogsmouth (*Philydrum lanuginosum*), *Typha* sp., *Juncus prismatocarpus*, *Carex fascicularis*, Soft Tree Fern, Heron Bristle Sedge (*Chorizandra cymbaria*) and a species of Bladderwort (*Utricularia* sp.), were also present. Water present at the time of the second survey appeared clear and free of sediment (Plate 3&4).

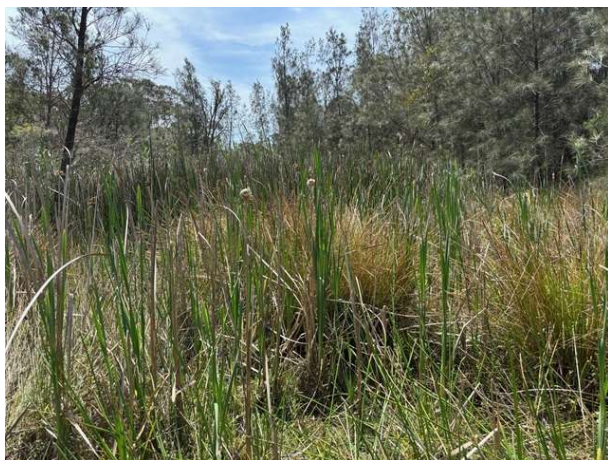
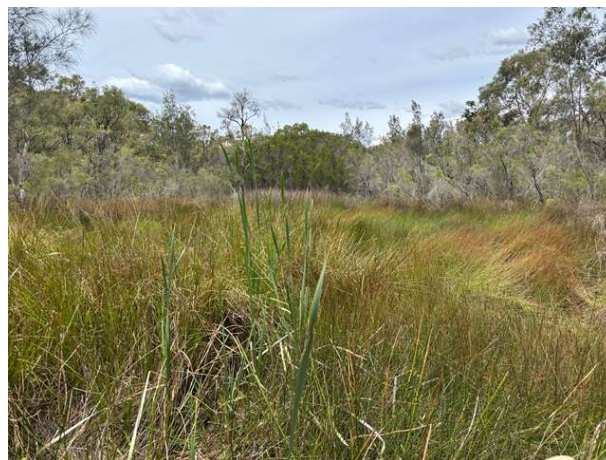
Plate 5: Site AQ8 – view downstream (21/10/25)

Stands of emergent macrophytes including Heron Bristle Sedge, Tall Spikerush (*Eleocharis sphacelata*) and Jointed Twig Rush occupied a large proportion of the stream channel (Plates 5&6). Other shorter plants, including Frogsmouth, Slender Knotweed and the introduced species, Umbrella Sedge (*Cyperus eragrostis*), have declined in abundance over the last two years, mostly likely due to shading by the taller species. Riparian vegetation continues to be dominated by *Casuarina* trees. Common Reed/Phragmites (*Phragmites australis*) and *Typha* were present at the downstream end of the site.

The stream channel at Site AQ8 (up to approximately 20 m wide) continues to be classified as stable, mostly due to the dense cover by emergent macrophytes in addition to a relatively intact, woody riparian zone (Appendix 2). Very little standing water was present within the study channel at the time of the spring 2025 surveys.

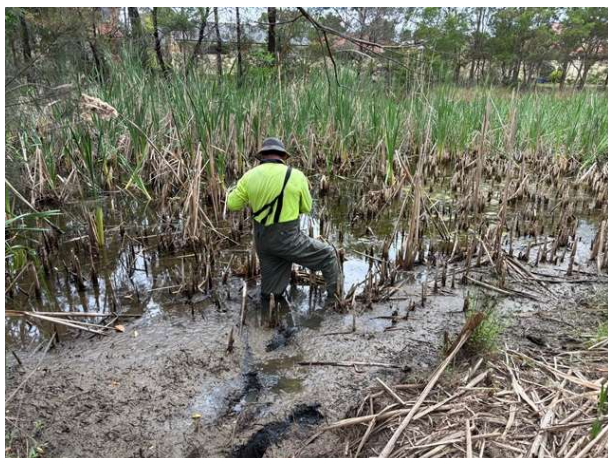
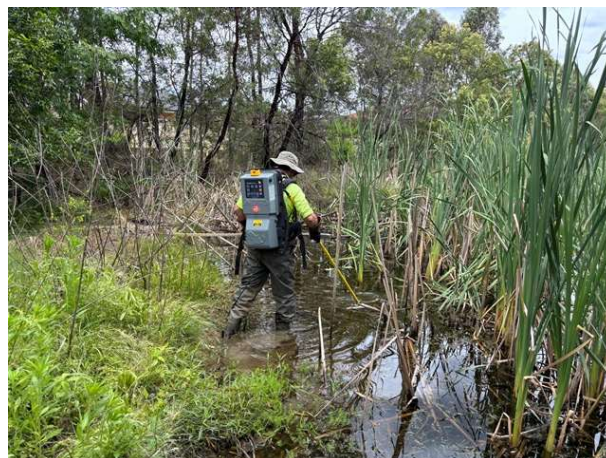
Plate 7: Site AQ12 – view upstream (21/10/25)

Also noted was the native perennial, *Utricularia* sp., and the small native fern, *Azolla*. *Egeria* (*Egeria densa*), which was collected close to the left-bank (facing downstream) of the pool in spring 2020, was not observed. Riparian vegetation included Casuarina, Eucalyptus and Melaleuca trees, Spiny-head Mat-rush/Basket Grass (*Lomdandra longifolia*) and *Persicaria decipiens* (Plates 7&8).

Extensive cover of vegetation within the riparian zone contributes stability to the edges of the pool at Site AQ12. An area of active erosion has been apparent at the downstream end of the pool since autumn 2020, associated with heavy rainfall and bank overflows, including at the time of the spring 2025 surveys.

Water level in the pool was approximately 0.3 m shallower than at the time of the autumn 2025 surveys. The pool edge substratum was composed primarily of fine sediment and decomposed plant material. Green filamentous macro-algae continue to be relatively abundant. Flow was not apparent at the downstream end of the pool at the time of both surveys. Water clarity was considered good.

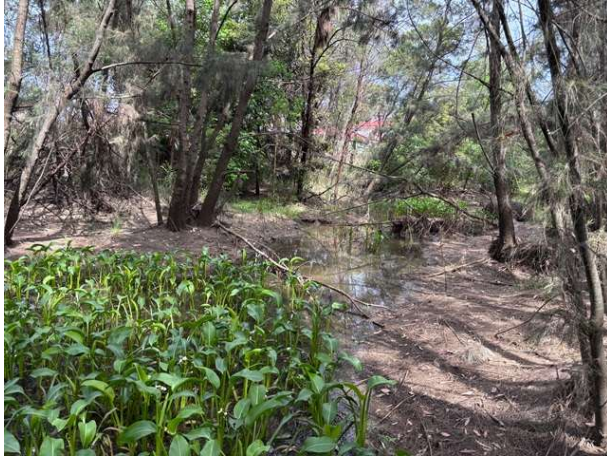
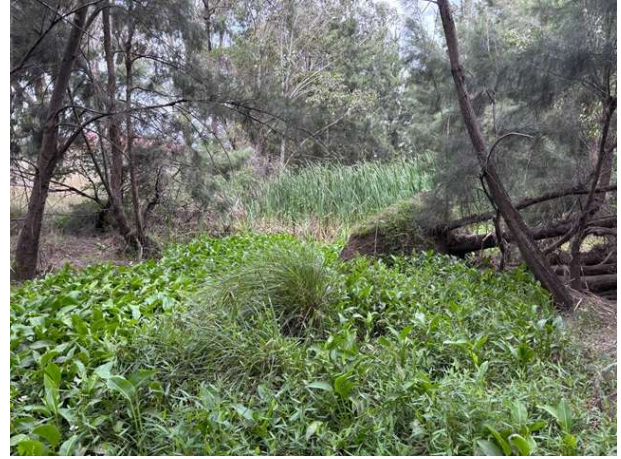
Plate 9: Site AQ13 – view upstream (21/10/25)

Site AQ13 was situated approximately 200 m downstream of Site AQ12 and approximately 150 m downstream from an overflow channel that enters the creek from Wattle Grove (Figure 1). A large proportion of the stream channel and edges had been recolonised by the aquatic weed, *Sagittaria platyphylla* (Sagittaria), since September 2024 (Plates 9&10). Slender Knotweed and Typha were also common. Water present was to a depth of approximately 0.5 m. Flow was not apparent. The stream channel appeared stable (Plate 10; Appendix 2).

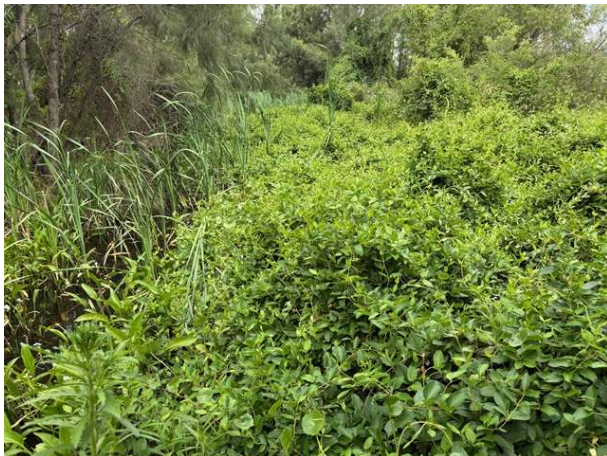
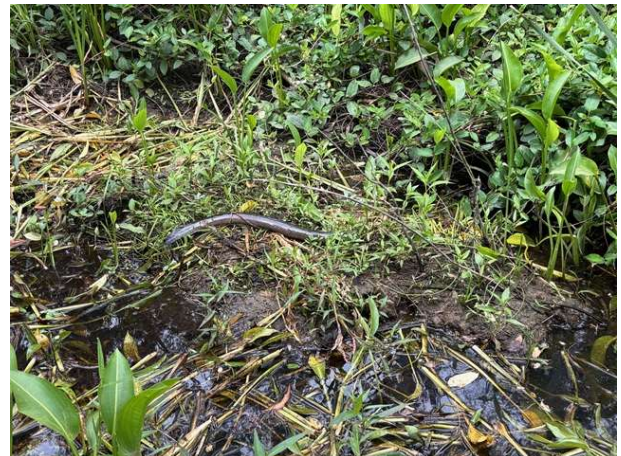
Plate 11: Site AQ14 – view upstream (21/10/25)

Site AQ14 was situated approximately 150 m downstream of Site AQ13 and immediately downstream of the culvert that links the dam within Commonwealth Department of Defence land to Anzac Creek (Figure 1). Flow was not apparent at the time of both spring 2025 surveys (Plates 11&12). Much of the instream vegetation scoured from much of the stream channel during autumn 2025 had recolonised the stream channel (Plates 11&12).

Typha, Slender Knotweed, River Clubrush and Whorled Pennywort/Shield Pennywort continue to be common (Plates 11&12). Sagittaria was common at the time of both survey's (Plates 11&12). This section of Anzac Creek remains mostly stable due to the presence of instream vegetation (Appendix 2). Water visibility was 'poor' at the time of first survey. Notably, some areas of instream vegetation were in poor condition, and a dead eel was observed (Plate 12).

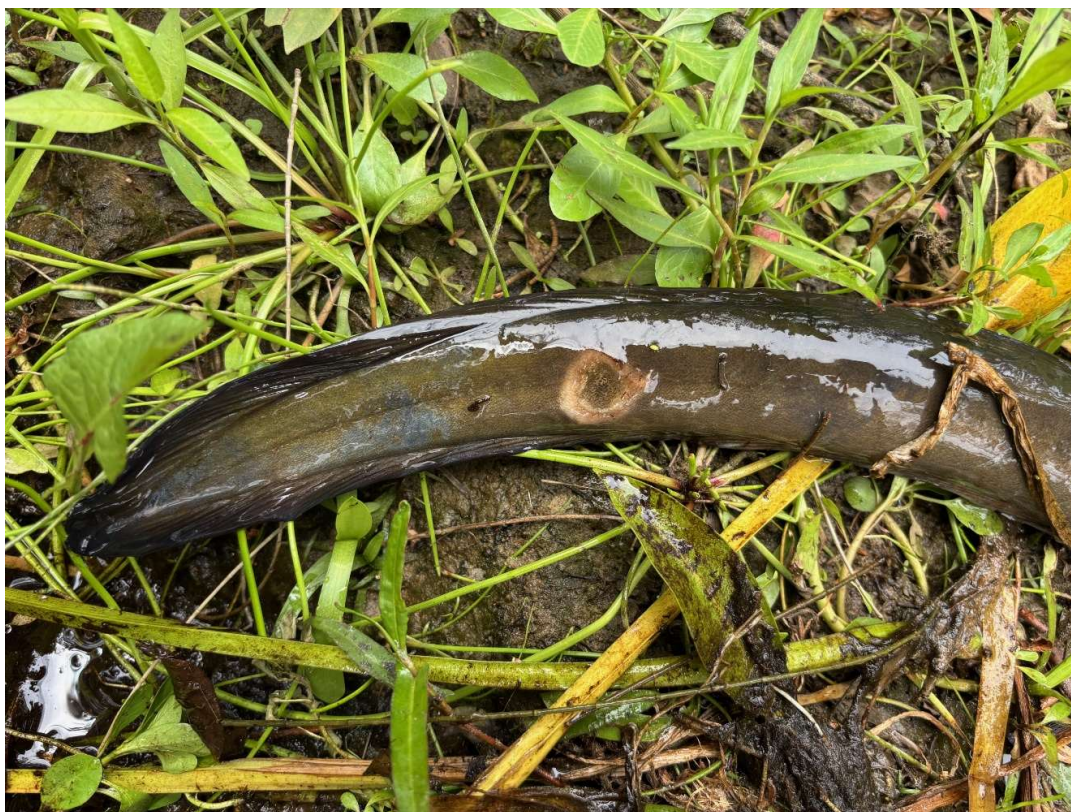
A dead eel was observed at Site AQ14: a deep lesion was observed near the tail, similar to those observed as a result of Epizootic Ulcerative Syndrome (Red Spot Disease) (Plate 14).

**Plate 14: Dead eel observed at Site AQ14 at the time of Spring 2025 Survey 2.
The apparent lesion is most likely an epizootic ulcer.**

Notably, a dead eel was observed at Site AQ14 on 1 December 2025 (Survey 2) had a deep lesion near the tail, similar to those observed as a result of Epizootic Ulcerative Syndrome (EUS) (Red Spot Disease). EUS is caused by a fungus, *Aphanomyces invadans*, and causes red lesions (sores) and deep ulcers, making affected fish unmarketable and sometimes resulting in their death (DPI NSW, 2023). EUS is a notifiable disease in NSW and this sighting has been reported to NSW Department of Primary Industries (DPI).
