**Subject** MPE Operational – Weed Monitoring Report August 2020

**Subject** MPE Operational – Weed Monitoring Report October 2020

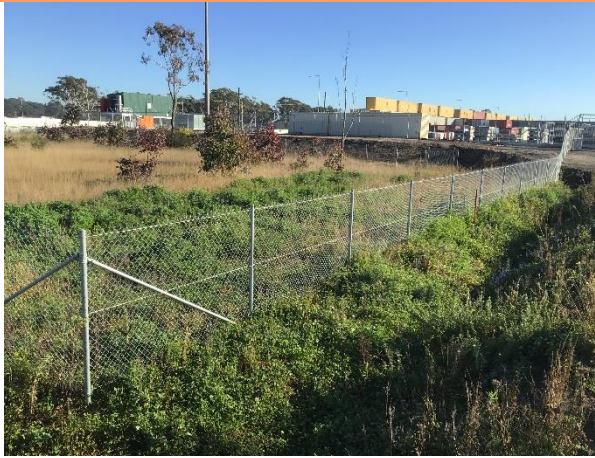
**Burr Medic encroaching on environmentally sensitive areas west of the the Rail Link corridor.**

- Burr Medic and other weed species were observed growing outside of the rail corridor fence adjacent to the Rail Link, nearest the operational facility (see Figure 3). These weeds are encroaching on areas known to support the 'Critically endangered' plant *Hibbertia fumana*. The encroachment of these weeds outside the rail Link may impact *Hibbertia fumana* plants and cause habitat to become unsuitable. It is important that these weeds are removed as a priority through manual methods including hand weeding and hand tools. If Burr Medic can not be manually removed cut and paint methodology may be adopted. Under no circumstance should herbicide spraying be conducted to treat weeds due to the chance of spray drift impacting *Hibbertia fumana*.

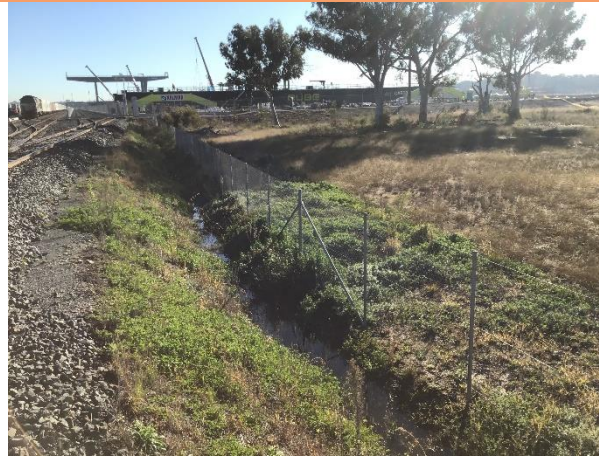
**Burr Medic encroaching on environmentally sensitive areas east of the Rail Link corridor.**

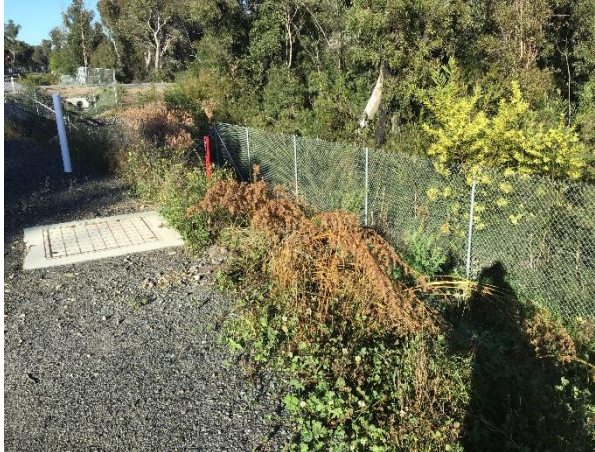
**Grader grass colonising soft batters beside rail track.**

- The exotic grass species *Themeda quadrivalvis* (Grader Grass)<sup>1</sup> is present within the Rail Link. This plant is growing as individuals and in small clumps on the soft batters either side of the rail track. This weed should be removed through hand weeding or slashed regularly to reduce its capacity to spread.

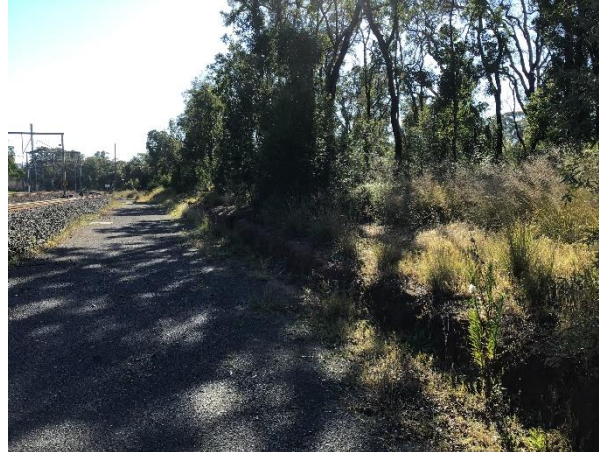
**African Love Grass on soft batters adjacent to South Sydney Freight Line**

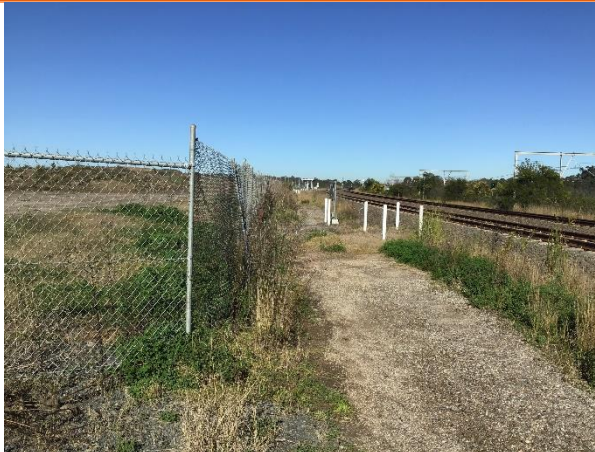
**Undeveloped lands at the western extent of the Rail Link, adjoining the South Sydney Freight Line, colonised by environmental weeds.**

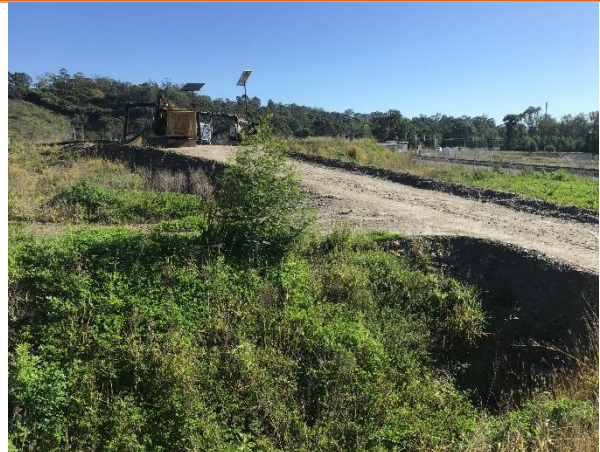
**Environmental weeds colonising undeveloped lands at the western extent of the Rail Link.**

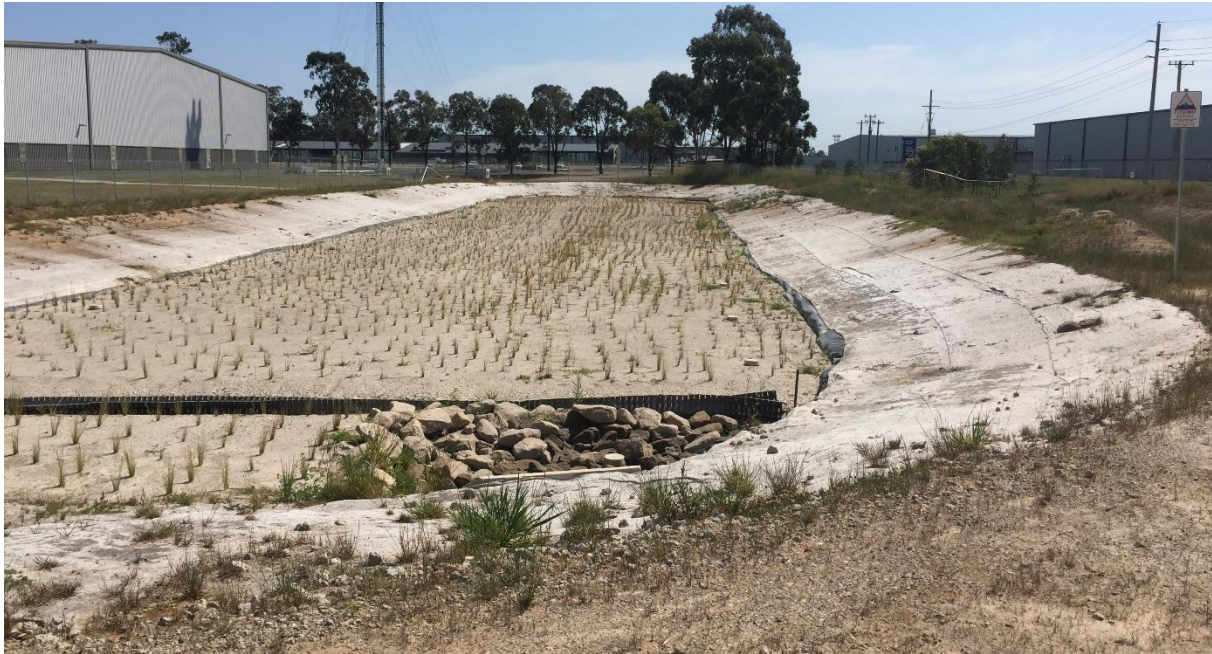
Weed cover across the operational facility is generally low. Invasive grasses and sparsely scattered herbaceous weeds remain present within the trunk drainage systems along the western boundary of the operational area and in the drainage swale/retention basin in the north eastern corner, albeit at low coverages (Plate 1).

*Plate 1. Drainage swale/retention basin in north eastern corner of operational area at risk of weed infiltration*

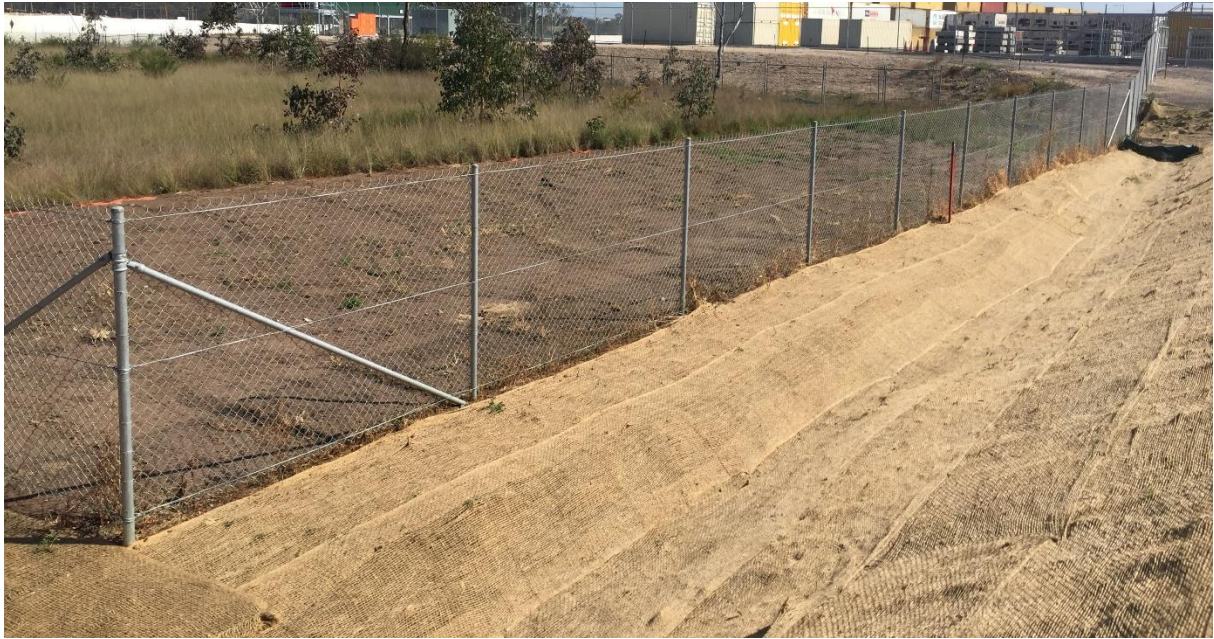
Since the previous monitoring survey (August 2020) remediation works have been conducted within the Rail Link to remove weeds and stabilise slumping soft batters (Plate 2). Works have occurred along the Rail Link from the operation facility to the junction between the Qube Rail Link and the Southern Sydney Freight Line. As noted in previous weed monitoring reports soft batters within the Rail Link were completely vegetated with exotic plant species. Remediation works included:

- Spraying of weeds colonising soft batters with herbicide
- Clearing of treated weeds, removing vegetative material back to exposed soil
- Reforming of slumped soft batters
- Placing and securing of coir mesh to stabilise exposed batters subject to weed removal and reformation.

*Plate 2. Soft batters being remediated through removal of weeds and stabilisation with coir mesh*

It is understood that all remediated areas within and adjacent to the Rail Link are set to be revegetated through hydroseeding using a native plant species seed mix as per the UDLP (Arcadis 2019a).

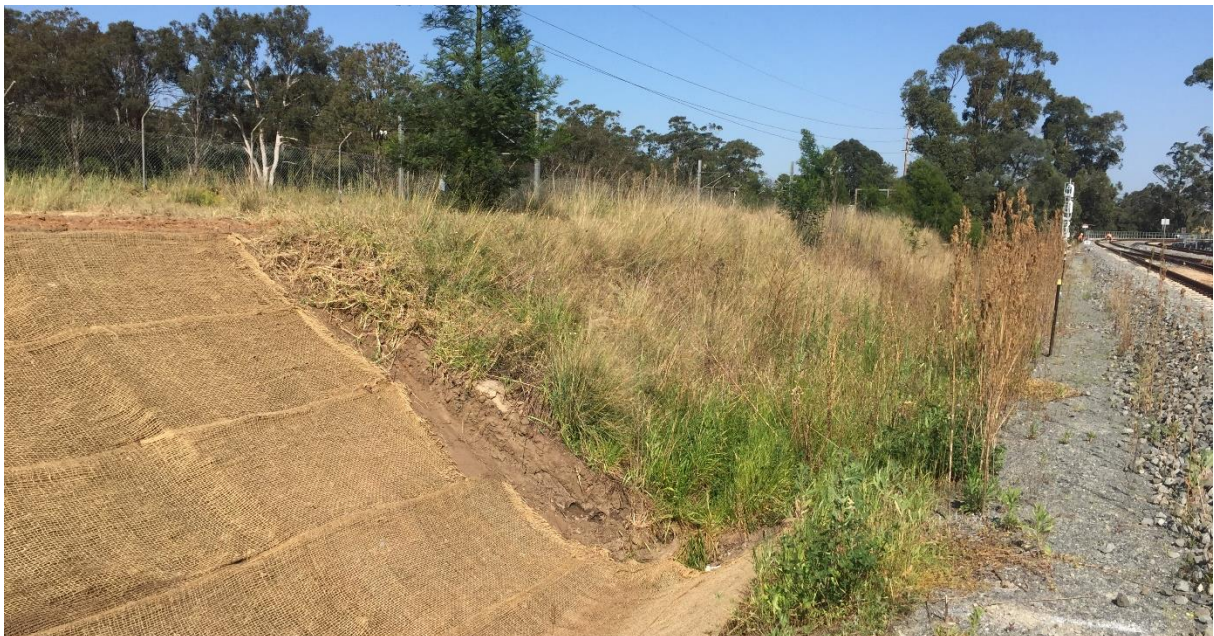
Sections of soft batter on the western side of the Rail Link running parallel to the East Hills Railway line have not been subject to weed removal or batter stabilisation as of the date of survey. This area of soft batter is dominated by exotic species which presents a risk of further weed recruitment occurring on the adjacent remediated areas.

*Plate 3. Areas of soft batter dominated by weeds adjoining recently remediated areas*

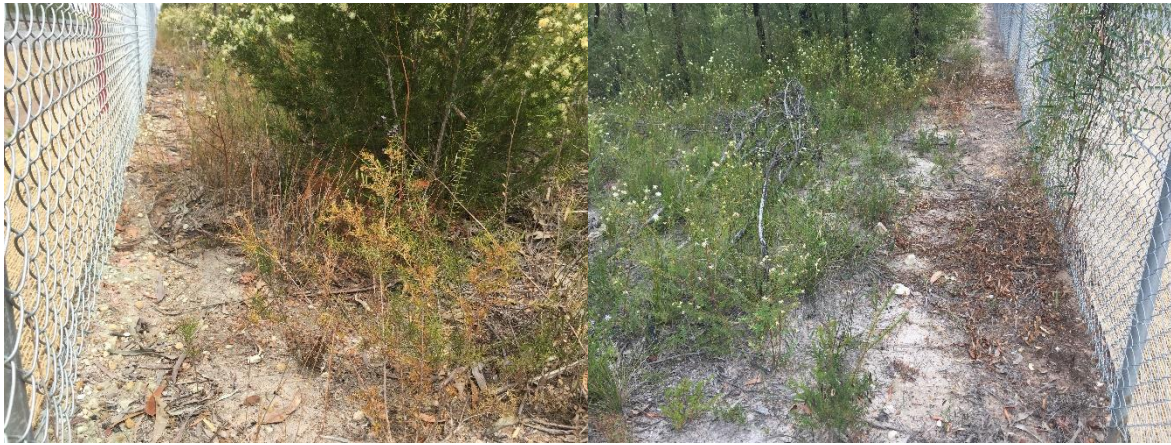
It was noted during the October survey that hi-volume spaying within the Rail Link along the soft batters adjacent to the Moorebank biobank site has resulted in damage to native plants outside of the corridor fencing (Plate 4). One individual of *Acacia bynoeana* (Bynoe's Wattle) was identified as being moderately impacted by herbicide overspray (Plate 5). Upon inspection the individual was still alive however displaying poor condition. This species is listed as Endangered under the BC Act<sup>1</sup> and Vulnerable under the EPBC Act<sup>2</sup>.

Plate 4. Native plants within the Moorebank biobank site poisoned due to over spray/ spray drift

Hi-volume spraying of herbicide to control weeds in the Rail Link along soft batters adjacent to the Moorebank biobank site should not be conducted. Application of herbicide should be administered through localised spot spraying during optimal spray conditions to prevent damage to native plants from over-spray/spray drift.

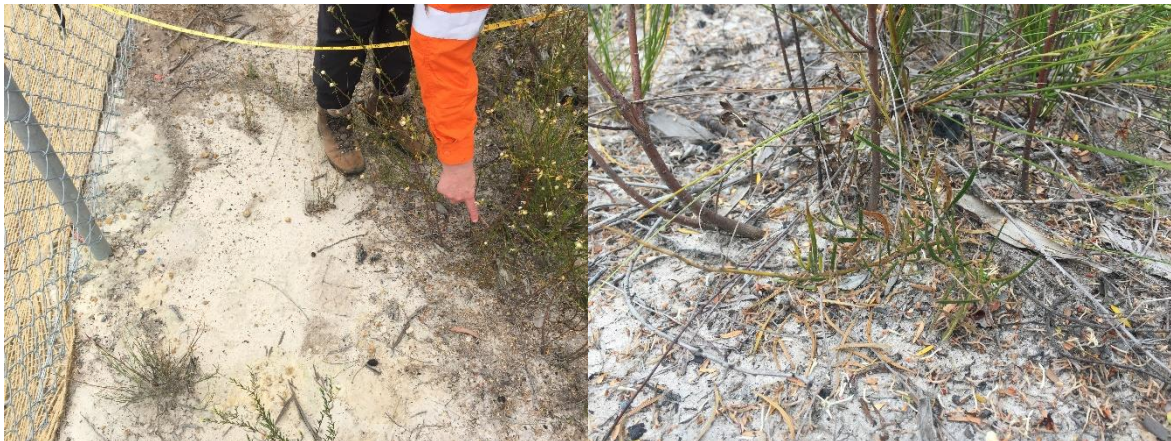
Plate 5. Bynoe's Wattle in close proximity to rail corridor fencing impacted by herbicide overspray

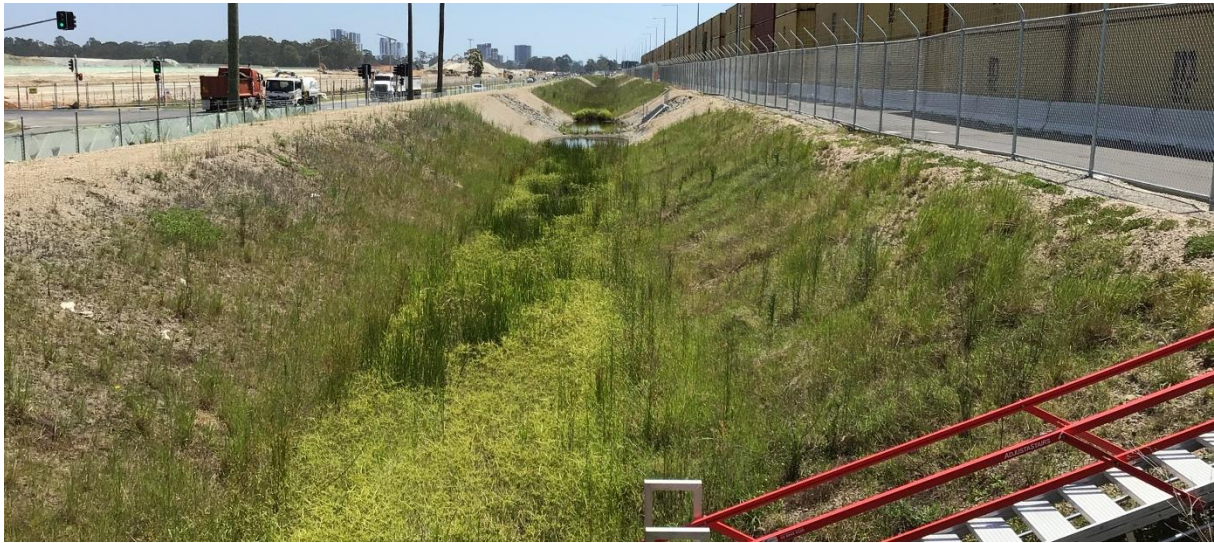
Weed levels across the operational facility have remained low since the October survey. Soft batters of the trunk drainage system, along the western boundary of the operational area, have a sparse scattering of the exotic grass (*Setaria* sp.) and herbaceous weeds including *Solanum sisymbriifolium*, *Sida rhombifolia* and *Conyza* sp. Within the channel of the truck drainage system, where water is present, *Cyperus eragrostis* (Umbrella sedge) is becoming dominant (Plate 1). This invasive sedge species is likely to outcompete native species within the channel if not controlled.

Plate 1. *Cyperus eragrostis* (Umbrella sedge) colonising wet environments in trunk drainage system

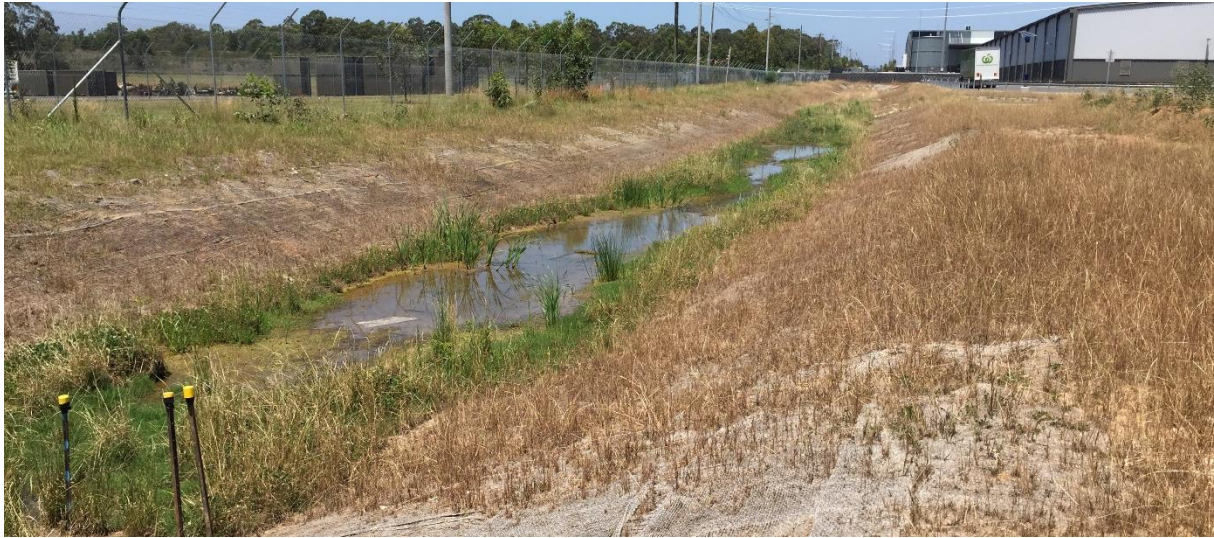
The drainage swale/retention basin in the north eastern corner of the operational precinct is majorly vegetated with *Secale cereale* (Cereal Rye) although in a senescent state (Plate 2). It is thought that this grass is remnant from the cover crop used to stabilise the soft batters during formation of the drainage swale/retention basin. Senescent Cereal Rye being the only vegetation present increases the susceptibility of the areas to invasion from herbaceous weeds and aggressive invasive grasses. One small patch of the woody weed, *Acacia saligna* (Golden Wreath Wattle), was observed on the eastern batter of the retention basin.

Plate 2. Senescing *Secale cereale* (Cereal Rye) on soft batters of drainage swale; increasing susceptibility of area to invasion by herbaceous weeds and aggressive invasive grasses.

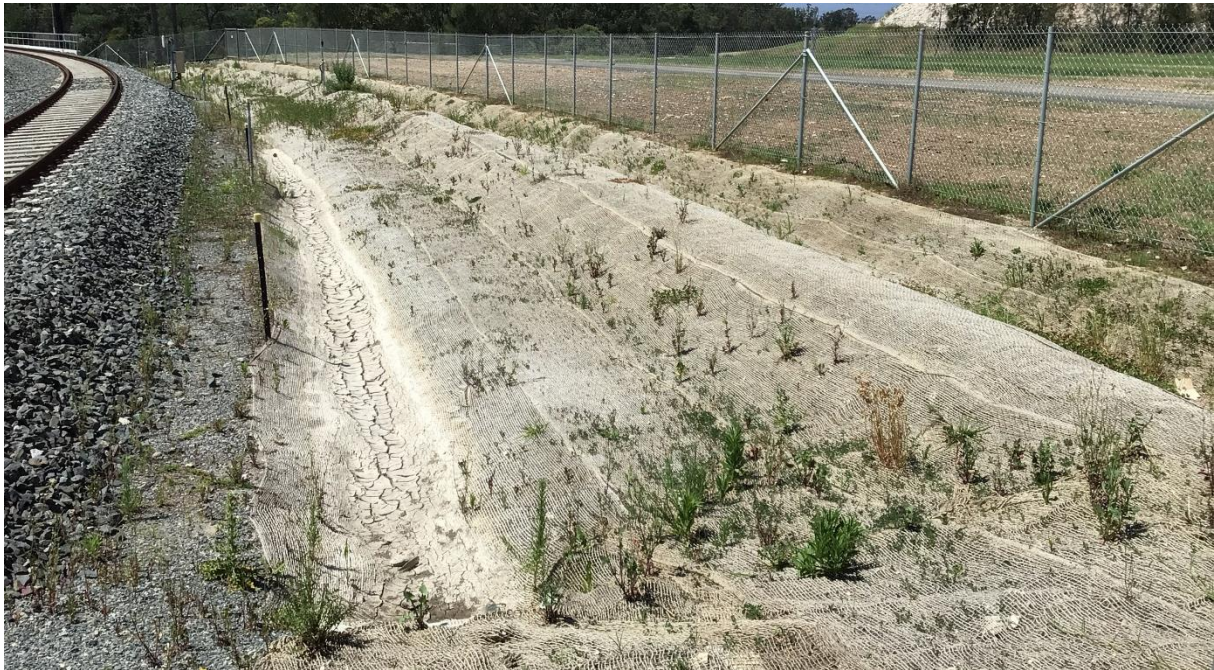
Herbaceous weeds and exotic grasses are beginning to colonise remediated areas within the Rail Link including, *Conyza* sp. (Fleabane), *Medicago polymorpha* (Burr Medic), *Solanum nigrum* (African Nightshade) and *Trifolium repens* (White Clover) (Plate 3). If left untreated these weeds will quickly colonise remediated areas.

Plate 3. Exotic grasses and herbaceous weeds colonising remediated areas

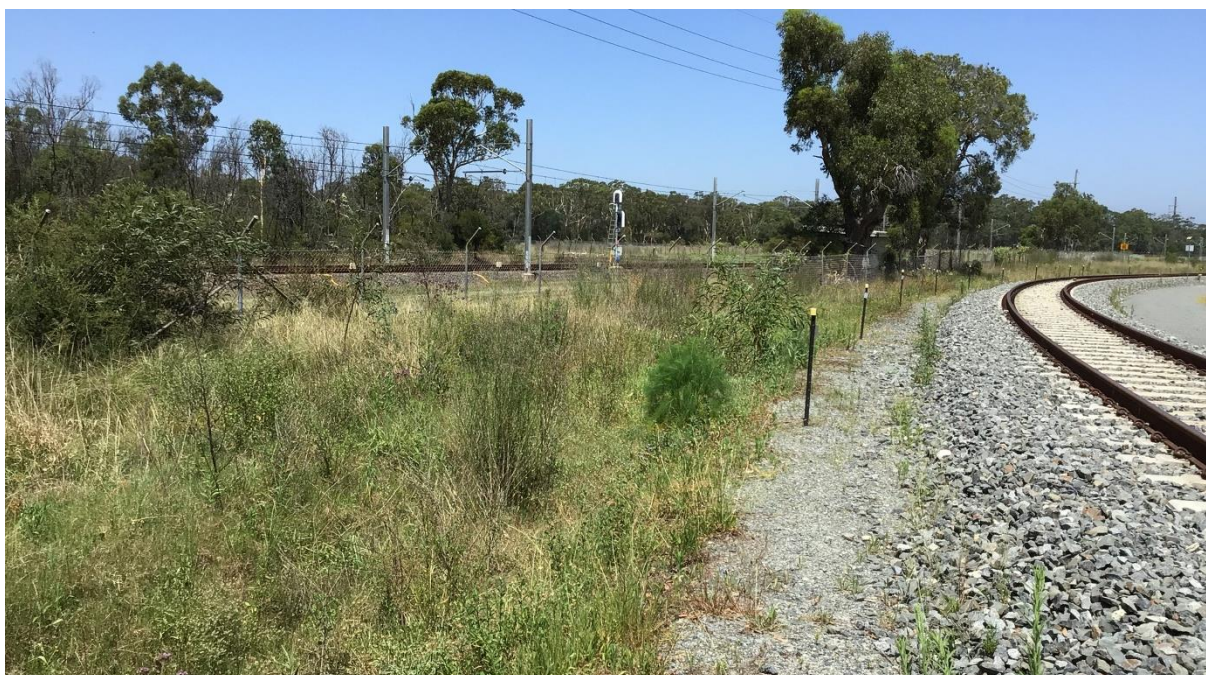
Areas not subject to remediation within the Rail Link continue to have a high percentage cover of exotic grasses and herbaceous weeds (Plate 4).

Plate 4. Weeds dominating non-remediated areas within the Rail Link

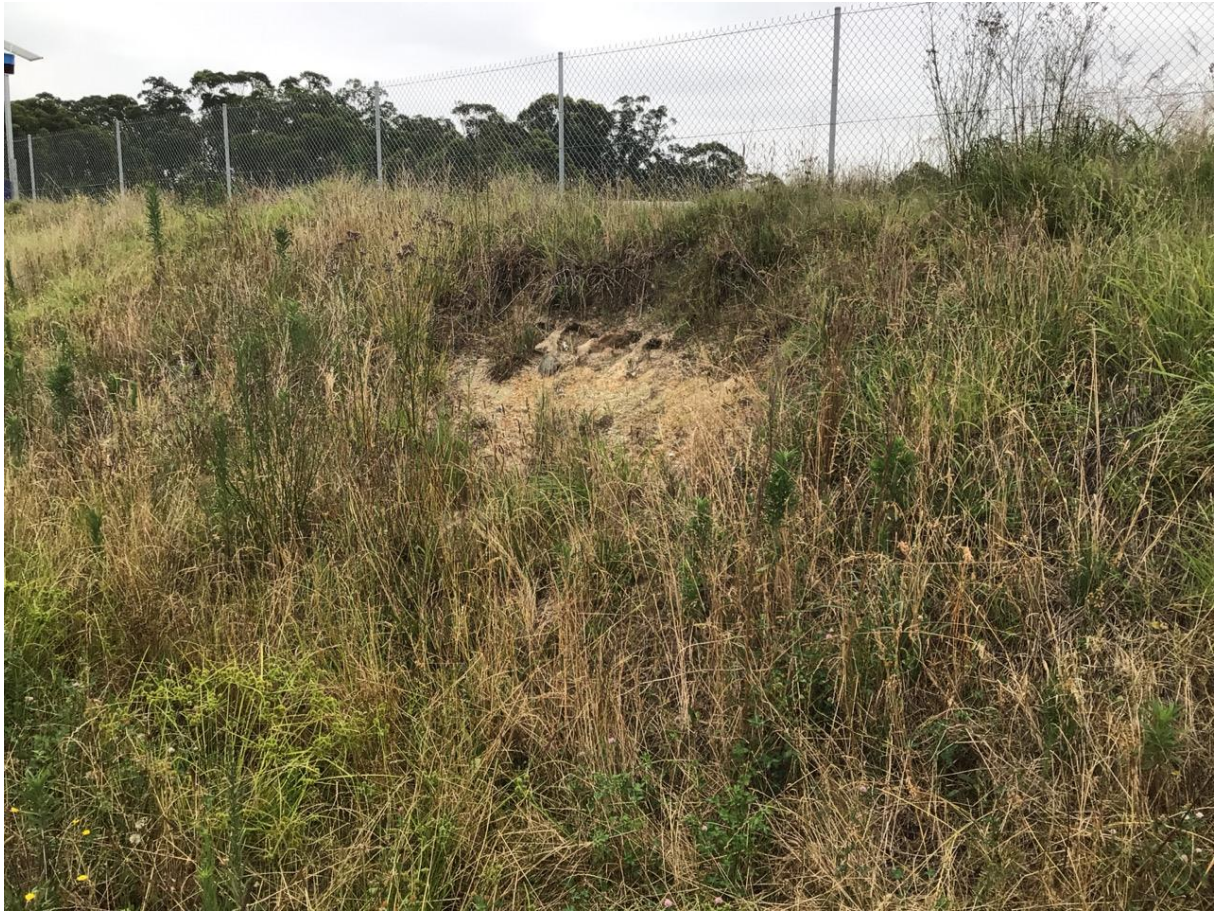
Batter slumping was observed at two locations within the Rail Link (Figure 2 - Figure 6). These areas were not remediated during recent works and are completely vegetated with exotic grasses and herbaceous weeds (Plate 5).

*Plate 5. A section of soft batter which has slumped within the Rail Link*
