**Date** 13/09/2022  
**To** [REDACTED]  
**From** [REDACTED]  
**Copy to** [REDACTED]  
**Subject** MPE operational facility – Weed monitoring report August 2022

## Introduction

Arcadis has been commissioned to conduct bi-monthly weed monitoring surveys within Moorebank Precinct East (MPE) operational facility at Moorebank Logistics Park. The MPE operational facility includes the following:

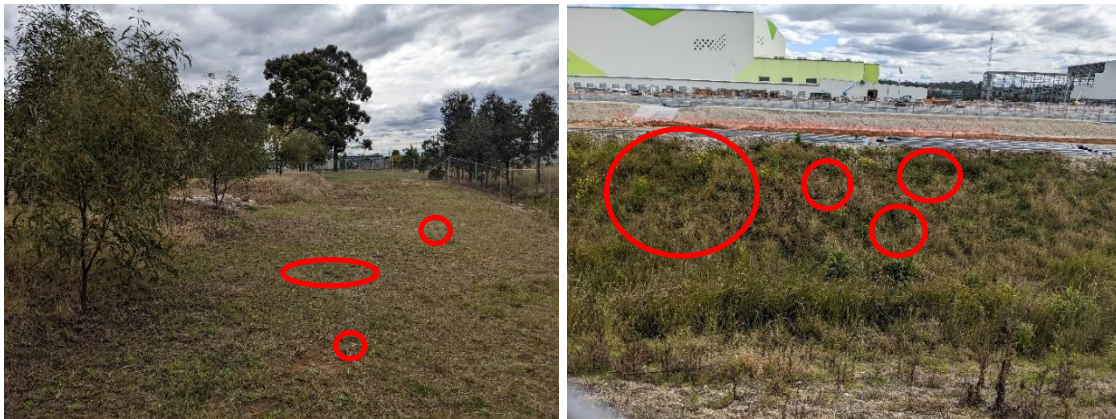
Weed cover has slightly increased within the MPE operational facility to what was recorded during the July 2022 surveys. While weed cover remains low, the current survey identified new instances of priority weed *Senecio madagascariensis* (Fireweed) (Plate 1). No signs of weed control works (chipping or herbicide spraying of weeds) were observed at the northeastern extent of the facility surrounding drainage basins and swales.

Plate 1. New observations of Fireweed in drainage basins

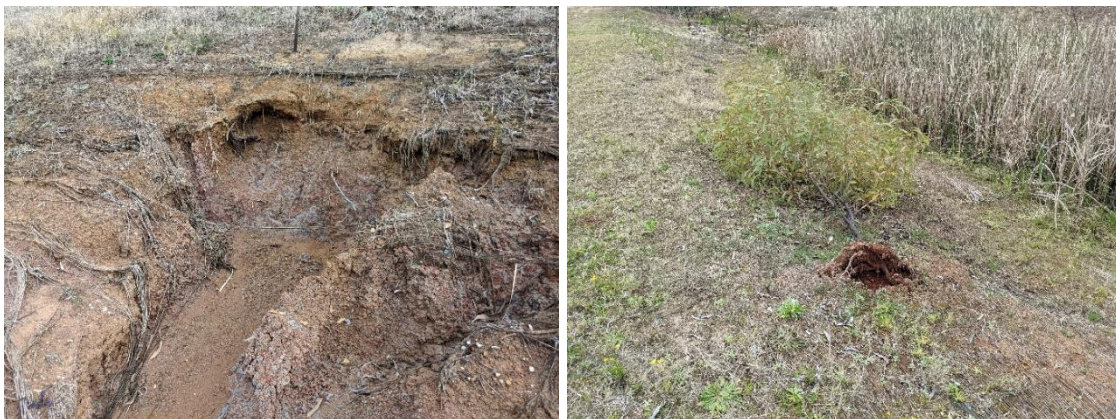
Due to high rainfall across the Sydney region in June and July 2022, instances of erosion and damage to native species *Acacia falcata* (Hickory Wattle) were observed (Plate 2), as highlighted in the July 2022 report. Since the July surveys there has been no management action undertaken to remedy this damage. Several native species are present and continue to grow on soft batters and in the drainage swale, including Hickory Wattle, *Typha orientalis* (Bulrush), *Persicaria decipiens* (Slender Knotweed), *Ficinia nodosa* (Knotted Club-rush) and *Lomandra longifolia* (Mat Rush).

Plate 2. Observation of native plant damage and erosion in drainage basins. Observations were also present in the July 2022 survey.

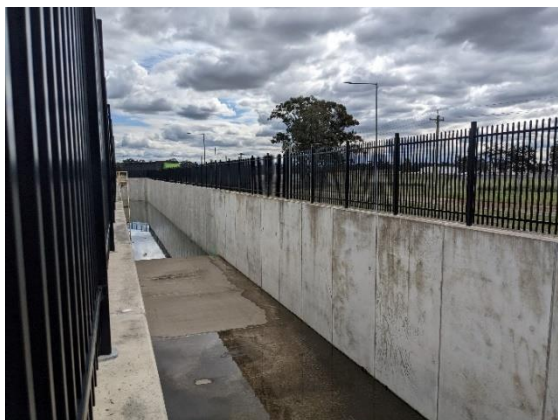
No plant growth was observed in the trunk drainage systems at the northernmost point of MPE (Plate 3). The absence of soil or other growing substrate will likely mean a continued lack of vegetation in this area.

Plate 3 Northern drainage area of MPE with lack of any plant growth

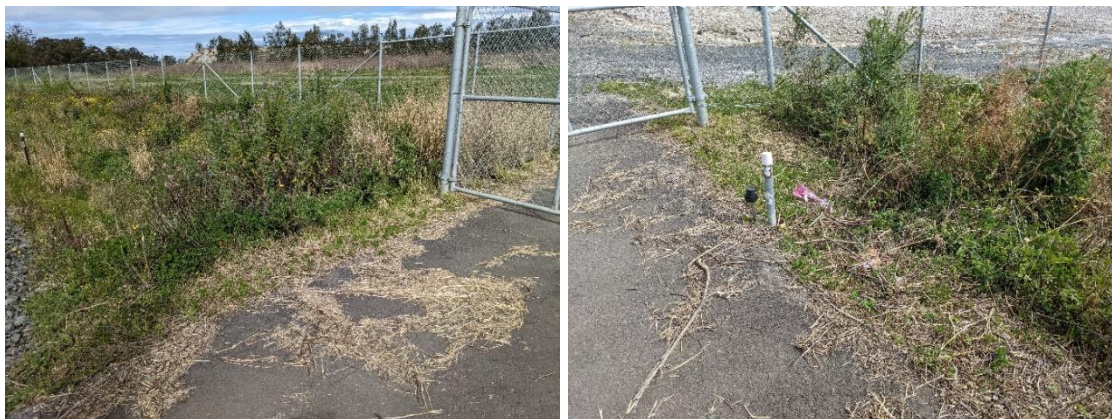
No evidence of recent targeted weed control works was observed along the extent of the Rail Link since targeted slashing of herbaceous weeds (Fleabane) was undertaken between the December 2021 and April 2022 inspection. However, some slashing appears to have been conducted on either side of a gate located along the western side of the rail link corridor (Plate 4) which appears to aid access rather than targeting weed species in this area.

Plate 4 Evidence of slashing at the western side of the rail link corridor

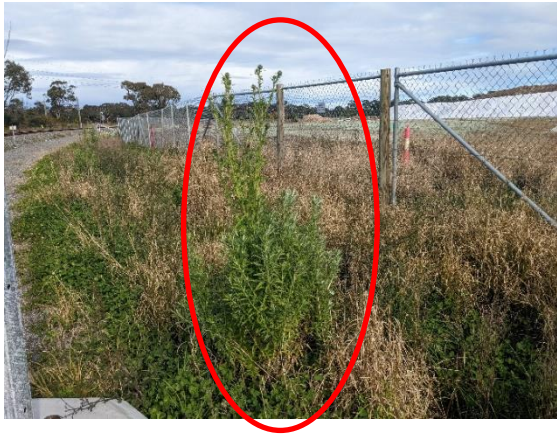
Most areas of soft batter on either side of the rail link displayed increases in exotic biomass since the previous inspection during the July 2022 survey. Notable increases were observed in the height of *Cirsium vulgare* (Spear Thistle), where there are instances of thistles up to 2 meters (Plate 5). An increase in priority and key weed species, including Fireweed, *Chloris gayana* (Rhodes Grass) and *Themeda quadrivalvis* (Grader Grass) was observed along the entire Rail Link. It is likely that recent climatic variables, including the combination of high rainfall and sunny days, in addition to the lack of weed management, have created favourable conditions for herbaceous and grass weeds to thrive. As the weather warms heading into spring, there are expected to be many emergent weed species.

Plate 5 Spear Thistle approaching two meters in height

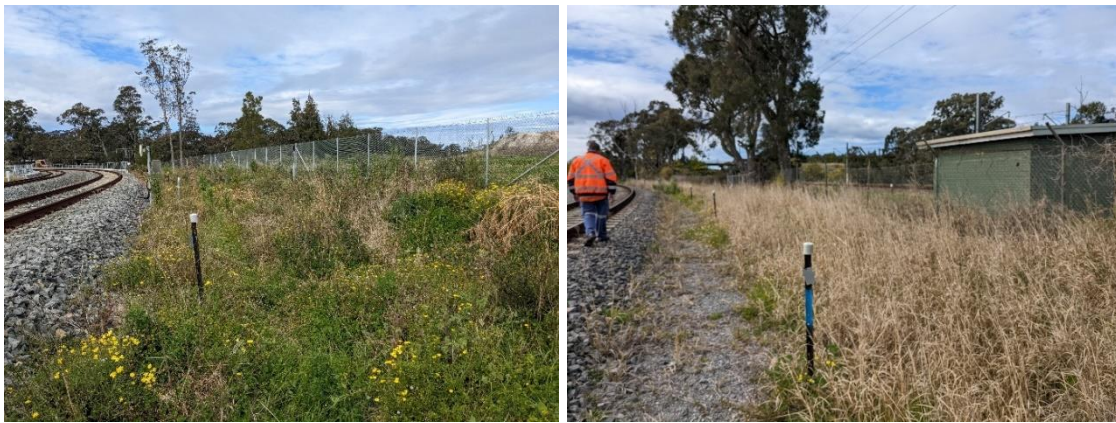
Plate 6. Exotic species, Rhodes Grass and Fireweed continue colonising remediating soft batters within the Rail Link corridor

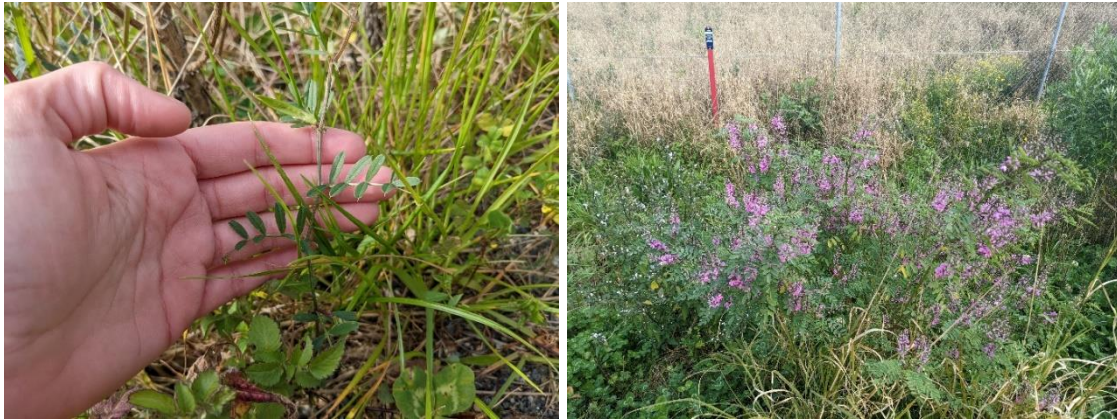
Some hardier native seedlings, such as Hickory Wattle and *Indigofera australis* (Australia Indigo), were observed to be growing unimpeded by increasing weed cover (Plate 7). The juvenile vine-like growth form of Australia Indigo allows for growth in the spaces between weed biomass (Plate 7). During the August 2022 survey, Australian Indigo was observed to be flourishing with many new and established instances of the species. The flowering of Australian Indigo was observed and occurring due to the warming temperatures heading into spring (Plate 7).

Plate 7 *Australia indigo* juvenile (left) and in flower (right) observed to be growing despite an increase in exotic biomass

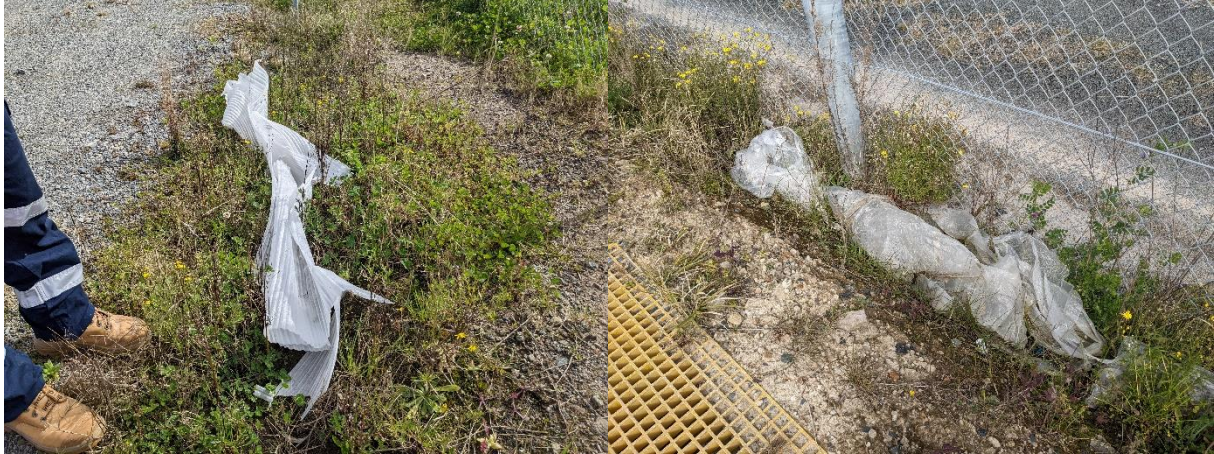
An increased amount of litter was again observed within the rail corridor and in adjacent areas at the western extent of the Qube Rail Link nearest Glenfield waste facility. Litter was observed within native and exotic vegetation and blocking drainage infrastructure within the rail corridor and the Georges River (Plate 8).

Plate 8. Litter observed within the rail corridor during the August inspection

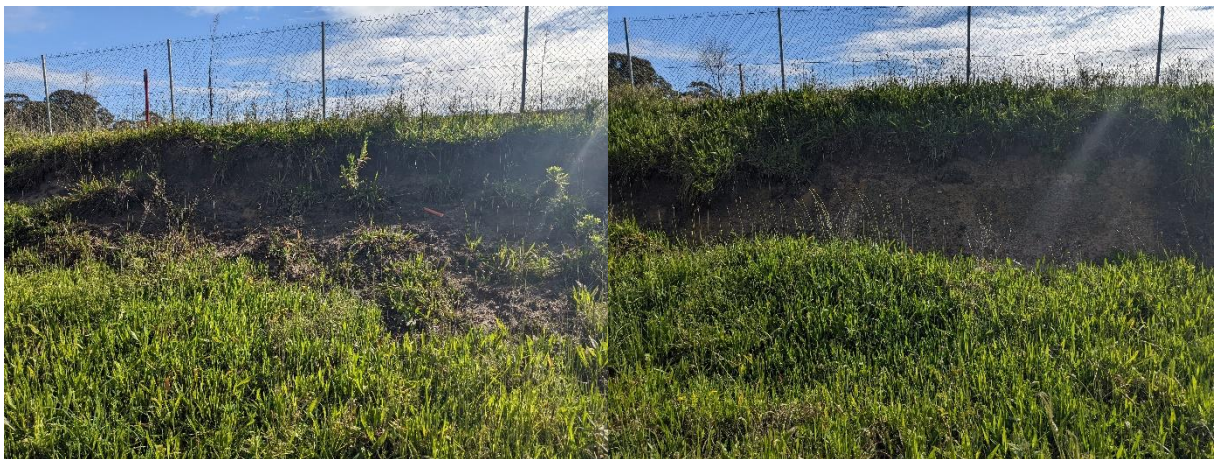
High rainfall events between April and July 2022 resulted in the slipping of remediated soft batters within the Rail Link corridor, as observed in the July 2022 survey (Plate 9). The location of the areas where batter slipping was observed is presented in Figure 6. During the August 2022 survey, no evidence of erosion control or management has been put in place. *Plantago lanceolata* (Lambs tongue) was observed recruiting in bare soil exposed by slippage. It is recommended that native deep rooted grasses and shrubs be installed along these batter to increase batter stability into the future.

Plate 9. Batter slumping observed within the Rail Link

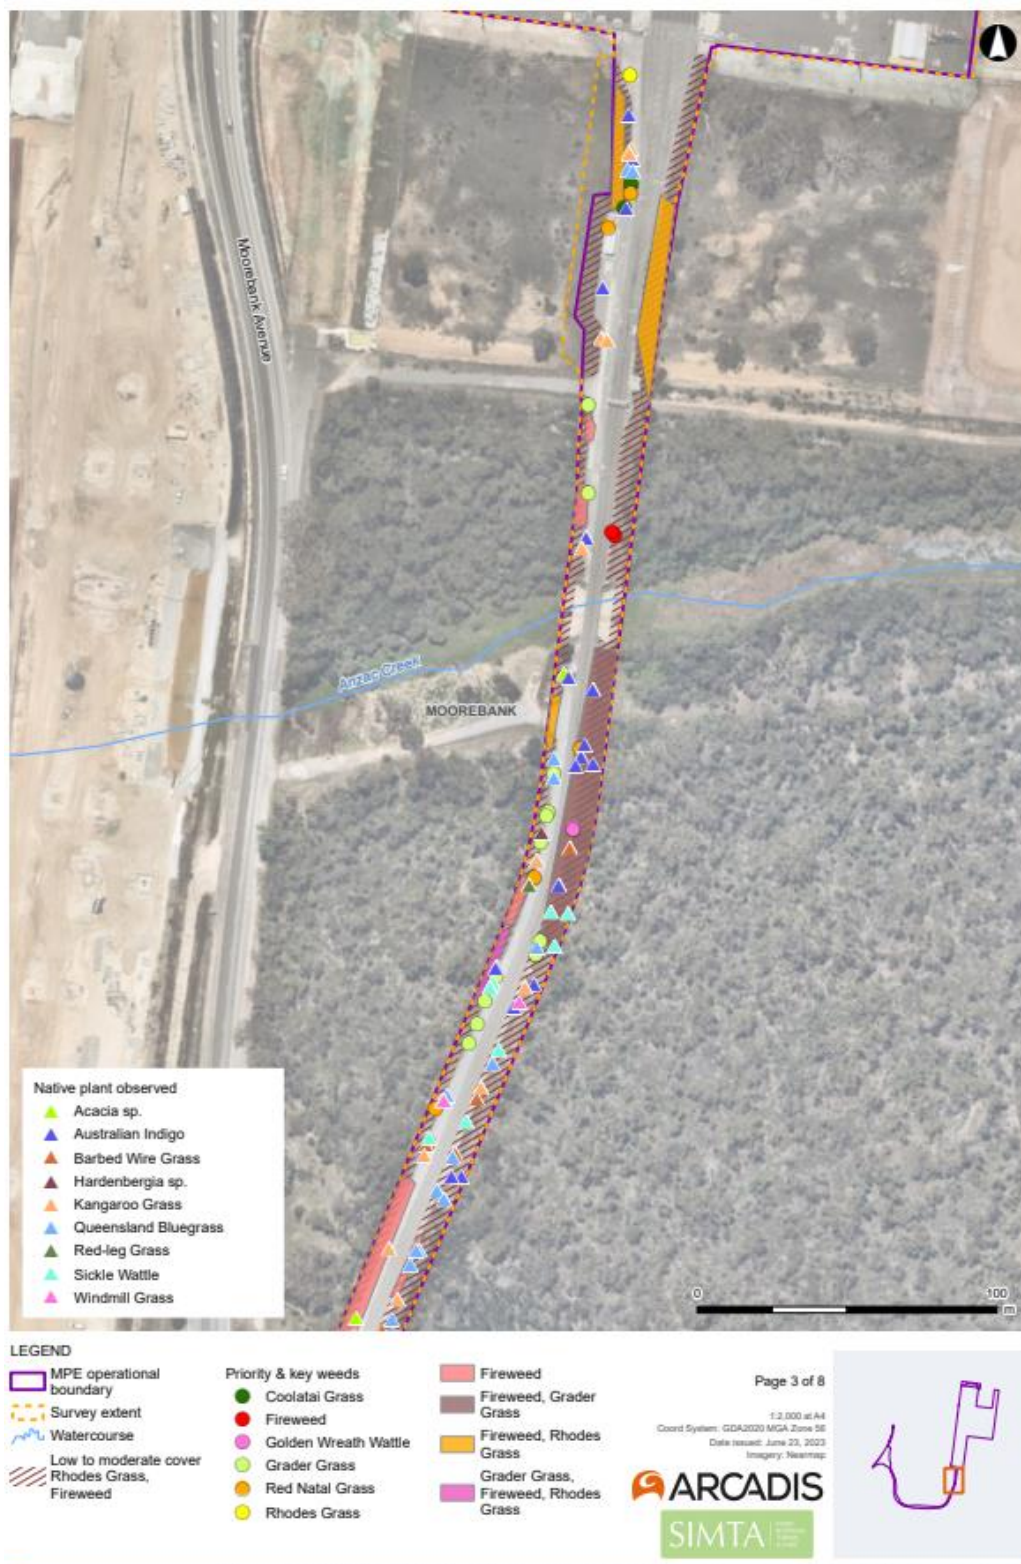
Figure 4. Native species, weed covers and aggressive weeds identified across the MPE operational facility. The coloured areas under the "Priority & key weeds" legend area areas that have high-density weeds (Map 3 of 8)

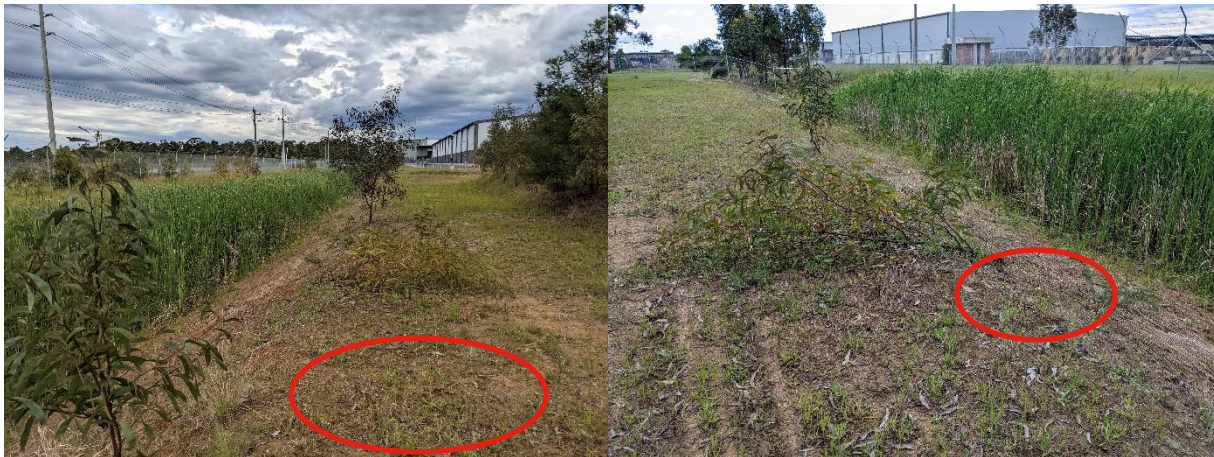
Weed cover has slightly increased within the MPE operational facility to what was recorded during the August 2022 surveys. While weed cover remains low, the current survey identified new instances of priority weed *Senecio madagascariensis* (Fireweed) (Plate 1). No signs of weed control works (chipping or herbicide spraying of weeds) were observed at the northeastern extent of the facility surrounding drainage basins and swales.

Plate 1. New observations of Fireweed and Catsear in drainage basins

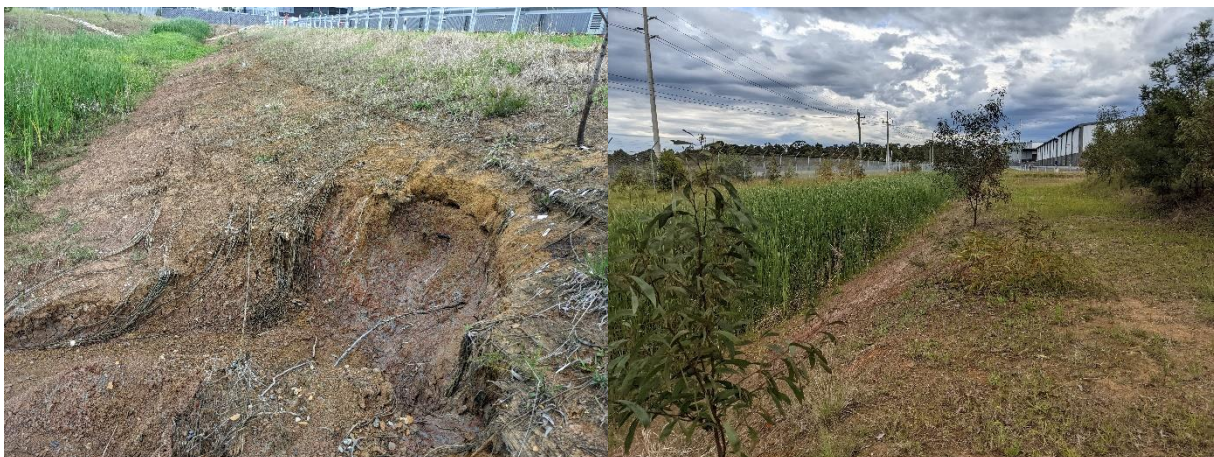
Due to high rainfall across the Sydney region in June and July 2022, instances of erosion and damage to native species *Acacia falcata* (Hickory Wattle) were observed (Plate 2), as highlighted in the August 2022 report. Since the August surveys, no management action has been undertaken to remedy this damage. Several native species are present and continue to grow on soft batters and in the drainage swale, including Hickory Wattle, *Typha orientalis* (Bulrush), *Persicaria decipiens* (Slender Knotweed), *Ficinia nodosa* (Knotted Club-rush) and *Lomandra longifolia* (Mat Rush).

Plate 2. Observation of native plant damage and erosion in drainage basins. Observations were also present in the August 2022 survey.

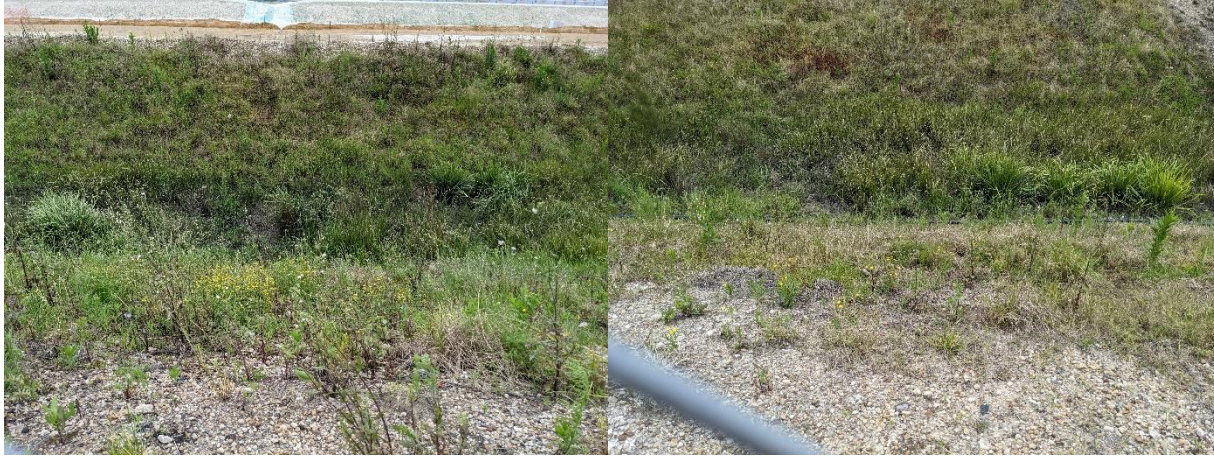
The soft batters of the northeast trunk drainage system have a low cover of exotic grasses, which are currently acting to stabilise the soil, with some native species, such as Hickory Wattle, persisting. Instances of Fireweed observed in the August 2022 survey persist in the current survey and appear to have increased biomass during the October 2022 survey (Plate 3).

Plate 3 Fireweed growing on soft batters of the northeast trunk drainage system.

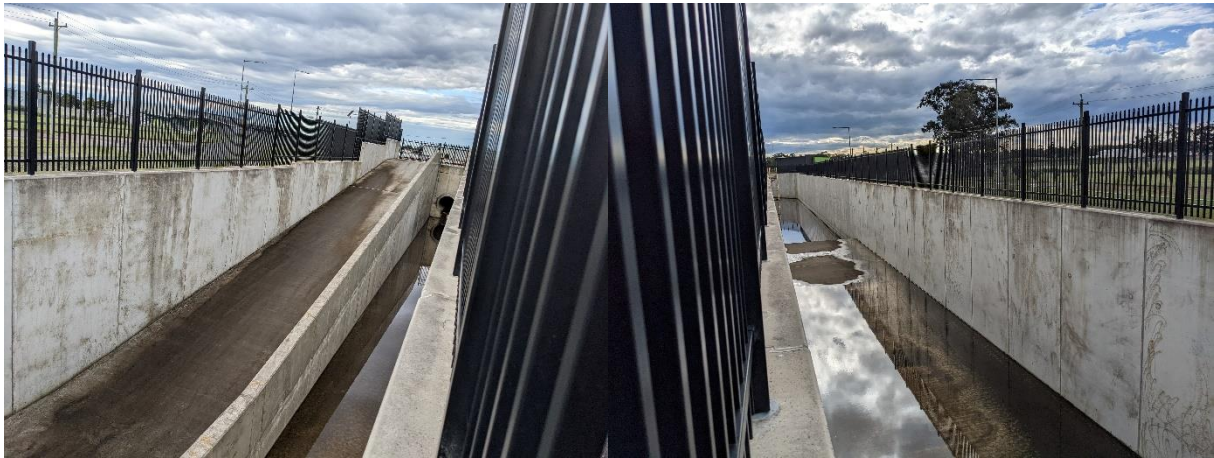
No plant growth was observed in the trunk drainage systems at the northernmost point of MPE (Plate 4). The absence of soil or other growing substrate will likely mean a continued lack of vegetation in this area.

Plate 4 Northern drainage area of MPE with lack of any plant growth

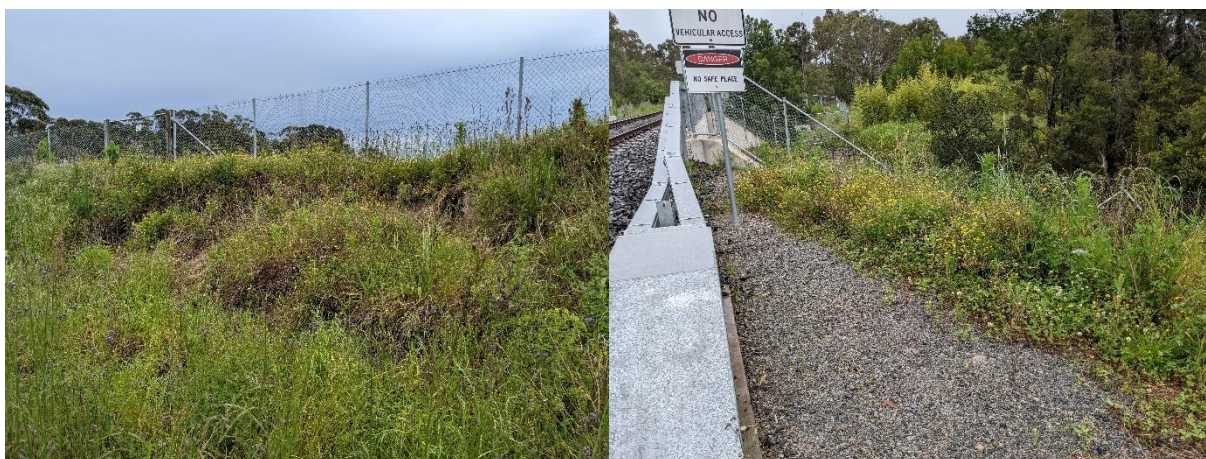
observed along the entire Rail Link (Plate 5). It is likely that recent climactic variables, including the combination of high rainfall and sunny days, in addition to the lack of weed management, have created favourable conditions for herbaceous and grass weeds to thrive. As the weather continues to warm during spring and summer, there are expected to be many emergent weed species and seeding of established weed species.

Plate 5. Exotic species, *Rhodes Grass* and *Fireweed*, continue colonising remediated soft batters within the Rail Link corridor

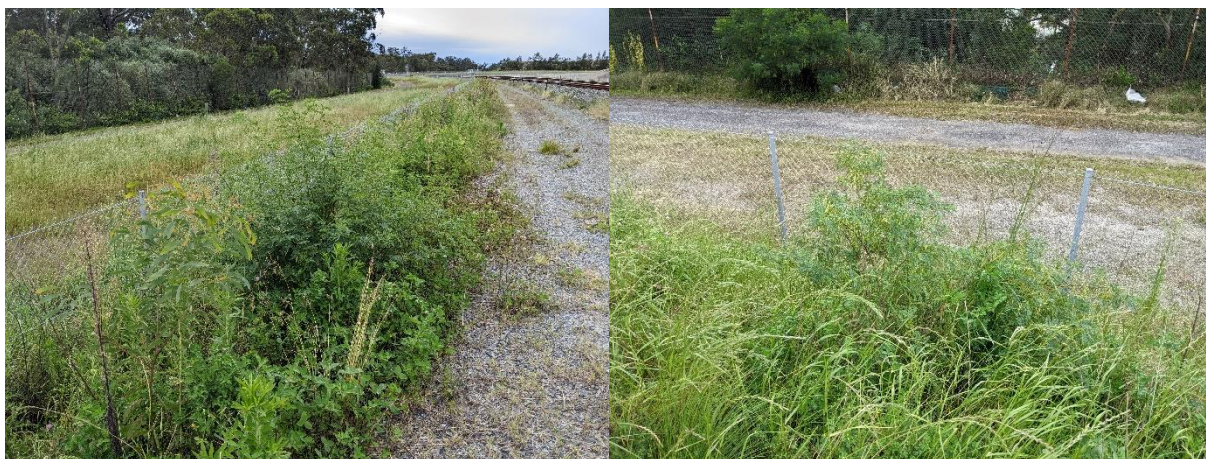
Some hardier native seedlings *Indigofera australis* (Australia Indigo), were observed to be growing unimpeded by increasing weed cover (Plate 6).

Plate 6 Australia indigo observed to be growing despite an increase in exotic biomass

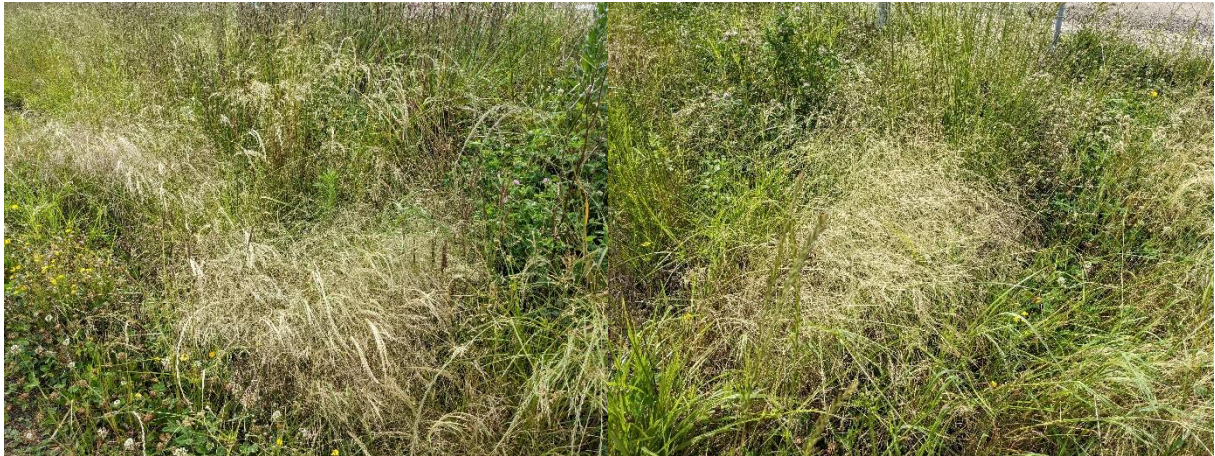
*Plate 7 Blown Grass growing in isolated strips among exotic grasses.*

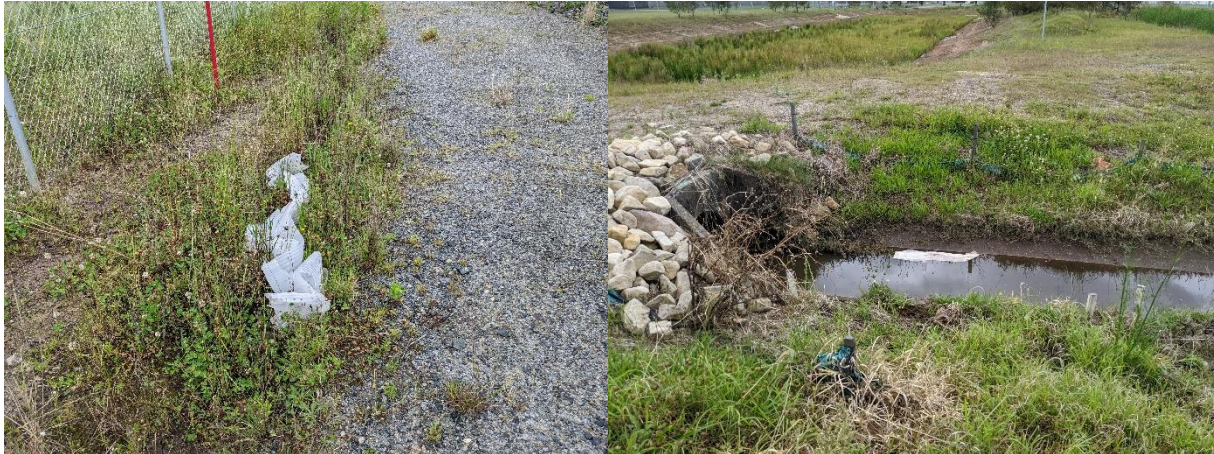
An increased amount of litter was observed within the rail corridor, IMEX, warehouses and drainage infrastructure and in adjacent areas at the western extent of the Qube Rail Link nearest Glenfield waste facility. Litter was observed within native and exotic vegetation, blocking drainage infrastructure within the rail corridor and the Georges River (Plate 8).

*Plate 8. Litter observed within the rail corridor and IMEX, warehouses and drainage infrastructure during the October inspection*

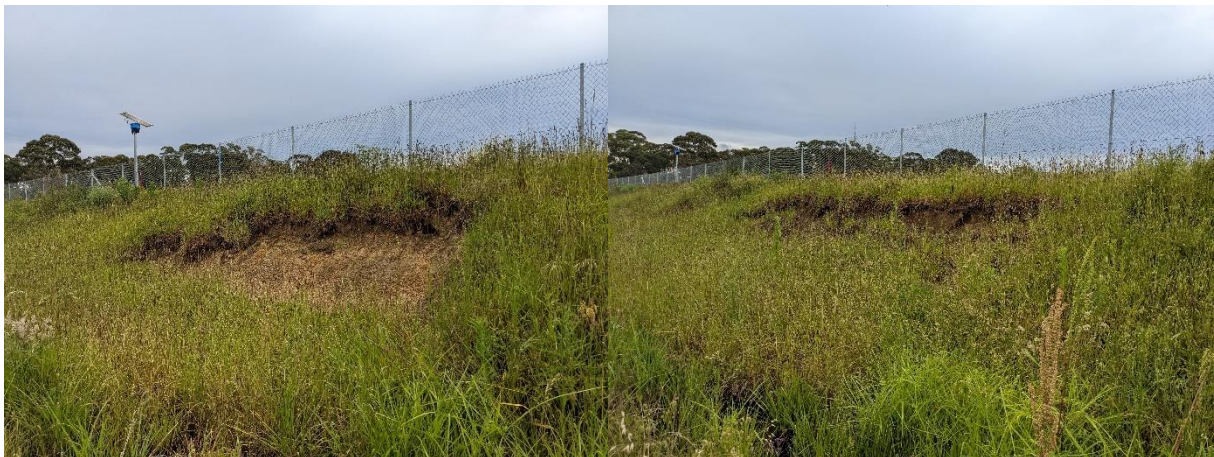
High rainfall events between April and July 2022 resulted in the slipping of remediated soft batters within the Rail Link corridor (Plate 9). The location of the areas where batter slipping was observed is presented in Figure 6. During the October 2022 survey, no evidence of erosion control or management was put in place. It is recommended that native deep rooted grasses and shrubs be installed along these batter to increase batter stability. *Plantago lanceolata* (Lamb's tongue) was observed recruiting in bare soil exposed by slippage. New instances of the exotic grass *Briza media* (Quaking-Grass) were observed growing around erosion sites.

*Plate 9. Batter slumping observed within the Rail Link*

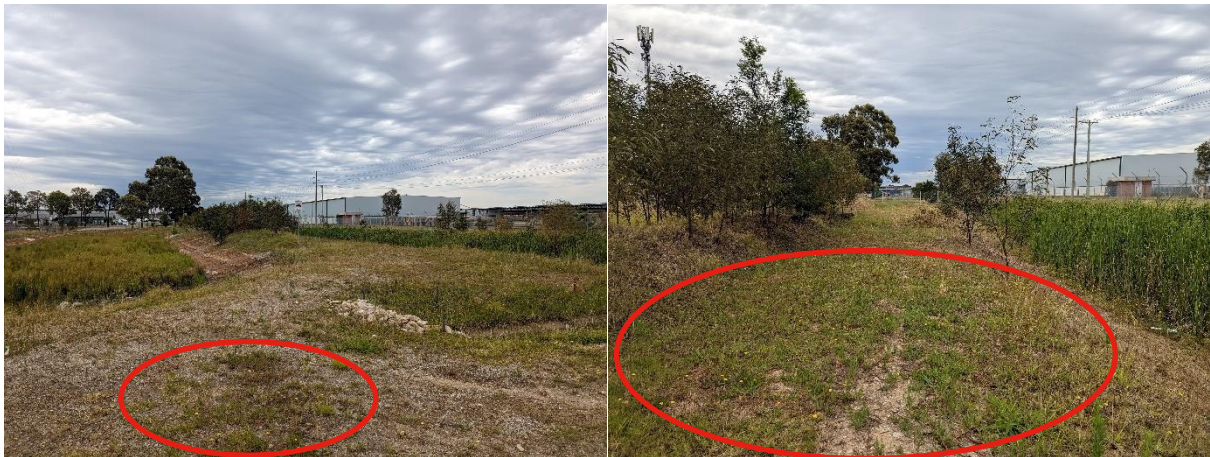
Plate 1. New observations of Fireweed and Catsear in drainage basins

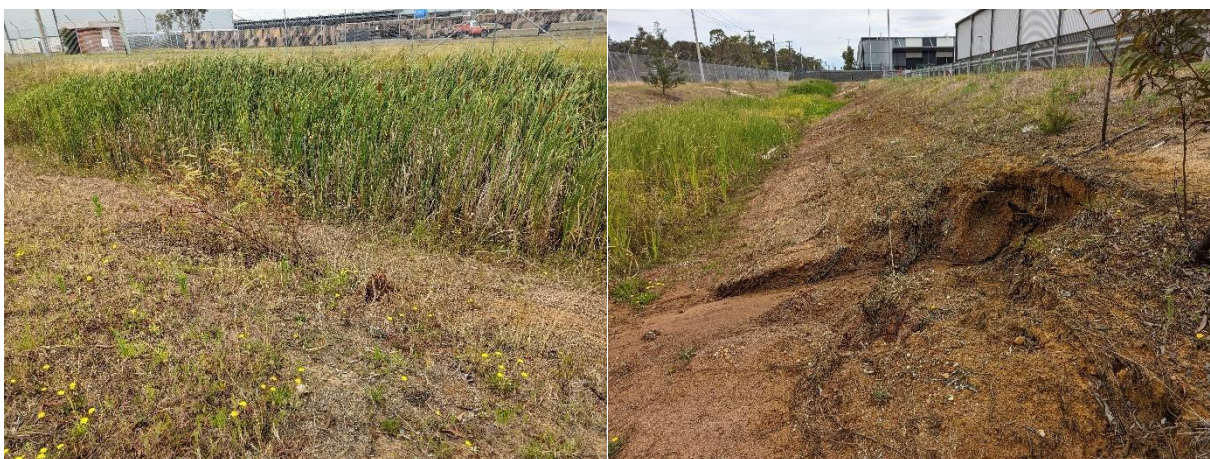
Plate 2. Observation of native plant damage and erosion in drainage basins.

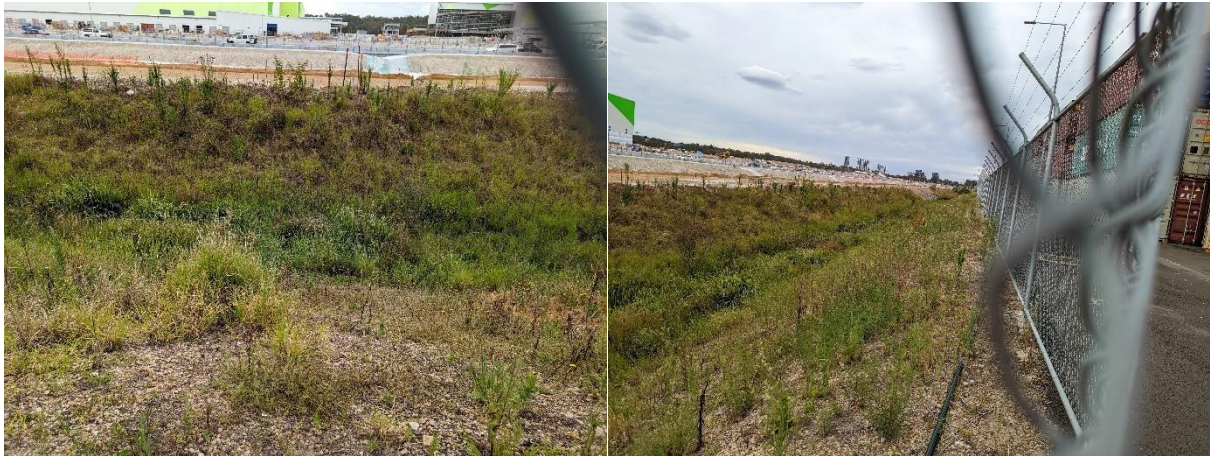
*Plate 3 Fireweed, Flee Bane and Rhodes grass growing on soft batters of the northeast trunk drainage system.*

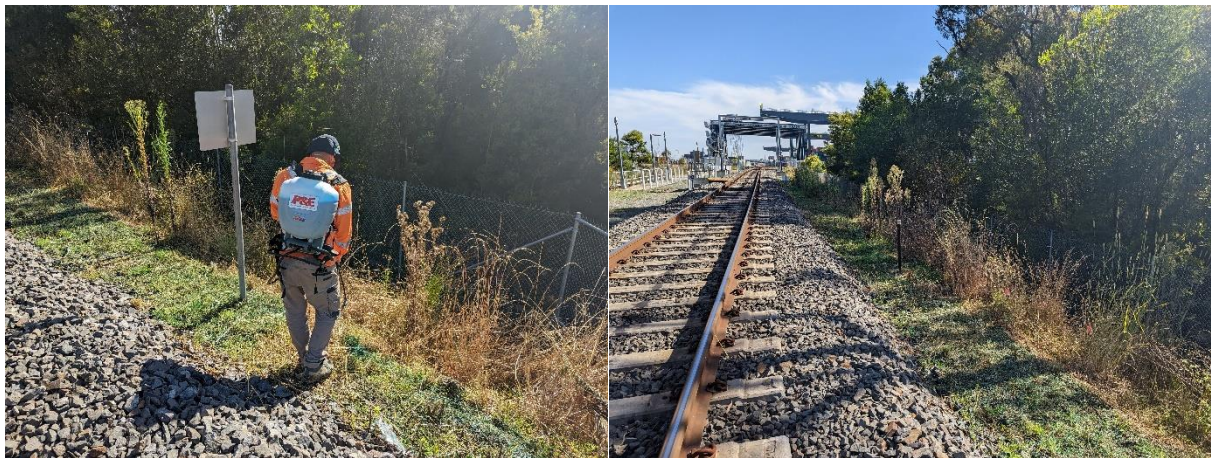
Plate 5 P&E Group personnel applying herbicide (Roundup) on gravel area following trimming

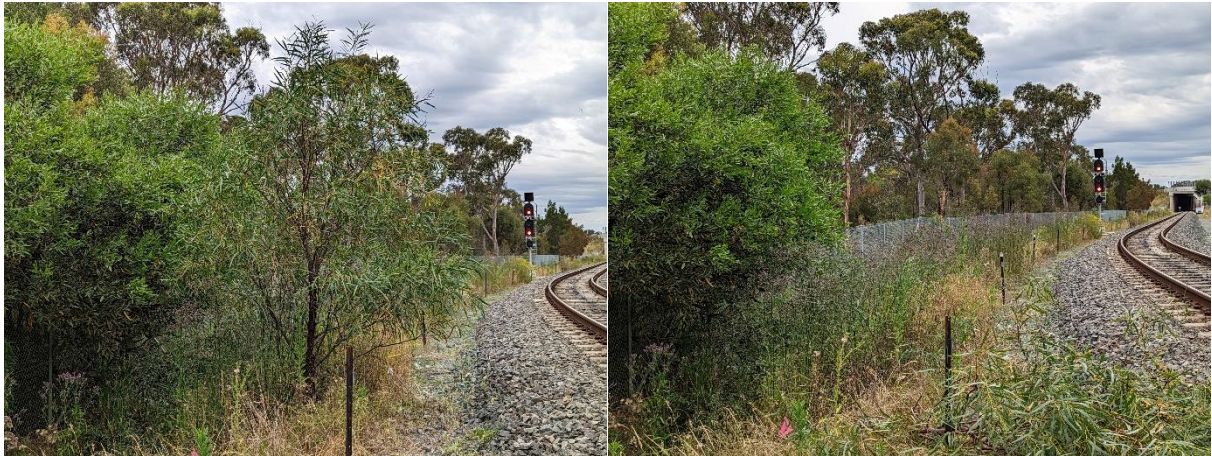
One large Golden Wreath wattle, considered a weed species, was from the soft batter due to its presence obstructing the view of traffic signals (Plate 9). Other instances of larger woody vegetation were removed from the gravel and ballast areas as they were encroaching on the rail line. Instances of excessive vegetation overhang from adjacent BioBank areas were trimmed back to the fenceline by P&E Services under the supervision of Arcadis Ecologists Thea Kane and Kate Mauger (Plate 10). Future works to include weed remediation works along soft batters of RALP are planned throughout 2023.

*Plate 6 Instance of Golden Wreath Wattle removal due to location of tree impeding vision of traffic signal*

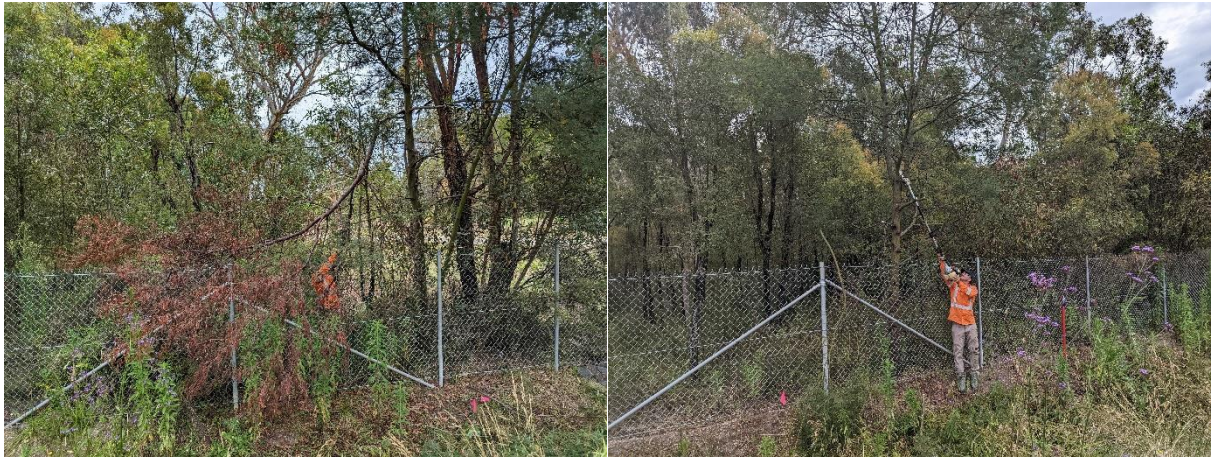
*Plate 7 Instance of tree branch removal encroaching from biobank site.*

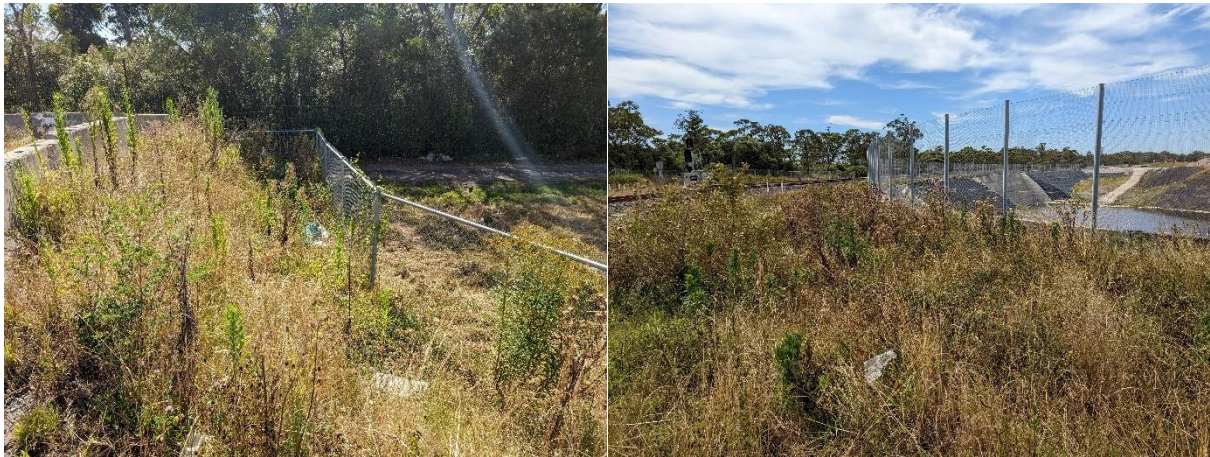
Plate 8. Exotic species continue colonising remediated soft batters within the Rail Link corridor

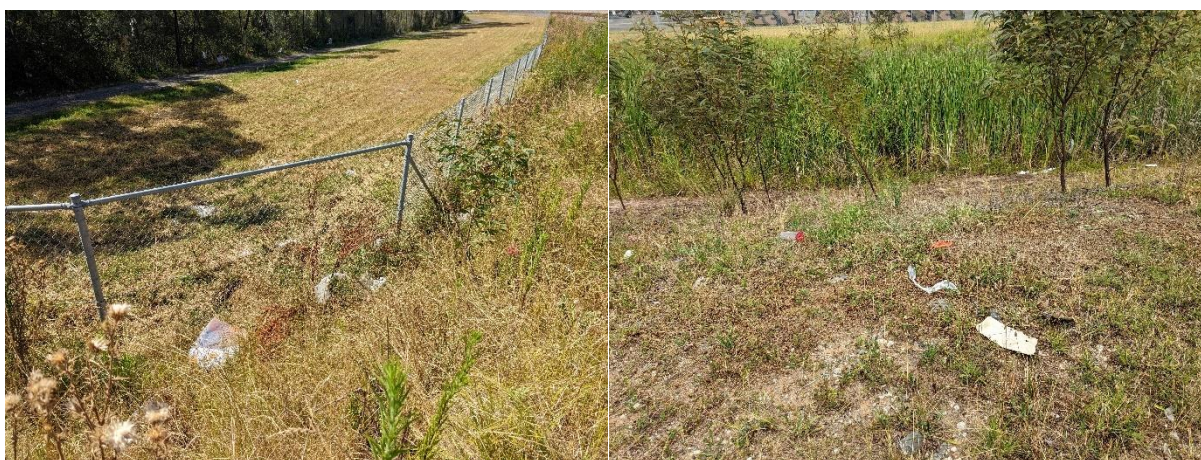
Plate 9. Litter observed within the rail corridor and IMEX, warehouses and drainage infrastructure during the December inspection

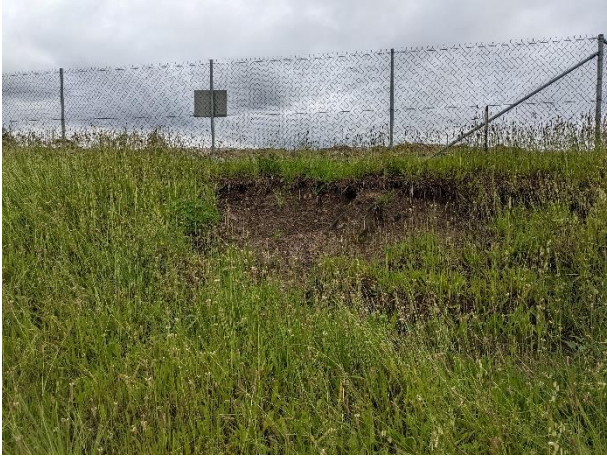
*Plate 10 Batter slumping observed within the Rail Link*

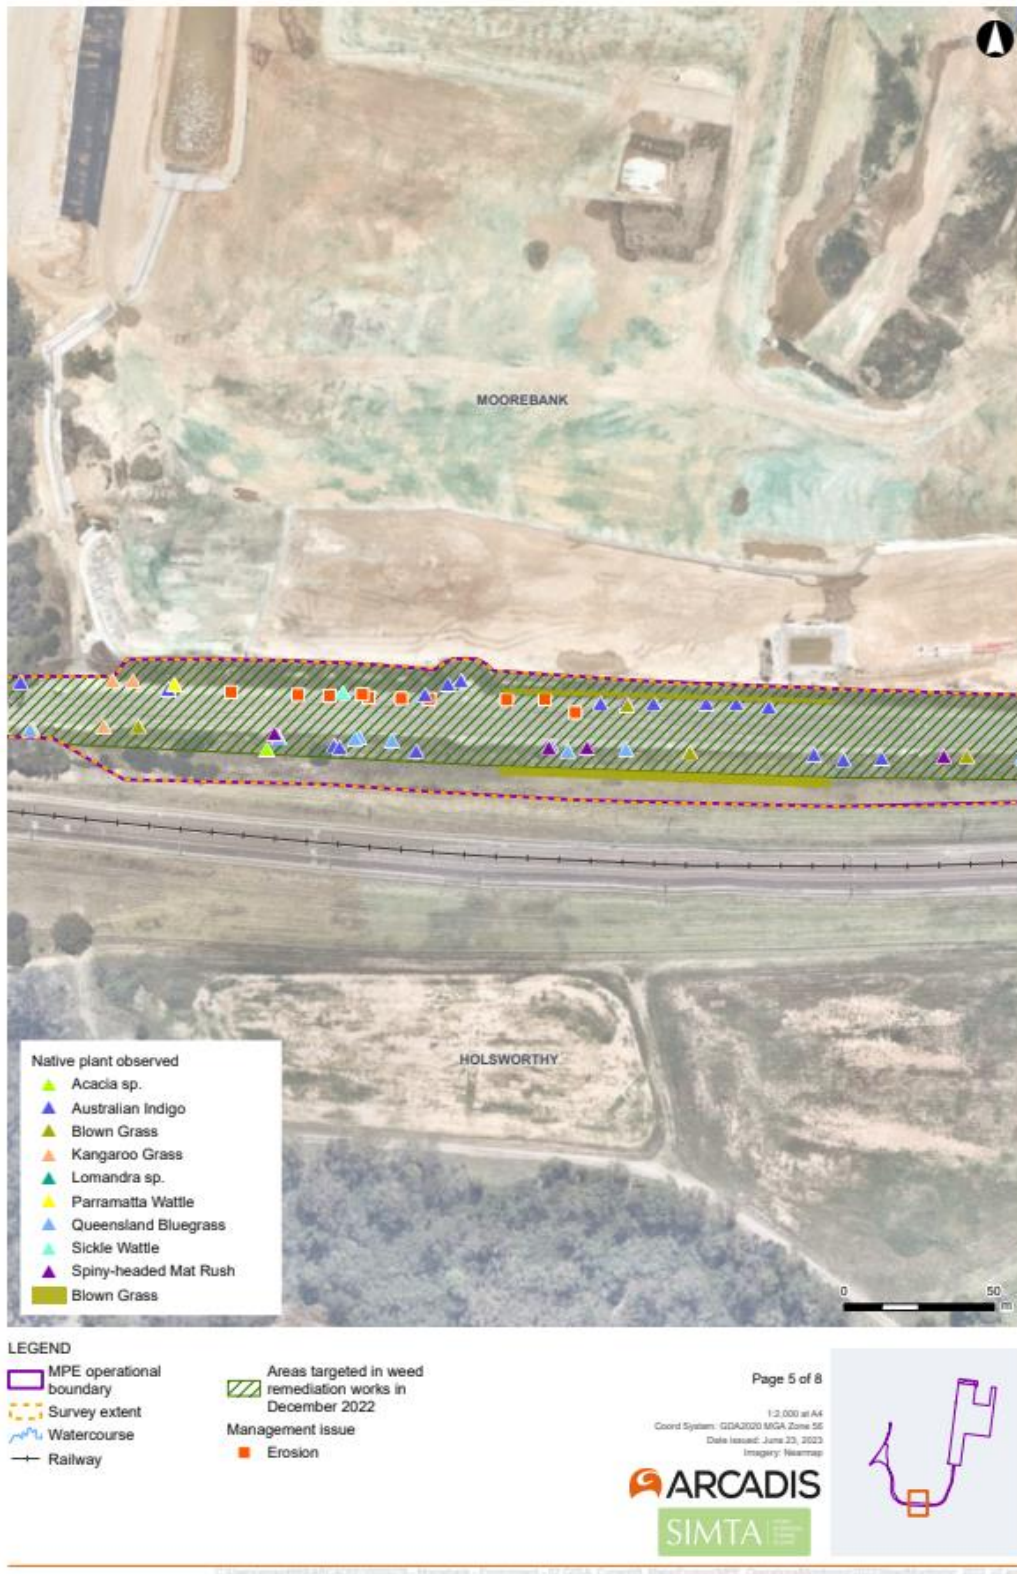
Figure 6. Native plant, weed covers and aggressive weeds identified across the MPE operational facility (Map 5 of 8)

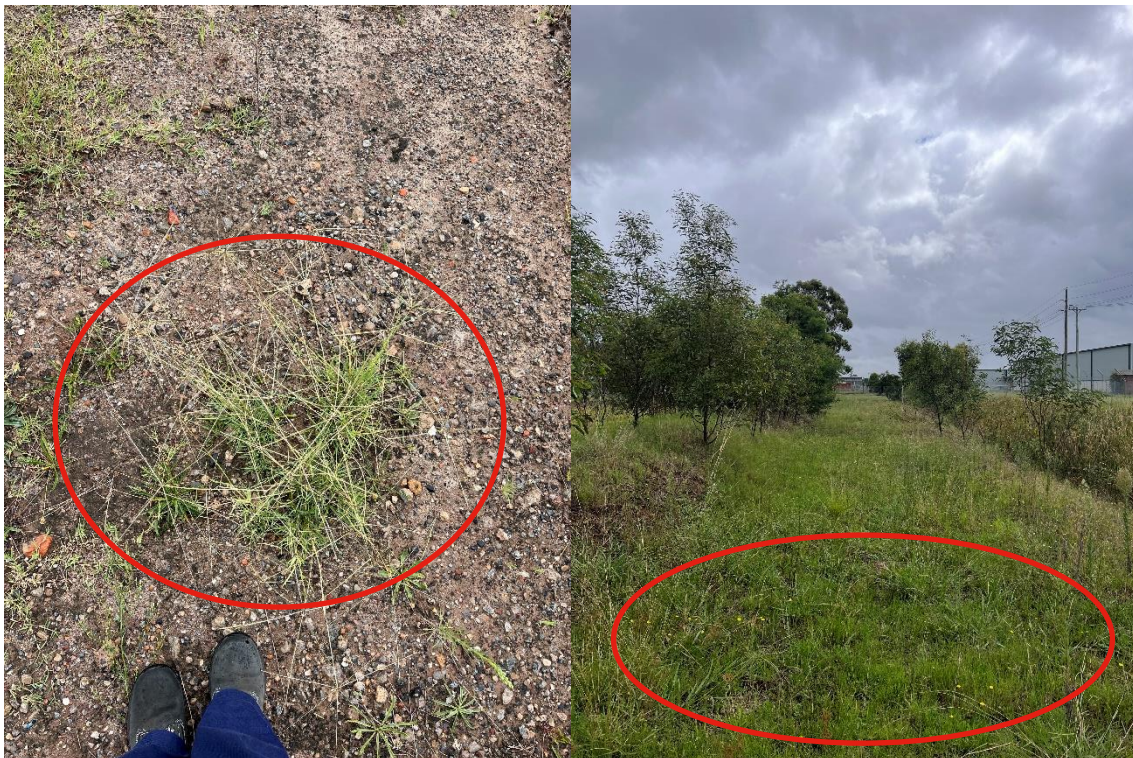
Plate 1. New observations of Windmill Grass (left) and Fireweed (right) in drainage basins

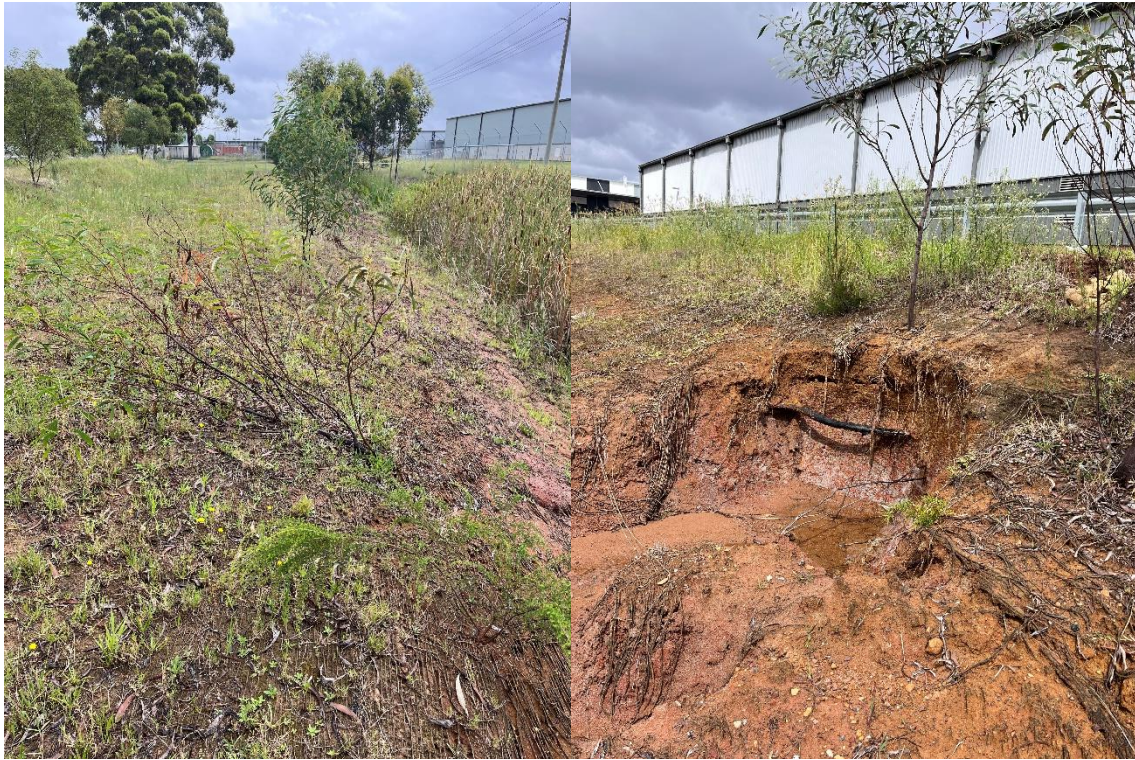
*Plate 2. Observation of native plant damage and erosion in drainage basins.*

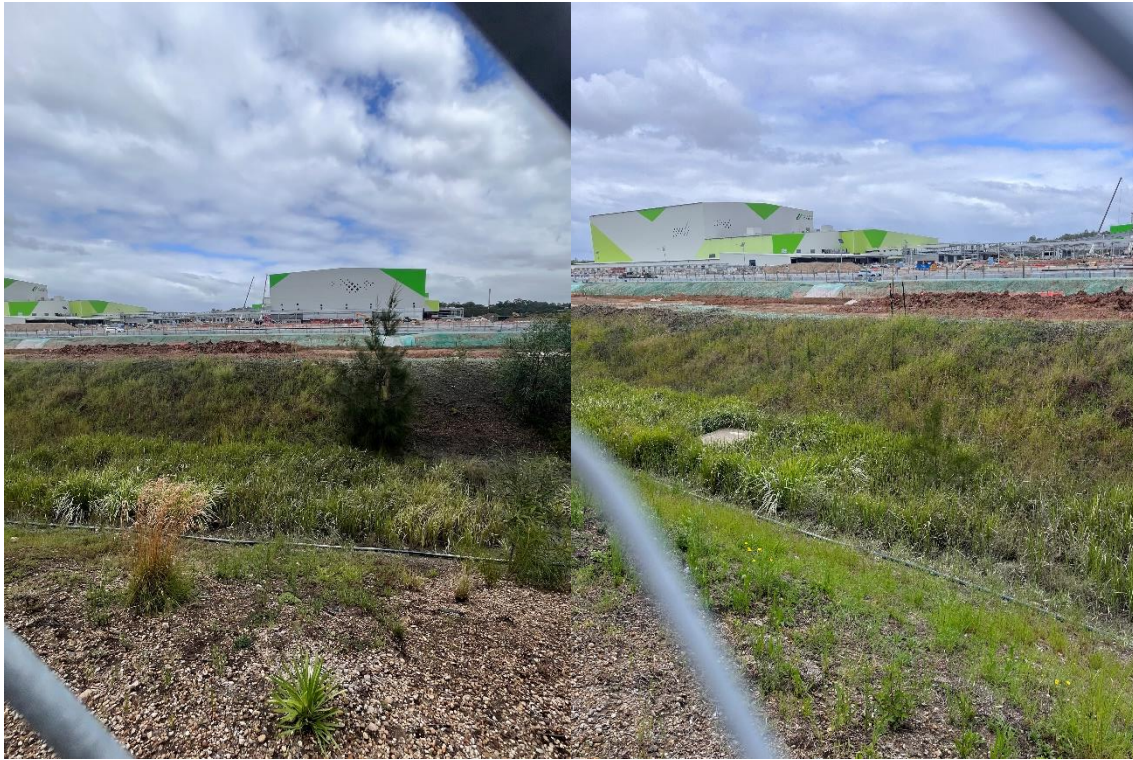
*Plate 3 Fireweed, Grader Grass and Rhodes Grass growing on soft batters of the northeast trunk drainage system.*
