**Date** 13/09/2022  
**To** [REDACTED]  
**From** [REDACTED]  
**Copy to** [REDACTED]  
**Subject** MPE operational facility – Weed monitoring report August 2022

## Introduction

Arcadis has been commissioned to conduct bi-monthly weed monitoring surveys within Moorebank Precinct East (MPE) operational facility at Moorebank Logistics Park. The MPE operational facility includes the following:

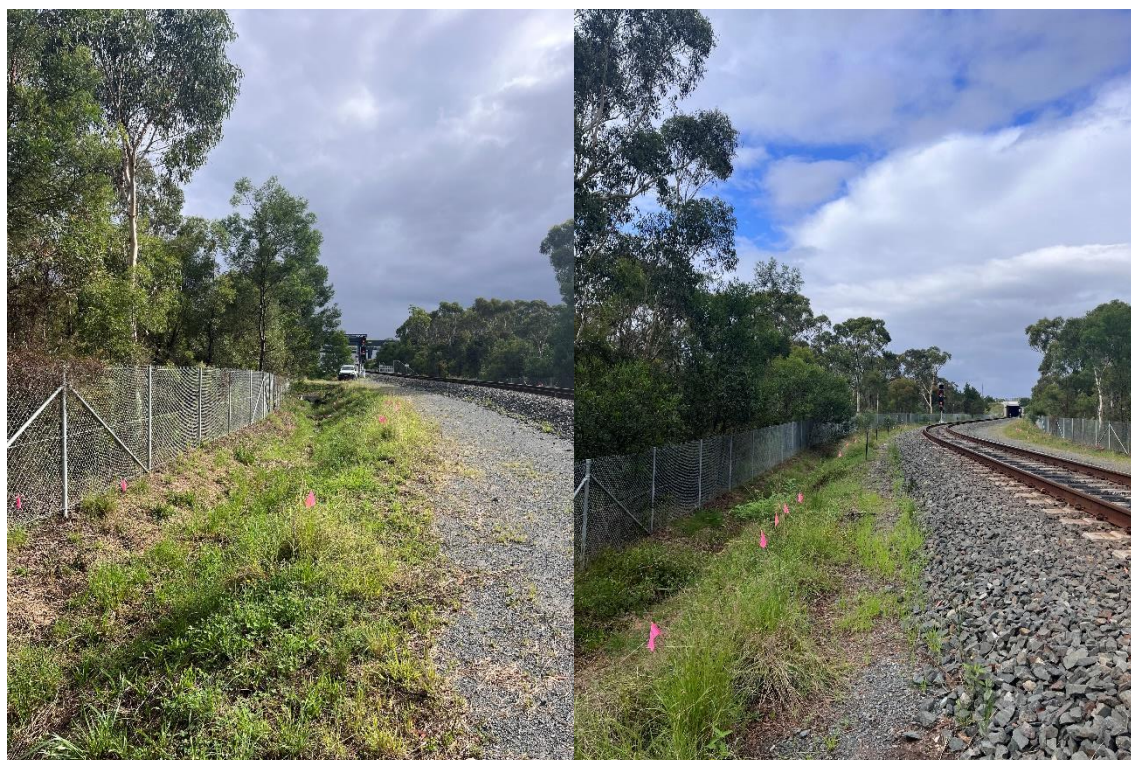
The areas flagged off by ecologists to mark the location of native species have been avoided by the weed remediation team (Plate 5). The decreased competition for the native species due to the remediation works removing the weed biomass will allow the native species to produce more biomass, facilitate seed growth and open space for native recruitment. The increased native biomass will eventually act as effective competition, preventing weed recruitment, limiting dependence on herbicides and slashing. However, the continued human intervention must be maintained in order to reach a point where native species restrict weed recruitment.

*Plate 5 Pink flagging tape marking the location of native species to be retained during the remediation works.*

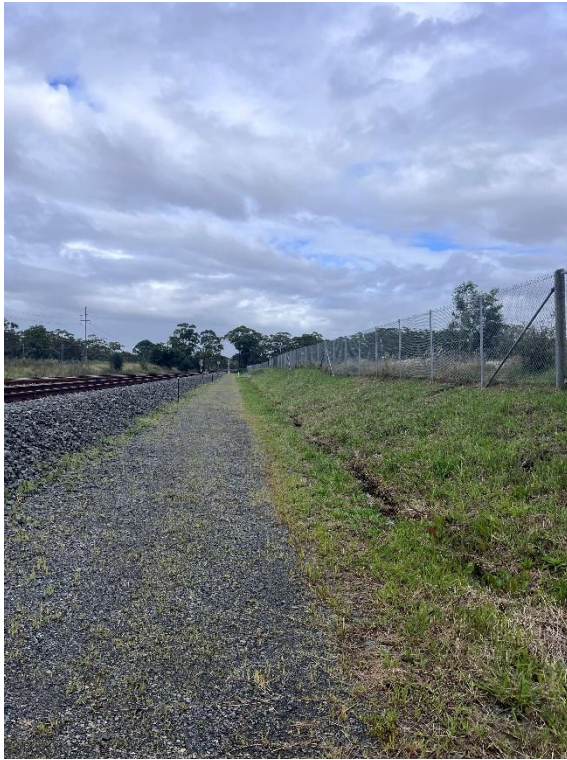
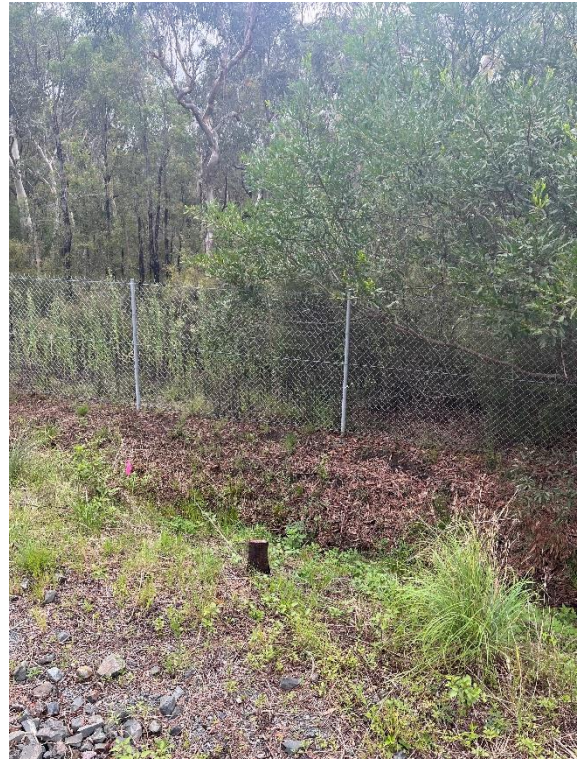
Plate 6 Evidence of continued weed removal (left) and tree removal (right) remediation works as of February 2023.

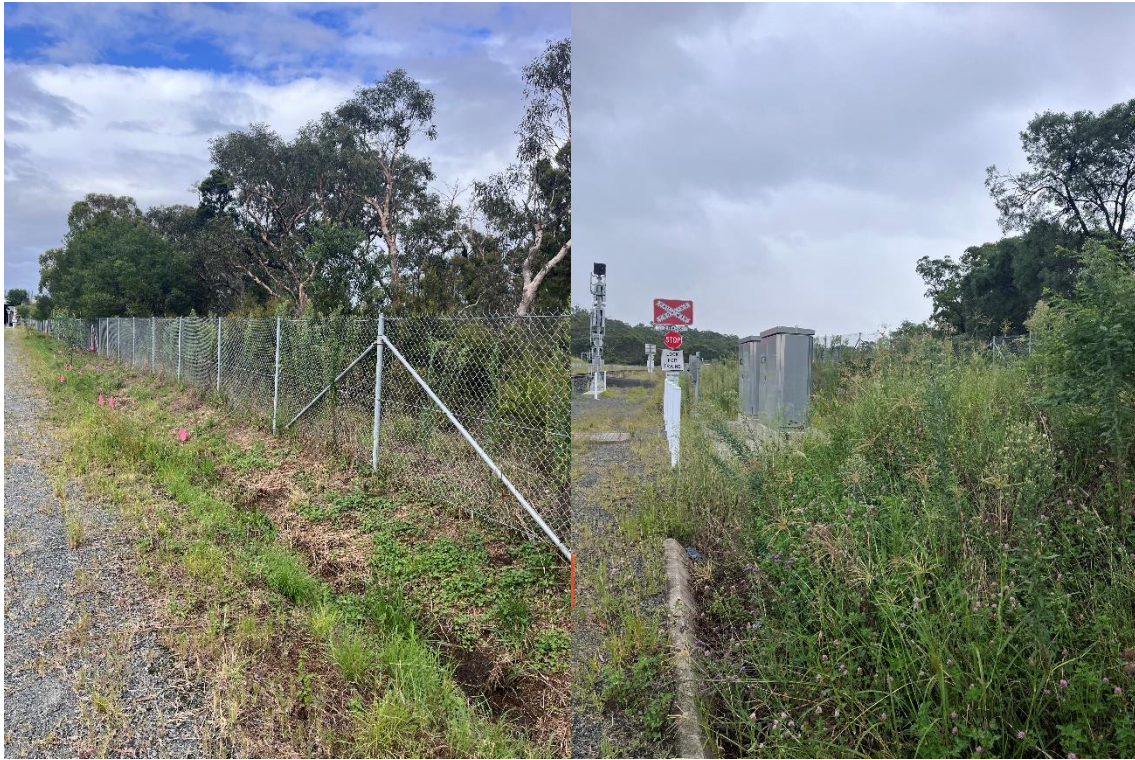
Plate 7. Exotic species continue to colonise remediated soft batters within the Rail Link corridor (right)

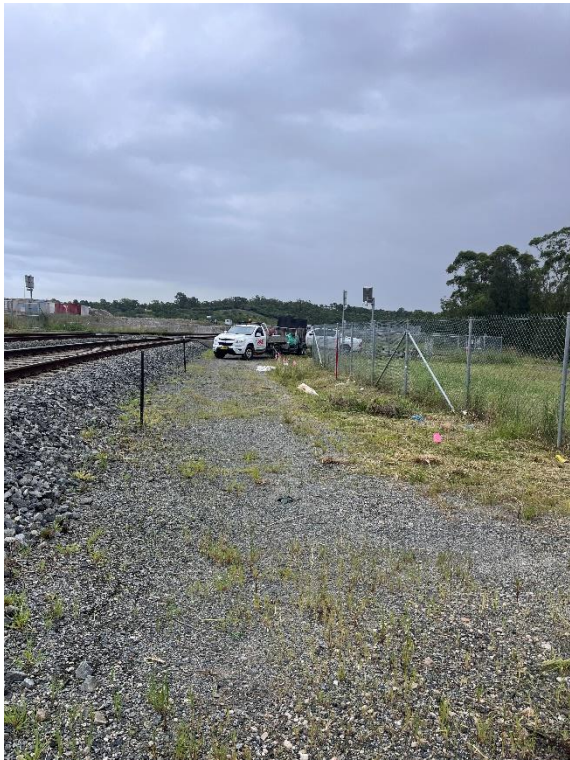
*Plate 8. Litter observed within the rail corridor during the February inspection*

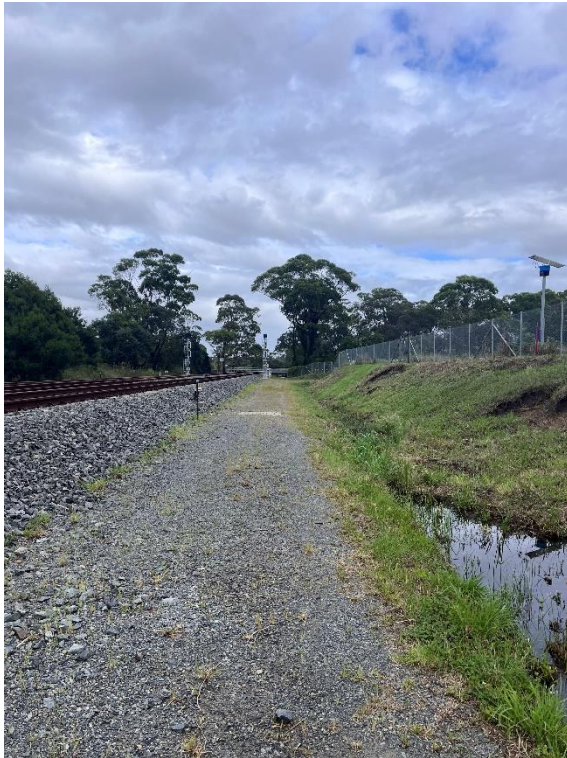
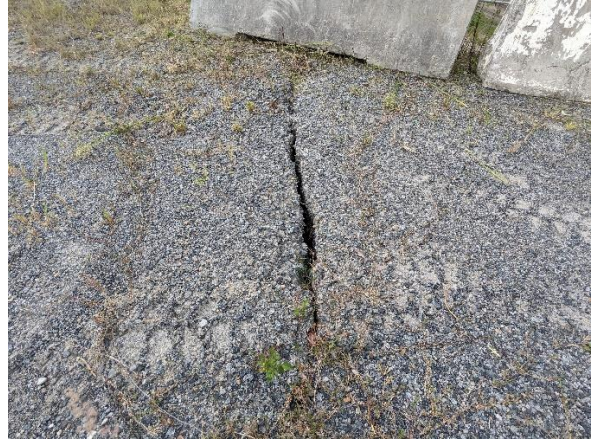
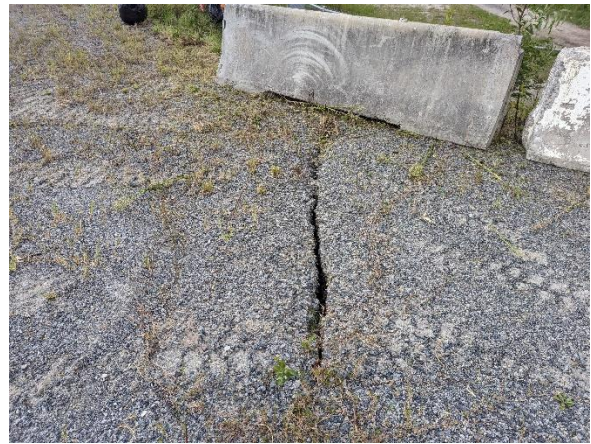
*Plate 9 Batter slumping observed within the Rail Link (left) and concrete platform cracking (right)*

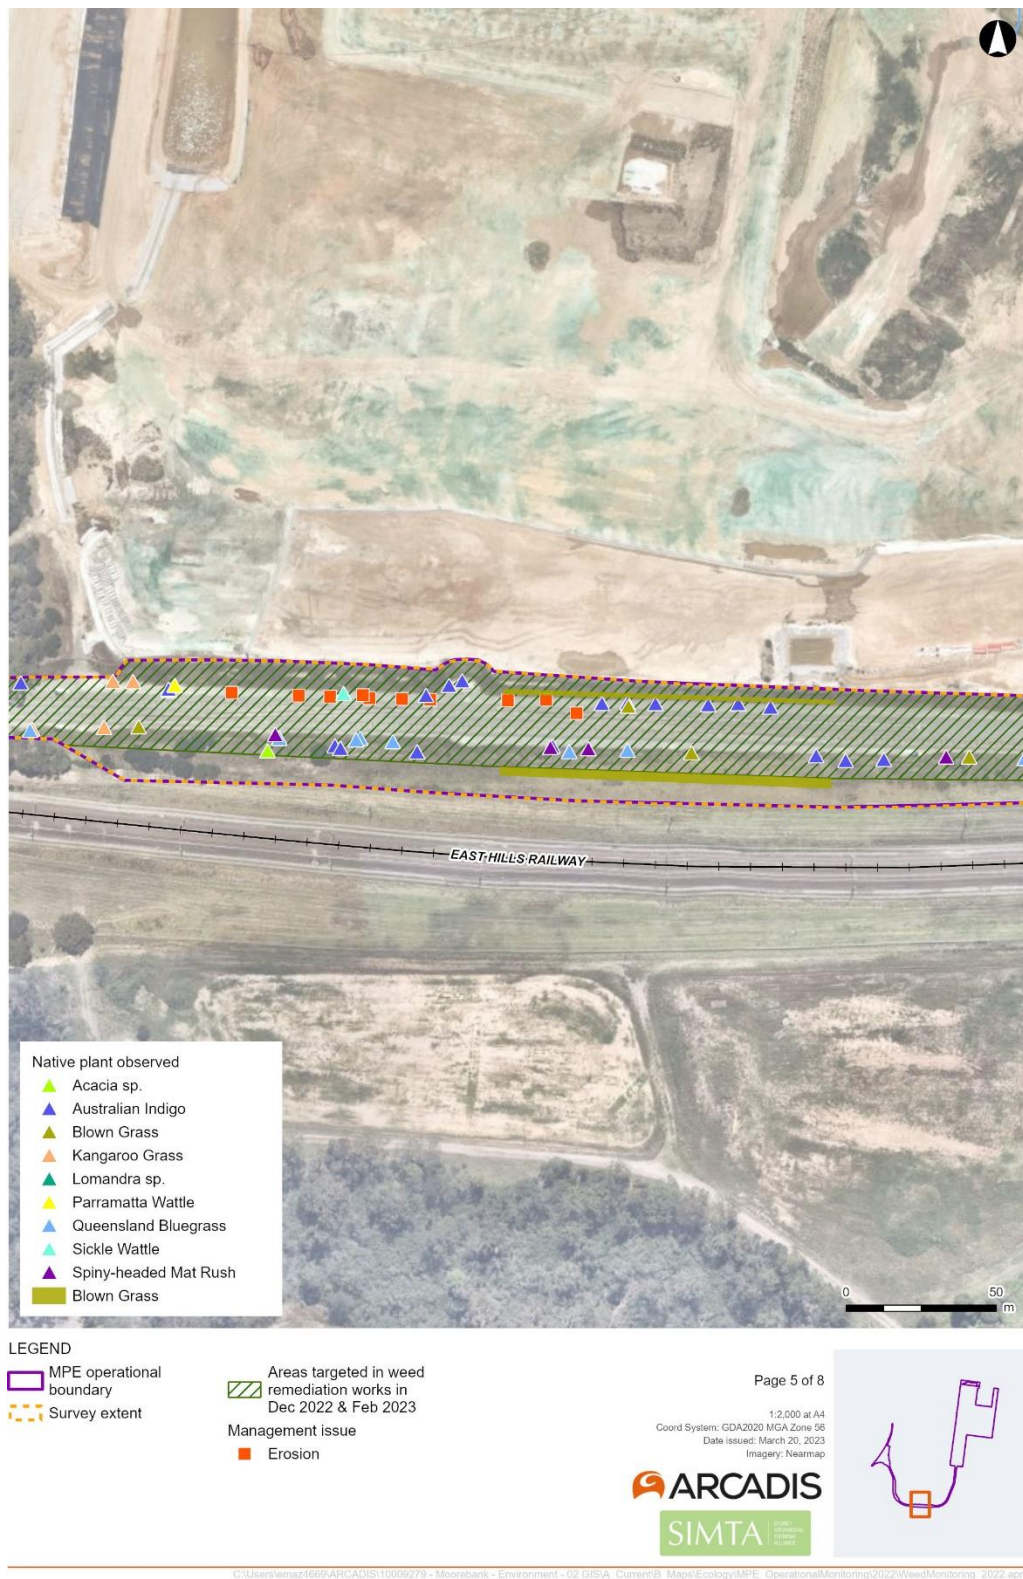
Figure 6. Native plant, weed covers and aggressive weeds identified across the MPE operational facility (Map 5 of 8)
