# MOOREBANK INTERMODAL PRECINCT – OPERATIONAL FACILITY

## Annual Flora and Fauna Monitoring Report

16 MAY 2025

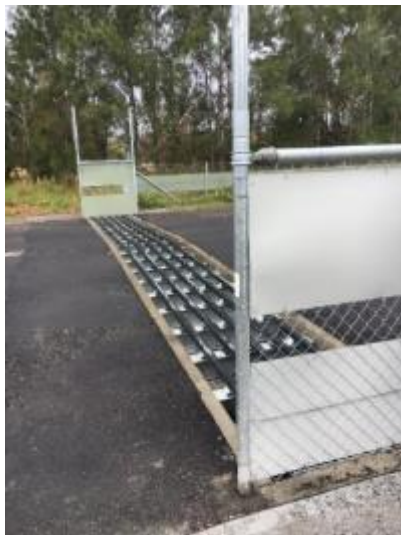
Plate 2-5 Koala structures to be constructed along the perimeter fencing. Left: Koala grids. Right: Koala bridges.

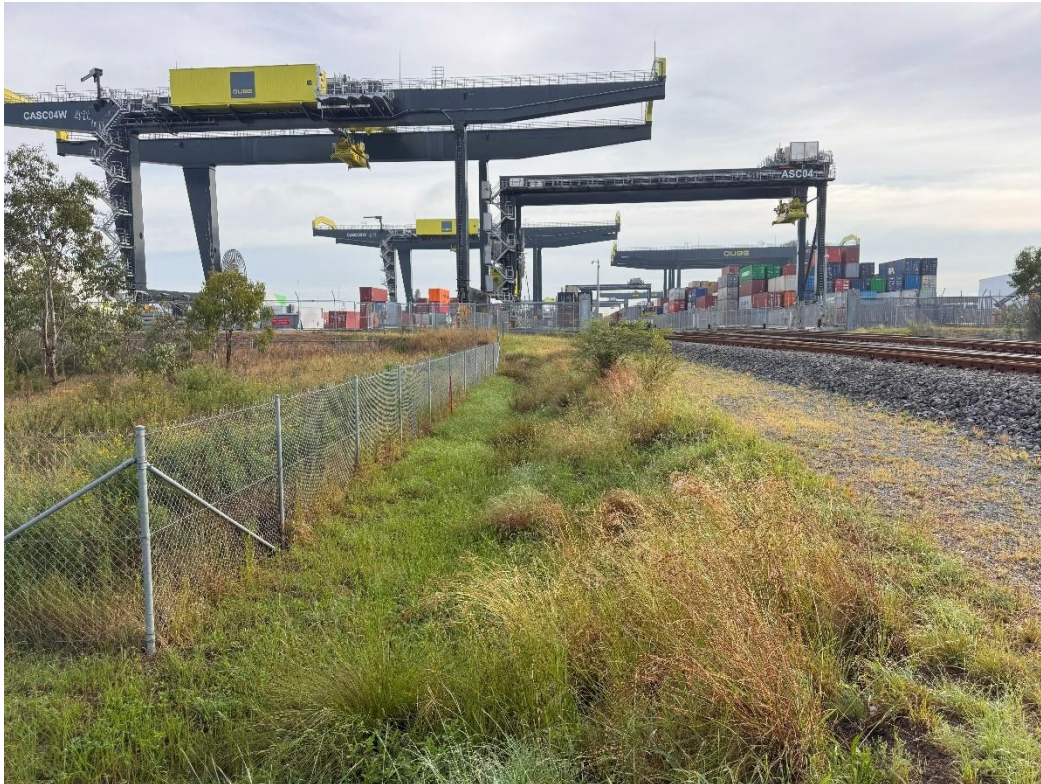
Weed cover across the MPE operational facility was generally low throughout the monitoring year. Minor changes in weed cover and exotic species diversity were observed in landscaped areas around warehousing units, within trunk drainage infrastructure running along the western boundary, and in drainage swales at the north-eastern extent of the site. This was maintained by regular mowing, which reduces occurrences of *Chloris virgata* (Rhodes Grass). Ongoing, periodic weed control works carried out in these areas were observed to be sufficient in maintaining a low weed cover and promoting an increase in cover of native species like *Daviesia ulicifolia* (Gorse Bitter Pea), *Acacia falcata* (Sickle Wattle), *Persicaria decipiens* (Slender Knotweed), *Typha orientalis* (Bulrush), *Chloris truncata* (Windmill Grass) and *Ficinia nodosa* (Knobby Club Rush).

Plate 3-1 Photographs captured during the February 2025 inspection showing low weed cover in the Rail Link. Native grasses have begun heavily colonising the on soft batters on either side of the rail line.

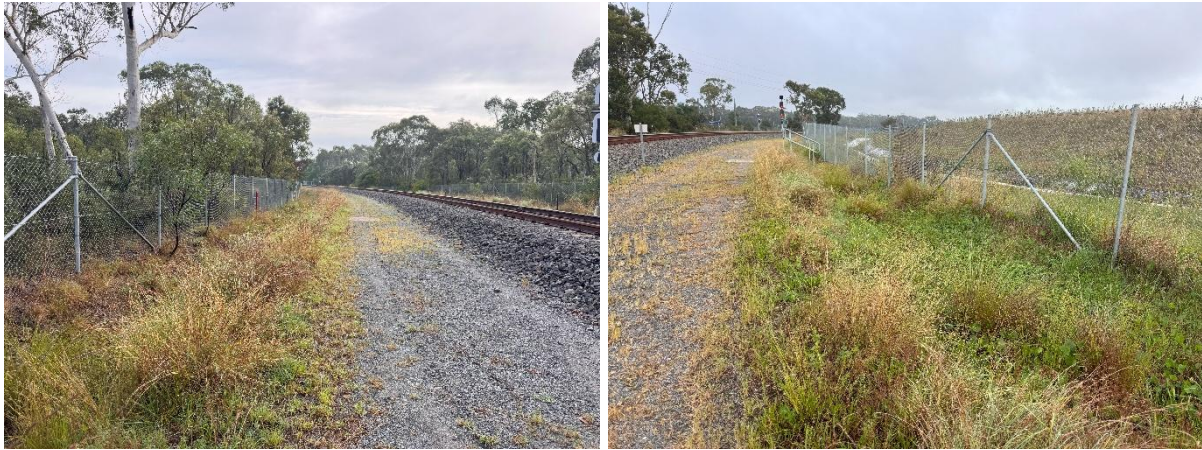
Over the period that weed control works were undertaken native plants were observed to be increasing in size and colonising new areas. Native species observed included *Melaleuca nodosa* (Prickly-leaved Paperbark), *Leptospermum parvifolium* (Small-flowered Tea Tree), *Leptospermum trinervium* (Woolly Tea Tree), *Empodisma minus* (Wire Rush) and *Hakea sericea* (Silk Hakea).

Plate 3-2. Soft batters in the Rail Link corridor following weed removal works by Toolijooa.

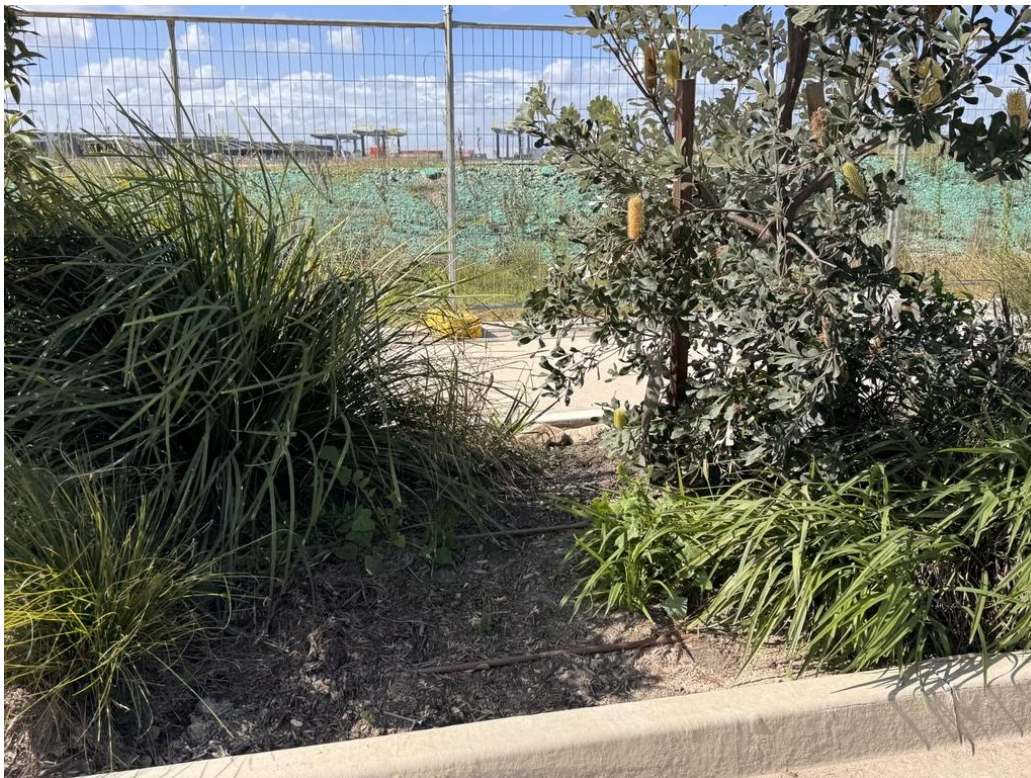
Weed monitoring conducted in April 2025 concluded that the landscaped areas along Bushmasters Avenue are in good condition, with minor weed incursions of *Sonchus oleraceus* (Common Sowthistle), *Chloris virgata* (Rhodes Grass), *Bidens pilosa*, *Conyza bonariensis* (Fleabane), *Cyclospermum leptophyllum* (Slender Celery), and *Tagetes minuta* (Stinking Roger). Whilst the current levels of these weeds are low, if continued maintenance of these landscaped areas is not frequent enough their coverage could increase. This is pertinent for areas where landscaped species have died back, and bare ground is more abundant (Plate 3-3).

Plate 3-3 Areas of bare ground along Bushmasters Avenue which could be colonised by weed species

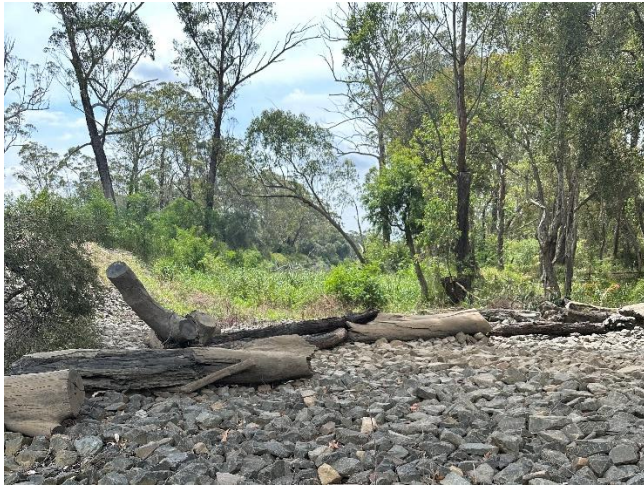
for the bridge on the eastern side of the Georges River during construction. No fauna were observed utilising the woody debris during the current monitoring period, with no use observed during the previous spring monitoring in 2022. Installation of additional woody debris or flat wooden ramps similar to those at the Anzac Creek culverts should be considered to encourage movement between areas of habitat.

Plate 4-1. Large logs and piles, of course, woody debris placed to facilitate movement of fauna across ballast at Georges River beneath the rail link bridge

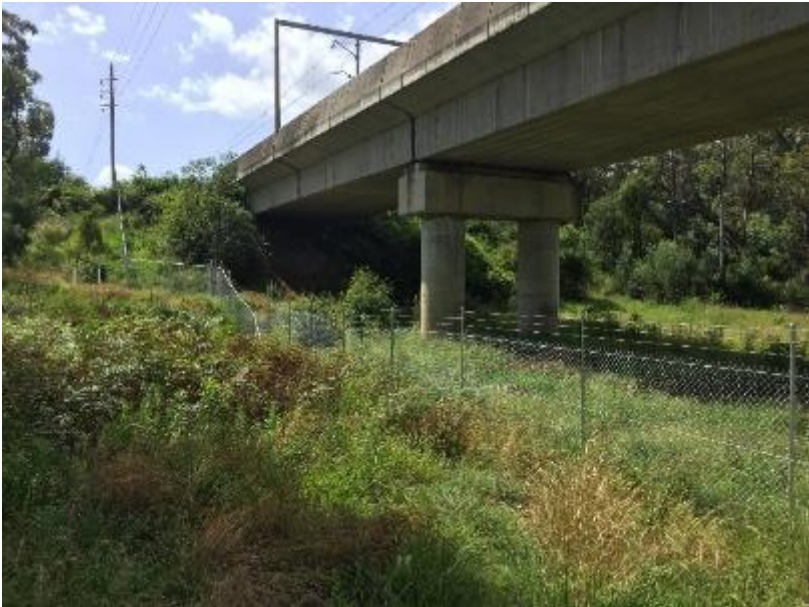
Additionally, a six-foot-high cyclone fence with top-lined barbed wire installed to the south of the Georges River management site is likely a barrier to the movement of some fauna species between the MPW site and bushland to the south. Ground-dwelling fauna like macropods are unlikely to be able to pass this cyclone fence, and due to the barbed wire lined top, arboreal fauna is also likely prevented from climbing the fence and dispersing across the landscape. Koalas have been recorded in riparian bushland along the Georges River as well as bushland to the south outside of the MPW precinct. Koalas would readily move along this corridor for various reasons (foraging, dispersal, breeding), and cyclone fencing may be inhibiting these movements. A large hole has been discovered in this fence, with a remote camera installed to monitor fauna movement through this hole. Rusa deer, foxes and swamp wallaby were the only species recorded to be moving through this access point.

Plate 4-2. Cyclone fence at the southern extent of the management site

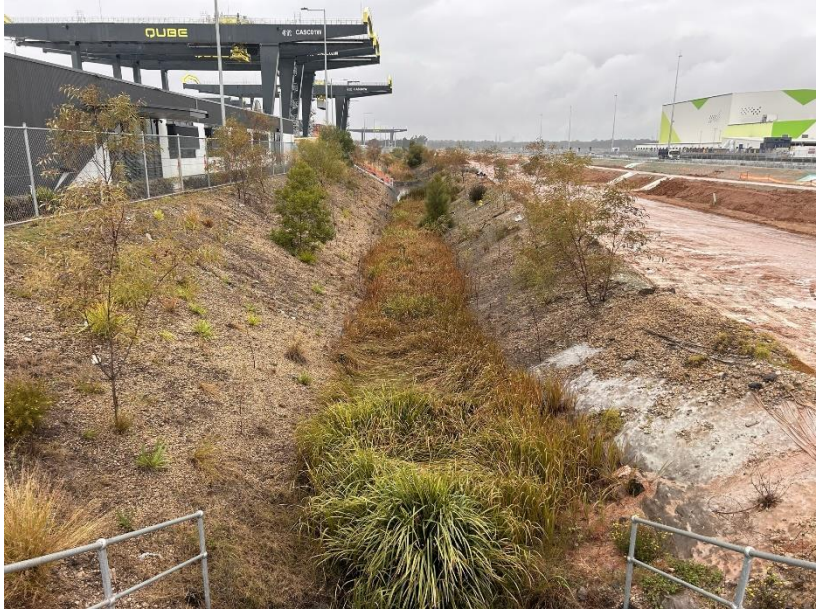
| Area of MPE | Photo |
|---|---|
| <p>IMEX building and adjacent drainage infrastructure</p> | <p><i>Plate 1 IMEX building drainage infrastructure</i></p> |

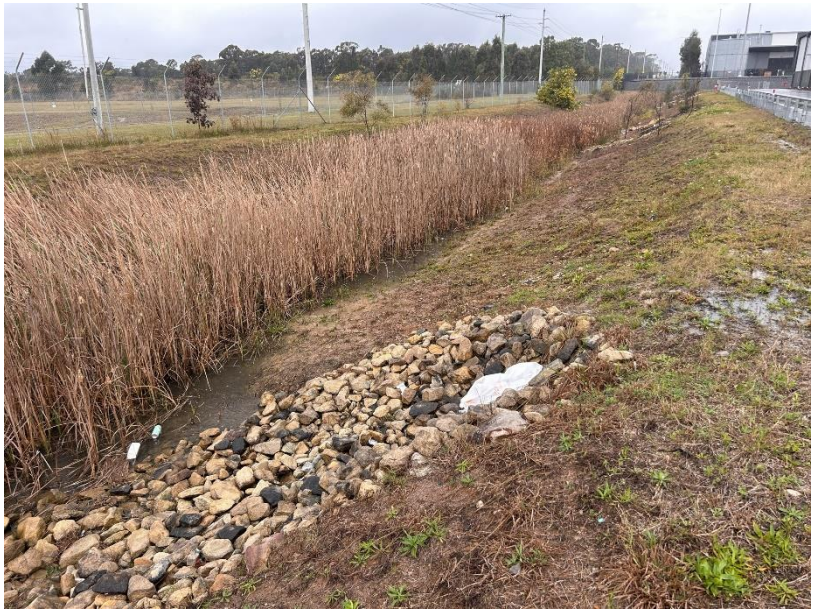
| Area of MPE | Photo |
|---|---|
| <p>Warehouse areas</p> | <p><i>Plate 2 Stabilized erosion areas with rainfall brining increased litter into drainage infrastructure</i></p> |

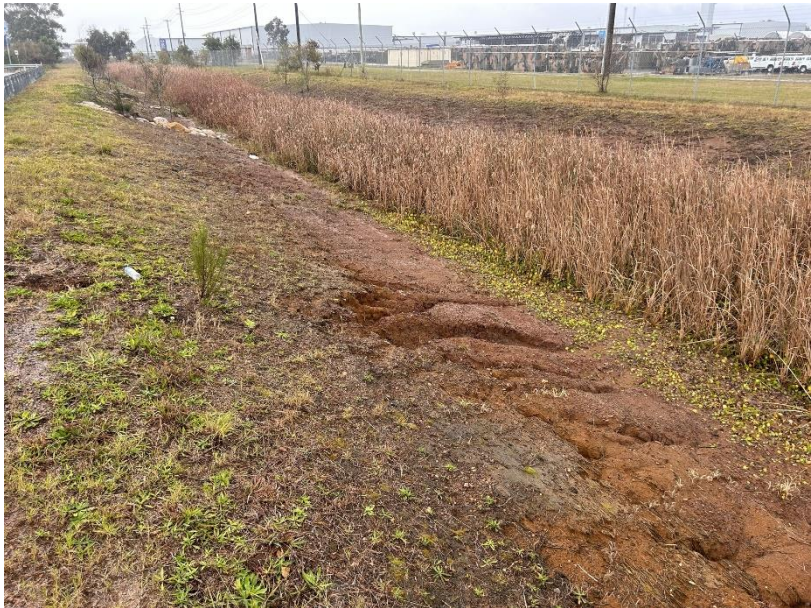
| Area of MPE | Photo |
|---|---|
| <p>Eastern boundary drainage infrastructure</p> | <p><i>Plate 3 Erosion from persistent rain events evident in areas with limited vegetation cover</i></p> |

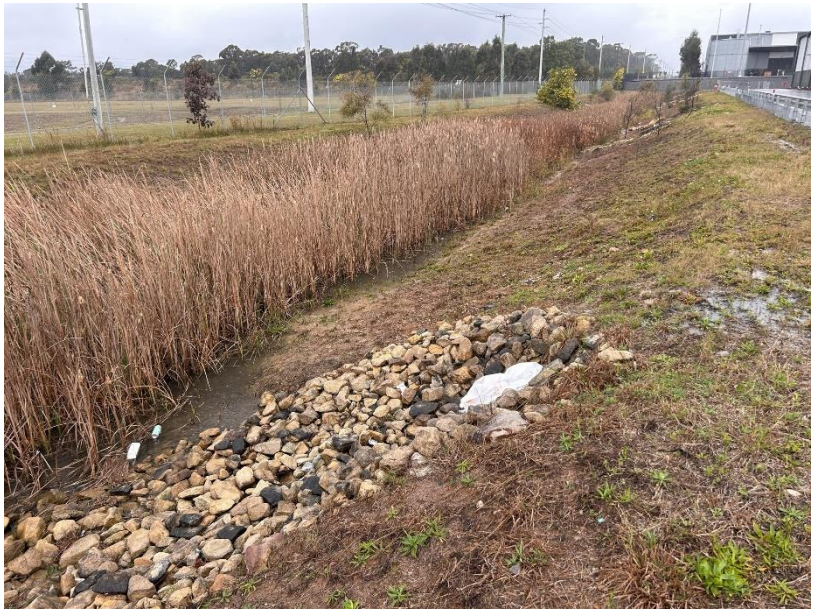
| Area of MPE | Photo |
|---|---|
| <p>Warehouse areas</p> | <p><i>Plate 2 Stabilized erosion areas with rainfall brining increased litter into drainage infrastructure (no change from August 2024)</i></p> |

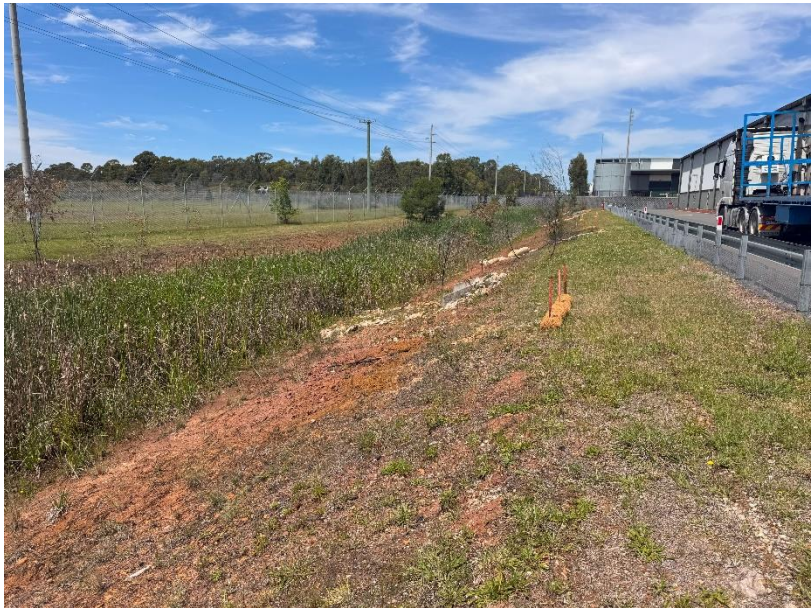
| Area of MPE | Photo |
|---|---|
| <p>Eastern boundary drainage infrastructure</p> | <p><i>Plate 3 Erosion from persistent rain events evident in areas with limited vegetation cover</i></p> |

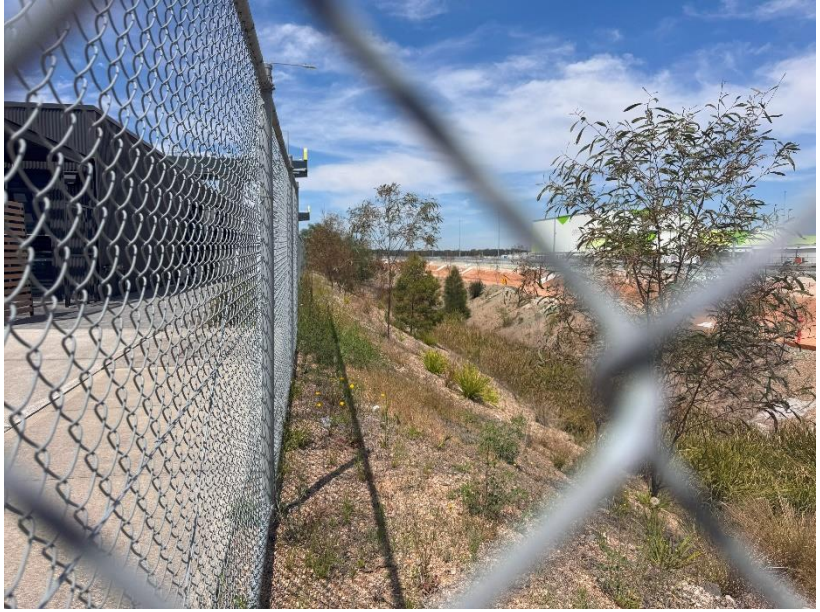
| Area of MPE | Photo |
|---|---|
| <p>IMEX building and adjacent drainage infrastructure</p> | <p><i>Plate 1 IMEX building drainage infrastructure (no change since October 2024)</i></p> |

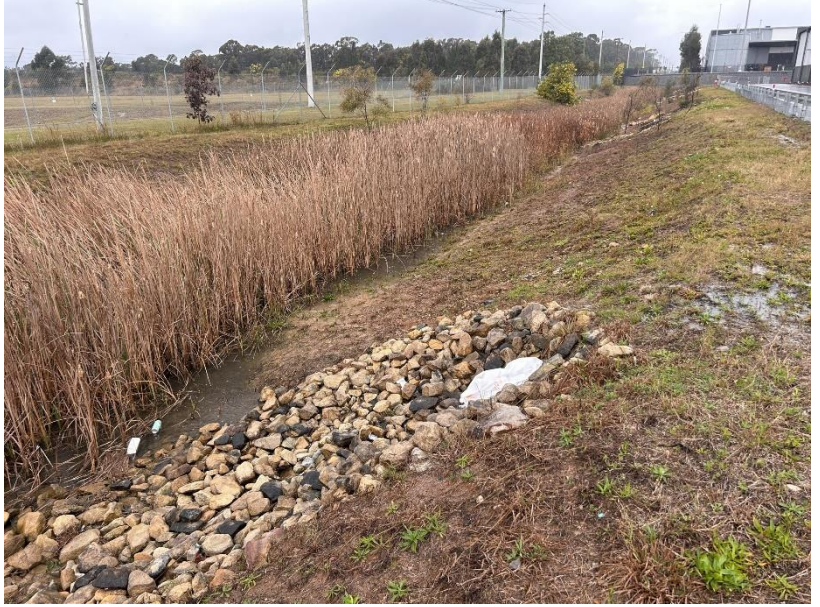
| Area of MPE | Photo |
|---|---|
| <p>Warehouse areas</p> | <p><i>Plate 2 Stabilized erosion areas with rainfall brining increased litter into drainage infrastructure (no change from August 2024)</i></p> |

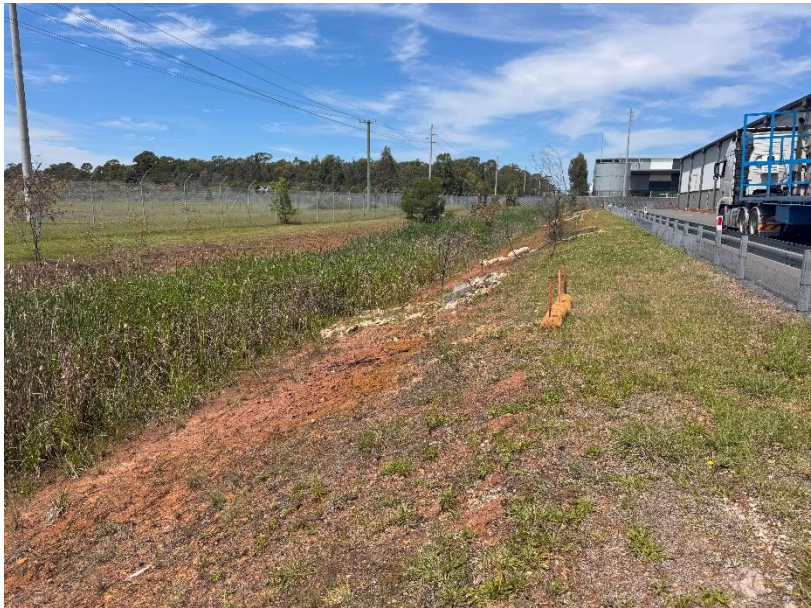
| Area of MPE | Photo |
|---|---|
| <p>Eastern boundary drainage infrastructure</p> | <p><i>Plate 3 Erosion from persistent rain events evident in areas with limited vegetation cover (no change since October 2024)</i></p> |
