# MOOREBANK INTERMODAL PRECINCT – OPERATIONAL FACILITY

## Annual Flora and Fauna Monitoring Report

31 MAY 2026

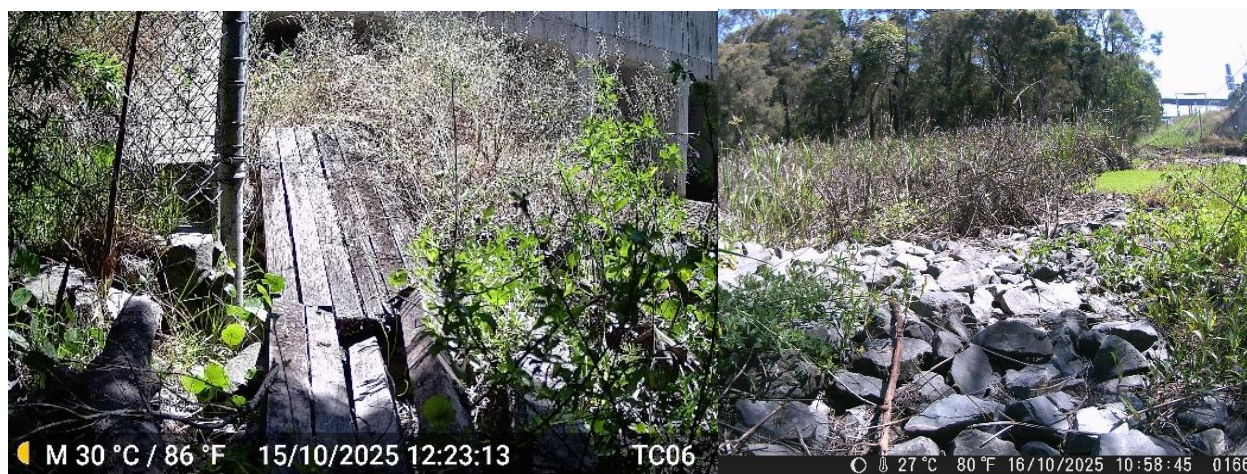
Plate 2-1 Examples of remote camera deployment at Anzac Creek management site to monitor habitat connectivity. Left: Remote camera: downstream south. Right: Remote camera: upstream south.

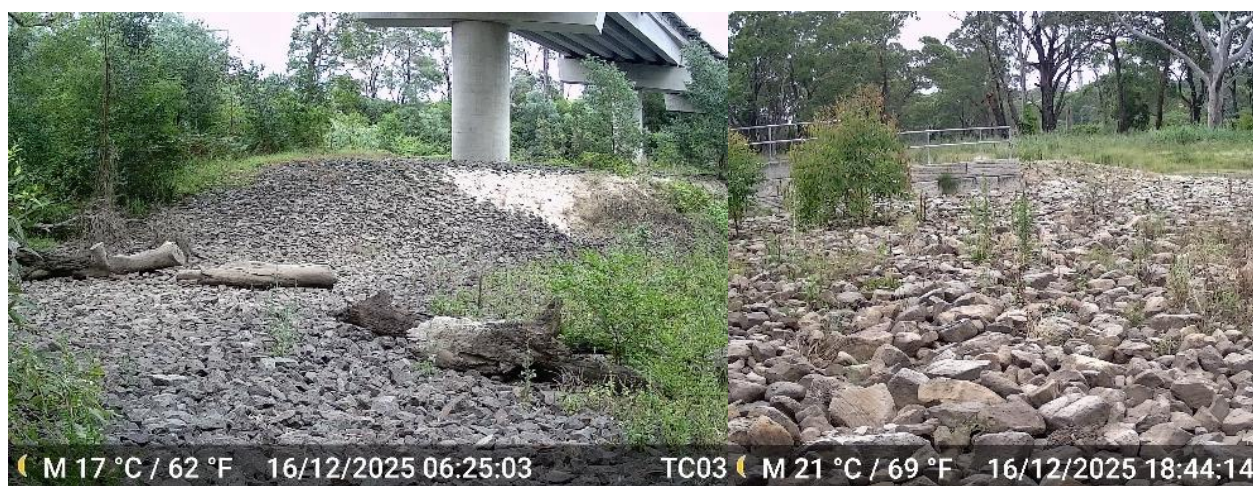
Plate 2-2 Example of remote camera deployment to assess the connectivity value of the Georges River management site. Left: Remote camera facing south west at rail underpass. Right: View of remote camera facing south at outlet basin

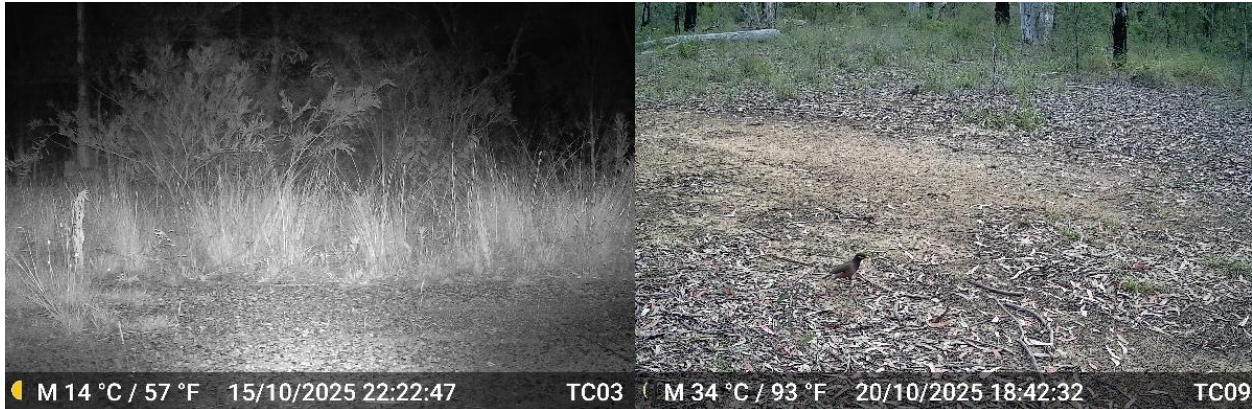
*Plate 2-3 Examples of feral animal remote camera deployment. The left camera faces the northern access track at the boundary fence to MPE, and the right-hand image faces an internal access track within the Wattle Grove offset area.*

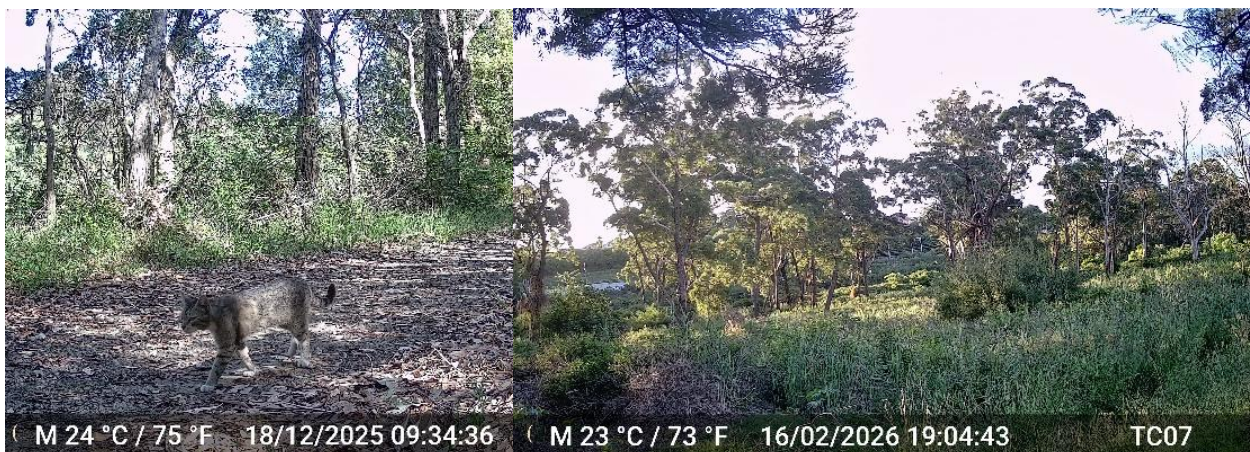
*Plate 2-4 Examples of remote cameras deployed at MPW targeting feral vertebrates. The left camera faces the internal Central access track in the southern section of the Georges River offset site, and the right image shows the view of a camera south of the northern most access track.*

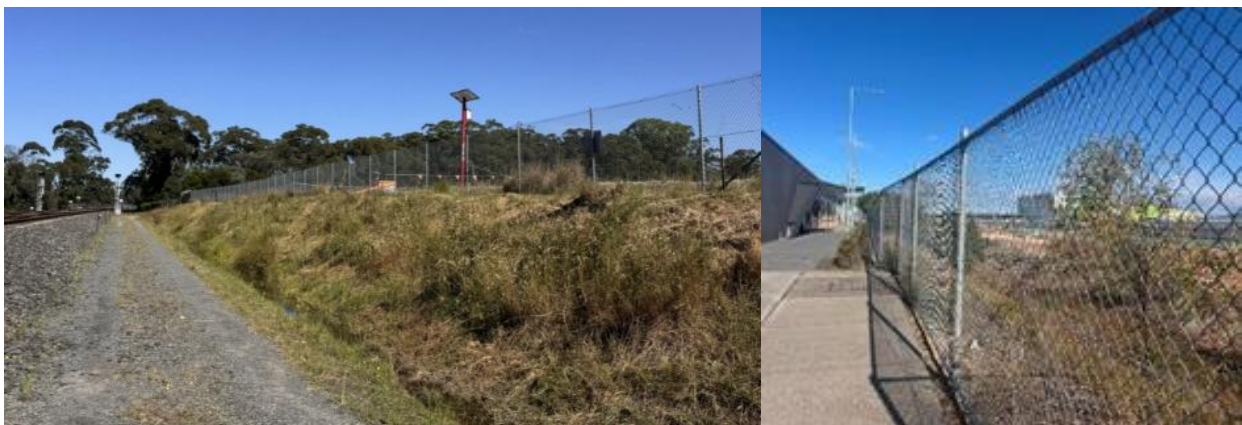
At the IMEX building and adjacent drainage infrastructure *Acacia falcata* (Hickory Wattle) continue to grow unimpeded by weeds.

Plate 3-1. Left: Soft batters in the Rail Link corridor following weed removal works by Toolijooa, native grasses (*Themeda triandra* and *Dichanthium sp.*) are growing substantially with weed growth suppressed particularly in the areas immediately adjacent to the BioBank Site. Right: at the IMEX building and adjacent drainage infrastructure *Acacia falcata* (Hickory Wattle) continue to grow unimpeded by weeds.

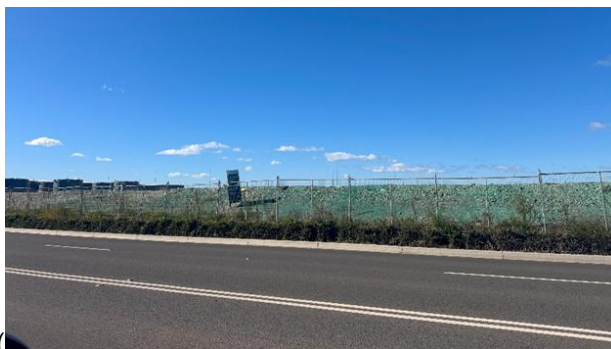
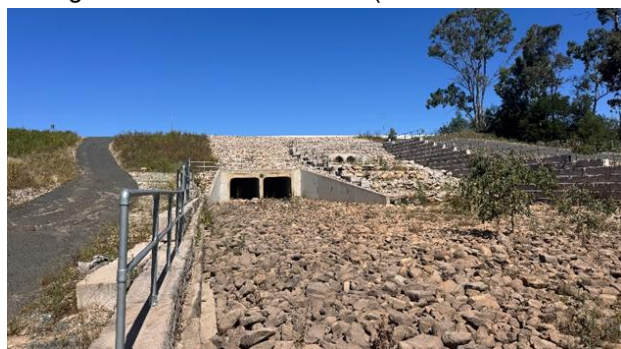
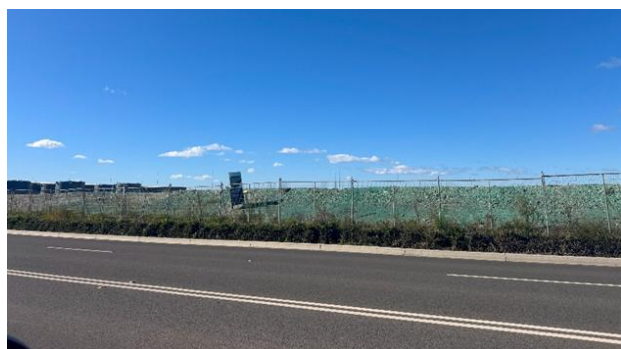
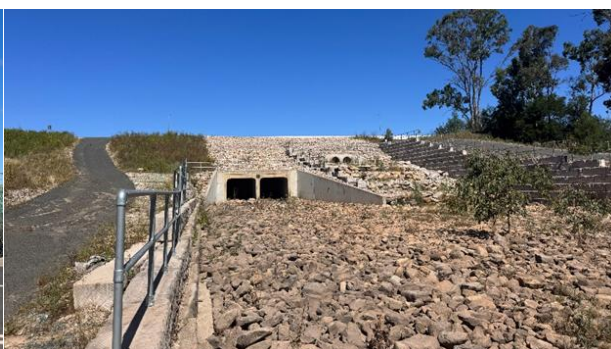
Weed monitoring conducted across 2025-2026 concluded that the landscaped areas along Bushmasters Avenue are in good condition, with minor weed incursions. Whilst the 2025-2026 surveys found the levels of weeds to be low, if continued maintenance of these landscaped areas is not frequent enough their coverage could increase. This is pertinent for areas where landscaped species have died back, and

Plate 3-2). Sediment basins adjacent to BioBank site showed no significant increases in weed coverage were observed around the basin outlet points. The APZ area – within northern MPW is showing a suppression of *Medicago polymorpha* and other herbaceous weeds occurring in this area (*Sonchus oleraceus* (Common Sow thistle), *Cirsium vulgare*) with large stands of the native shrub *Dodonaea viscosa* growing unimpeded.

Plate 3-2 Left: Areas with limited to no landscaped vegetation are particularly susceptible to weed incursion from cleared areas along Bushmasters Avenue which could be colonised by weed species. Right: No significant increases in weed coverage were observed around the basin outlet points

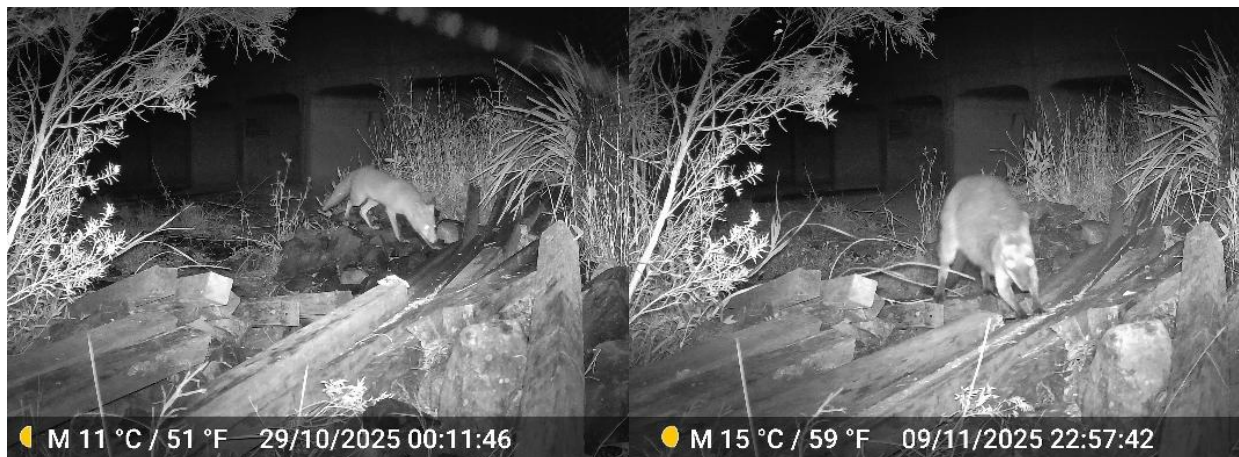
Remote infra-red cameras captured a suit of native and introduced fauna utilising the Anzac Creek culvert to move between patches of bushland within the Wattle Grove offset area. Fauna furniture provides a stable surface, enabling ground-dwelling mammals and birds to safely cross between fragmented bushland patches, supporting habitat connectivity. Common native species recorded utilising the fauna furniture included Swamp Wallaby (*Wallabia bicolor*), Eastern Grey Kangaroo (*Macropus giganteus*), Australasian Swamphen (*Porphyrio melanotus*), Australian Raven (*Corvus coronoides*), White-faced heron (*Egretta novaehollandiae*) and Superb Fairy-wren (*Malurus cyaneus*). Introduced fauna recorded included Red Fox (*Vulpes vulpes*), Domestic Cat (*Felis catus*) and Black Rat (*Rattus rattus*).

Plate 3-3 Fauna captured on remote cameras using fauna furniture to move between patches of bushland crossing Anzac Creek. Top Left: Red fox. Top Right: Swamp Wallaby.

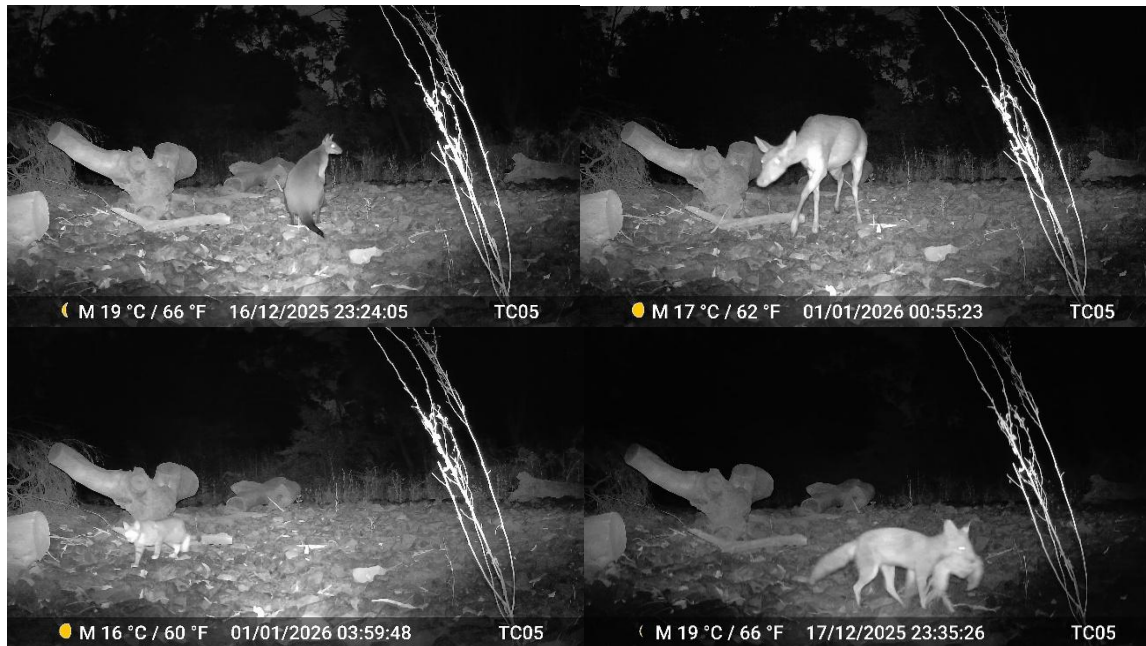
Terrestrial fauna were recorded on remote cameras beneath the Rail Link bridge on the eastern side of the Georges River and around the outlet basins. Native species detected included Swamp Wallaby and Brushtail Possum (*Trichosurus vulpecula*). More pest species were recorded at MPW than in the Wattle Grove offset area, including Rusa Deer (*Rusa timorensis*), Red Fox, Brown Hare (*Lepus europaeus*) and Domestic Cat (Plate 3-4). No fauna was captured utilising the woody debris to cross the ballast.

Plate 3-4 Fauna species identified beneath the Rail Link bridge (on the eastern side of Georges River). From top left clockwise: Swamp Wallaby, Rusa Deer, Red Fox carrying prey item, Domestic cat.

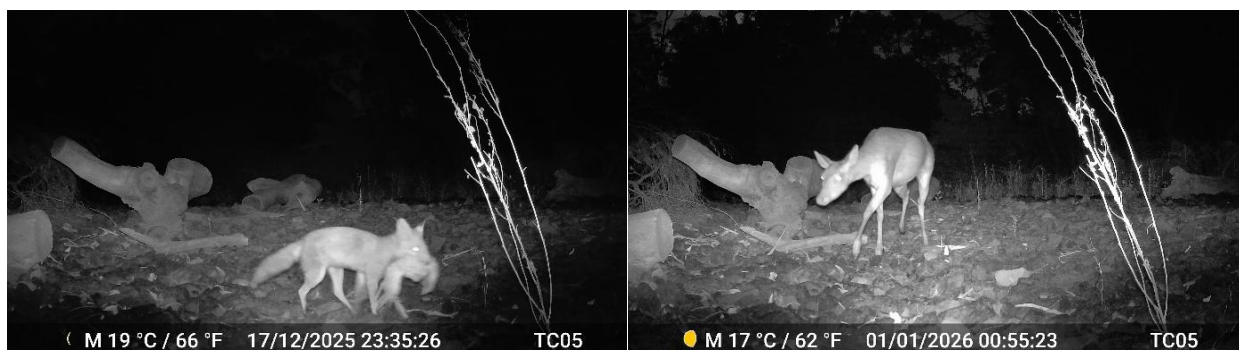
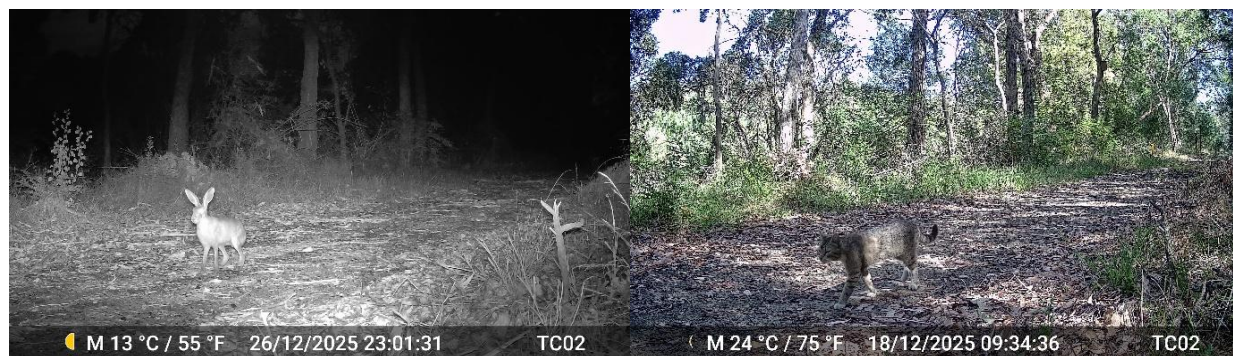
*Plate 3-5 Feral animal species within the MIP operational facility. Top left: Red fox. Top right: Red Deer. Bottom left: Brown Hare. Bottom right: Domestic cat.*

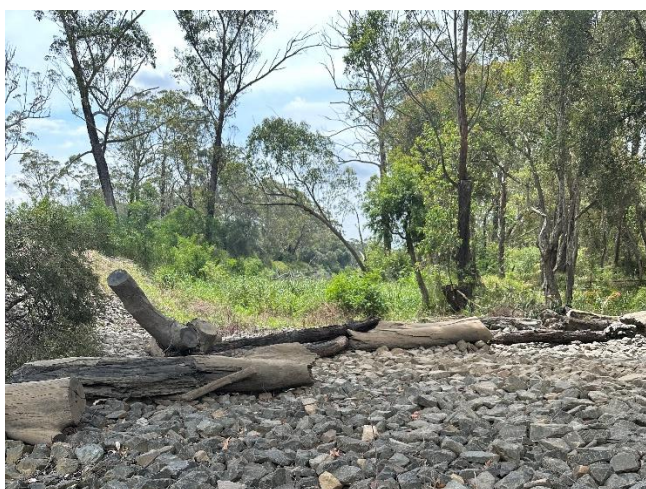
Large logs and coarse woody debris placed on rock ballast remain as the habitat connectivity measure linking riparian vegetation within the MPW precinct with bushland to the south. This alternative habitat connectivity measure was adopted following the placement of ballast in the 20-metre-wide gap cleared for the bridge on the eastern side of the Georges River during construction. No fauna were observed utilising the woody debris during the current monitoring period, with no use observed during the previous monitoring periods (2022-2025). Installation of additional woody debris or flat wooden ramps similar to those at the Anzac Creek culverts should be considered to encourage movement between areas of habitat.

Plate 4-1. Large logs and piles, of course, woody debris placed to facilitate movement of fauna across ballast at Georges River beneath the rail link bridge

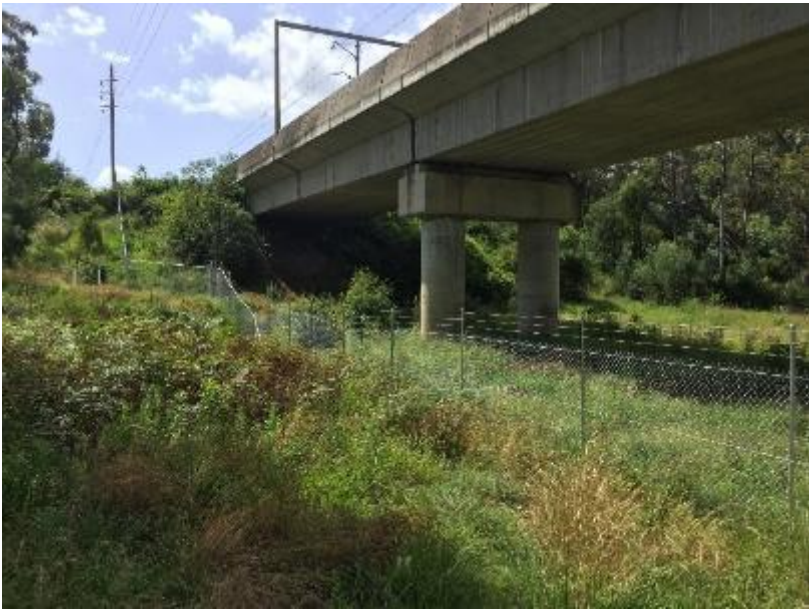
Additionally, a six-foot-high cyclone fence with top-lined barbed wire installed to the south of the Georges River management site is likely a barrier to the movement of some fauna species between the MPW site and bushland to the south. Ground-dwelling fauna like macropods are unlikely to be able to pass this cyclone fence, and due to the barbed wire lined top, arboreal fauna is also likely prevented from climbing the fence and dispersing across the landscape. Koalas have been recorded in riparian bushland along the Georges River as well as bushland to the south outside of the MPW precinct. Koalas would readily move along this corridor for various reasons (foraging, dispersal, breeding), and cyclone fencing may be inhibiting these movements.

Plate 4-2. Cyclone fence at the southern extent of the management site

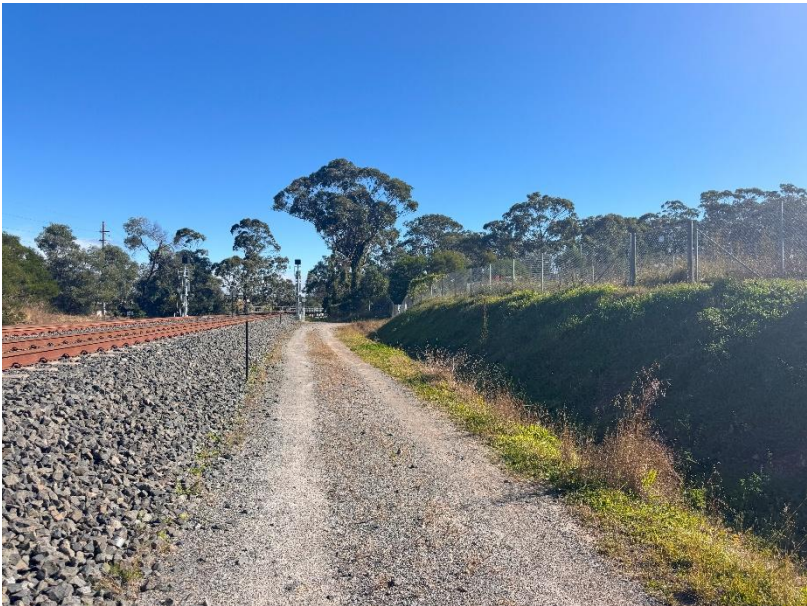
| Inspection area | Weed abundances for current survey | Photo of inspection area |
|---|---|---|
| Rail Access Land Package (RALP) | <ul style="list-style-type: none"> <li>Chloris gayana (Rhodes Grass) and small amounts of <i>Themeda quadrivalvis</i> (Grader Grass) were removed during this inspection</li> <li>Some areas of <i>Lantana camara</i> (Lantana) were slashed along the fences adjacent to the Georges River BioBank site</li> <li>The southern section of the RALP, in areas that have previously experienced significant batter erosion, were being colonised intensely by <i>Tagetes minuta</i> (Stinking Roger), and were slashed during this inspection (see adjacent photo).</li> </ul> | |

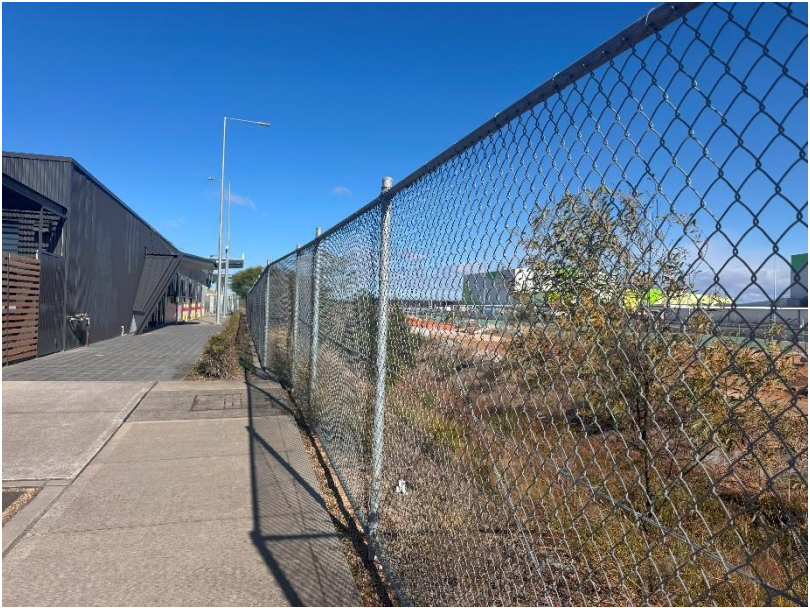
| Inspection area | Weed abundances for current survey | Photo of inspection area |
|---|---|---|
| <p>IMEX building and adjacent drainage infrastructure</p> | <ul style="list-style-type: none"> <li>• <i>Acacia falcata</i> (Hickory Wattle) continue to grow unimpeded by weeds.</li> </ul> | |

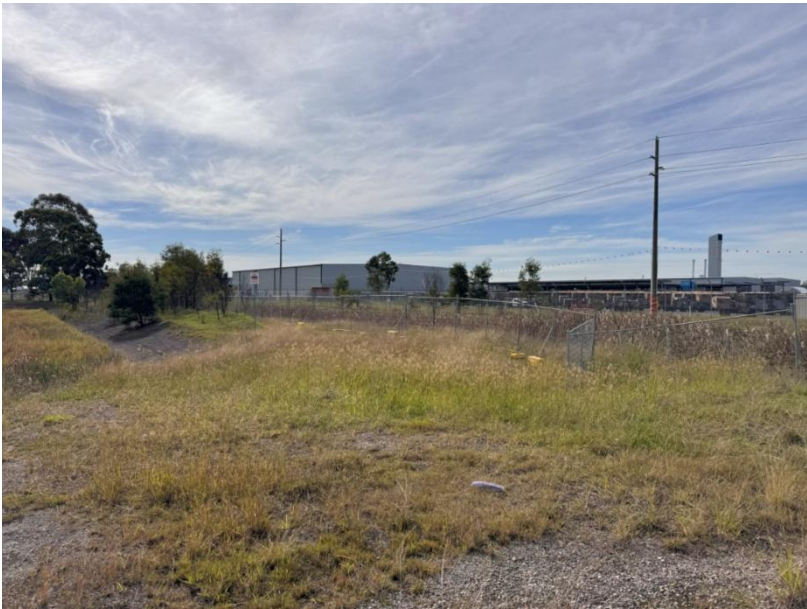
| Inspection area | Weed abundances for current survey | Photo of inspection area |
|---|---|---|
| Warehouse areas | <ul style="list-style-type: none"> <li>• Large areas of the native <i>Cynodon dactylon</i> (Couch Grass) are present across most of these areas and is generally outcompeting weed species.</li> <li>• Occurrences of weeds in the warehouse area and the adjacent drainage infrastructure is restricted to scattered individuals of <i>Senecio madagascariensis</i> (Fireweed), <i>Plantago lanceolata</i> (Plantain), <i>Trifolium arvense</i> (Clover) and exotic grasses like <i>Chloris gayana</i> (Rhodes Grass), <i>Sporobolus africanus</i> (Parramatta Grass), <i>Paspalum urvillei</i> (Giant Paspalum) and <i>Ehrharta erect</i> (Panic Veldtgrass)</li> <li>• Majority of this area has now been claimed by the Moorebank Avenue Upgrade project.</li> </ul> | |

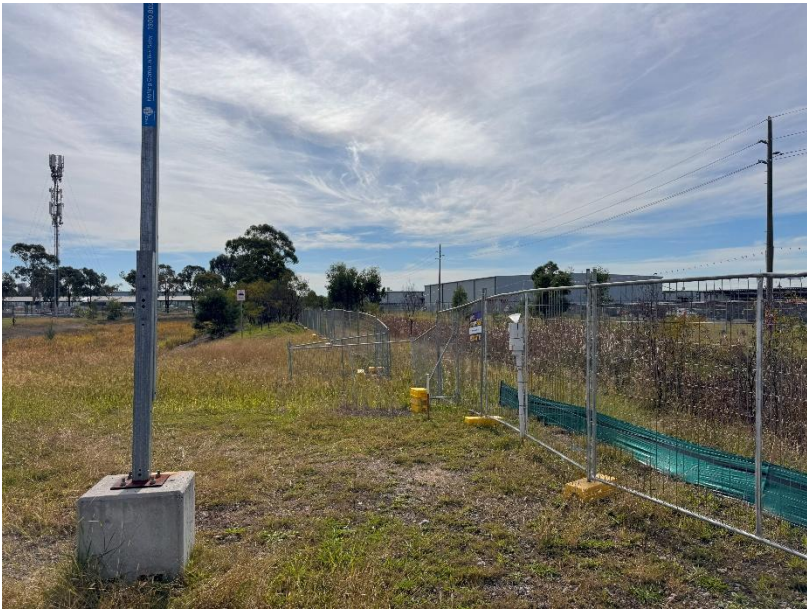
| Inspection area | Weed abundances for current survey | Photo of inspection area |
|---|---|---|
| <p>Eastern boundary drainage infrastructure</p> | <ul style="list-style-type: none"> <li>• Drainage infrastructure dominated by <i>Bulboschoenus fluviatilis</i> (Marsh club-rush) whilst other are dominated by <i>Typha orientalis</i> (Bulrush). Where space is present between stands of these native emergent species small clumps of <i>Pericaria decipiens</i> (Slender Knotweed), <i>Daviesia ulicifolia</i>, <i>Ficinia nodosa</i> (Knotted Club-rush), <i>Carex tereticaulis</i> and <i>Juncus usitatus</i> are present. Other native species such as <i>Imperata cylindrica</i> and <i>Lomandra longifolia</i> were observed in the drainage channels.</li> <li>• Areas of erosion still present.</li> </ul> | |

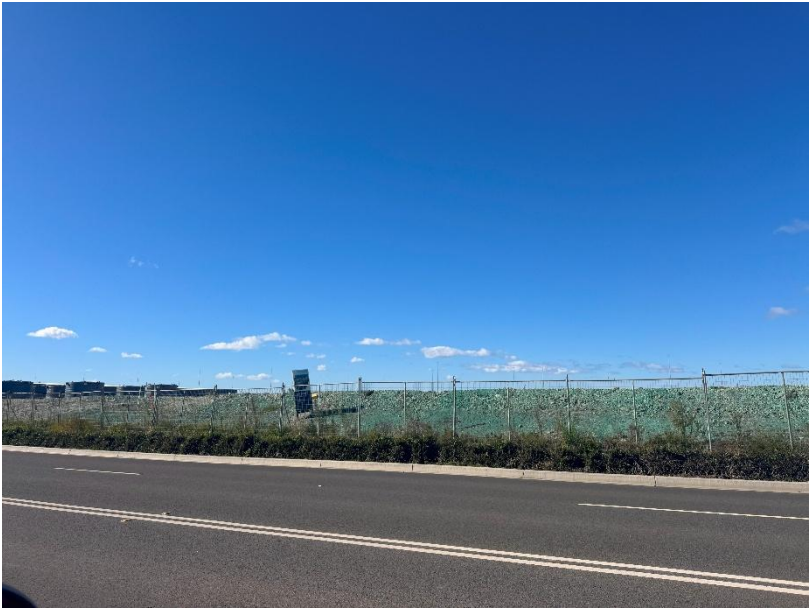
| Inspection area | Weed abundances for current survey | Photo of inspection area |
|---|---|---|
| Landscaped areas along Bushmasters Avenue | <ul style="list-style-type: none"> <li>Landscapes vegetation is in good condition, with minor weed incursions</li> <li>Weed species present include <i>Sonchus oleraceus</i> (Common Sowthistle), <i>Chloris virgata</i> (Rhodes Grass), <i>Bidens pilosa</i>, <i>Conyza bonariensis</i> (Fleabane), <i>Cyclosporum leptophyllum</i> (Slender Celery), and <i>Tagetes minuta</i> (Stinking Roger).</li> <li>Areas with limited to no landscaped vegetation are particularly susceptible to weed incursion from cleared areas (see adjacent photo)</li> </ul> | |

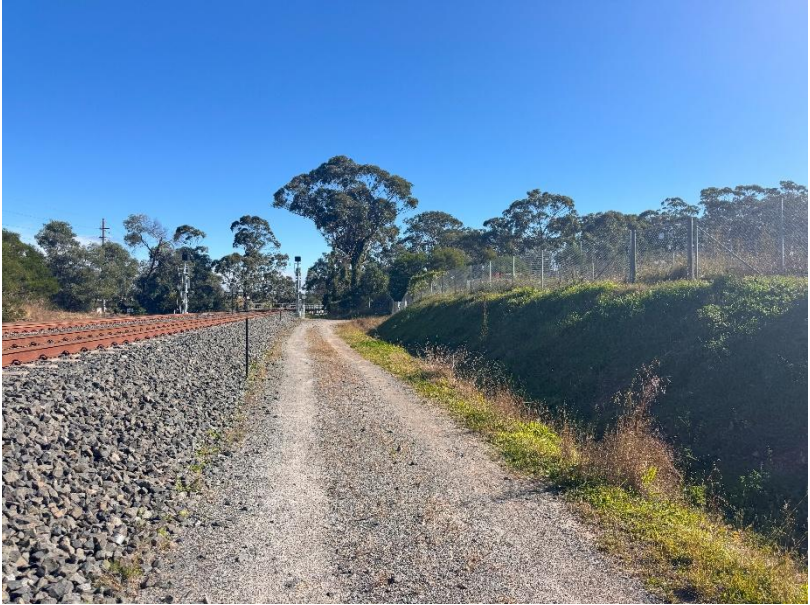
| Inspection area | Weed abundances for current survey | Photo of inspection area |
|---|---|---|
| Rail Access Land Package (RALP) | <ul style="list-style-type: none"> <li>• Weed growth has been slow since June 2025 inspection</li> <li>• Small instances of Fireweed slashed</li> <li>• Steep areas along berms are being avoided for slashing due to safety concerns. Additionally, the small amounts of exotic vegetation are currently stabilising these berms, and will be targeted once construction is finalised in the MPW areas.</li> </ul> | |

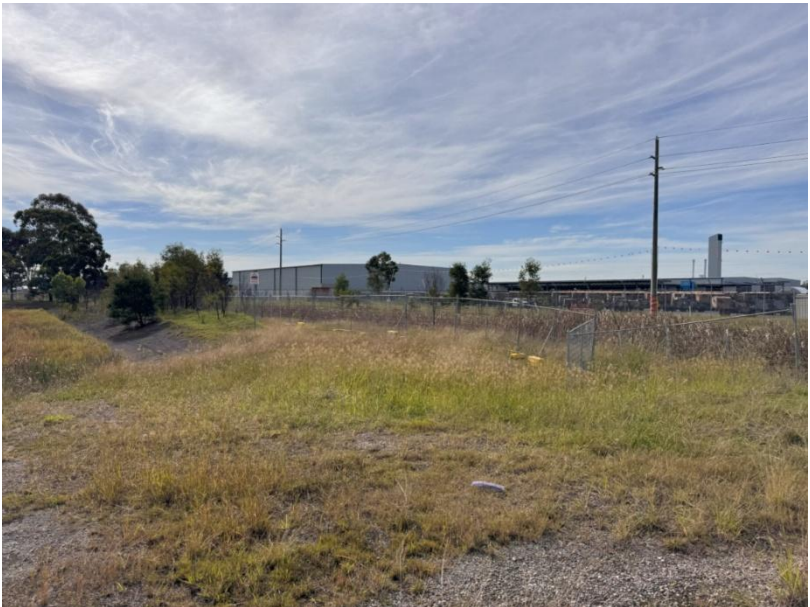
| Inspection area | Weed abundances for current survey | Photo of inspection area |
|---|---|---|
| Warehouse areas | <ul style="list-style-type: none"> <li>• Large areas of the native <i>Cynodon dactylon</i> (Couch Grass) are present across most of these areas and is generally outcompeting weed species.</li> <li>• Occurrences of weeds in the warehouse area and the adjacent drainage infrastructure is restricted to scattered individuals of <i>Senecio madagascariensis</i> (Fireweed), <i>Plantago lanceolata</i> (Plantain), <i>Trifolium arvense</i> (Clover) and exotic grasses like <i>Chloris gayana</i> (Rhodes Grass), <i>Sporobolus africanus</i> (Parramatta Grass), <i>Paspalum urvillei</i> (Giant Paspalum) and <i>Ehrharta erect</i> (Panic Veldtgrass)</li> <li>• Majority of this area has now been claimed by the Moorebank Avenue Upgrade project.</li> </ul> | |

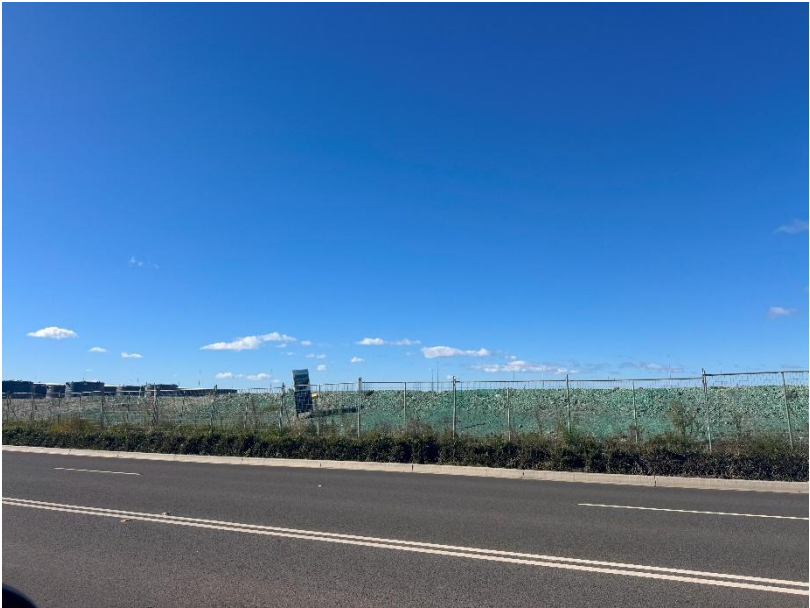
| Inspection area | Weed abundances for current survey | Photo of inspection area |
|---|---|---|
| Landscaped areas along Bushmasters Avenue | <ul style="list-style-type: none"> <li>Landscapes vegetation is in good condition, with minor weed incursions</li> <li>Weed species present include <i>Sonchus oleraceus</i> (Common Sowthistle), <i>Chloris virgata</i> (Rhodes Grass), <i>Bidens pilosa</i>, <i>Conyza bonariensis</i> (Fleabane), <i>Cyclosporum leptophyllum</i> (Slender Celery), and <i>Tagetes minuta</i> (Stinking Roger).</li> <li>Areas with limited to no landscaped vegetation are particularly susceptible to weed incursion from cleared areas (see adjacent photo)</li> </ul> | |

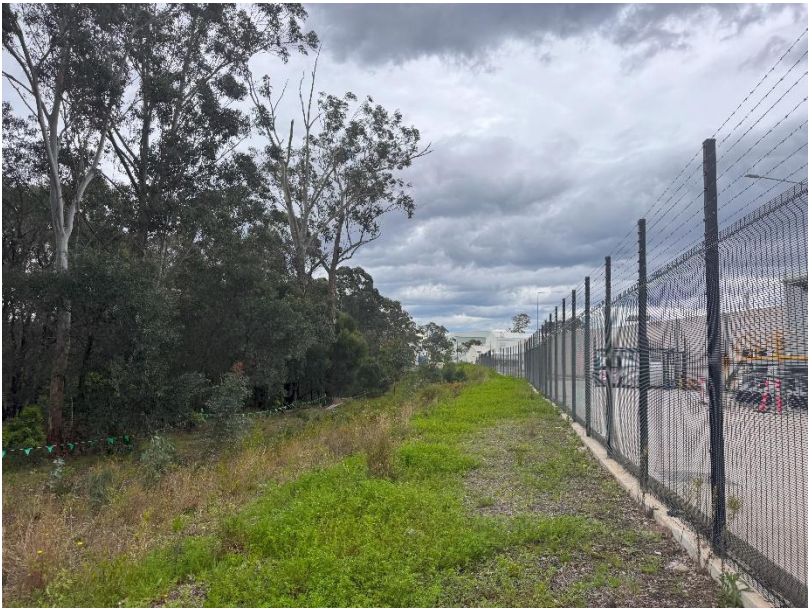
| Inspection area | Weed abundances for current survey | Photo of inspection area |
|---|---|---|
| <p>APZ area – northern MPW</p> | <ul style="list-style-type: none"> <li>• Suppression of Medicago and other herbaceous weeds occurring in this area (<i>Sonchus oleraceus</i> (Common Sowthistle), <i>Cirsium vulgare</i>)</li> <li>• Methods include slashing and hand removal around native species</li> </ul> | |

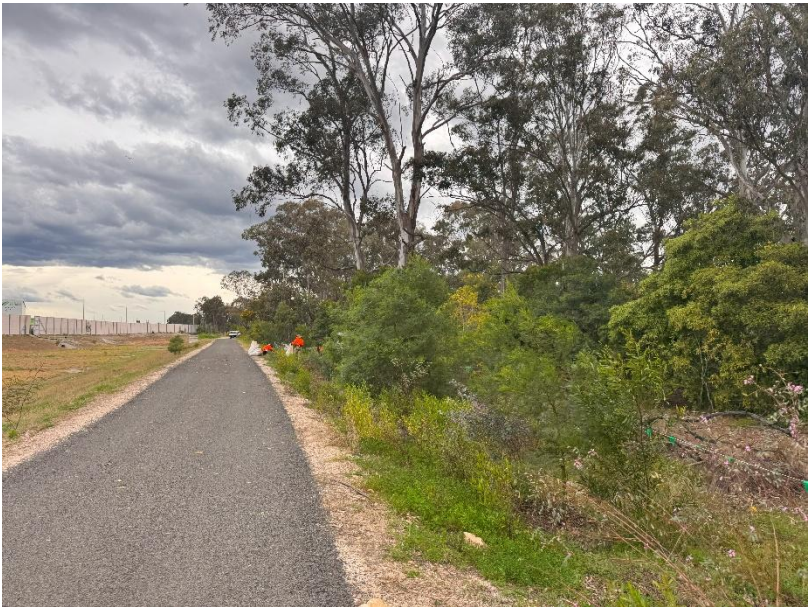
| Inspection area | Weed abundances for current survey | Photo of inspection area |
|---|---|---|
| Sediment basins adjacent to BioBank site | <ul style="list-style-type: none"> <li>Spot spraying, and hand pulling of weeds occurring along boundary of basins and BioBank site</li> </ul> | |

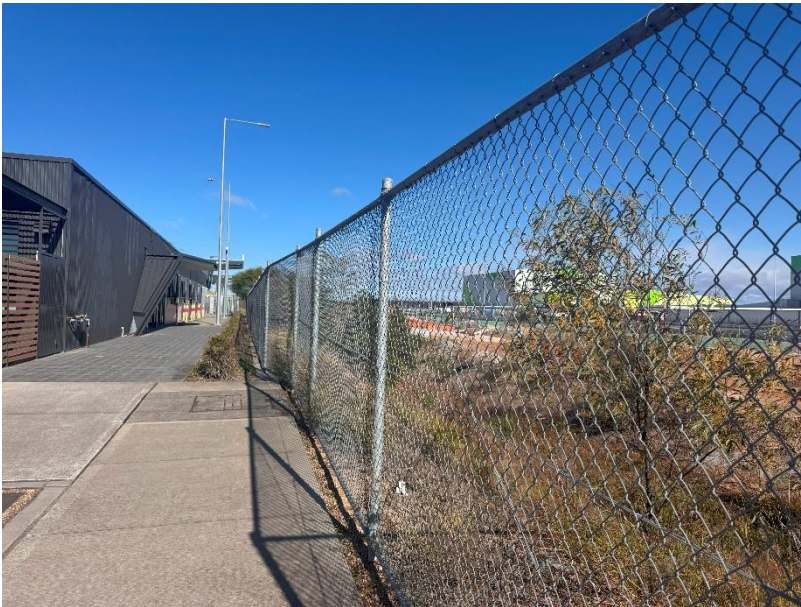
| Inspection area | Weed abundances for current survey | Photo of inspection area |
|---|---|---|
| <p>IMEX building and adjacent drainage infrastructure</p> | <ul style="list-style-type: none"> <li>• <i>Acacia falcata</i> (Hickory Wattle) continue to grow unimpeded by weeds.</li> </ul> | |

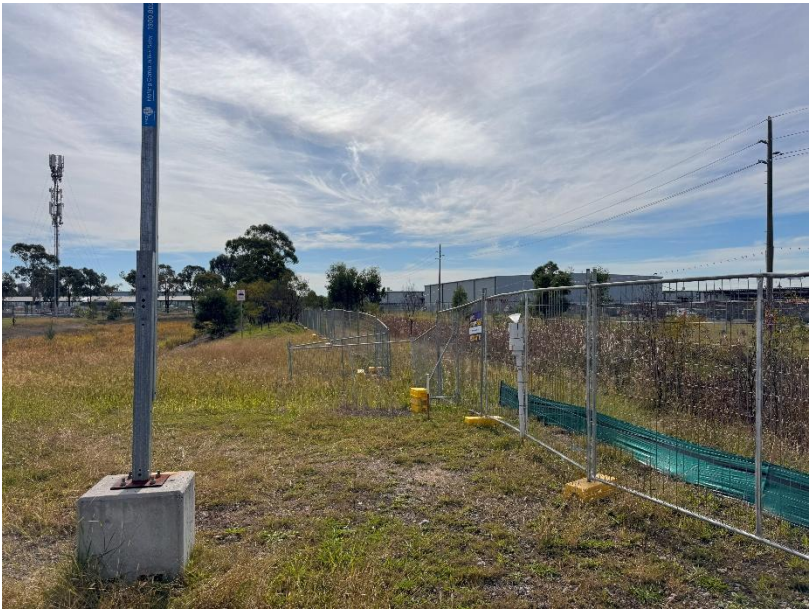
| Inspection area | Weed abundances for current survey | Photo of inspection area |
|---|---|---|
| Eastern boundary drainage infrastructure | <ul style="list-style-type: none"> <li>Majority of this area has now been claimed by the Moorebank Avenue Upgrade project and is unable to be surveyed adequately</li> <li>Drainage infrastructure dominated by <i>Bulboschoenus fluviatilis</i> (Marsh club-rush) whilst other are dominated by <i>Typha orientalis</i> (Bulrush). Where space is present between stands of these native emergent species small clumps of <i>Persicaria decipiens</i> (Slender Knotweed), <i>Daviesia ulicifolia</i>, <i>Ficinia nodosa</i> (Knotted Club-rush), <i>Carex tereticaulis</i> and <i>Juncus usitatus</i> are present. Other native species such as <i>Imperata cylindrica</i> and <i>Lomandra longifolia</i> were observed in the drainage channels.</li> <li>Areas of erosion still present.</li> </ul> | <p>The photograph shows a grassy field with a fence line running across it. In the foreground, there is a concrete base for a utility pole. The background features a cloudy sky and some distant structures.</p> |

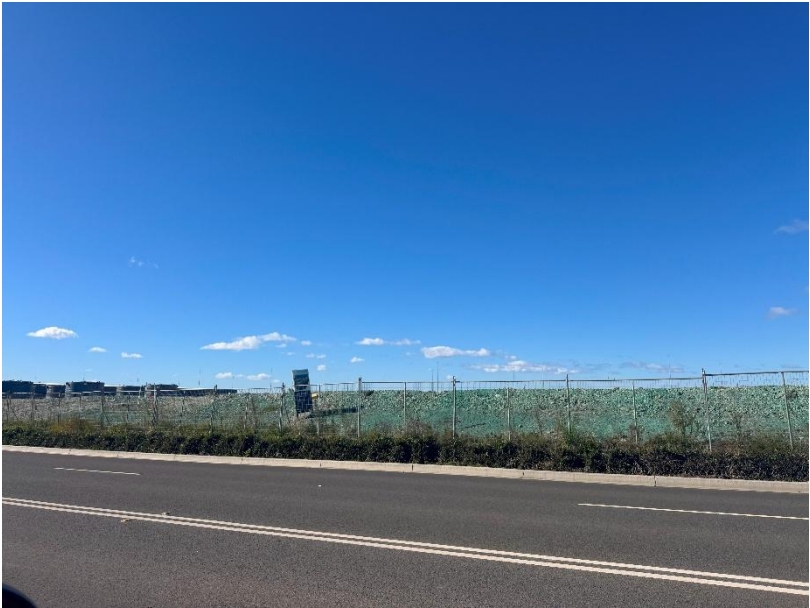
| Inspection area | Weed abundances for current survey | Photo of inspection area |
|---|---|---|
| Landscaped areas along Bushmasters Avenue | <ul style="list-style-type: none"> <li>Landscapes vegetation is in good condition, with minor weed incursions</li> <li>Weed species present include <i>Sonchus oleraceus</i> (Common Sowthistle), <i>Chloris virgata</i> (Rhodes Grass), <i>Bidens pilosa</i>, <i>Conyza bonariensis</i> (Fleabane), <i>Cyclosporum leptophyllum</i> (Slender Celery), and <i>Tagetes minuta</i> (Stinking Roger).</li> <li>Areas with limited to no landscaped vegetation are particularly susceptible to weed incursion from cleared areas (see adjacent photo)</li> </ul> | |

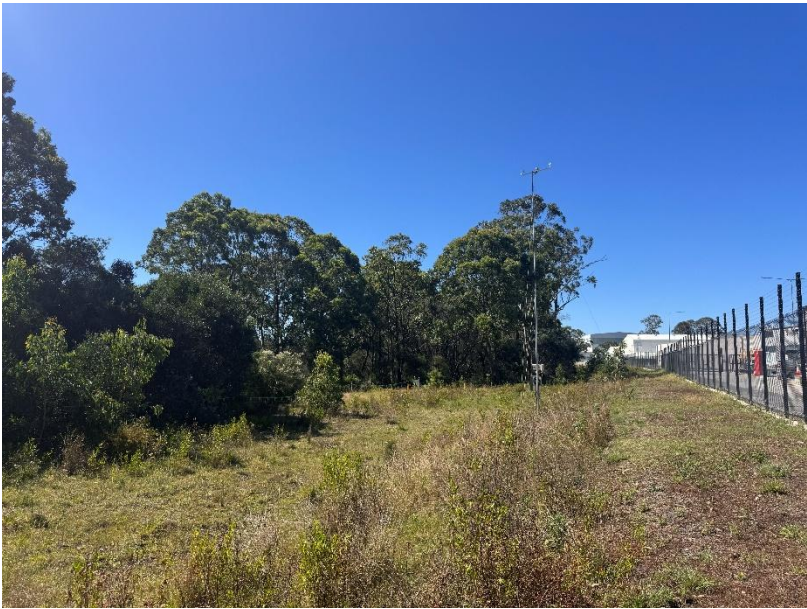
| Inspection area | Weed abundances for current survey | Photo of inspection area |
|---|---|---|
| APZ area – northern MPW | <ul style="list-style-type: none"> <li>• Suppression of <i>Medicago polymorpha</i> and other herbacious weeds occuring in this area (<i>Sonchus oleraceus</i> (Common Sowthistle), <i>Circium vulagre</i>)</li> <li>• Methods include slashing and hand removal around native species</li> <li>• Large stands of the native shrub <i>Dodonea viscosa</i> are growing unimpeded.</li> </ul> | |

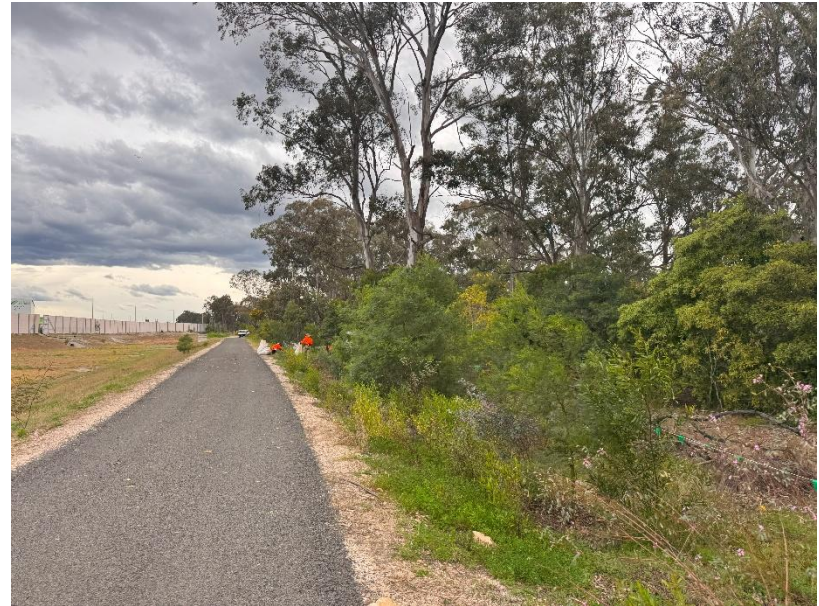
Sediment basins adjacent  
to BioBank site

- Spot spraying, and hand pulling of weeds occurring along boundary of basins and BioBank site
- No significant increases in weed coverage were observed around the basin outlet points

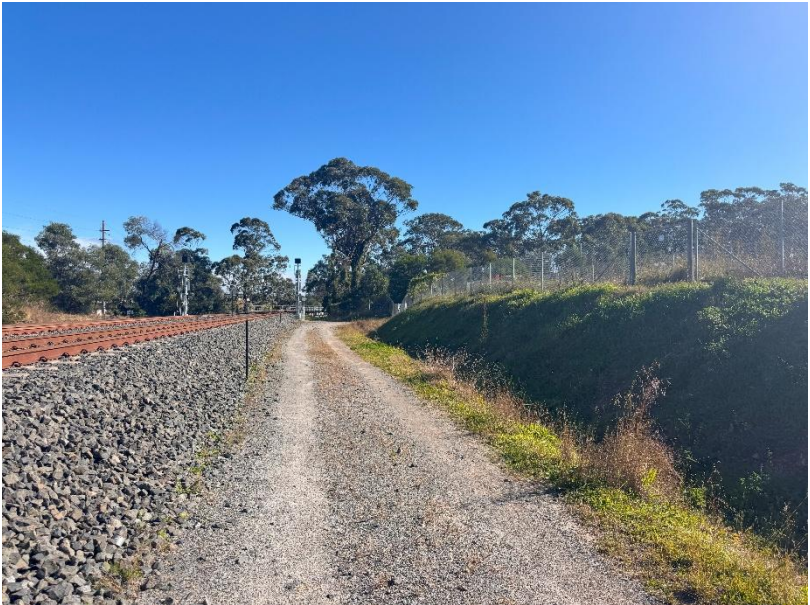
| Inspection area | Weed abundances for current survey | Photo of inspection area |
|---|---|---|
| Rail Access Land Package (RALP) | <ul style="list-style-type: none"> <li>• Weed growth continuous to be suppressed, particularly in the areas immediately adjacent to the BioBank site. Large instances of native grasses (<i>Themeda triandra</i> and <i>Dichanthium</i> sp.) are growing substantially</li> <li>• Steep areas along berms are being avoided for slashing due to safety concerns. Additionally, the small amounts of exotic vegetation are currently stabilising these berms, and will be targeted once construction is finalised in the MPW areas.</li> </ul> | |

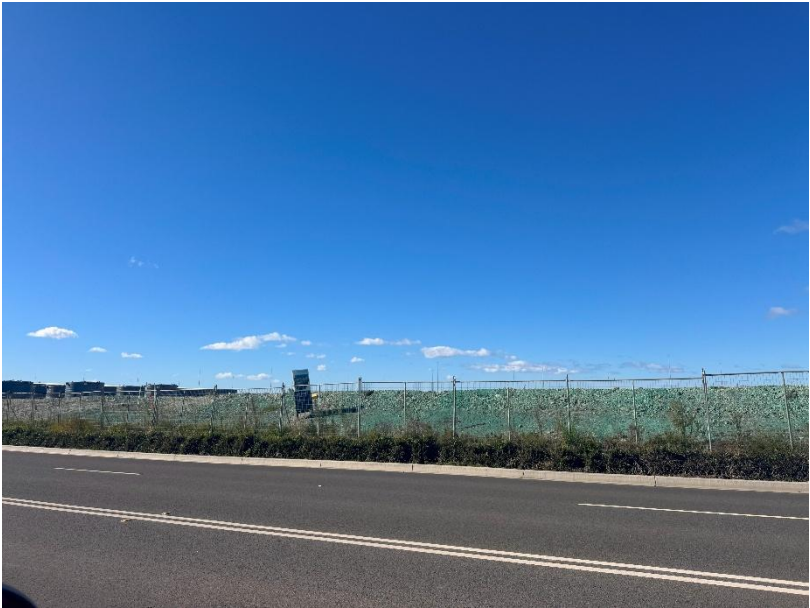
| Inspection area | Weed abundances for current survey | Photo of inspection area |
|---|---|---|
| Landscaped areas along Bushmasters Avenue | <ul style="list-style-type: none"> <li>Landscapes vegetation is in good condition, with minor weed incursions</li> <li>Weed species present include <i>Sonchus oleraceus</i> (Common Sowthistle), <i>Chloris virgata</i> (Rhodes Grass), <i>Bidens pilosa</i>, <i>Conyza bonariensis</i> (Fleabane), <i>Cyclosporum leptophyllum</i> (Slender Celery), and <i>Tagetes minuta</i> (Stinking Roger).</li> <li>Areas with limited to no landscaped vegetation are particularly susceptible to weed incursion from cleared areas (see adjacent photo)</li> </ul> | |

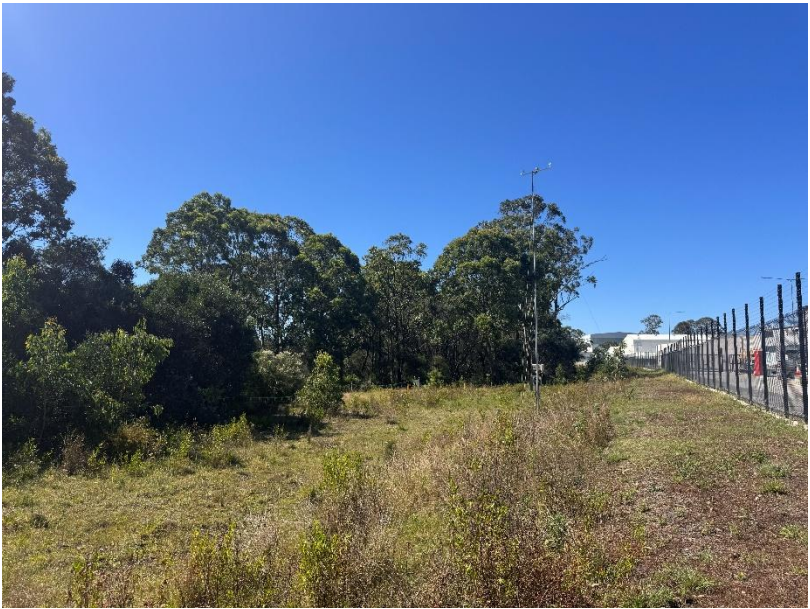
| Inspection area | Weed abundances for current survey | Photo of inspection area |
|---|---|---|
| APZ area – northern MPW | <ul style="list-style-type: none"> <li>• Suppression of <i>Medicago polymorpha</i> and other herbacious weeds occuring in this area (<i>Sonchus oleraceus</i> (Common Sowthistle), <i>Circium vulagre</i>)</li> <li>• Methods include slashing and hand removal around native species</li> <li>• Large stands of the native shrub <i>Dodonea viscosa</i> are growing unimpeded.</li> </ul> | |
