CONTRACT REPORT

Road Safety Audit - Cambridge and Moorebank Avenues, Moorebank - Construction Traffic Accesses

Project No: PRS17114

date August 2017

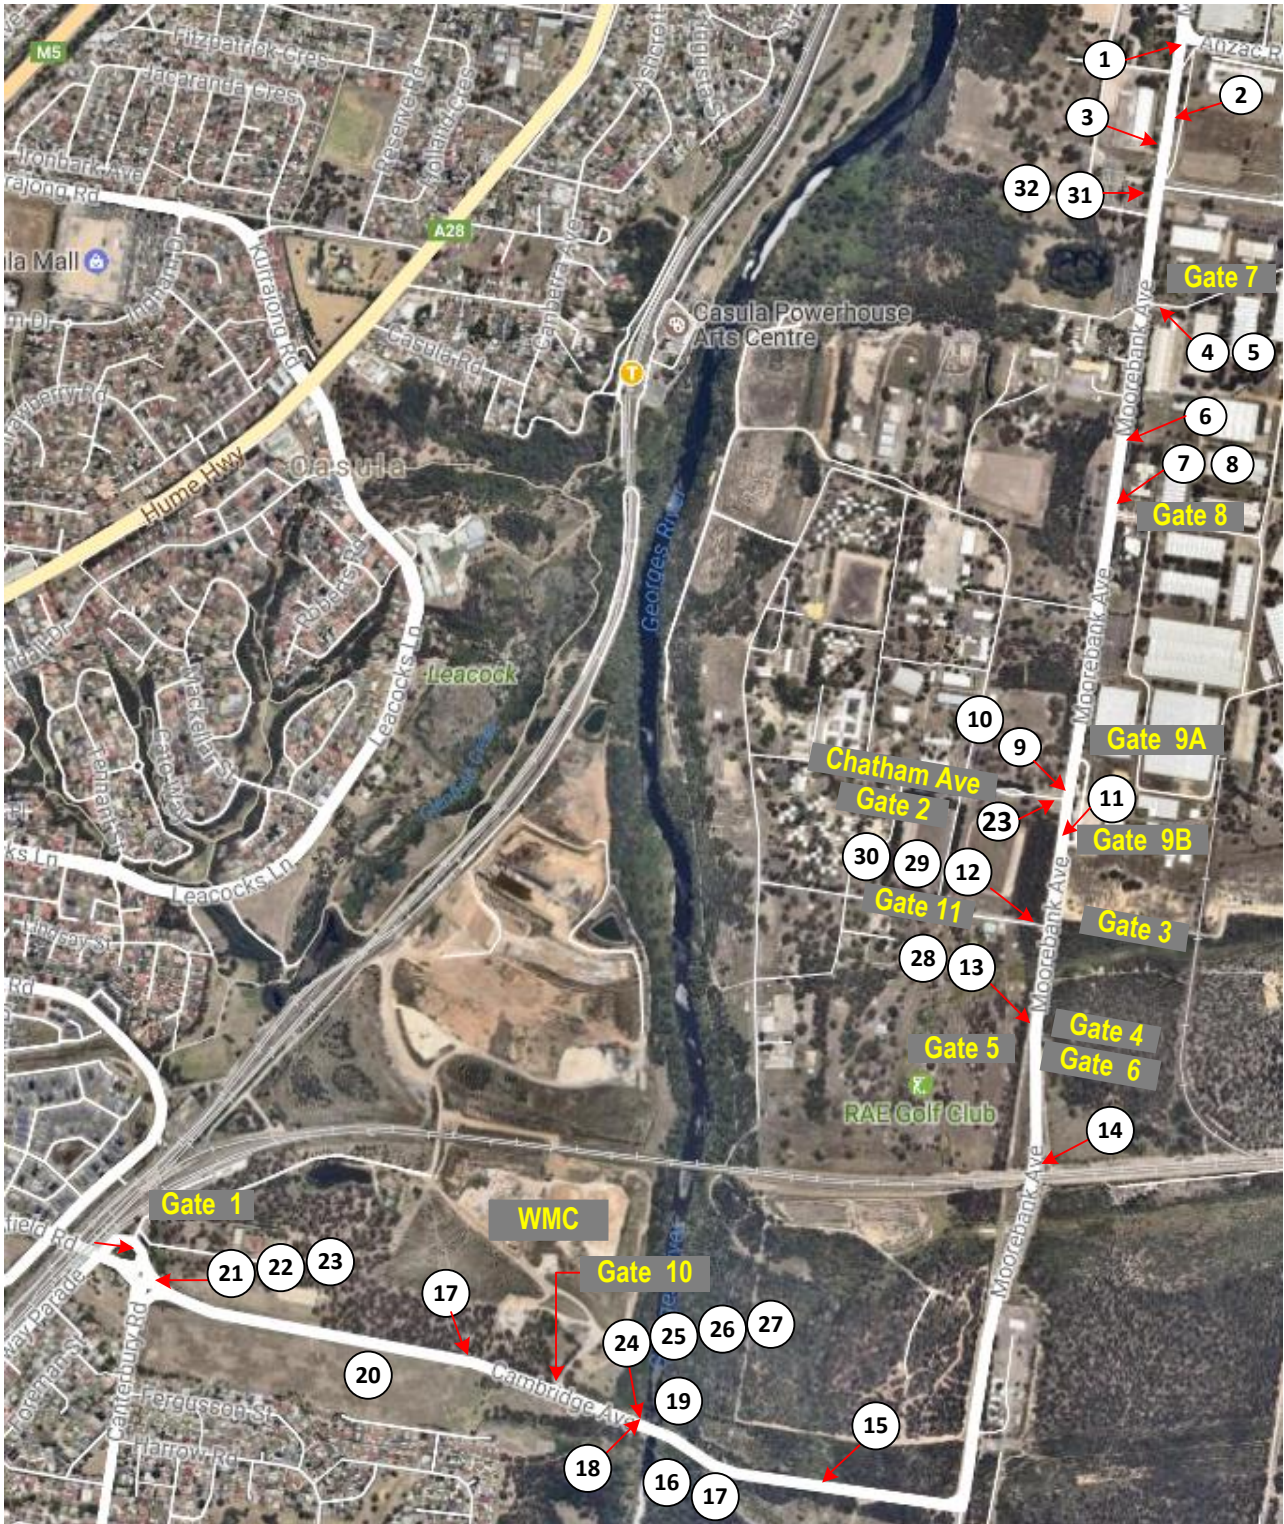
Figure 3.1: Road safety audit location of issues

A detailed tabulation of all the road safety audit findings along Moorebank and Cambridge Avenues is presented in Table 3.2, with the location of each issue shown in Figure 3.1.
