**MOOREBANK PRECINCT EAST STAGE 1
RALP No 1**

PRE-CONSTRUCTION DILAPIDATION REPORT

MOOREBANK AVENUE GLENFIELD

FOR
CPB CONTRACTORS PTY LTD
Level 2 – 177 Pacific Highway North Sydney

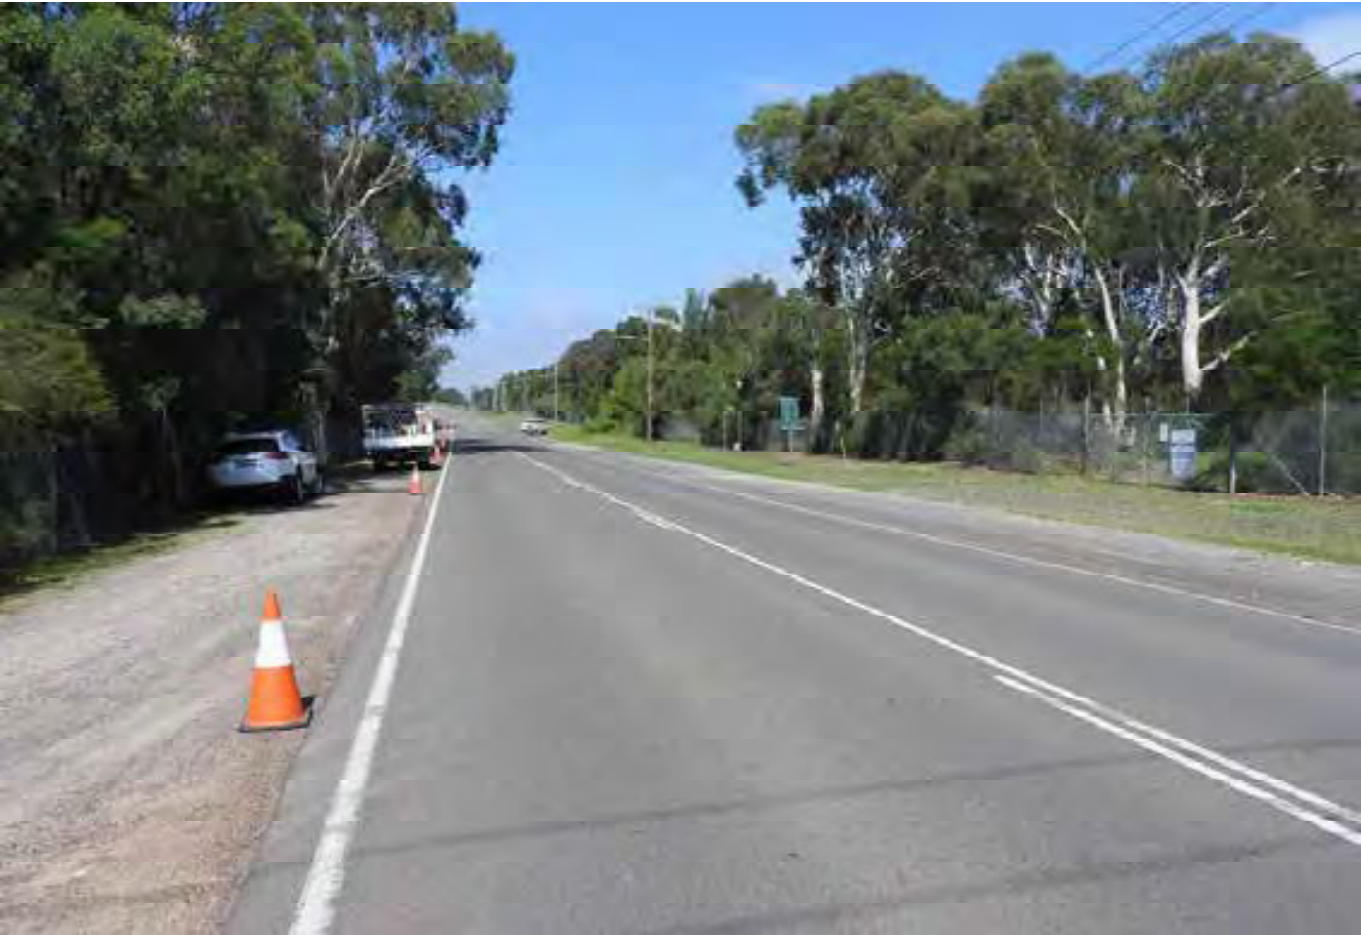
DSCN0001

AREA	LOCATION	DETAILS	PHOTO
Moorebank Avenue – Eastern Side	-	General photo of area facing south	1
Moorebank Avenue – Eastern Side		The survey begins at the corner of the boundary fence shown in Photo 2 walking south to the northern side of the crash barrier and opposite Light Post RG78	2
Moorebank Avenue – Eastern Side		See SK 1 for location of area surveyed	-
Moorebank Avenue – Eastern Side	Pavement, Shoulder/Verge, Kerb & Gutter & Crash Barrier	Photos showing general condition cracks damage and defects	3 - 255
Moorebank Avenue – Eastern Side	Pavement, Shoulder/Verge, & Crash Barrier	Between the northern side of the crash barrier (shown in photo 251) and the northern side of the safety fence over the railway lines (shown in photo 397). Photos showing general condition cracks damage and defects	256 - 403
Moorebank Avenue – Eastern Side	Pavement, Shoulder/Verge, & Fence	Between the northern side of the safety fence over the railway lines and the southern side of the safety fence over the railway lines (shown in photo 489). Photos showing general condition cracks damage and defects	404 - 490
