MOOREBANK LOGISTICS PARK

Moorebank Precinct East: Six-Monthly Operations Compliance Report

Report: #7

Period: June 2023 – October 2023

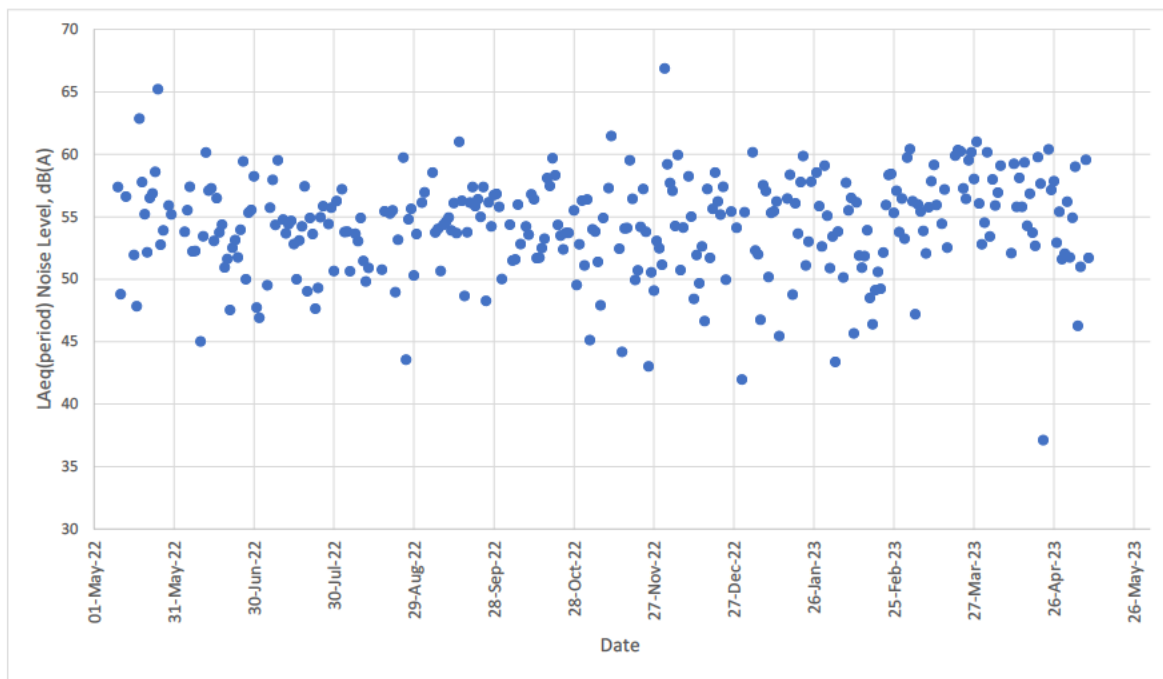
Figure 1 Measured $L_{Aeq(15hour)}$ daytime noise levels at 30 m from track centreline

Based on the results in Figure 1 and Figure 2, the measured $L_{Aeq(15hour)}$ and $L_{Aeq(9hour)}$ noise levels appear to be approximately 5 dB(A) higher than the Year 1 noise monitoring results (see Reference 3). This increase is related to the increased usage of the rail link between Year 1 and Year 3 (i.e. additional trains), rather than a result of increased noise levels from individual train passbys.

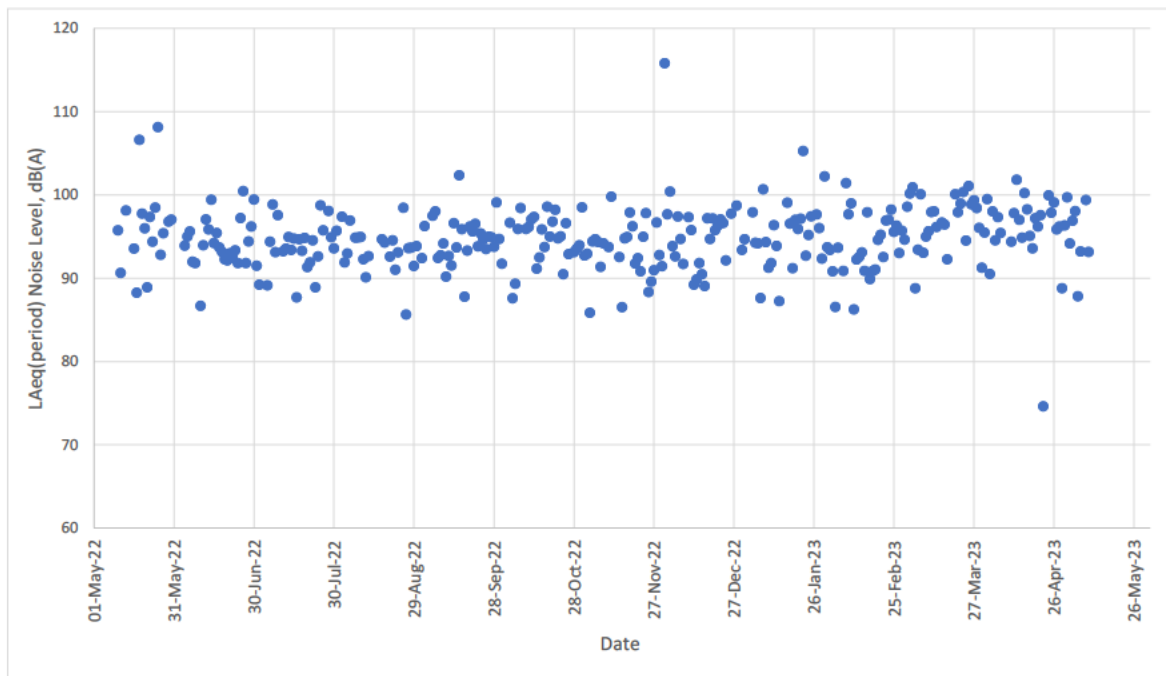
Figure 3 Measured L_{AFmax} daytime noise levels at 7.5 m from track centreline

Based on the results in Figure 3 and Figure 4, there does not appear to be any obvious trend in the measured L_{AFmax} noise levels during the monitoring period. The maximum noise levels are consistent with the Year 1 noise monitoring results (see Reference 3).

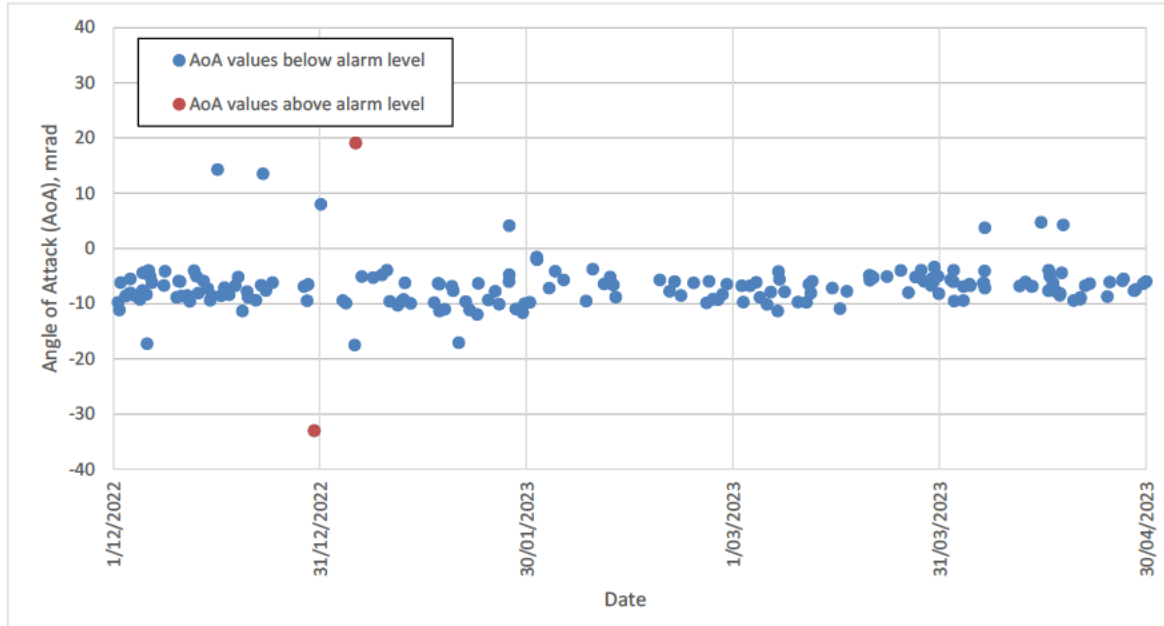
Figure 5 Maximum AoA value for each train - 1 December 2022 and 30 April 2023

A summary of the maximum AoA value measured for each train is provided in Figure 5. The results show that the maximum AoA value is typically less than 10 mrad. 2 train passbys had maximum AoA values greater than the established alarm level of approximately 19 mrad.

None of these AoA alarm events resulted in elevated noise levels at the permanent noise monitoring location (refer Section 5.1). Exceedances of the AoA alarm levels were viewed as one-off instances, occurring irregularly.

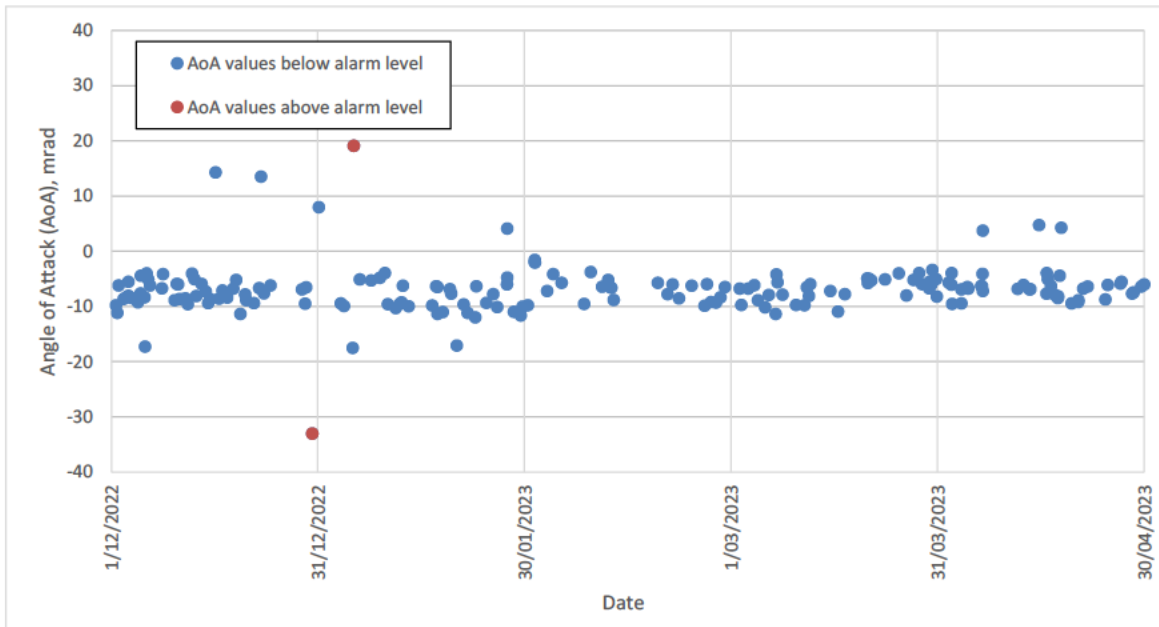
Figure 1 Maximum AoA value for each train passby

None of these AoA alarm events resulted in elevated noise levels at the permanent noise monitoring location [i.e. where the calculated $L_{Aeq(9hour)}$ noise levels at 30 m were above 60 dB(A)].

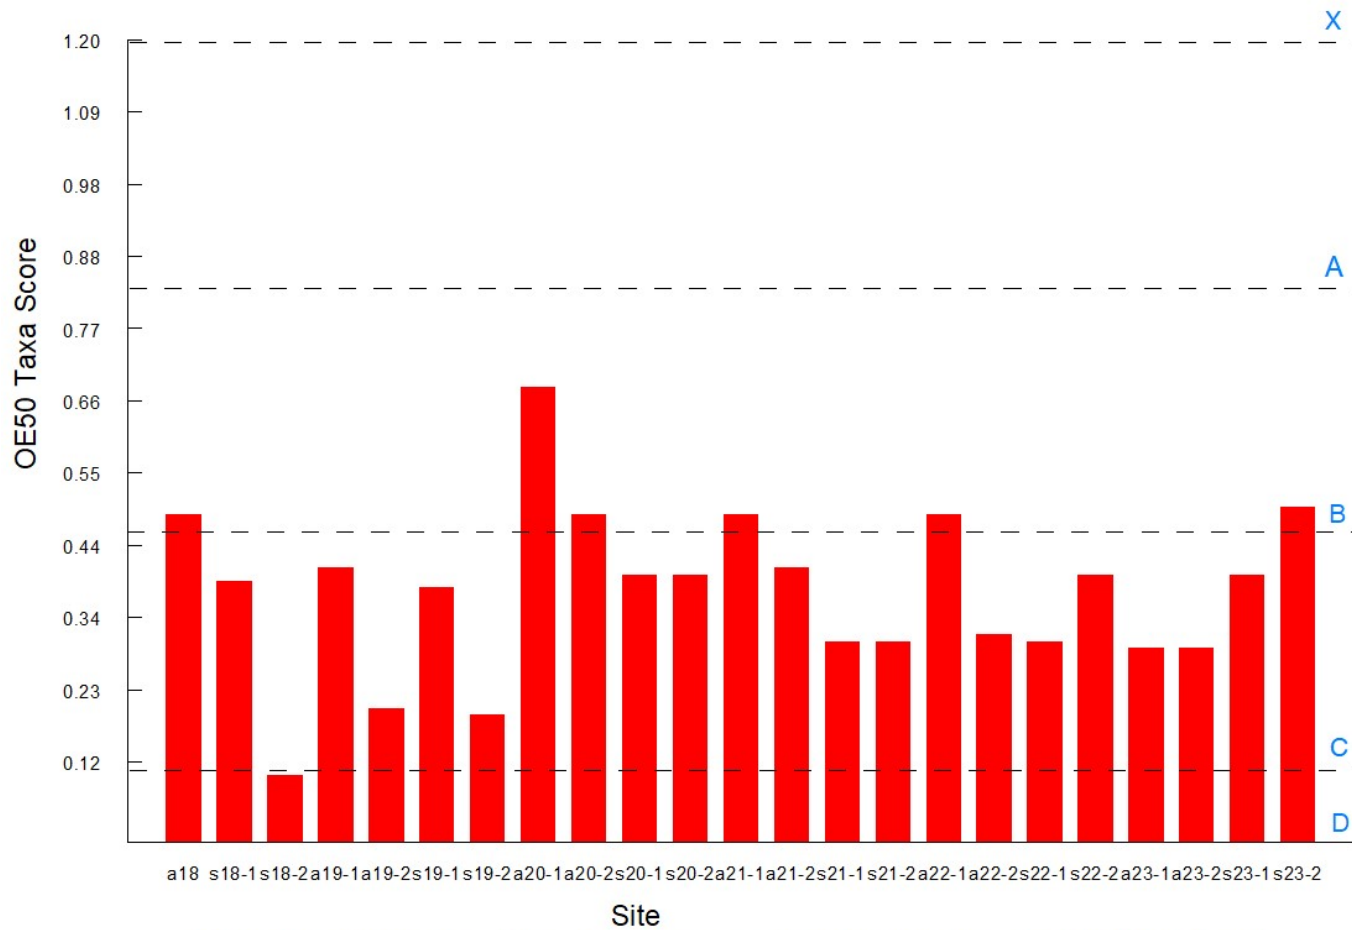
Figure 3. OE50 Taxa Scores and their respective Band Scores (B-D) for AUSRIVAS samples collected at Site AQ12 since autumn 2018.

Site AQ12 obtained an OE50 score of 0.40 for Survey 1 and 0.50 for Survey 2 during spring 2023 (Table 11, Figure 3), indicating that the macroinvertebrate assemblage at Site AQ12 was severely impaired (Band C) relative to reference sites selected by the AUSRIVAS model. The most recent OE50 scores were within the range of scores obtained since the baseline survey (Figure 3).

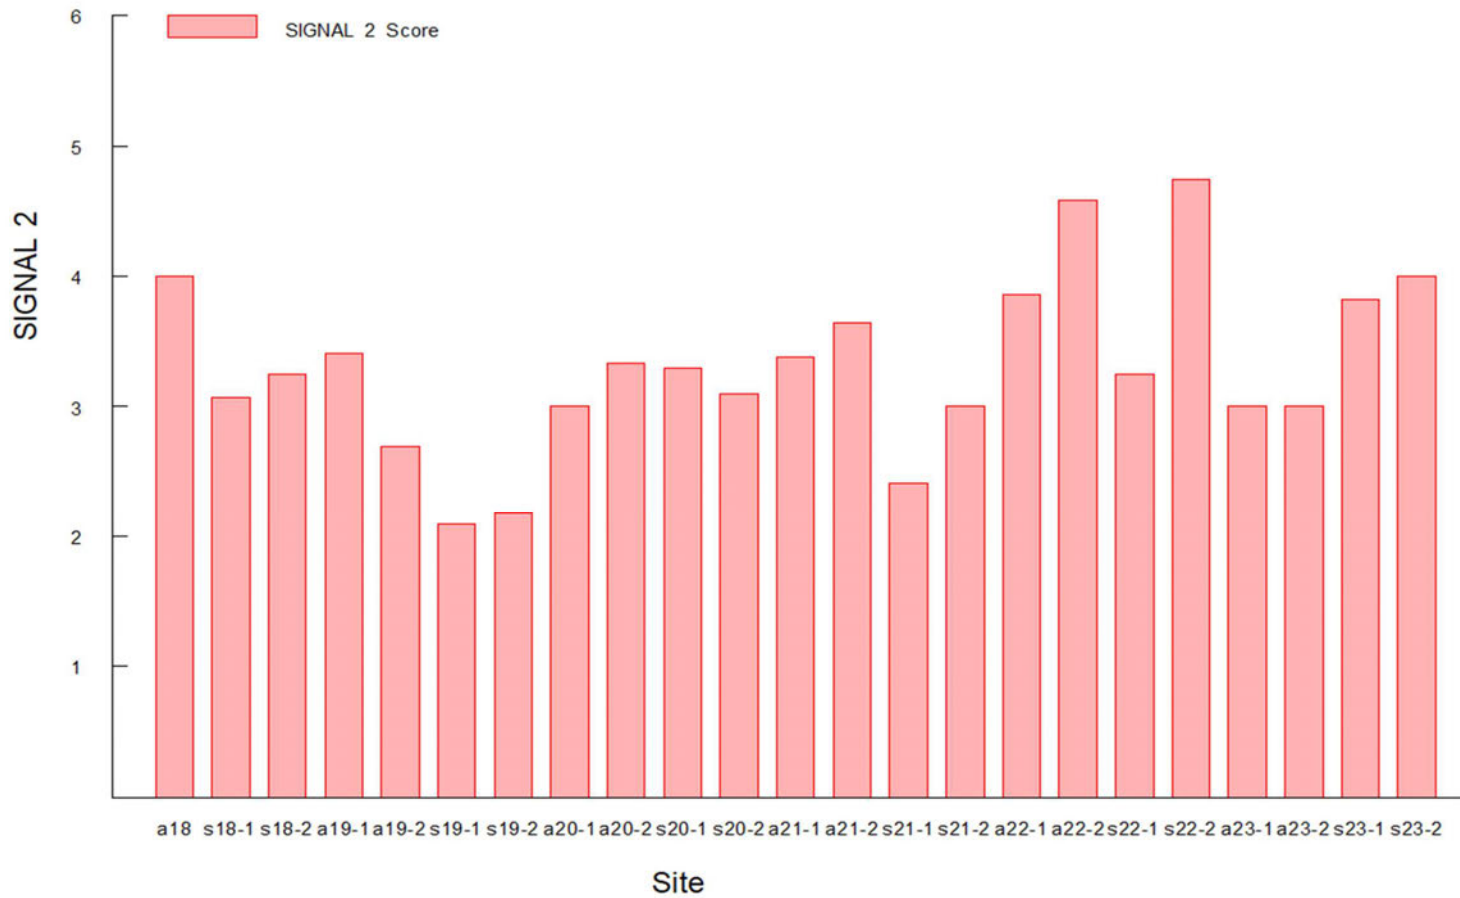
Figure 4. Quadrant diagram showing SIGNAL 2 results for Site AQ12 sampled in Anzac Creek since autumn 2018.

SIGNAL2 scores of 3.82 and 4.00 were obtained for both surveys (Table 4). The absence of Leptophlebiidae was likely to have contributed to the lower score (Table 4, Figure 4). In summary, SIGNAL 2 scores obtained for Site AQ12 have changed little over time and indicate that the macroinvertebrate assemblage at AQ12 has commonly been dominated by pollution-tolerant taxa since the commencement of sampling in autumn 2018 (Table 11, Figure 4).
