**Moorebank Avenue – Anzac Road (MAAI)
Works: Phase 2A**

Post-Opening Road Safety Audit Report

March 2024

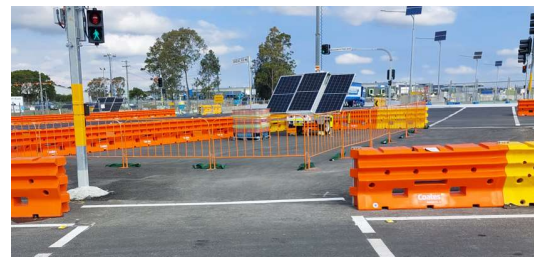
<i>For completion by BMD</i>	
No.	Description of Road Safety Issue	Risk Rating	Road Safety Category	Action by	Response	
1.	For some of the pedestrian crossing legs, there are no 'hold' lines to guide and separate pedestrian waiting areas from adjacent live traffic lanes – refer to <i>Photos 1 and 2</i> in <i>Appendix A</i> . This includes the marked pedestrian crossing across the Moorebank Avenue southbound left-turn slip-lane into Anzac Road.	Medium - High	Pedestrian infrastructure	Northrop BMD	<p>Linemarking of 'hold' lines to be implemented to delineate edge pedestrian waiting areas and adjacent live traffic.</p> <p>Completed on 25/03/2024</p>

PHOTOS 1 & 2: For the pedestrian crossing across Moorebank Avenue (north) (top photo) as well as across the Moorebank Avenue southbound left-turn slip-lane into Anzac Road (bottom photo), there are no 'hold' lines to guide and separate pedestrian waiting areas from adjacent live traffic lanes.

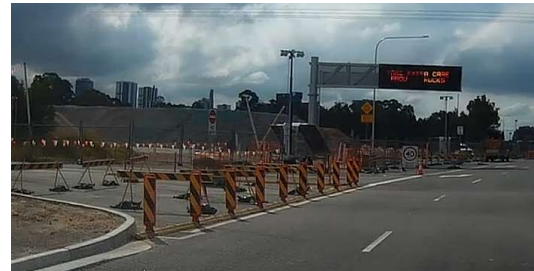
<i>For completion by BMD</i>	
No.	Description of Road Safety Issue	Risk Rating	Road Safety Category	Action by	Response
2.	<p>For Moorebank Avenue northbound travel, there is no physical obstruction to prevent a left-turn movement into Bapaume Road, which is a one-way exit only. Moreover, the 'No Left Turn' restriction sign for northbound Moorebank Avenue traffic could be reinforced with a 'No Entry' or 'One Way Exit' sign at Bapaume Road.</p> <p>During the site inspections, vehicles were observed entering Bapaume Road, ie. turning left from Moorebank Avenue northbound – refer to <i>Photo 3</i> in <i>Appendix A</i>. This is possibly due to a lack of adequate directional / destination signage to advise approaching traffic of the new intersection legs and their destinations as well as to advise traffic destined for the former Bapaume Road route to use the new Bushmaster Avenue intersection leg. This applies to traffic approaching from the south (along Moorebank Avenue northbound) and the east (along Anzac Road westbound).</p>	Medium	Delineation	Northrop BMD	<p>Additional 'Klemmfix' or similar to be installed to further restrict left turn movements into Bapaume Road.</p> <p>Completed on 26/03/2024</p>

PHOTO 3: For Moorebank Avenue northbound travel, there is no physical obstruction to prevent a left-turn movement into Bapaume Road, which is a one-way exit only. During the site inspections, vehicles were observed entering Bapaume Road, ie. turning left from Moorebank Avenue northbound.

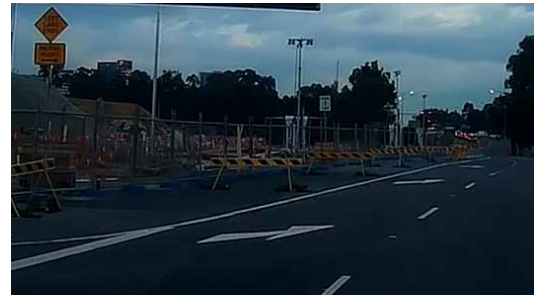
<i>For completion by BMD</i>	
No.	Description of Road Safety Issue	Risk Rating	Road Safety Category	Action by	Response
3.	For Moorebank Avenue northbound travel, the lane-drop north of Bapaume Road is poorly defined with a lack of merge arrows and the 'Left Lane Ends / Merge Right' and 'Form 1 Lane' signage being located too far left of the approach travel path – refer to <i>Photo 4</i> in <i>Appendix A</i> .	Medium	Delineation	North rop BMD	<p>Signage to be shifted closer to the edge of the carriageway, as these signs are on temporary concrete blocks they are to be placed 5m from the edge of the carriageway. Refer AS1742.2 Appendix D, TS 02642 Supplement to Austroads Guide to Road Design and TS 06307 Installation and Maintenance of Signs</p> <p>Completed on 27/03/2024</p>

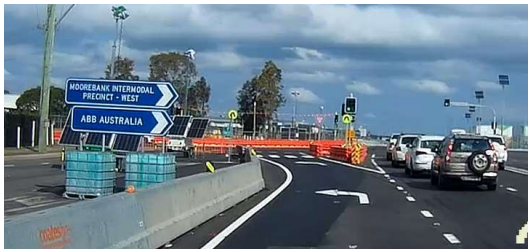
<i>For completion by BMD</i>	
No.	Description of Road Safety Issue	Risk Rating	Road Safety Category	Action by	Response
4.	For Moorebank Avenue southbound travel, the intersection direction signage approaching Bushmaster Avenue is located too far to the left of the approach travel path and is obstructed by lighting solar panels and other work-site obstructions – refer to <i>Photo 5</i> in <i>Appendix A</i> . Moreover, the signage would be better located to the right to reflect the destinations it is directing to.	Medium	Delineation / Traffic signs	BMD	<p>Signage to be shifted closer to carriageway behind existing temporary road safety barriers</p> <p>Completed 17/04/2024</p>

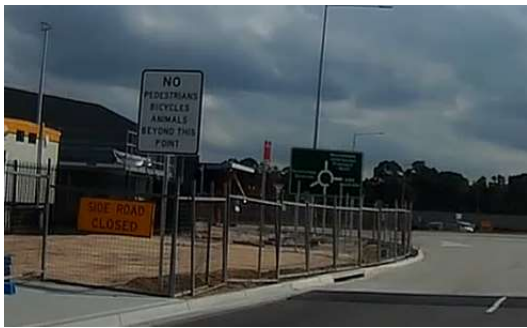
<p>6.</p>	<p>Existing directional signage is difficult to sight / read for westbound travel along Bushmaster Avenue approaching the precinct roundabout as well as along Moorebank Avenue northbound near the northern extent of the project works area – refer to <i>Photos 7 and 8</i> in <i>Appendix A</i>.</p>	<p>Low - Medium</p>	<p>Traffic signs</p>	<p>LOG OS BMD BMD</p>	<p>Signage at Bushmaster Ave Truck sign to be removed SIDE ROAD CLOSED to be relocated to east Completed 11/04/2024</p>

PHOTOS 7 & 8: Existing directional signage is difficult to sight / read for westbound travel along Bushmaster Avenue approaching the precinct roundabout (top photo) as well as along Moorebank Avenue northbound near the northern extent of the project works area (bottom photo).

<p>PROHIBITED ON MOTORWAY sign which was blocking the sighting of the large directional sign to be relocated to south for better visibility of the large directional sign. Completed 15/04/2024</p>
-----------	--	-------------------------	----------------------	--	---

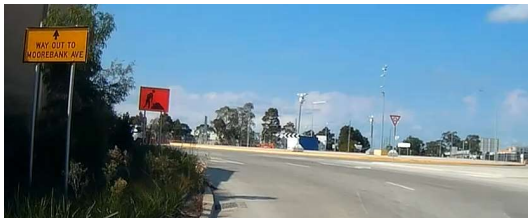
<i>For completion by BMD</i>	
No.	Description of Road Safety Issue	Risk Rating	Road Safety Category	Action by	Response
8.	Some temporary safety barrier ends do not have hazard markers to adequately delineate them, which is undesirable, eg. approach to the Anzac Road left-turn splitter island for Moorebank Avenue southbound travel – refer to <i>Photo 10</i> in <i>Appendix A</i> .	Low - Medium	Delineation	BMD	<p>Klemmfix delineation installed Completed 26/03/2024</p>

PHOTO 10: For the approach to the Anzac Road left-turn splitter island for Moorebank Avenue southbound travel, the temporary safety barrier ends do not have hazard markers to adequately delineate them. Also, note the 'Give Way' sign located on the right side of the approach only, which is non-standard and should be duplicated on the left side to reinforce the intersection control

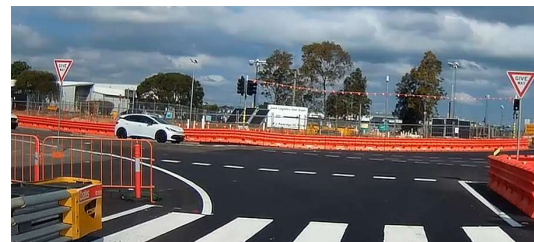
12.	At the former Bapaume Road exit, the 'Stop' sign is located on the right side of the approach only, which is non-standard and should be duplicated on the left side to reinforce the intersection control.	Low	Traffic signs	Northrop	<p>This arrangement matches the approved ultimate arrangement of signage. Note, this is due to the large left exit radii preventing a 'STOP' sign from being located in a prominent location on the left side of the roadway.</p>
