APPENDIX G – WEED MONITORING REPORTS

MIP BI-MONTHLY WEED MONITORING REPORT – JUNE 2025

Arcadis has been commissioned to conduct bi-monthly weed monitoring surveys within the operational areas of Moorebank Precinct East (MPE) and Moorebank Precinct West (MPW). These areas together are known as the Moorebank Intermodal Precinct (MIP).

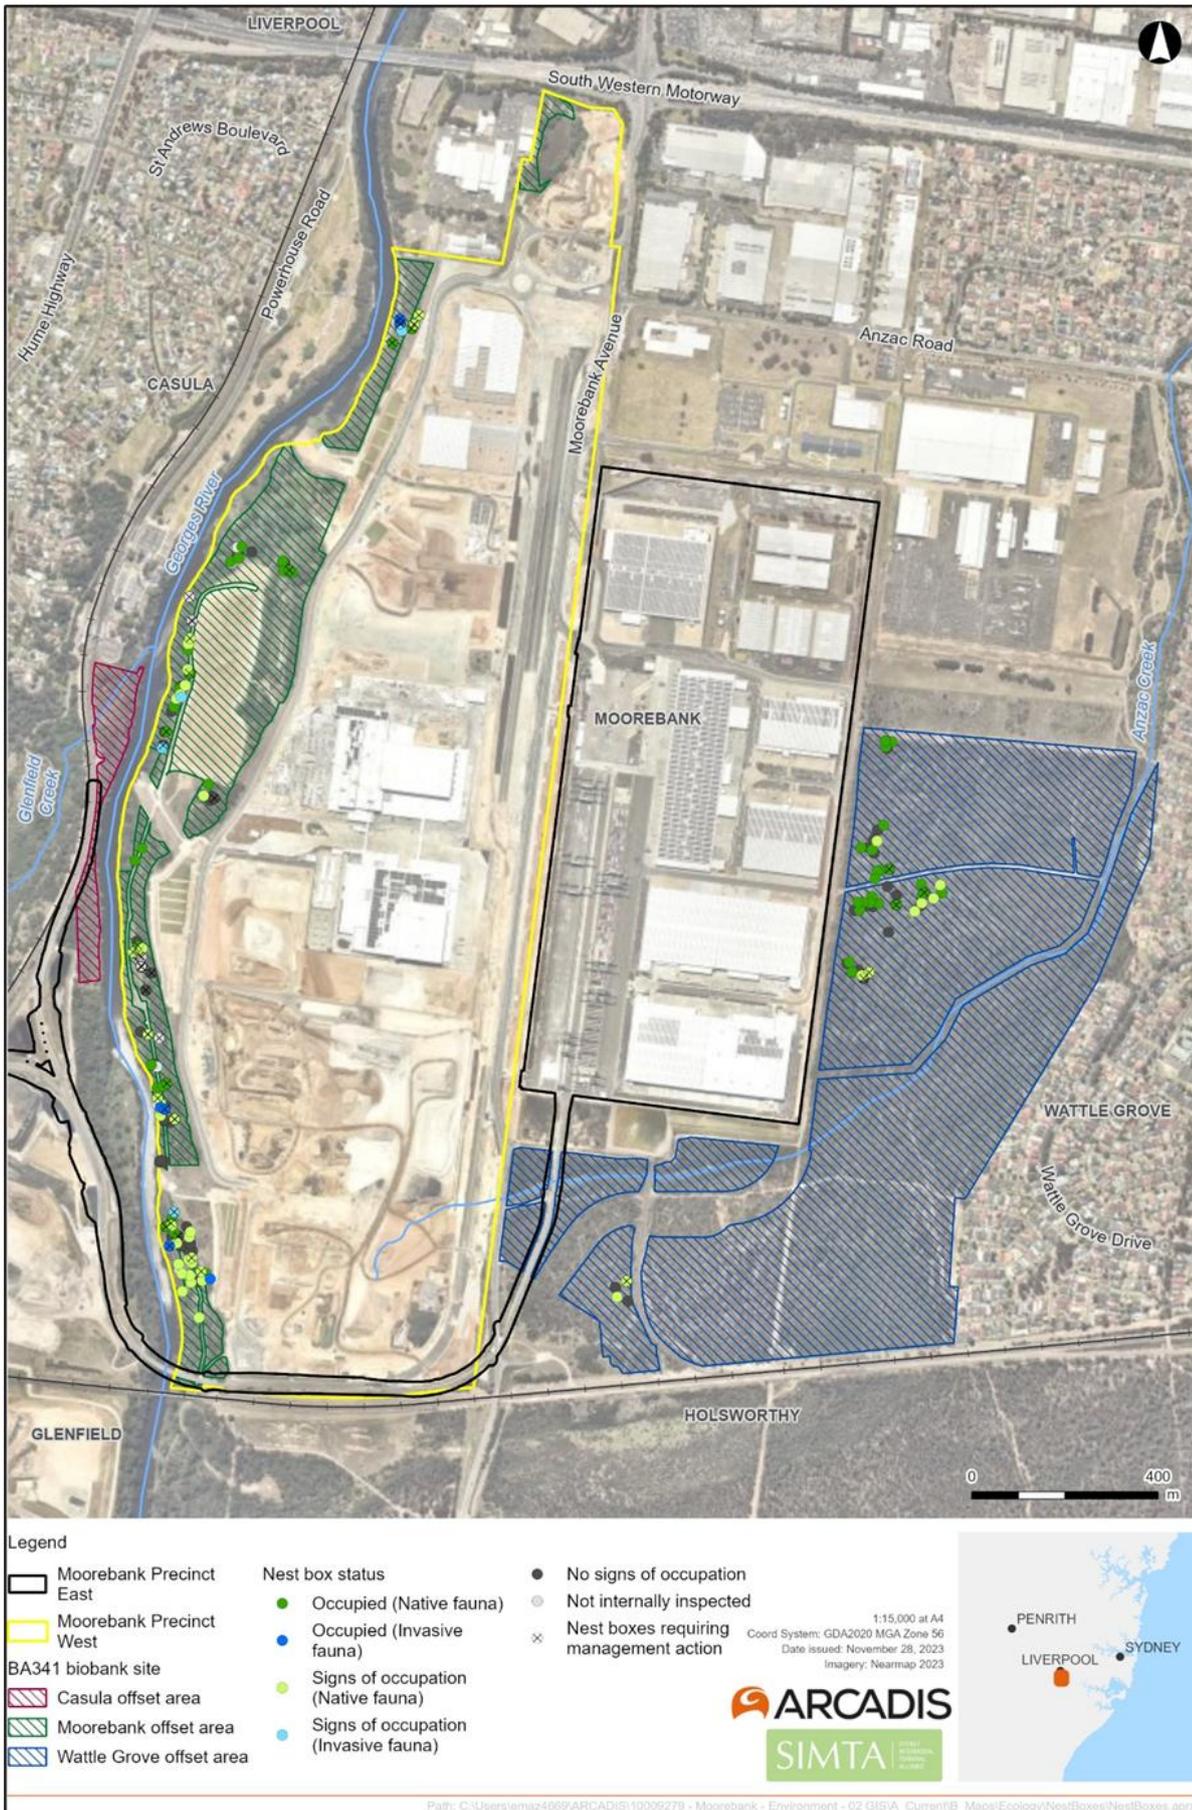
Since the initial monitoring survey (2018) there has been a reduction in the number of functional nest boxes across the site from 247 to 187 due to deterioration and decommission for various reasons (Arcadis 2025). There have also been some changes to the location of nest boxes along the Georges River Corridor and within the Bootland due to nest boxes being re-located from the impact area of MIP and the more recently the Moorebank Avenue Realignment project. A map showing the current locations of the 187 functional nest boxes is shown in Figure 1-1.

Figure 1-1. A map showing the locations of nest boxes checked in spring 2024.

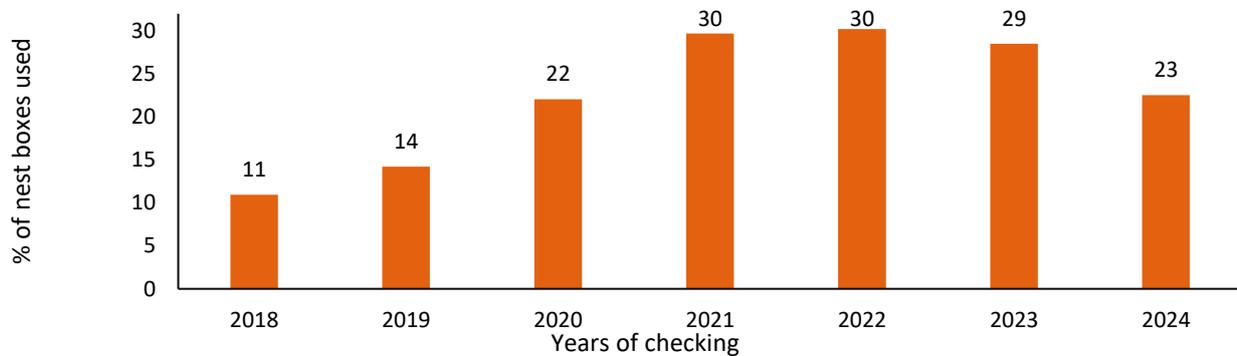
Figure 4-1. Nest box utilisation rates recorded during monitoring between 2018 -2024

Review of fauna use and uptake of nest boxes across five years of monitoring has revealed high utilisation by suite of native fauna species including Sugar Gliders, Australia Wood Duck, Green Tree Frog, Rainbow Lorikeet and Southern Boobook Owl. Utilisation rates recorded across monitoring years has been shown in Figure 4-1. Nest box utilisation by native fauna are considered adequate if occupancy rates are greater than 10 per cent (Lindenmayer et al. 2017, Goldingay et al. 2018). Greater than 10 per cent occupancy has been recorded across all monitoring years. None of the target threatened species (Barking Owl, Brown Treecreeper, Gang-gang Cockatoo, Little Lorikeet, Eastern Pygmy-possum and Squirrel Glider) have been recorded using the nest boxes since monitoring commenced in 2018.

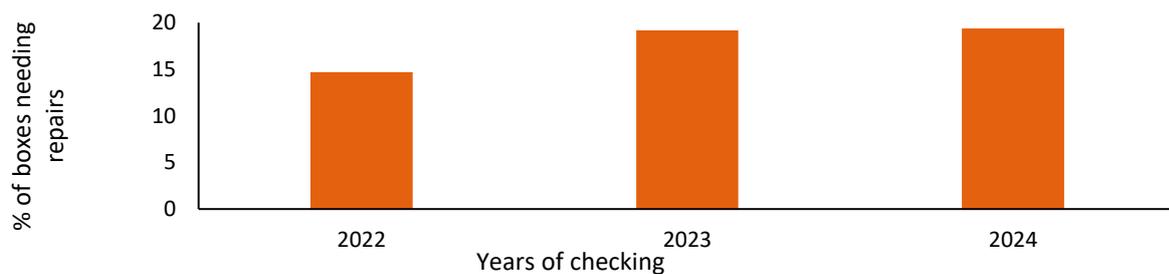
Figure 4-2. Percentage of nest boxes identified as requiring repairs over the past three years

Monitoring of these artificial hollows has identified high levels of attrition with many requiring reinstallations, refurbishments and replacements. Nest box maintenance works has been undertaken several times over the past five years in response to necessary actions identified in monitoring reports.

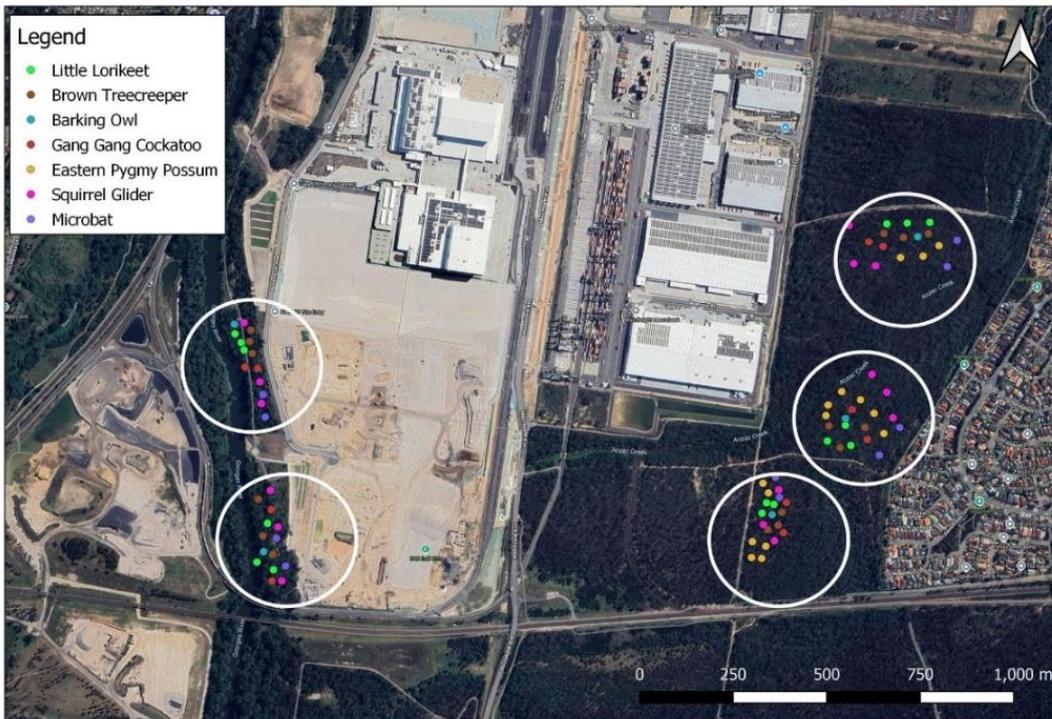
Figure 5-1. Proposed clusters of artificial hollows. Note that the habitat on the Georges River is considered of lower suitability for Eastern Pygmy-possum and therefore more hollows for this species have been added to Wattle Grove sites.

In considering the available habitat across the MIP for the target species, it is recommended that the 108 artificial hollows be distributed in five clusters (see Figure 5-1) across the Bootland (Wattle Grove Offset Area) and along the Georges River corridor (Moorebank Offset Area). Arcadis recommends that artificial hollows be installed in clusters because it will allow for an even coverage and ensures maximum opportunities for target species. Some species such as arboreal mammals also require nest sites that are nearby so that they can move between the suitable nest sites.

The Bootland (Wattle Grove Offset Area), which contains rich habitat for the target fauna species contains a relatively low number of nest boxes currently. It is recommended to distribute artificial hollows across these areas to ensure maximum opportunities for target species uptake. Nest boxes requiring repair or replacement along the Georges River or in over saturated areas should be progressively added to the Bootland until the cluster numbers are achieved.

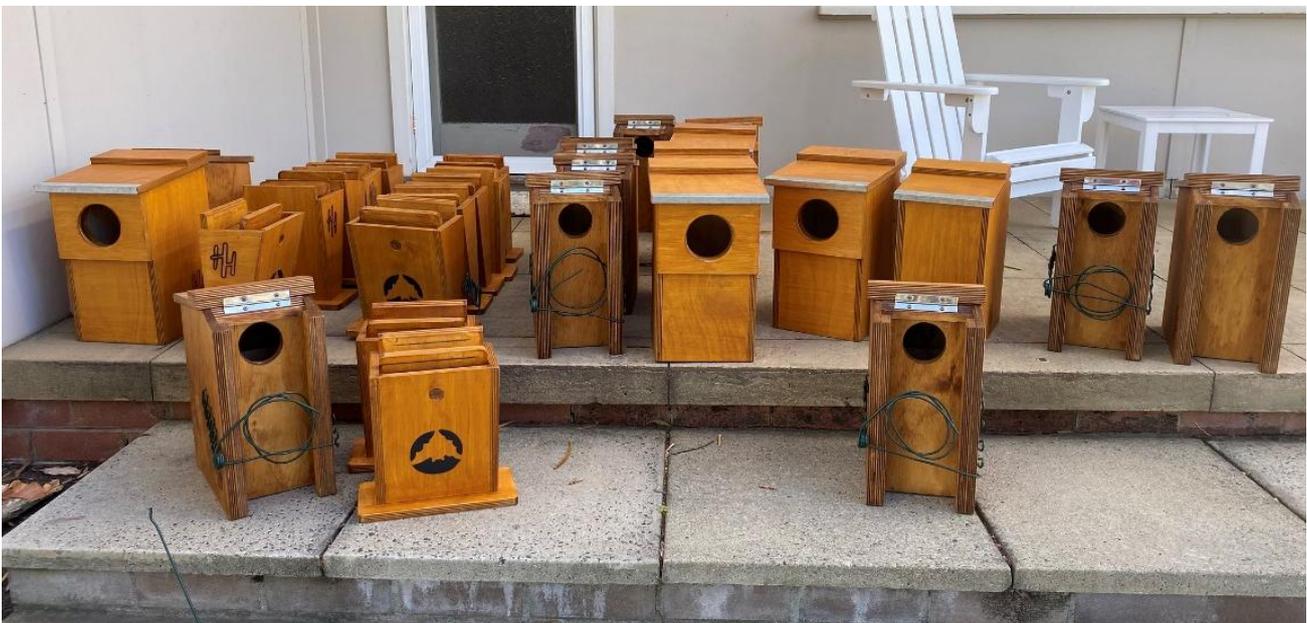
Plate 6-1. Commercially available nest boxes are usually constructed from ply

Sourcing nest boxes from large suppliers can be an easy way to obtain them. However, it is important that the construction requirements discussed here are implemented into the box designs. Many large suppliers are either inexperienced with nest boxes or design their nest boxes for backyard hobbyists (Plate 6-1, Plate 6-2). The latter means that boxes are not designed to last many years with minimal maintenance. Nest boxes should consist of a waterproofed box. Avoid the use of mounting brackets on the back of nest boxes which can trap moisture. Ensuring that nest boxes have been constructed using appropriate materials will ensure long lifespans.

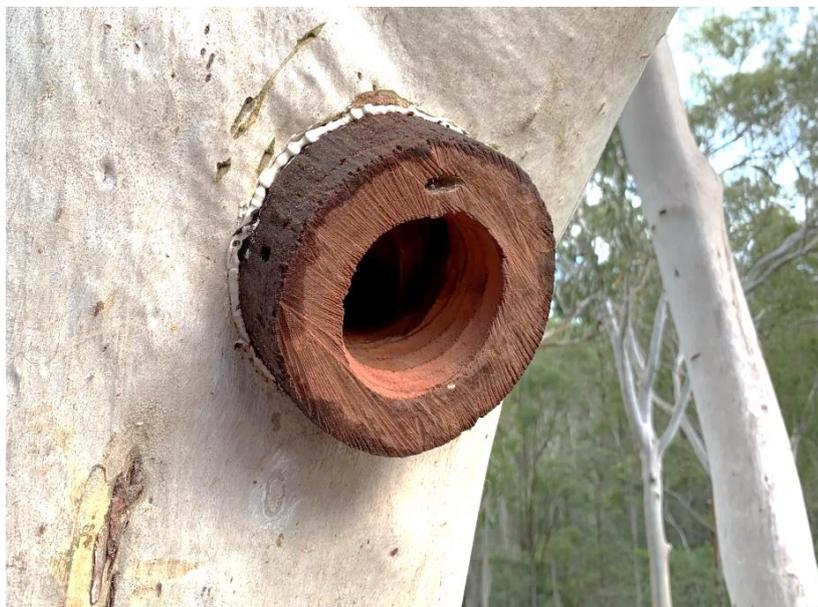
Plate 6-3. An example Hollow Hog with a short spout. The short spout will assist with preventing water egress while also allowing for a ground-based pole camera to be inserted without the need to climb the tree. Image by Matt Stephens from Hollow Hog

Where possible, it is also recommended that an entrance spout (Plate 6-3) be provided to reduce chances of callous regrowth over the entrance hollow. Care should be taken to ensure that the entrance spout be only short in length to allow for an inspection camera to be able to enter and inspect from the ground. A short entrance hollow spout is required. Where possible, the spouts should be positioned so that they point slightly downwards to prevent water egress.
