Annual EPBC Offset Site Monitoring (2024-25)

Arcadis were commissioned by Tactical Group on behalf of LOGOS to conduct the annual spring nest box monitoring survey within the Moorebank Logistics Park (MLP). The spring 2024 monitoring event marks the seventh year that Arcadis has monitored nest boxes installed within the Bootland and Georges River corridor to offset the removal of hollow-bearing trees for the construction of the MLP development. As a requirement of the State Conditions of Consent and Commonwealth Conditions of Approval and to guide the replacement of hollows removed during construction, a Nest Box Management Strategy (CPB, 2017) was prepared. This project document also included the requirement for monitoring of nest boxes. This memorandum has been prepared to document the findings of the 2024 nest box monitoring survey.

## Addendum to the Moorebank Annual Flora and Fauna Monitoring Report

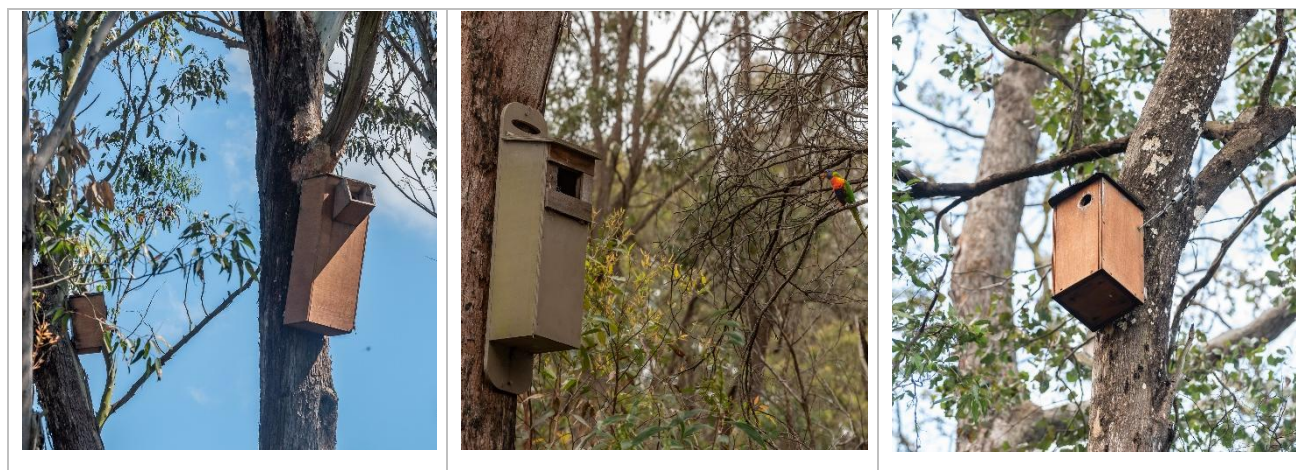
It is no longer recommended that nest boxes be installed using the 'Habisure' method due the damage the wire causes the trees they are installed on. Nest boxes installed in this manner should be eventually changed to the preferred direct screw attachment method. Nest boxes with fixed lids are unable to be inspected during monitoring and thus cannot be used when calculating occupancy rates. It is recommended that fixed nest box lids be phased out in favour of hinged lids. Annual inspection of nest boxes is a requirement of the NBS.

Plate 1: Examples of nest box designs and installation methods in the Moorebank Logistics Park. Left to right: cockatoo/owl and arboreal mammal/lorikeet nest boxes installed using habisure method, cockatoo/owl nest box installed using the screws attaching to the tree, glider nest box installed using the habisure method.

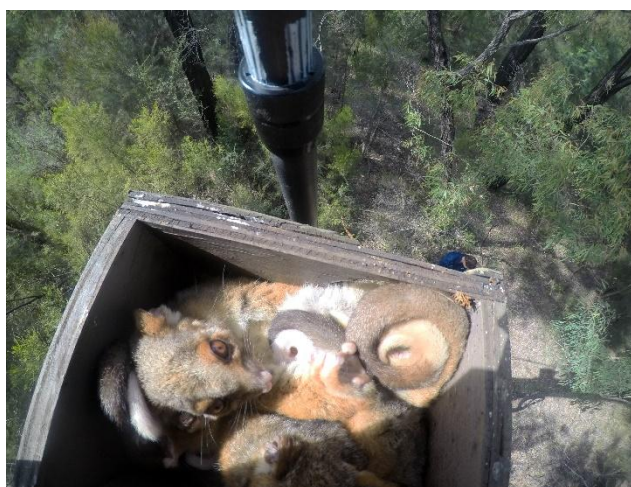
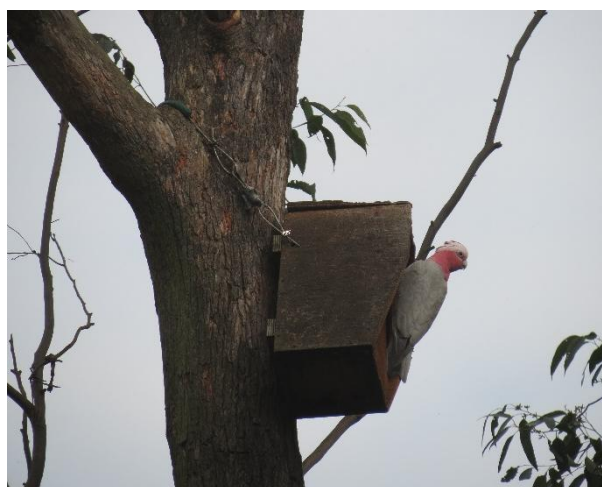
Plate 2: Native fauna recorded occupying nest boxes within the survey area – Common Ringtail Possum (left), Galah (right)

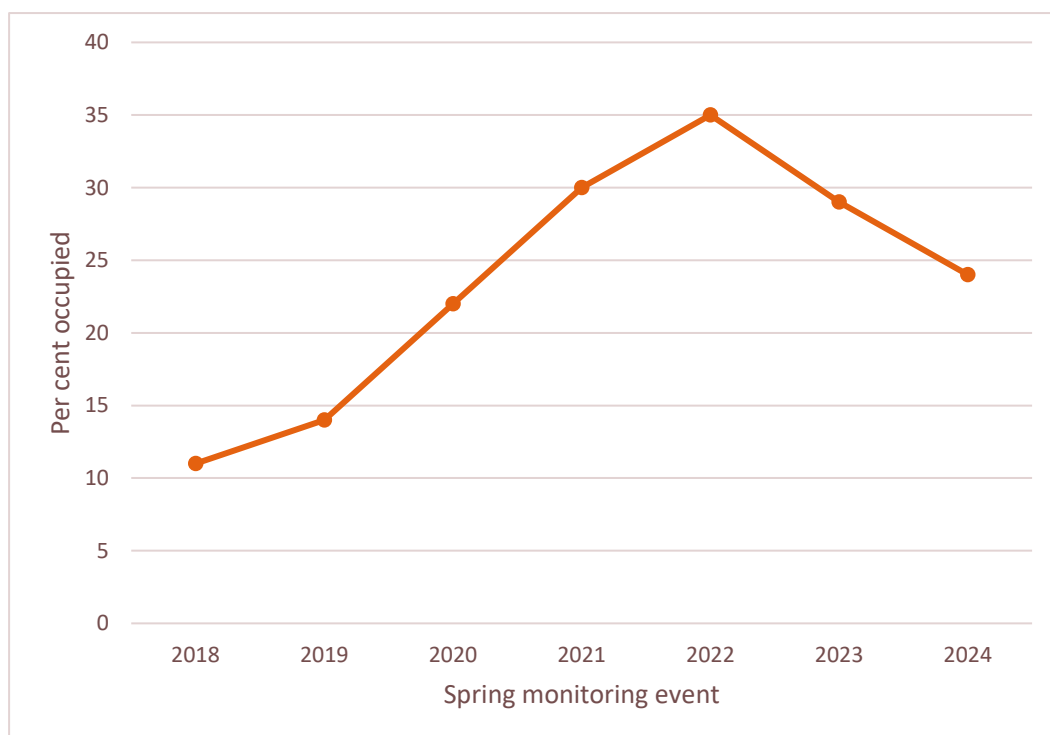
Figure 2). In the 2018 monitoring event, 11 per cent of nest boxes were occupied, which had increased to a 35 per cent rate of occupation in 2022 but decreased to 24 per cent in the 2024 survey period. The 2024 result was the fourth highest occupancy rate in the seven years of monitoring.

Overall, there has been a 5 per cent reduction in the occupation of nest boxes by native fauna across both offset sites during the 2024 monitoring period. The Bootland showed a large decrease from 59% to 21% occupation of nest boxes by native fauna between the 2023 and 2024 monitoring periods, while Georges River had a small increase from 20% to 26% occupation by native fauna between the same monitoring periods. It in the 2023 nest box monitoring report, it was suggested that the reduction in the 2023 Georges River nest boxes could be attributed to the maintenance actions that occurred in the site.

Figure 2: Occupancy rate of nest boxes by native fauna for spring monitoring events between 2018 and 2024

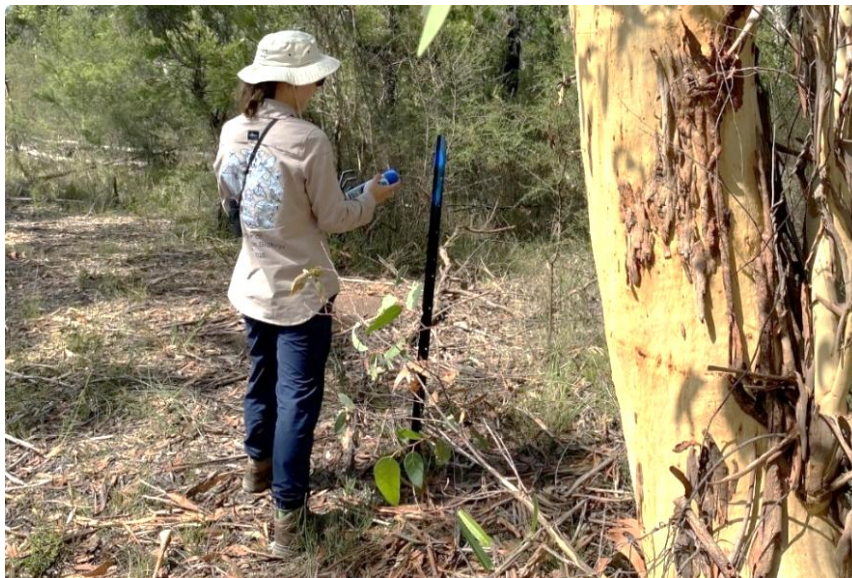
*Plate 2-1 All SAT sites were marked with a star picket, which was spraypainted with blue paint to ensure easy locating in future years, and to help distinguish them from other monitoring stakes for vegetation within the Biobank.*

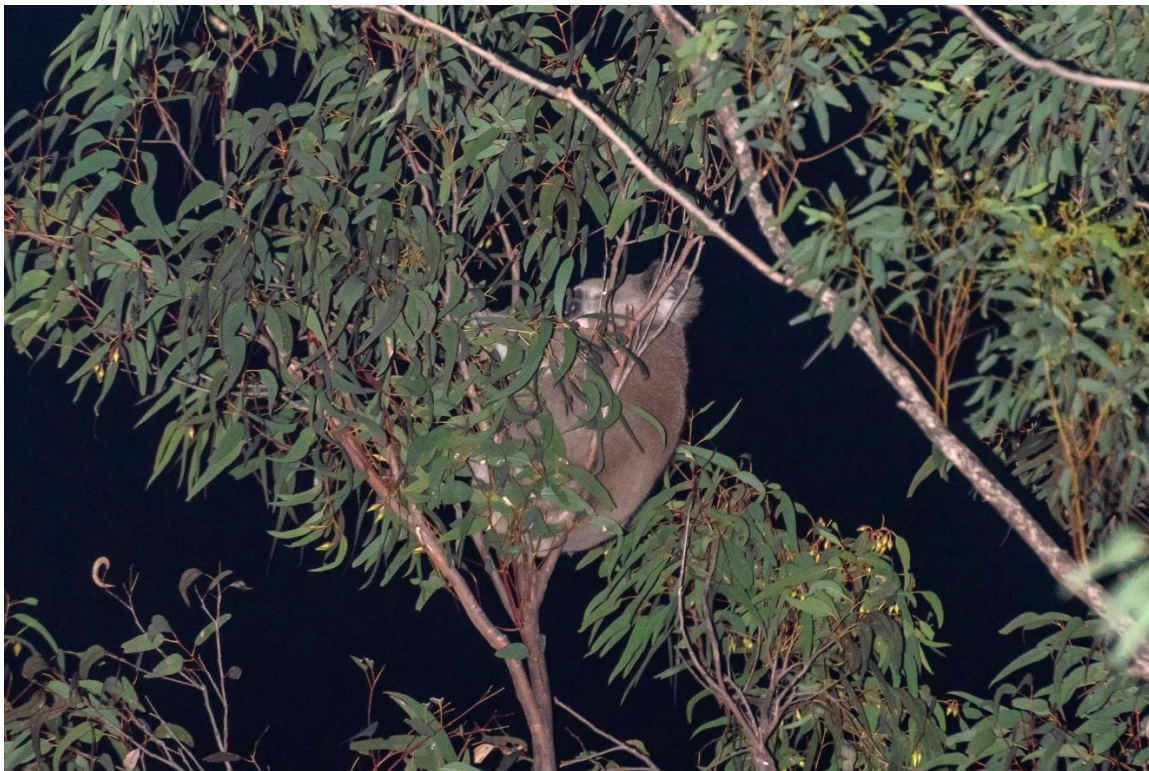
Plate 5-2. Koala feeding in a *E. moluccana* on the northern edge of the Wattle Grove site.

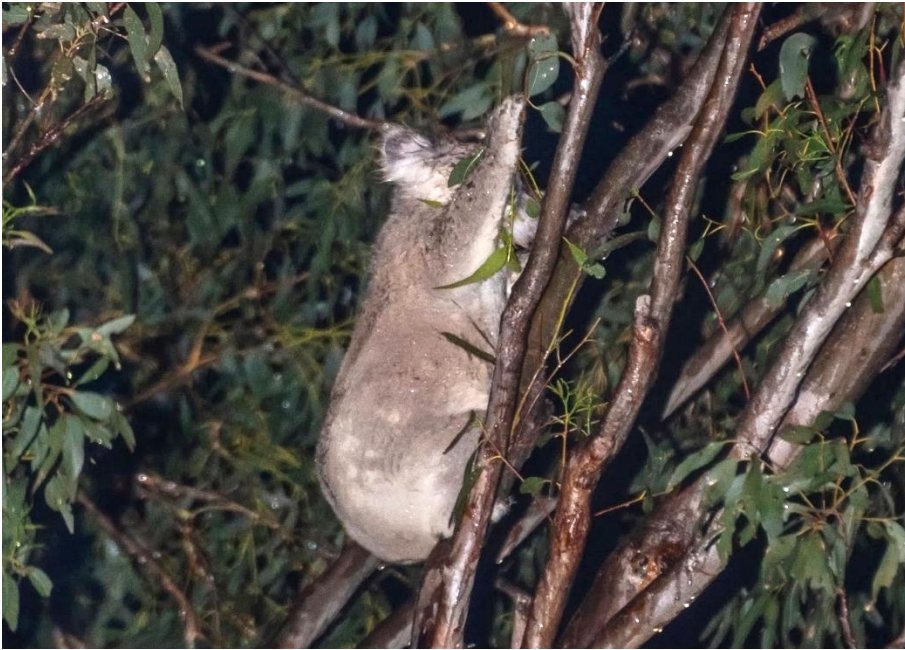
Plate 5-3. Koala observed in a *E. tereticornis* on the northeast side of the Wattle Grove opposite the warehouses.

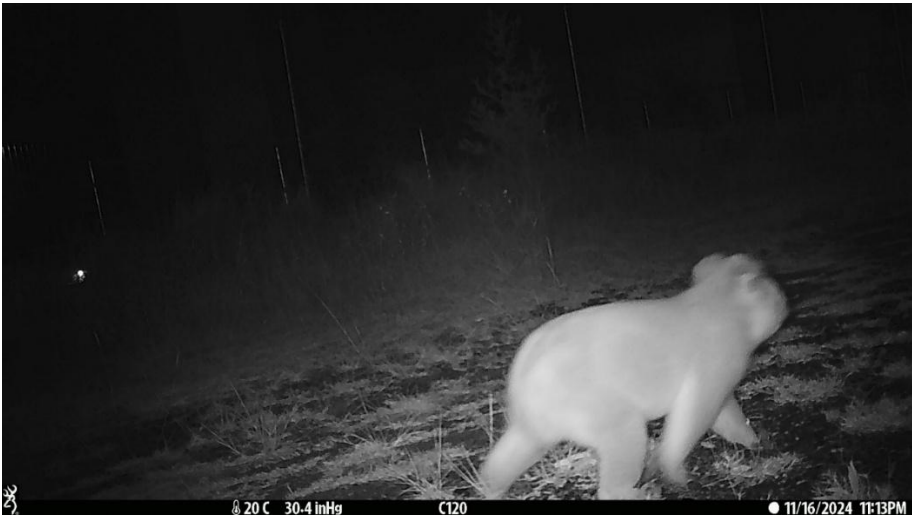
Plate 5-4.. This observation was on the western boundary of the Wattle Grove site and another observation was made on the same night near the southern end of the reserve, presumably a different individual.

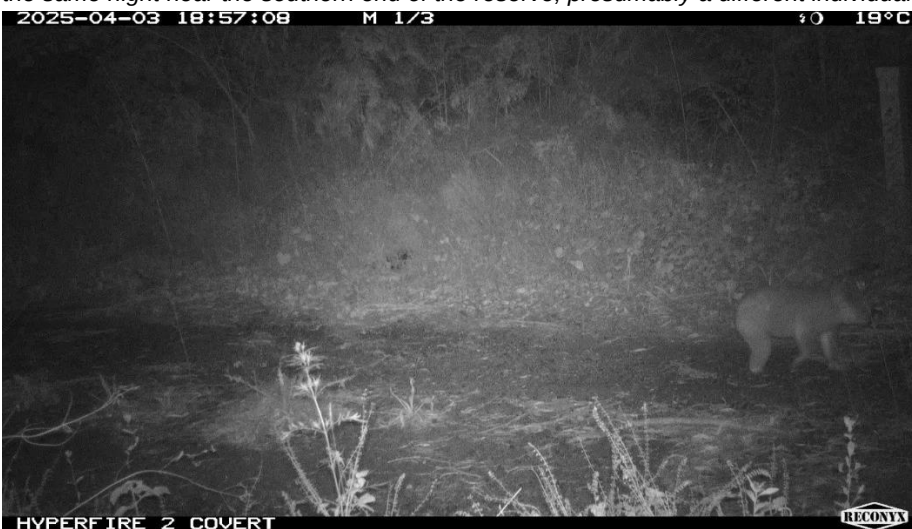
Plate 5-5. Koala photographed along the Georges River close to the site where scats were detected previously.

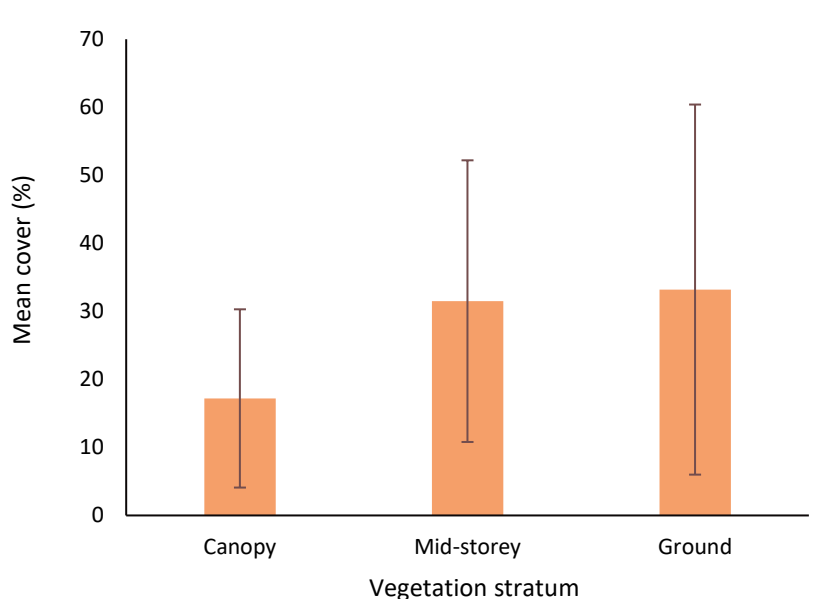
Figure 5-2. Mean (STD) foliage cover of each stratum across the Koala SAT sites.

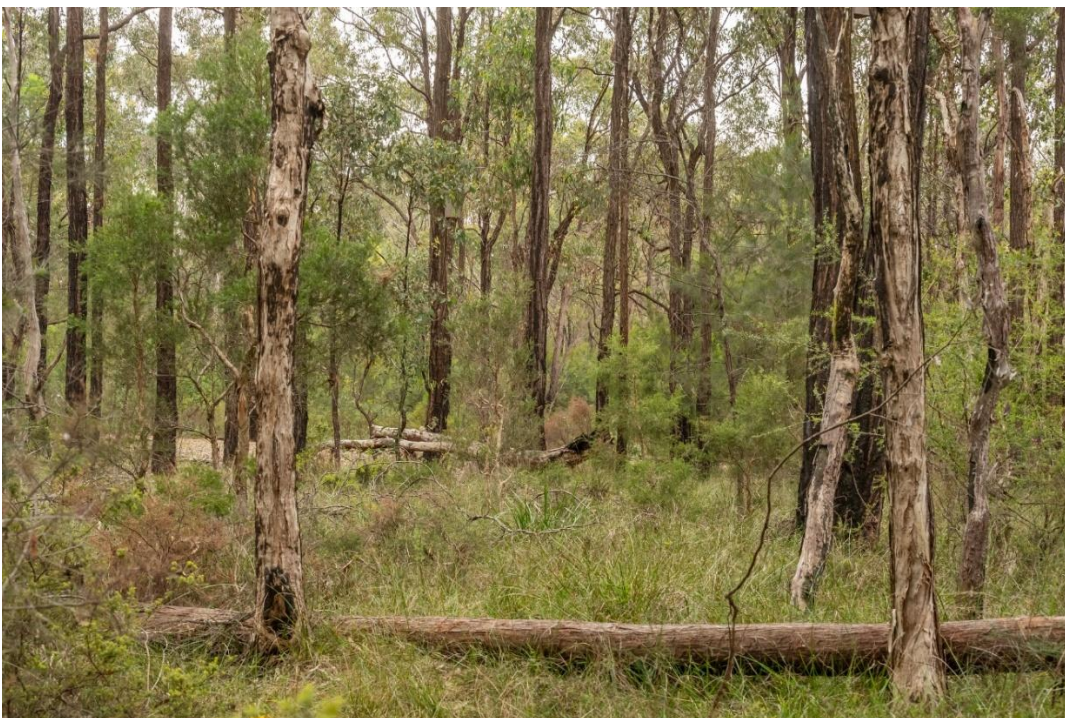
*Plate 3-7 Most sites were of juvenile or maturing trees with narrow DBH.*

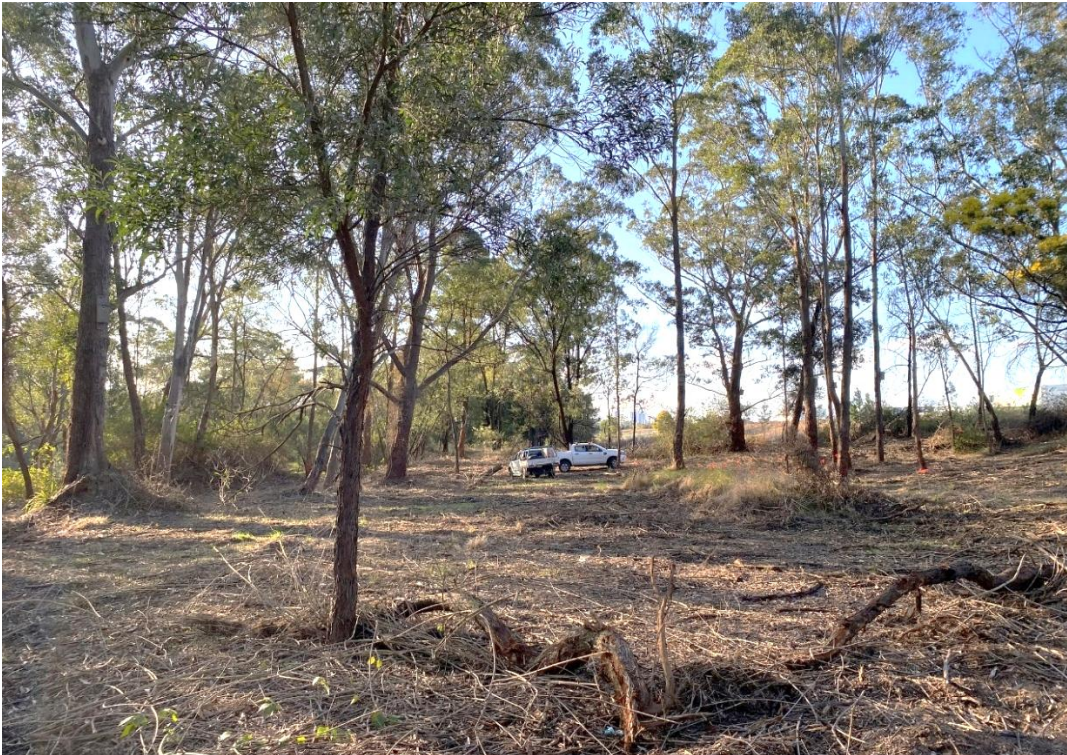
*Plate 3-8 The Georges River Biobank site consists of Eucalyptus botryoides x saligna, Forest Red Gum and Broad-leaved Apple. Some areas have recently had the Lantana cleared as seen here which could improve Koala habitat.*

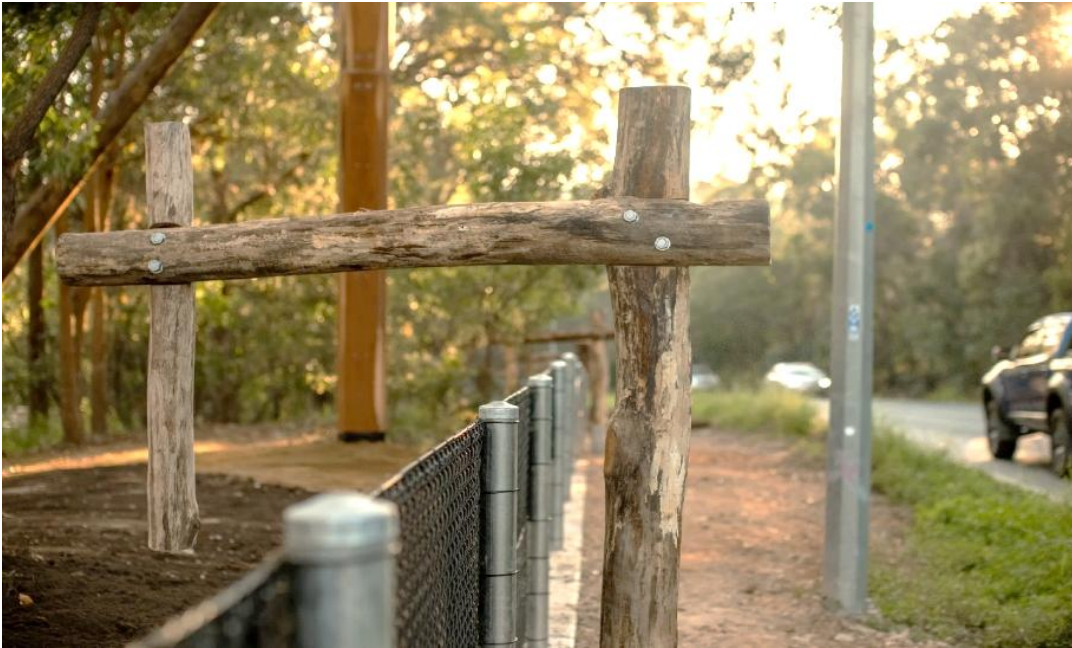
The existing fencing surrounding the Wattle Grove offset site currently protects Koalas from predation by dogs (Dissanayake *et al.* 2023) and vehicle strikes. However, the barbed wire on the top of the fence is likely to represent a threat to Koalas (and other fauna) if they climb the fence. During our field assessment, a dead Federally Listed Grey-headed Flying Fox (*Pteropus poliocephalus*) was observed entangled in the barbed wire fencing. Modification to the fence should include removal of barbed wire and the installation of Koala friendly overpass bridges (see Plate 6-1) and gates (see Plate 6-2), to facilitate access in and out of the offset site which would ensure safe passage to the larger Holsworthy Reserve to the south. Details of the specific locations where these should be installed are noted in the original Koala Management Plan (2020). In areas of high risk such as those in close proximity to the road, a floppy top fence may be required to help deter Koalas climbing.

*Plate 4-1 Example of simple Koala bridge to allow for safe passage over a fence. Image Brisbane City Council.*

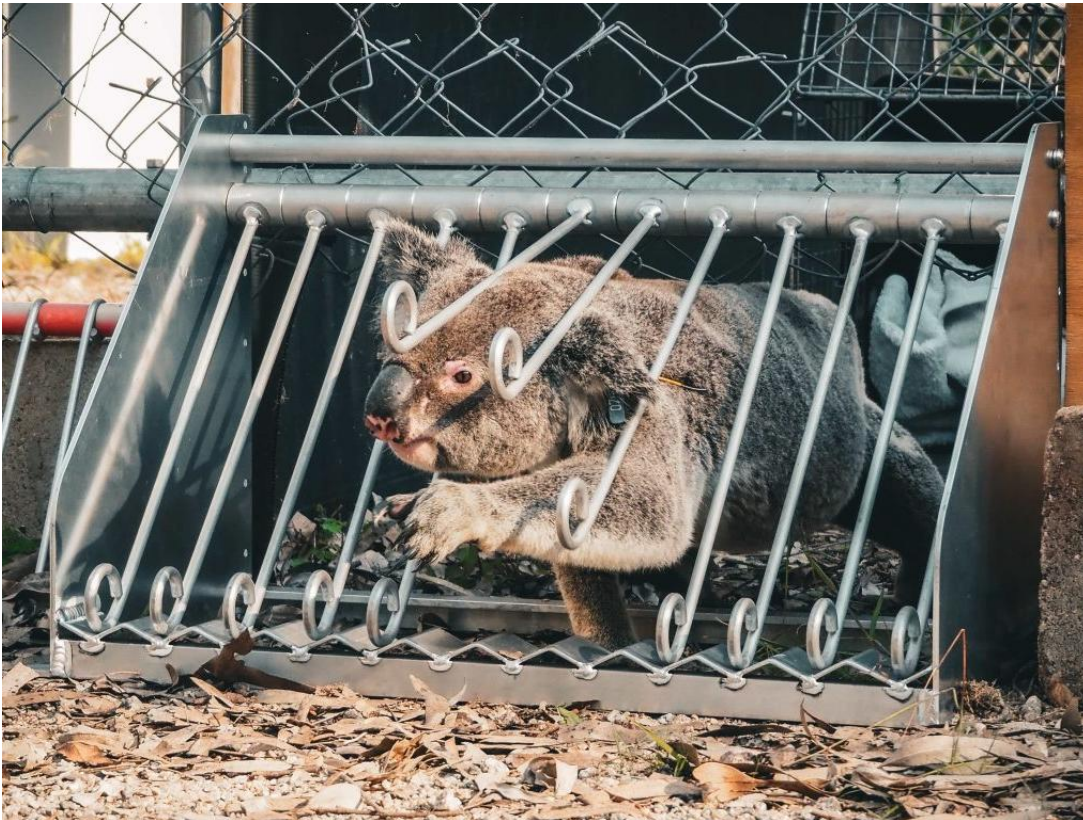
*Plate 6-2 The 'Koala Doggy Door' has recently been implemented by Endeavour Veterinary Ecology with evidence of successful use by Koalas.*
