CONSTRUCTION SOIL AND WATER MANAGEMENT PLAN

Moorebank Precinct West Stage 1

Construction Soil and Water Management Plan

MIC1-QPMS-EN-PLN-00005

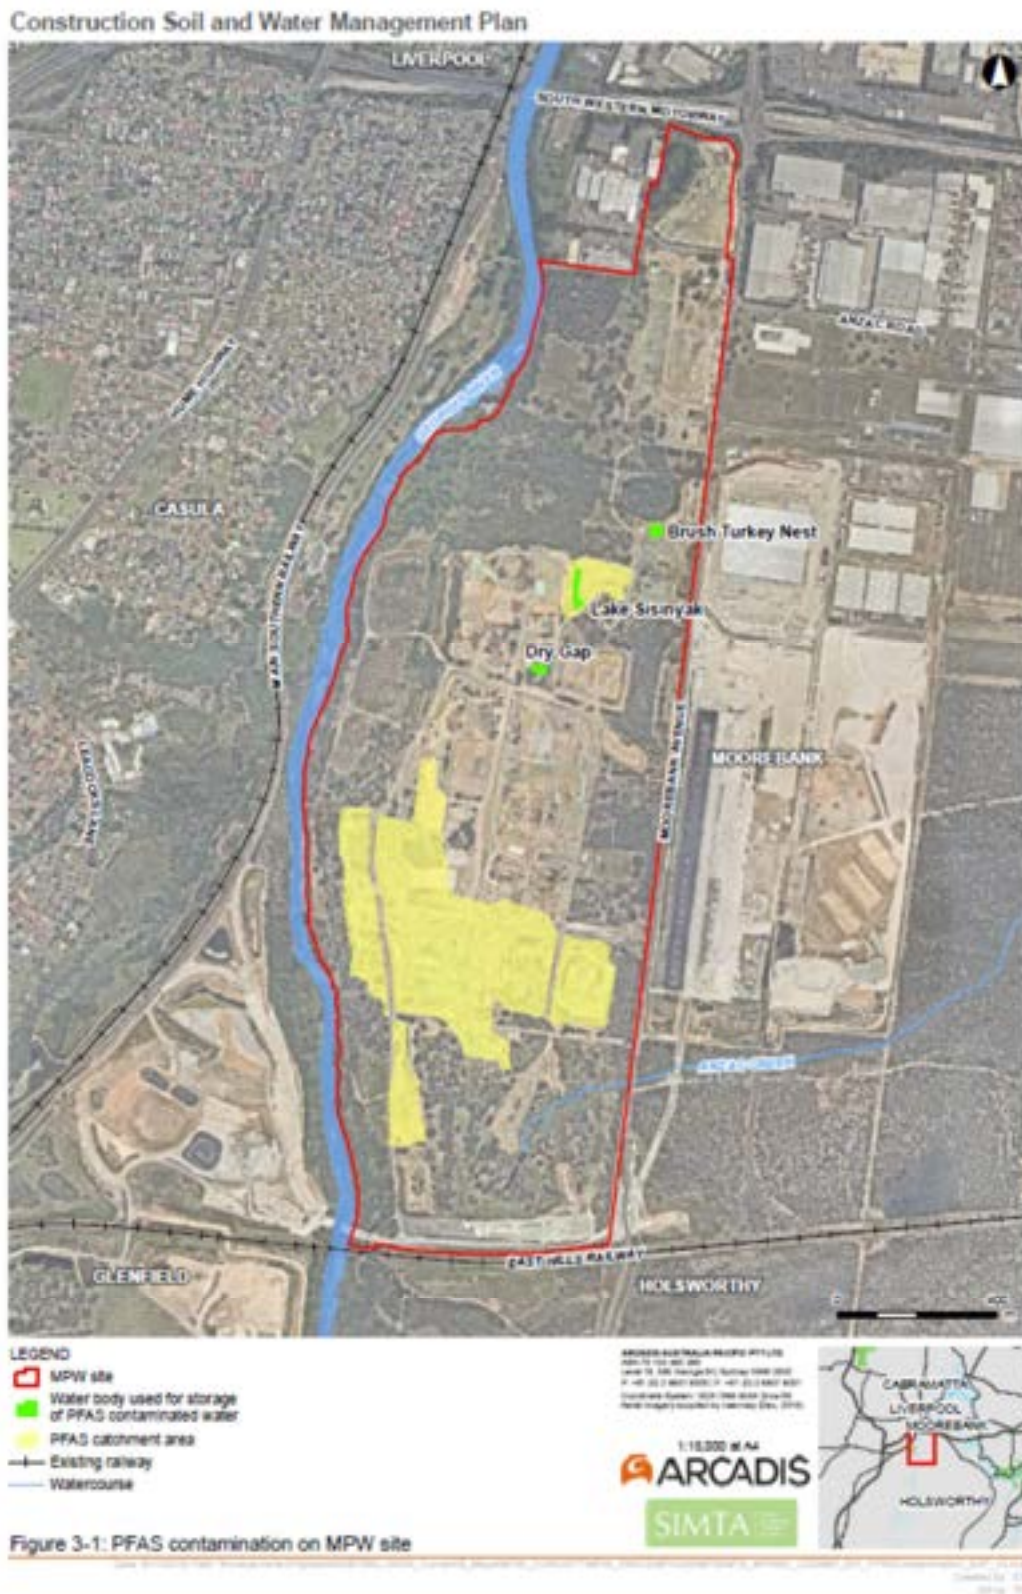
Figure 3-0-1 PFAS Contamination on MPW site

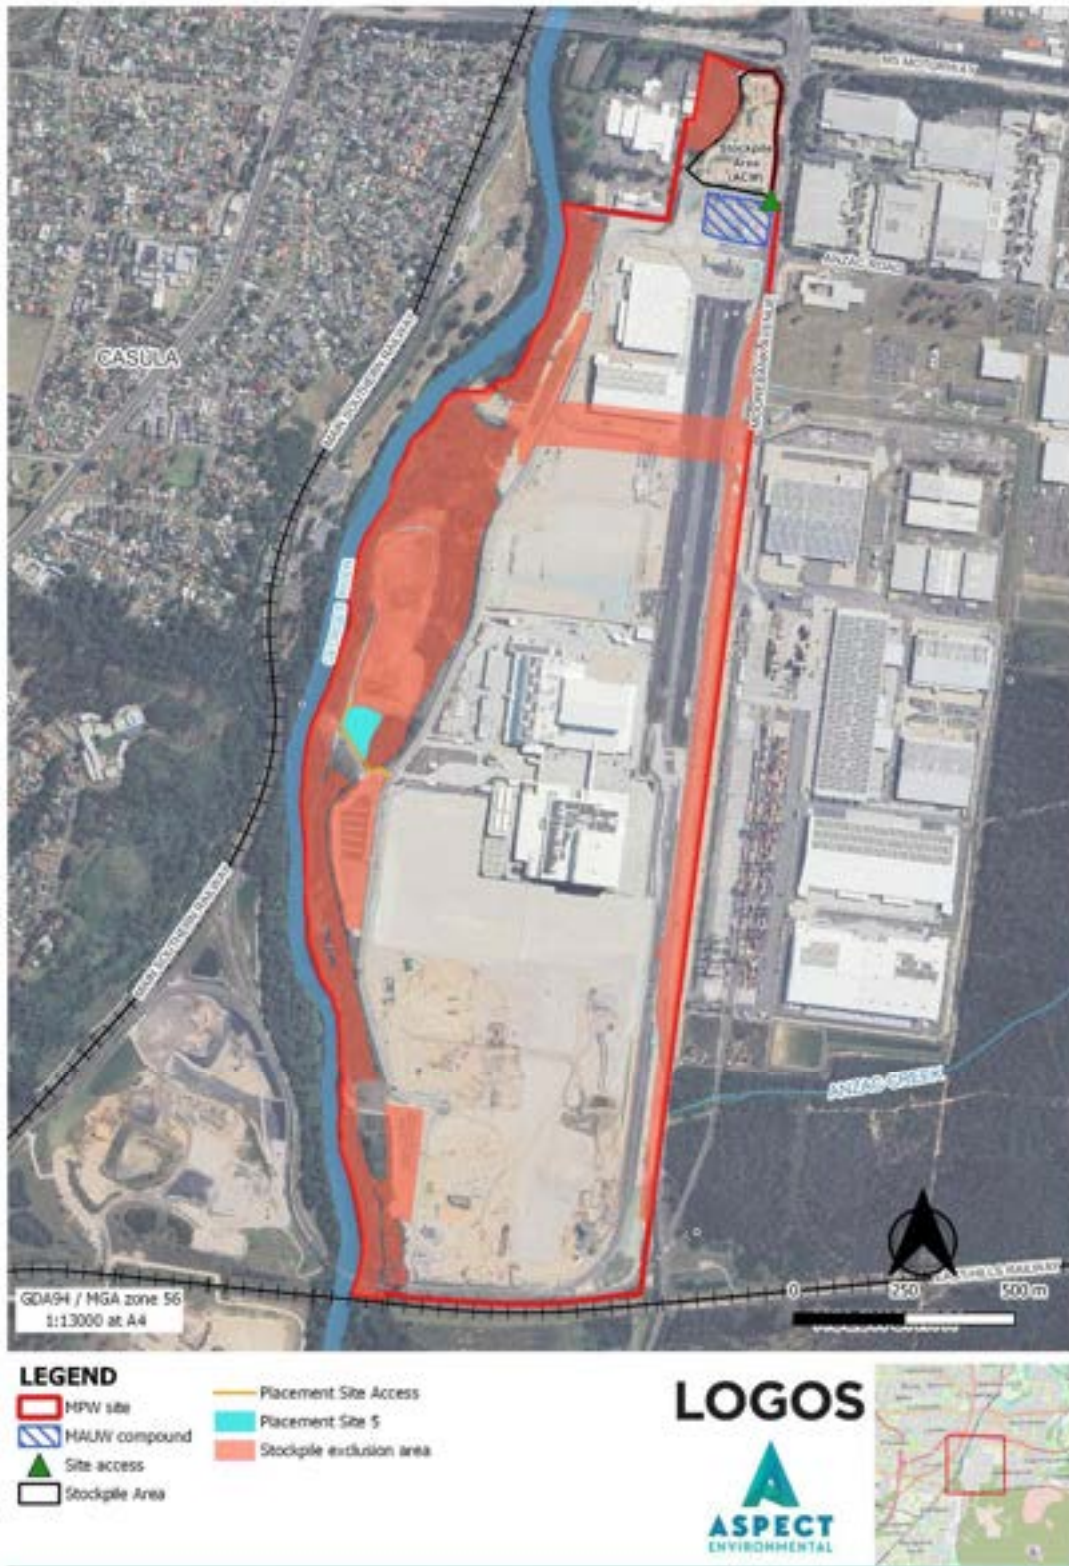
Figure 3-0-2 Placement Site 5

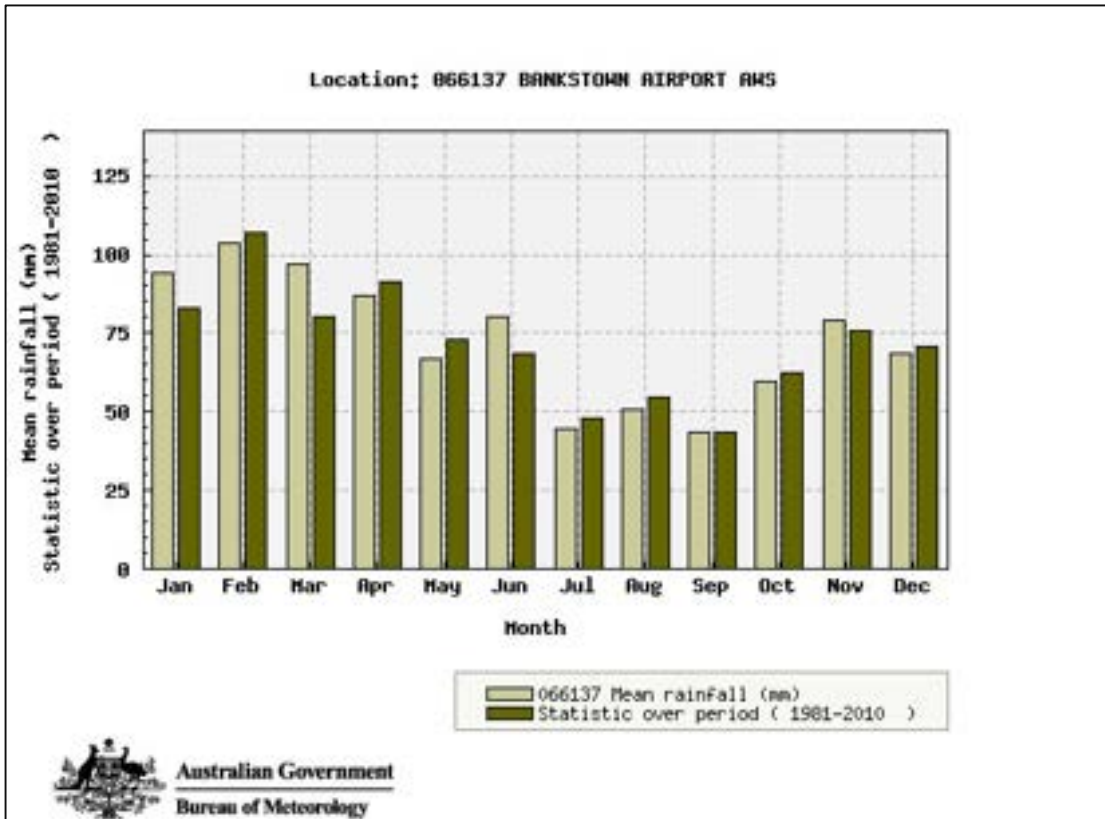
Figure 3-0-3 Bankstown Airport AWS Long term and Statistical Average

The wettest months generally occur during late summer and early autumn. The wettest month is usually February, with an average rainfall of 106 mm. The lowest rainfall usually occurs in September with a monthly average of 45 mm. The long-term average annual rainfall experienced at the Bankstown Airport AWS is 896 mm, which falls over an average of 115 days over the course of the year.

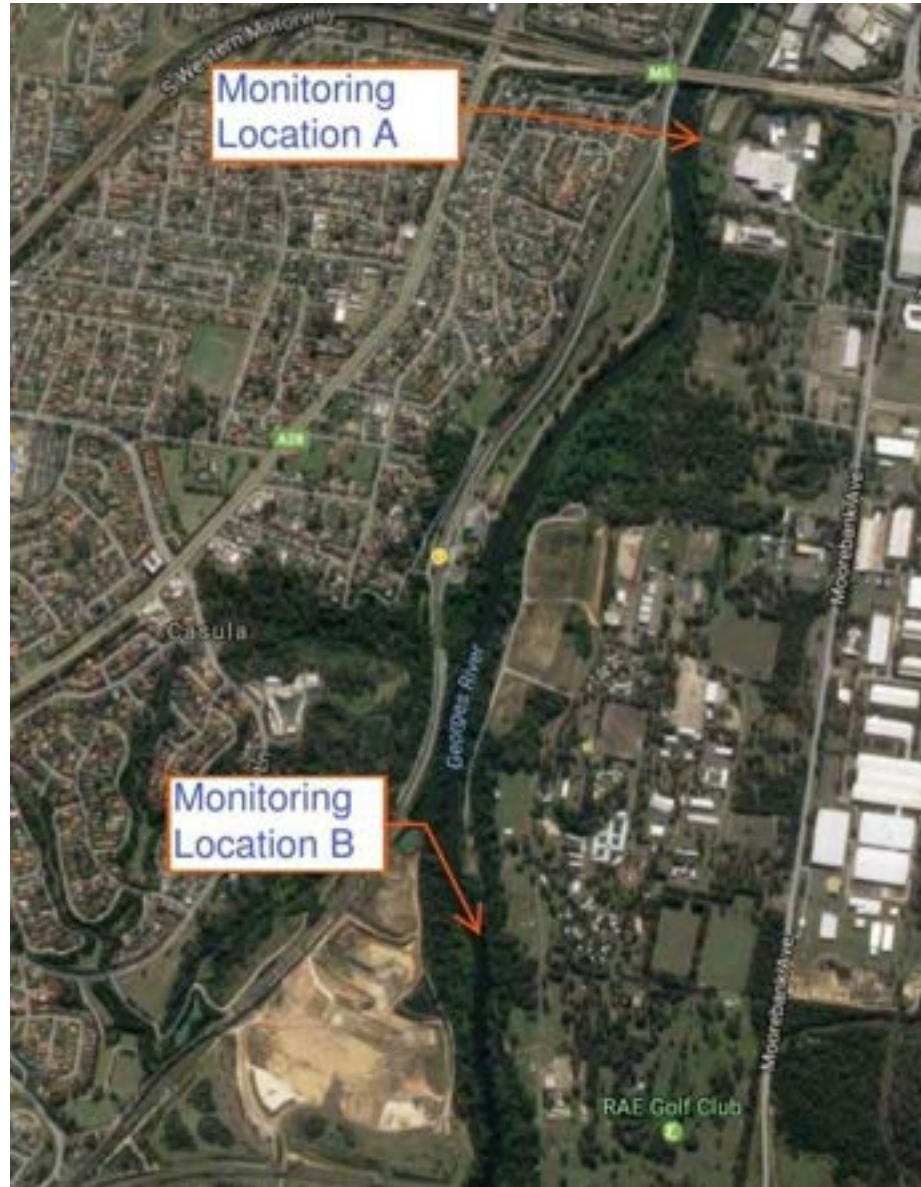
Figure 8-0-1 Receiving Water Monitoring Locations

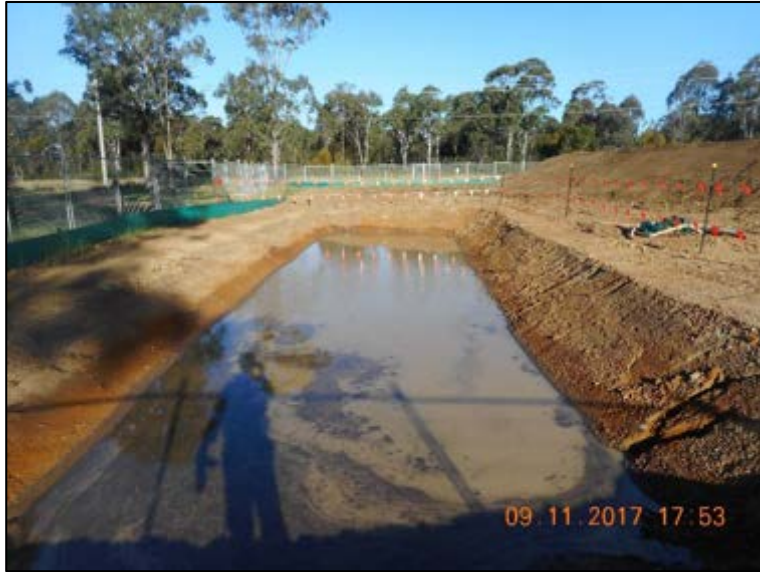
Inspecting basin for water level, and sample collection

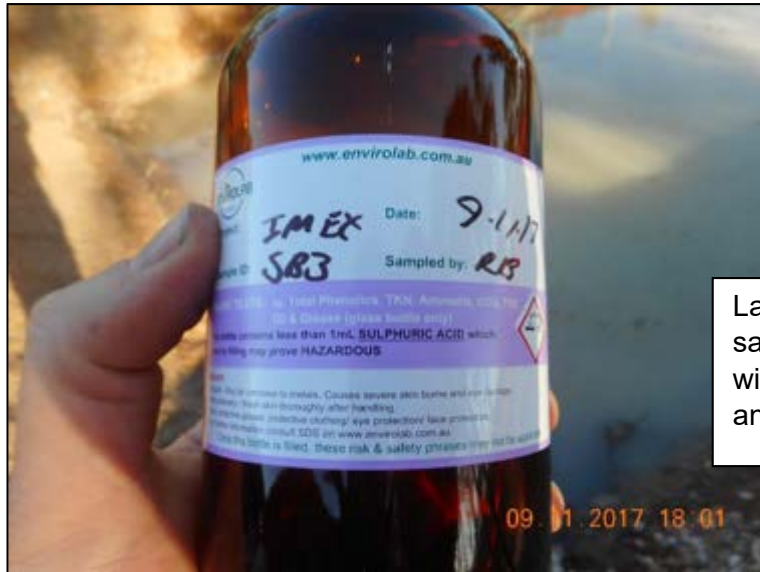
Laboratory supplied sample bottles, labelled with date, basin number and sampler's initials

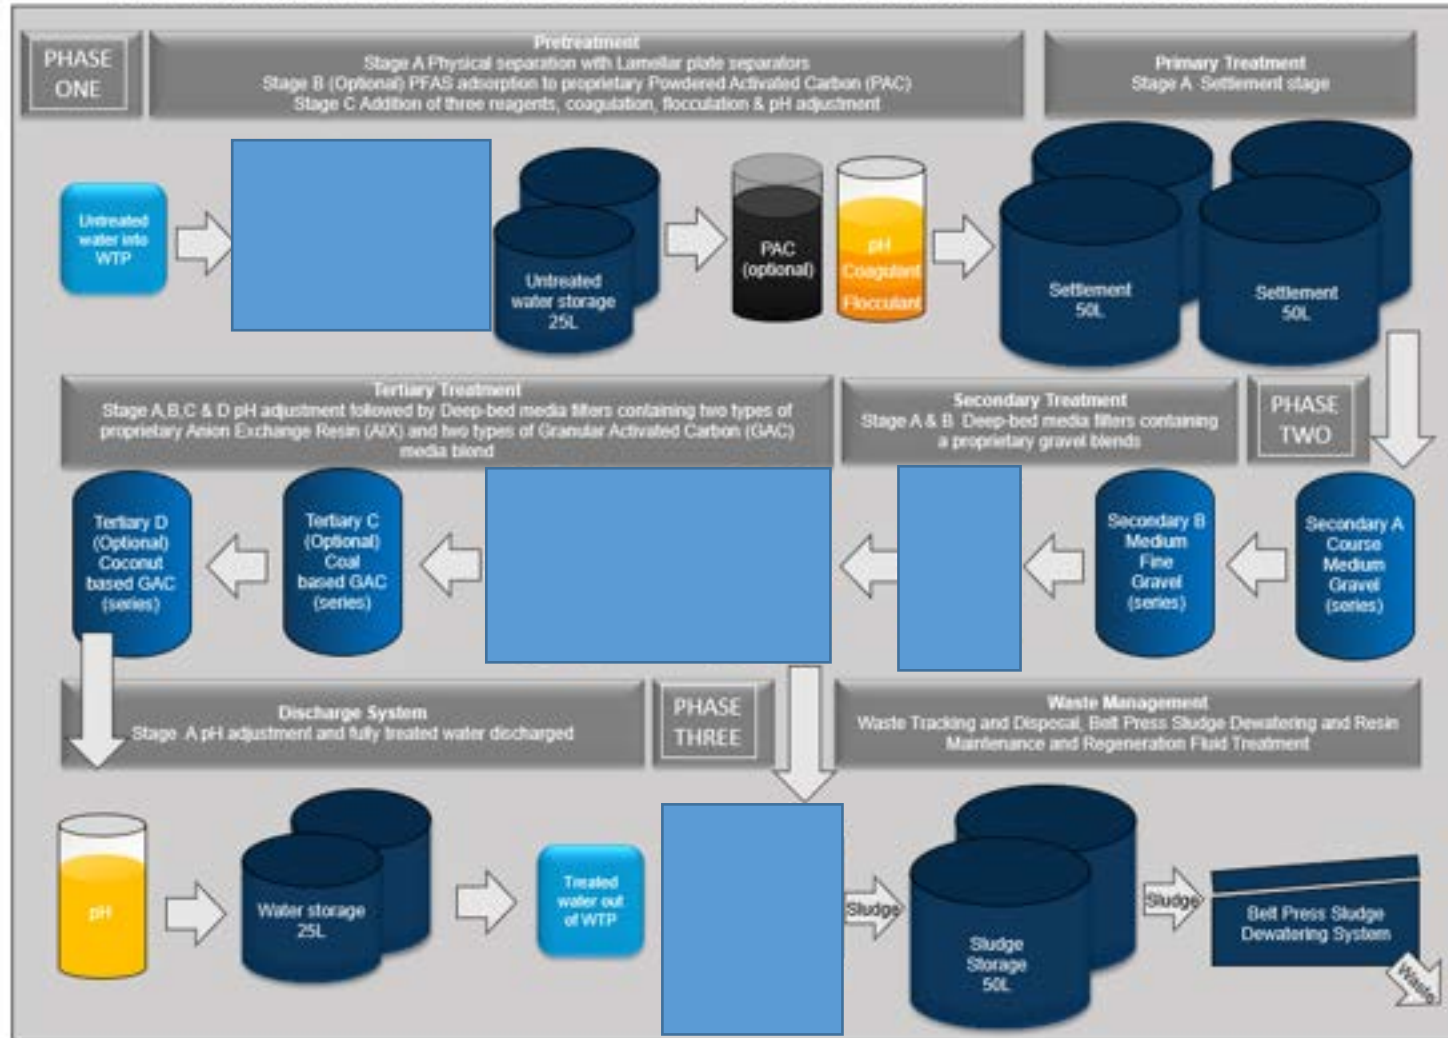
Figure 1. Synergy's multi-barrier water treatment methodology to sequentially remove PFAS and other contaminants

The equipment for this WTP broadly:
