# Long-Term Environmental Management Plan

Lot 6, 7 and 12, Moorebank Precinct West, 400 Moorebank Avenue, Moorebank, NSW

Prepared for: Qube c/- Tactical EP1489.007\_v5 8 December 2021

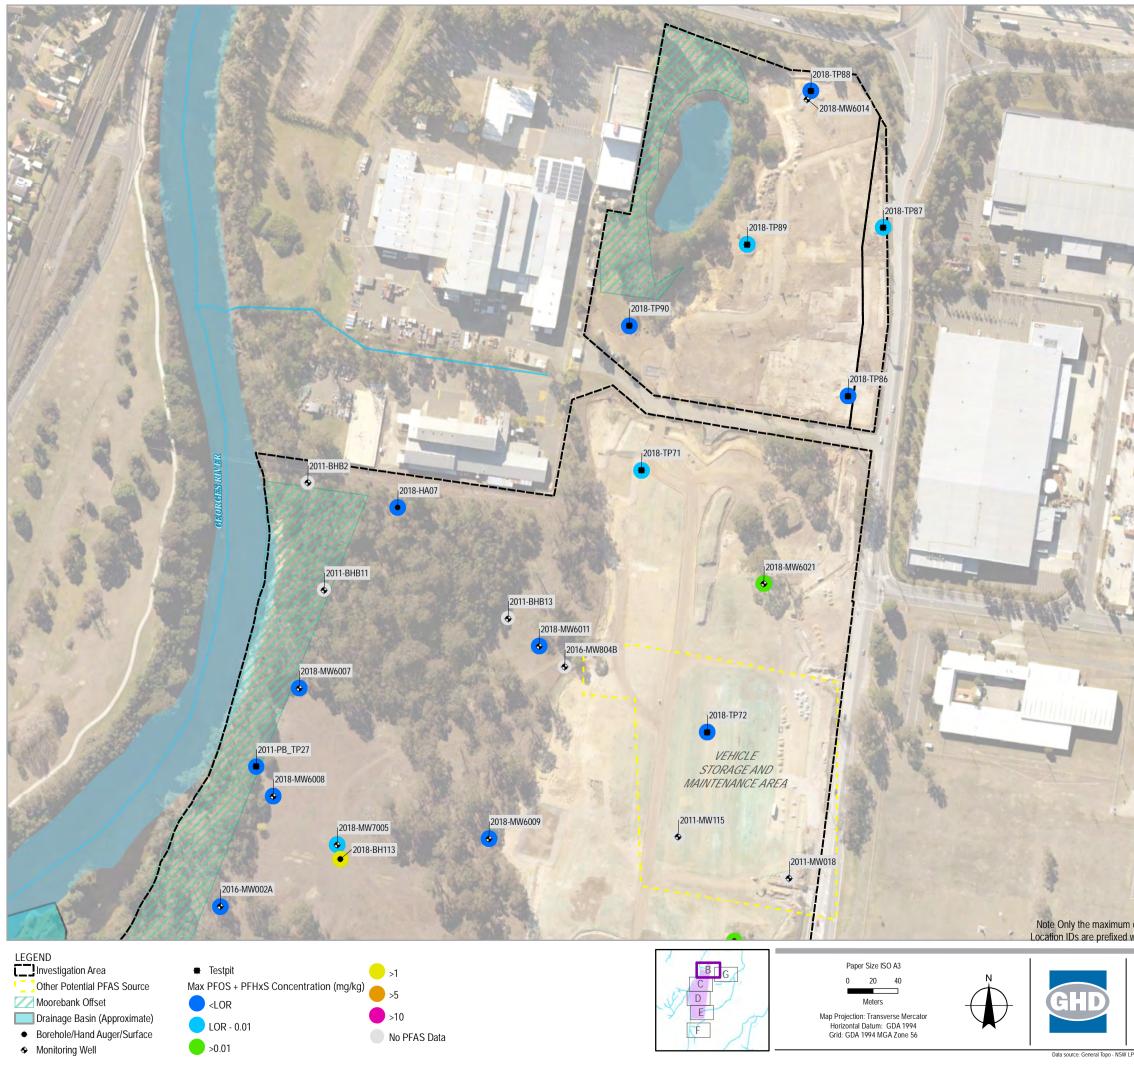
Note: The location of 2018-BH113 has been provided in error in this drawing

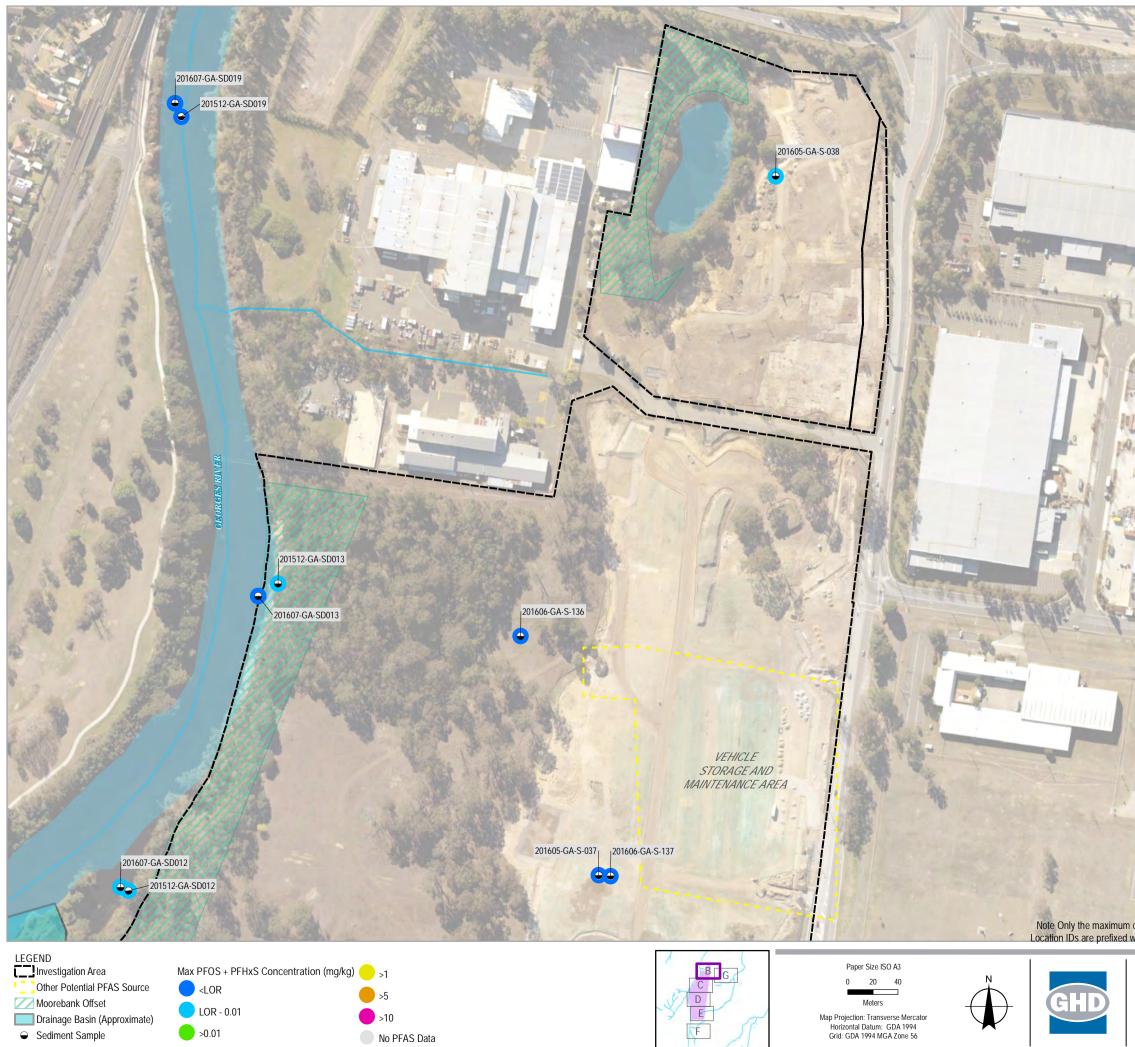
- The Work was a feature of the	
Enformant and	
E PHILIPHI MITTERIA	215 7 2 1
	me . S /
	44
concentration for each location is shown, based on reports re	eviewed as details in Annendiv C
vith the year the well was installed (for monitoring wells) or the	e year the sample was collected.
	, <u> </u>
Moorebank Intermodal Company Limited	Project No. 21-28111
Moorebank Intermodal Company Limited Summary Report PFAS Investigations Moorebank Precinct West	Revision No. A Date 12 Apr 2019
	Date 12 Apr 2019
Sediment	
PFOS + PFHxS Results	FIGURE 7B
Grid 1

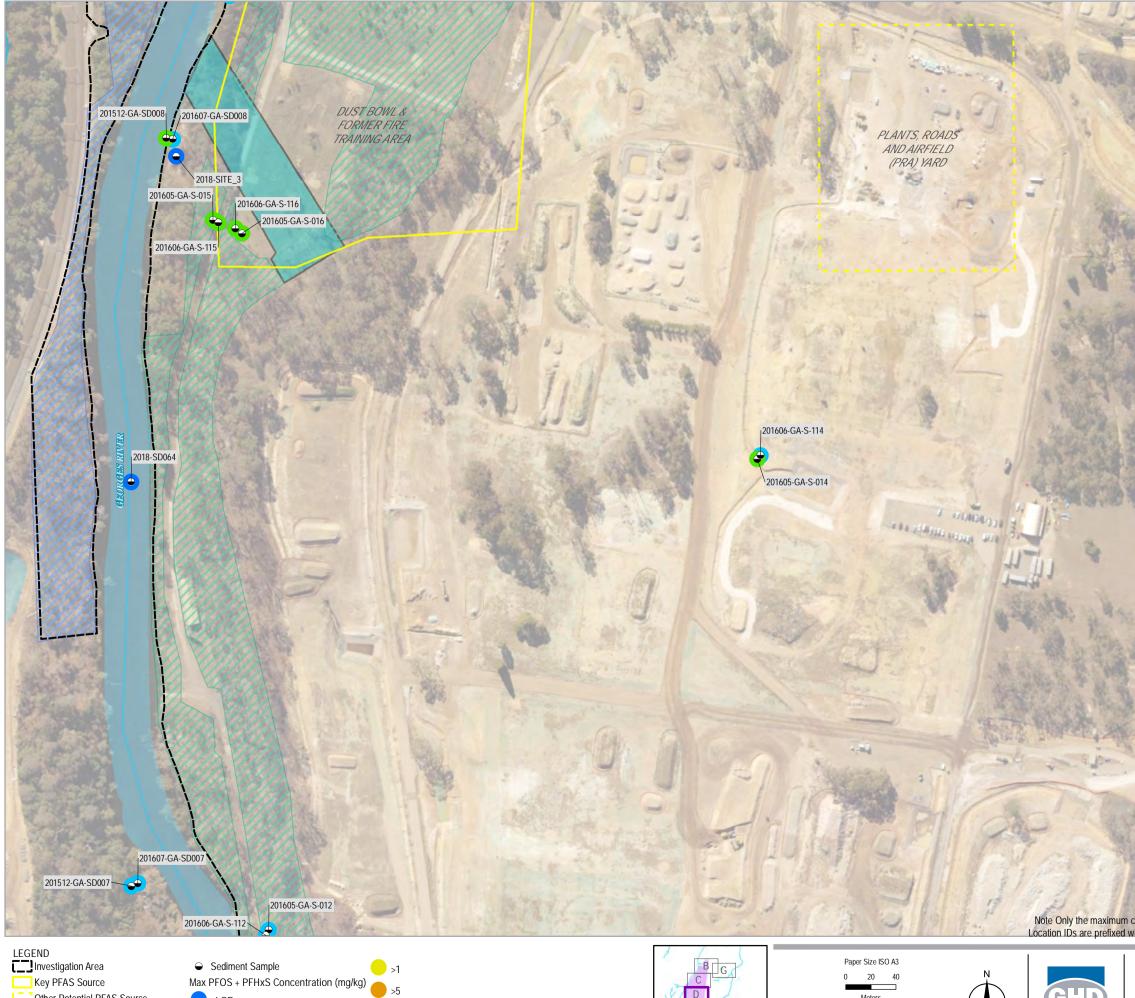
FIGURE 7D Grid 3 Data source: General Topo - NSW LPI DTDB 2018 (Date Extracted: 18 Feb 2019). Cadastre - NSW LPI DCDB 2018 (Date Extracted: 18 Feb 2019). Aerial Imag

Note Only the maximum concentration for each location is shown, based on reports reviewed as details in Appendix C. Location IDs are prefixed with the year the wellwas installed (for monitoring wells) or the year the sample was collected. Moorebank Intermodal Company Limited Summary Report PFAS Investigations Moorebank Precinct West Project No. 21-28111 Revision No. A Date 12 Apr 2019 Sediment PFOS + PFHxS Results

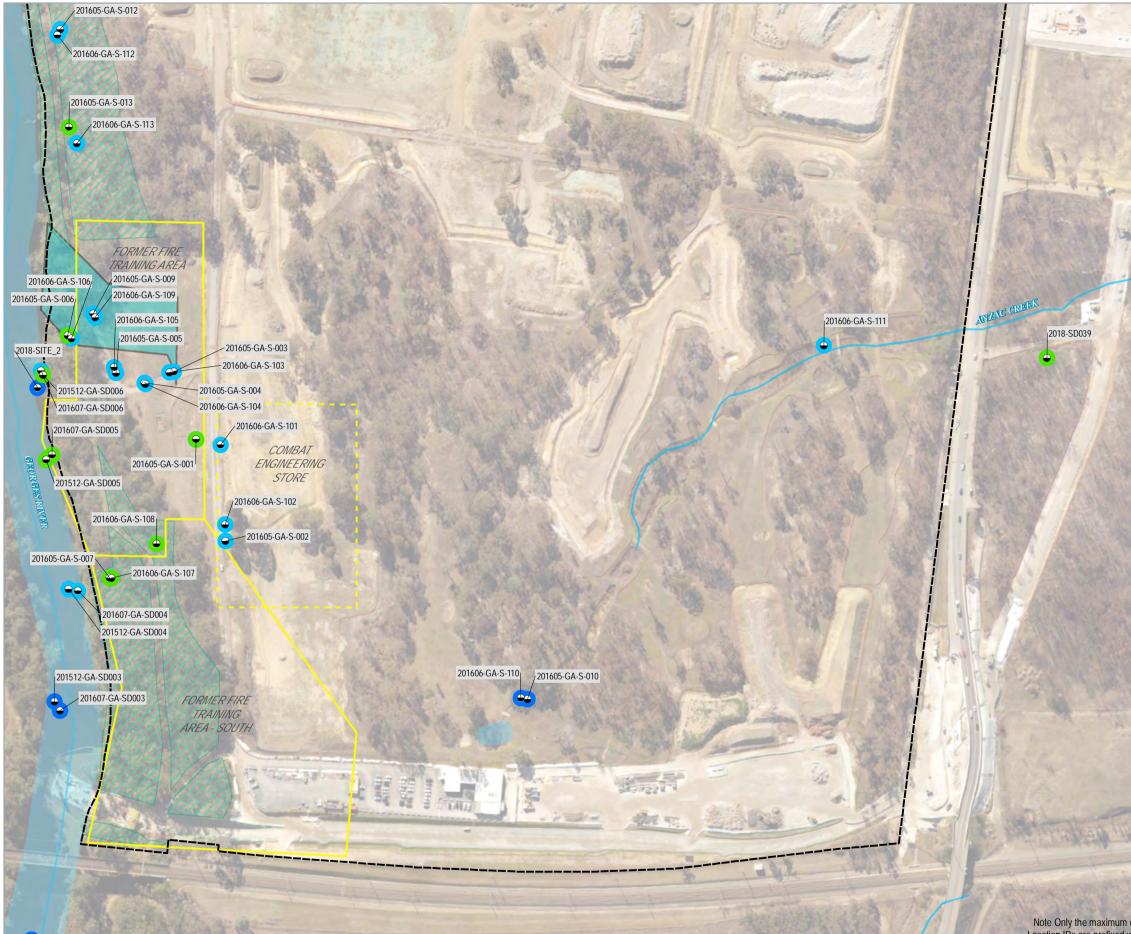
Note Only the maximum concentration for each location is shown, based on reports reviewed as details in Appendix C. Location IDs are prefixed with the year the well was installed (for monitoring wells) or the year the sample was collected. Moorebank Intermodal Company Limited Summary Report PFAS Investigations Moorebank Precinct West Project No. 21-28111 Revision No. A Date 12 Apr 2019 Sediment PFOS + PFHxS Results FIGURE 7E

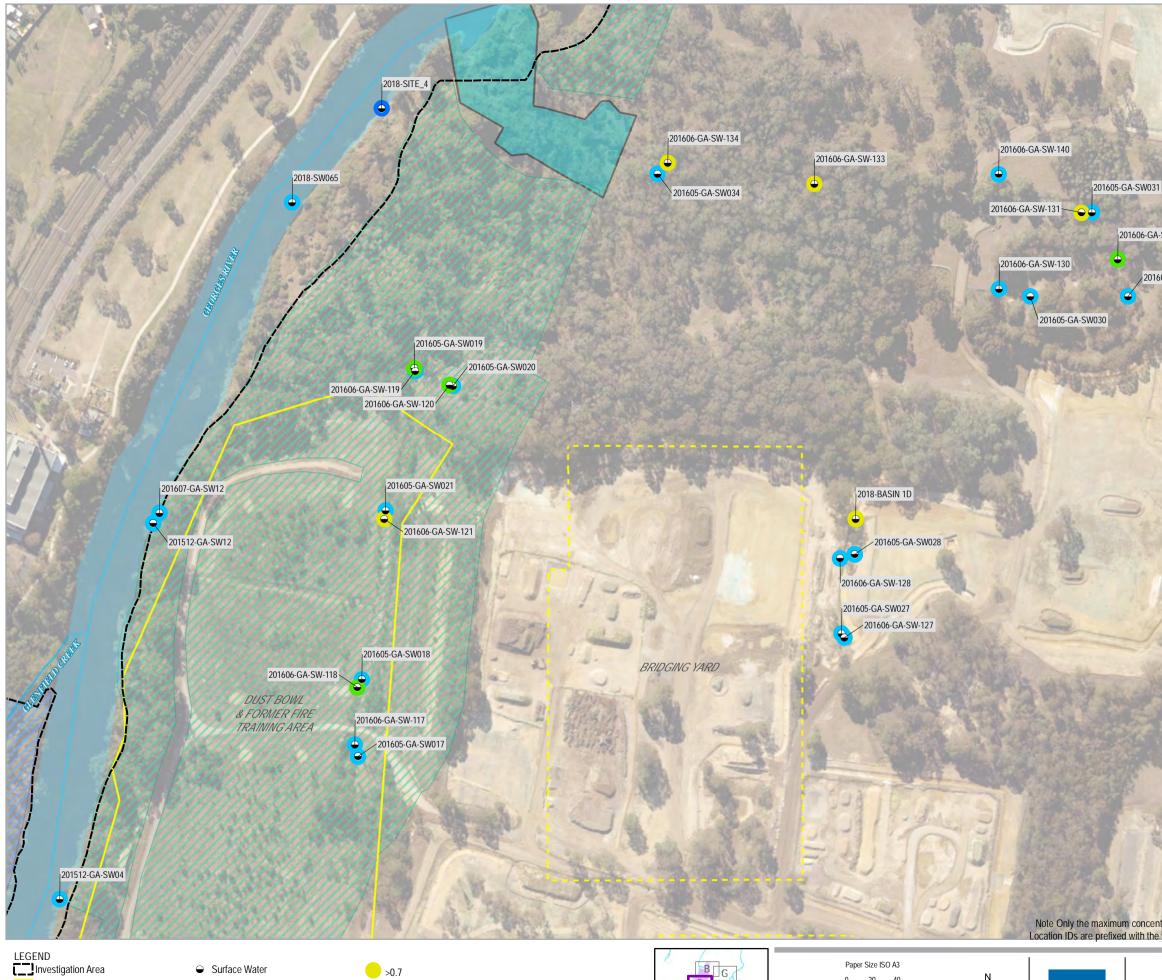
vith the year the well was installed (for monitoring wells) or the Moorebank Intermodal Company Limited Summary Report PFAS Investigations Moorebank Precinct West	e year the sample was collected. Project No. 21-28111
concentration for each location is shown, based on reports re with the year the well was installed (for monitoring wells) or the Moorebank Intermodal Company Limited Summary Report PFAS Investigations Moorebank Precinct West Surface Water PFOS + PFHxS Results	Project No. 21-28111 Revision No. A

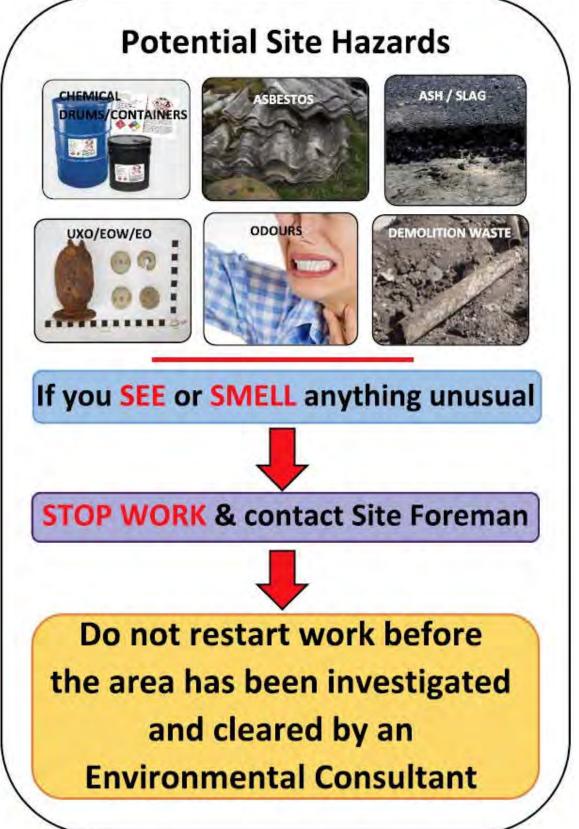
Unexpected Finds Protocol (UFP)

As a precautionary measure to ensure the protection of the workforce, should any of the abovementioned substances (or any other unexpected potentially hazardous substance) be uncovered during ground disturbance activities, then the following should be immediately implemented:

During subsurface maintenance works post construction, there is a possibility some hazards within the Site have not been identified to date. The nature of hazards which may be present, and which may be discovered are expected to generally be detectable through visual or olfactory means, for example:
