Long-Term Environmental Management Plan

Southern Ring Road, Moorebank Precinct West,
400 Moorebank Avenue, Moorebank, NSW

Prepared for: Logos Property Group c/- Tactical Group Pty Ltd

EP1489.013_v1 22 December 2022

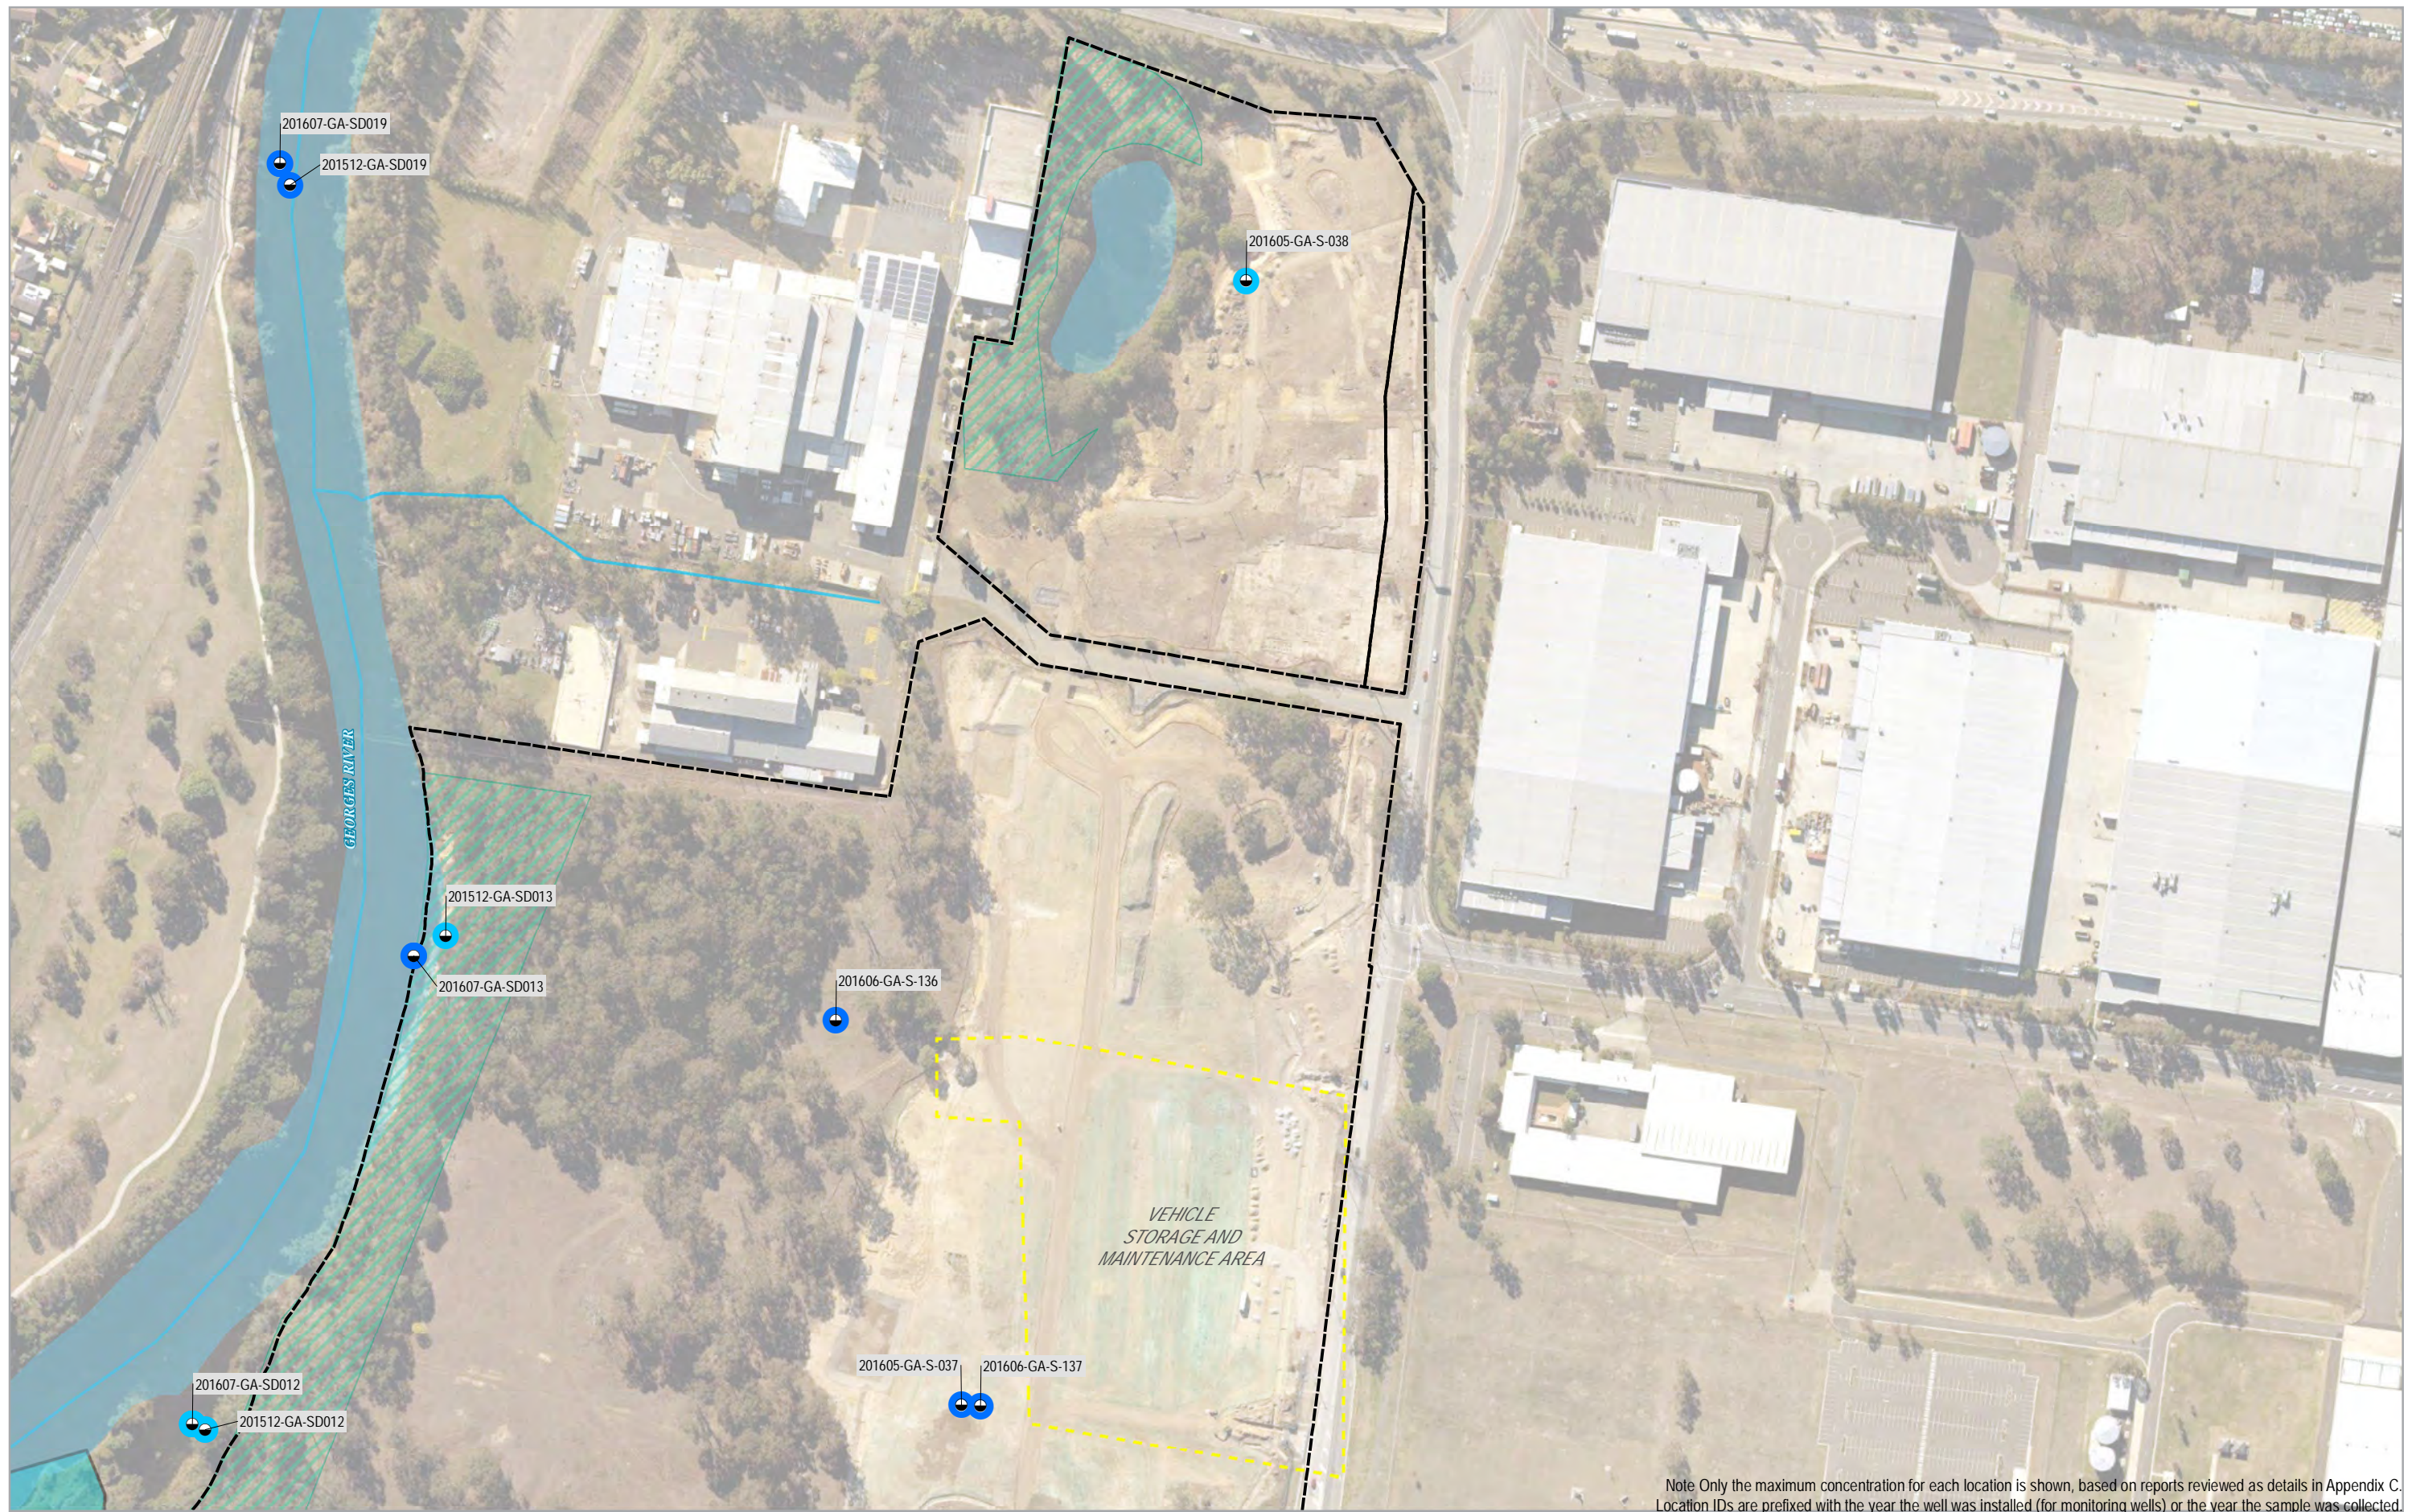
FIGURE 7B

Note Only the maximum concentration for each location is shown, based on reports reviewed as details in Appendix C. Location IDs are prefixed with the year the well was installed (for monitoring wells) or the year the sample was collected.

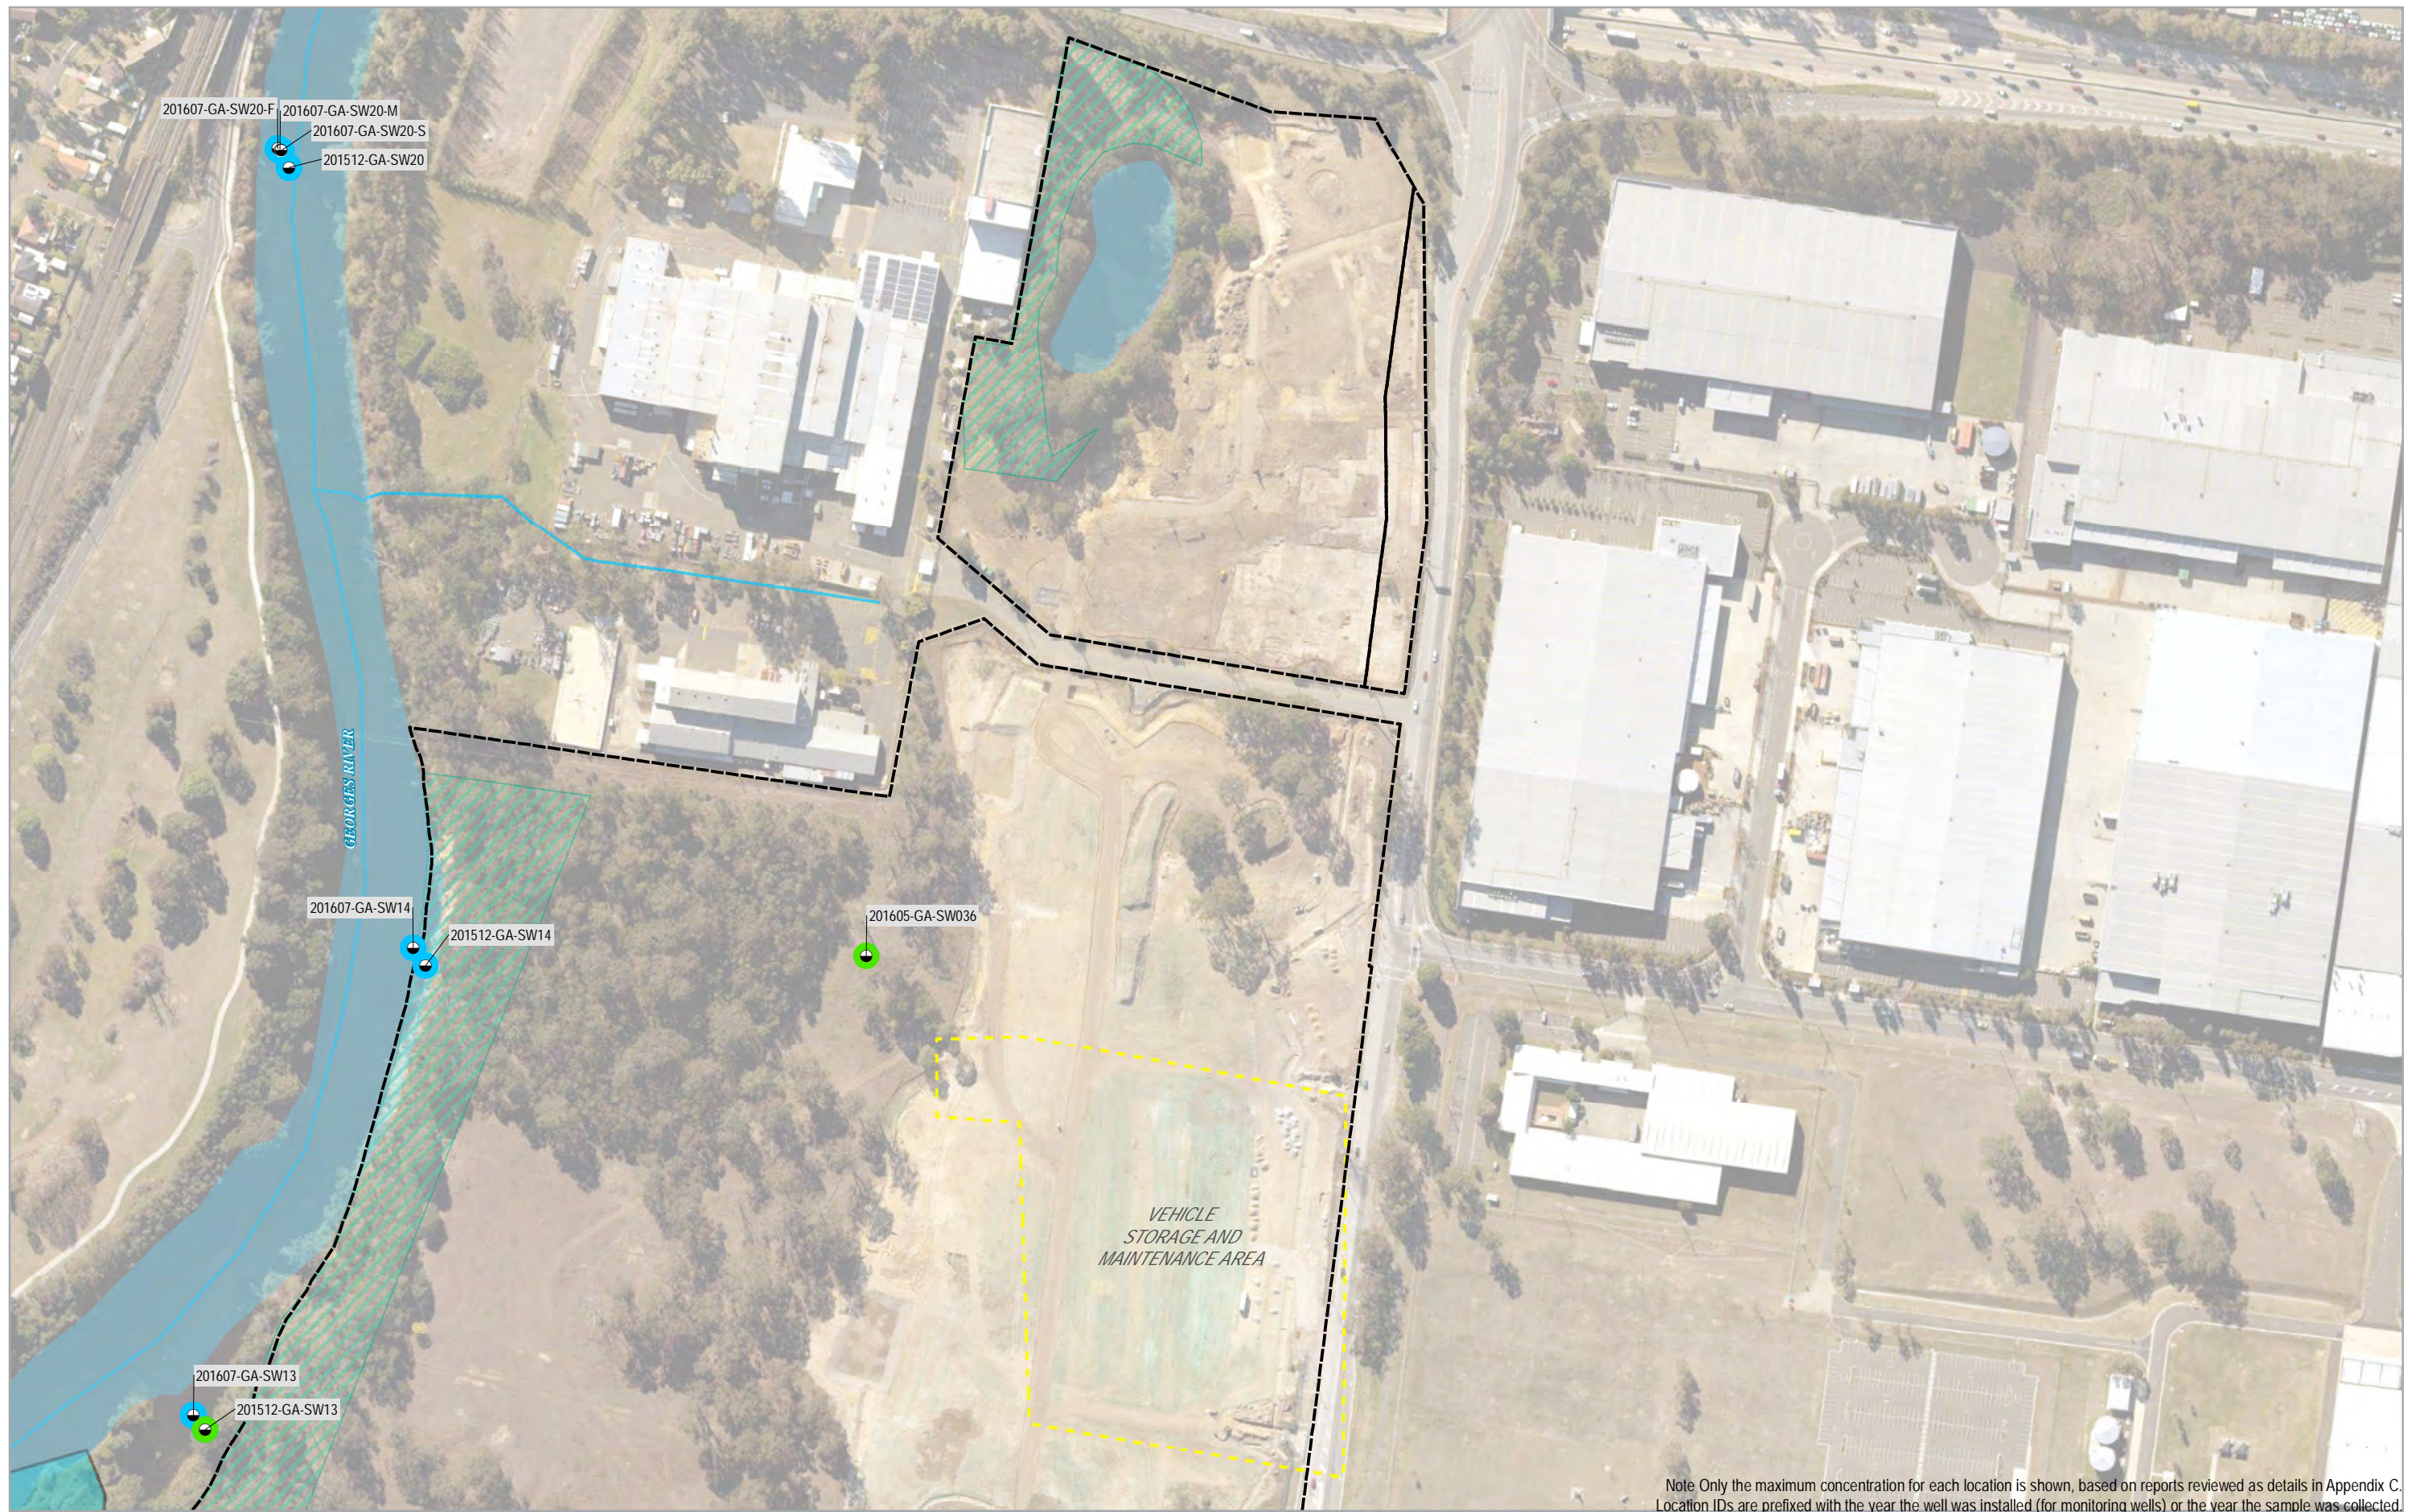
FIGURE 8B

Note: Only the maximum concentration for each location is shown, based on reports reviewed as details in Appendix C. Location IDs are prefixed with the year the well was installed (for monitoring wells) or the year the sample was collected.
