# Long-Term Environmental Management Plan

Eagles Beak, Moorebank Precinct West,  
400 Moorebank Avenue, Moorebank, NSW

Prepared for: Logos Property Group c/- Tactical Group Pty Ltd  
EP1489.023\_v0 11 November 2024

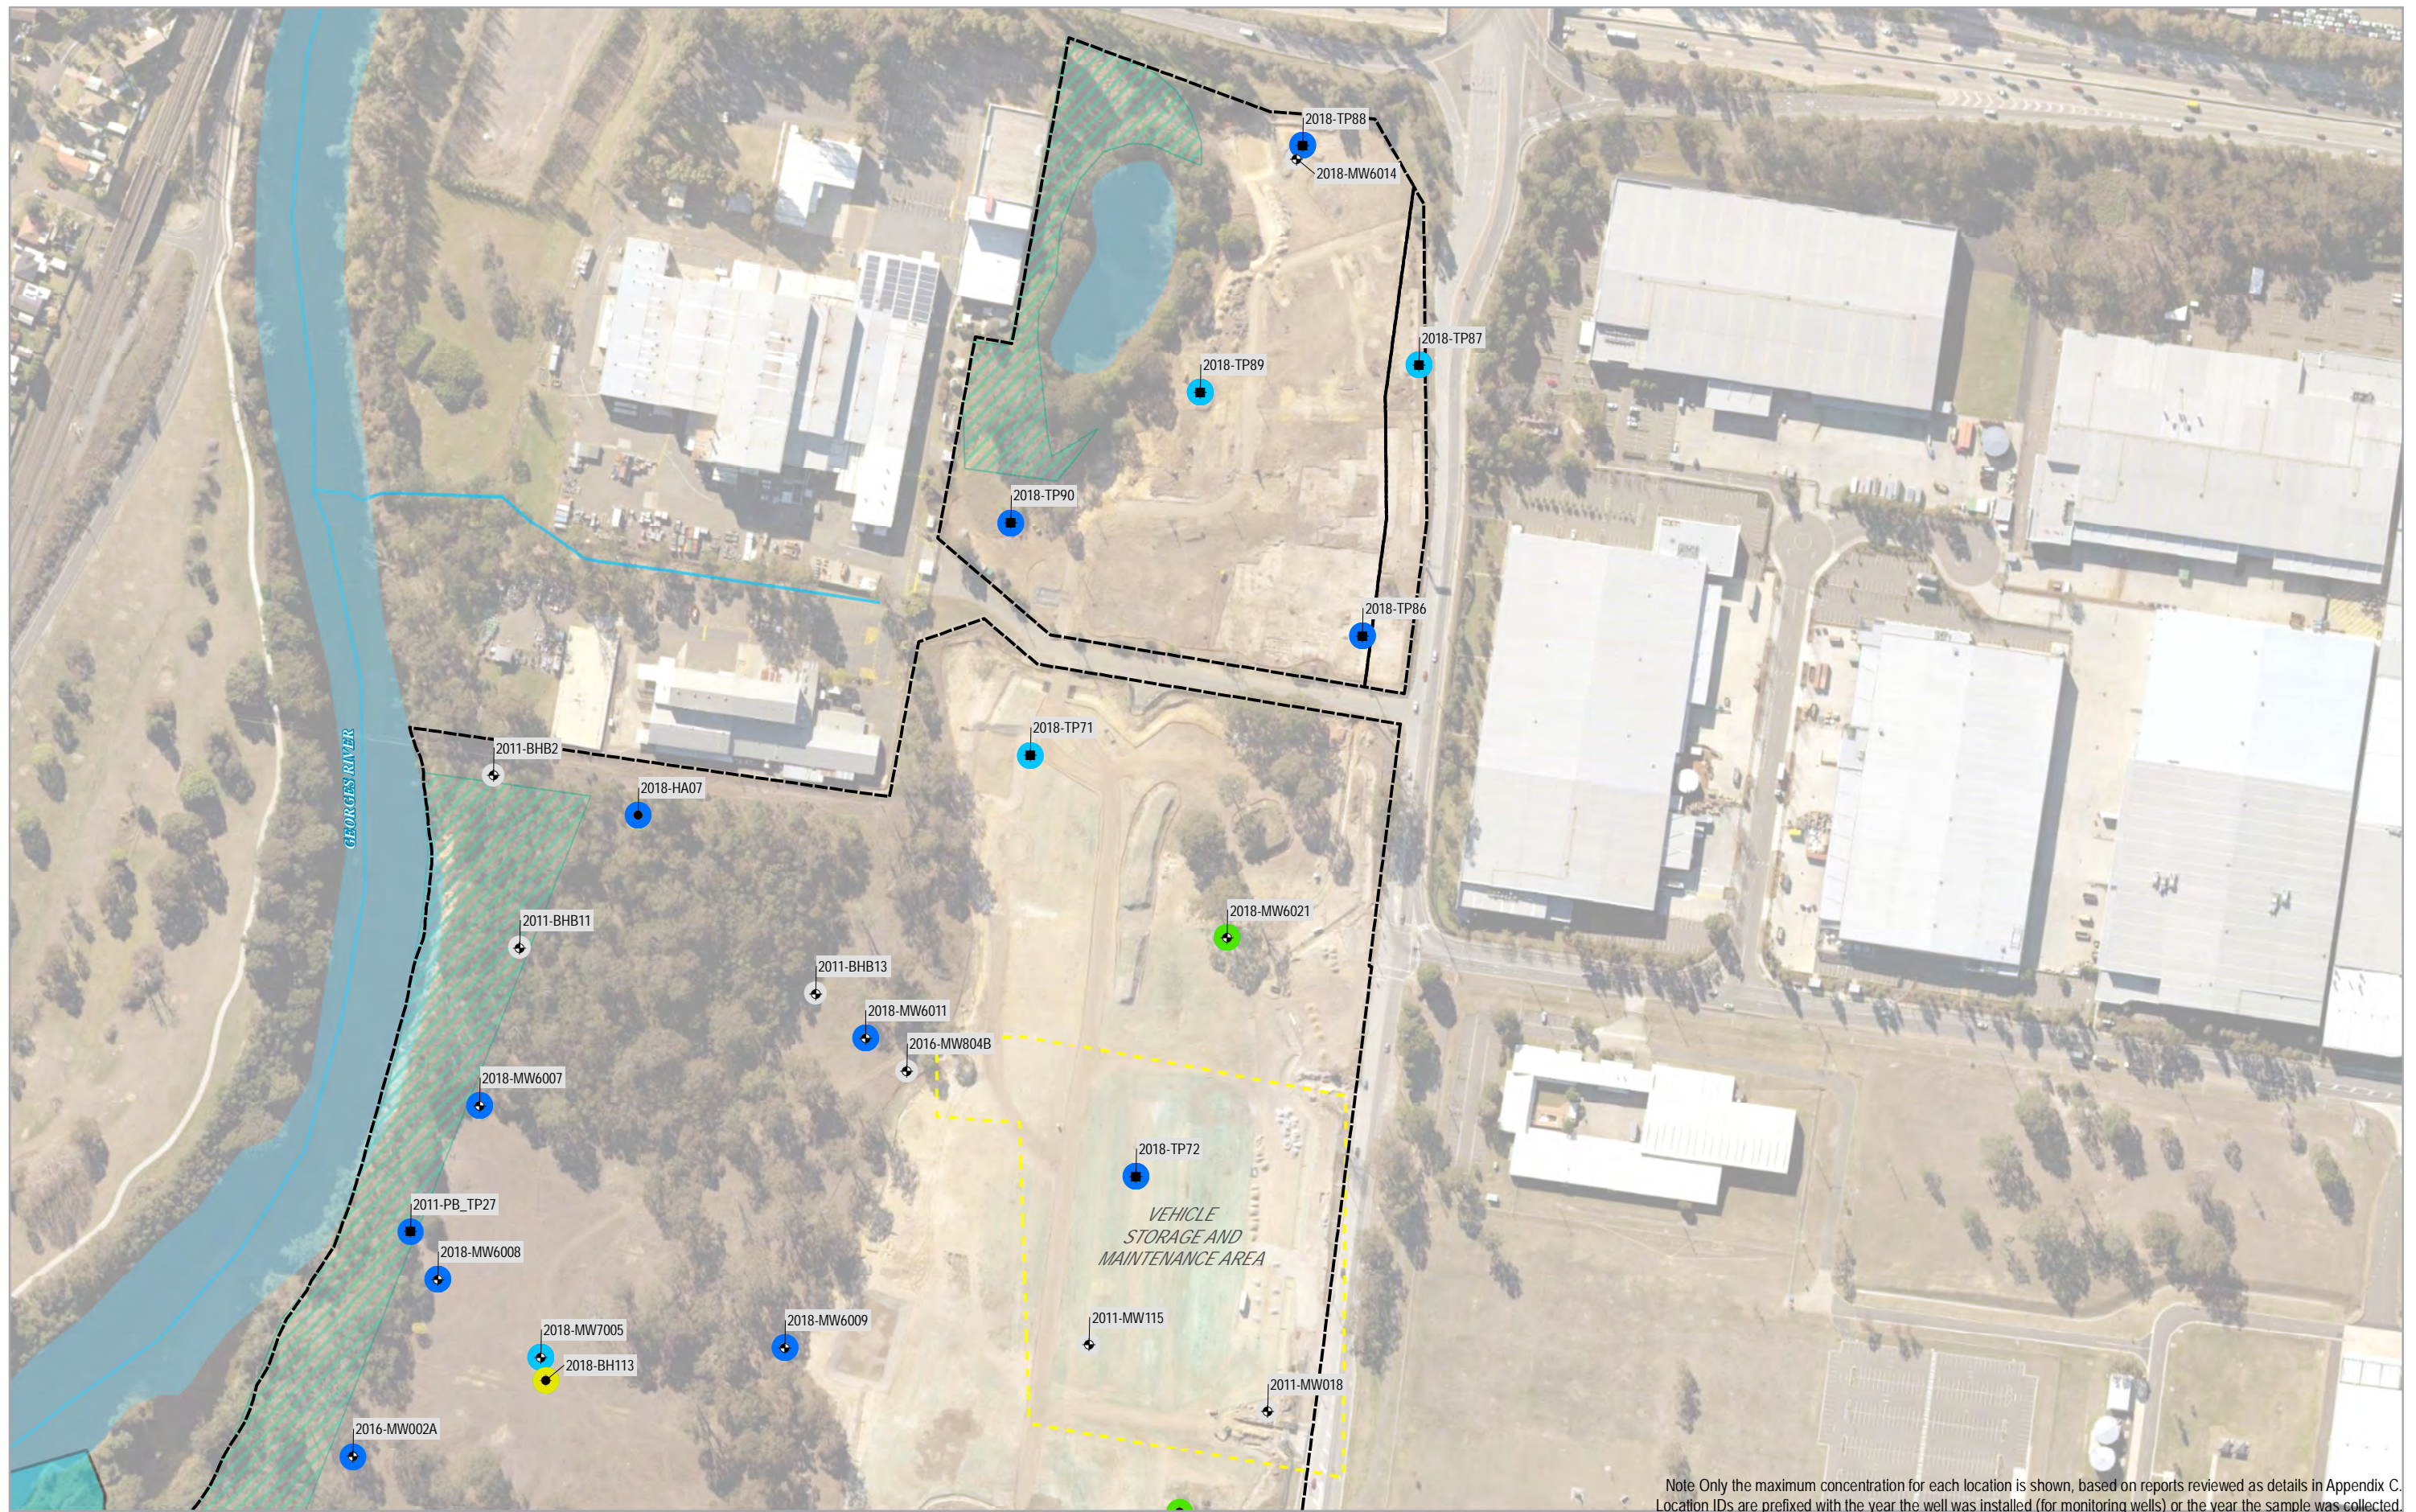
Note: Only the maximum concentration for each location is shown, based on reports reviewed as details in Appendix C. Location IDs are prefixed with the year the well was installed (for monitoring wells) or the year the sample was collected.

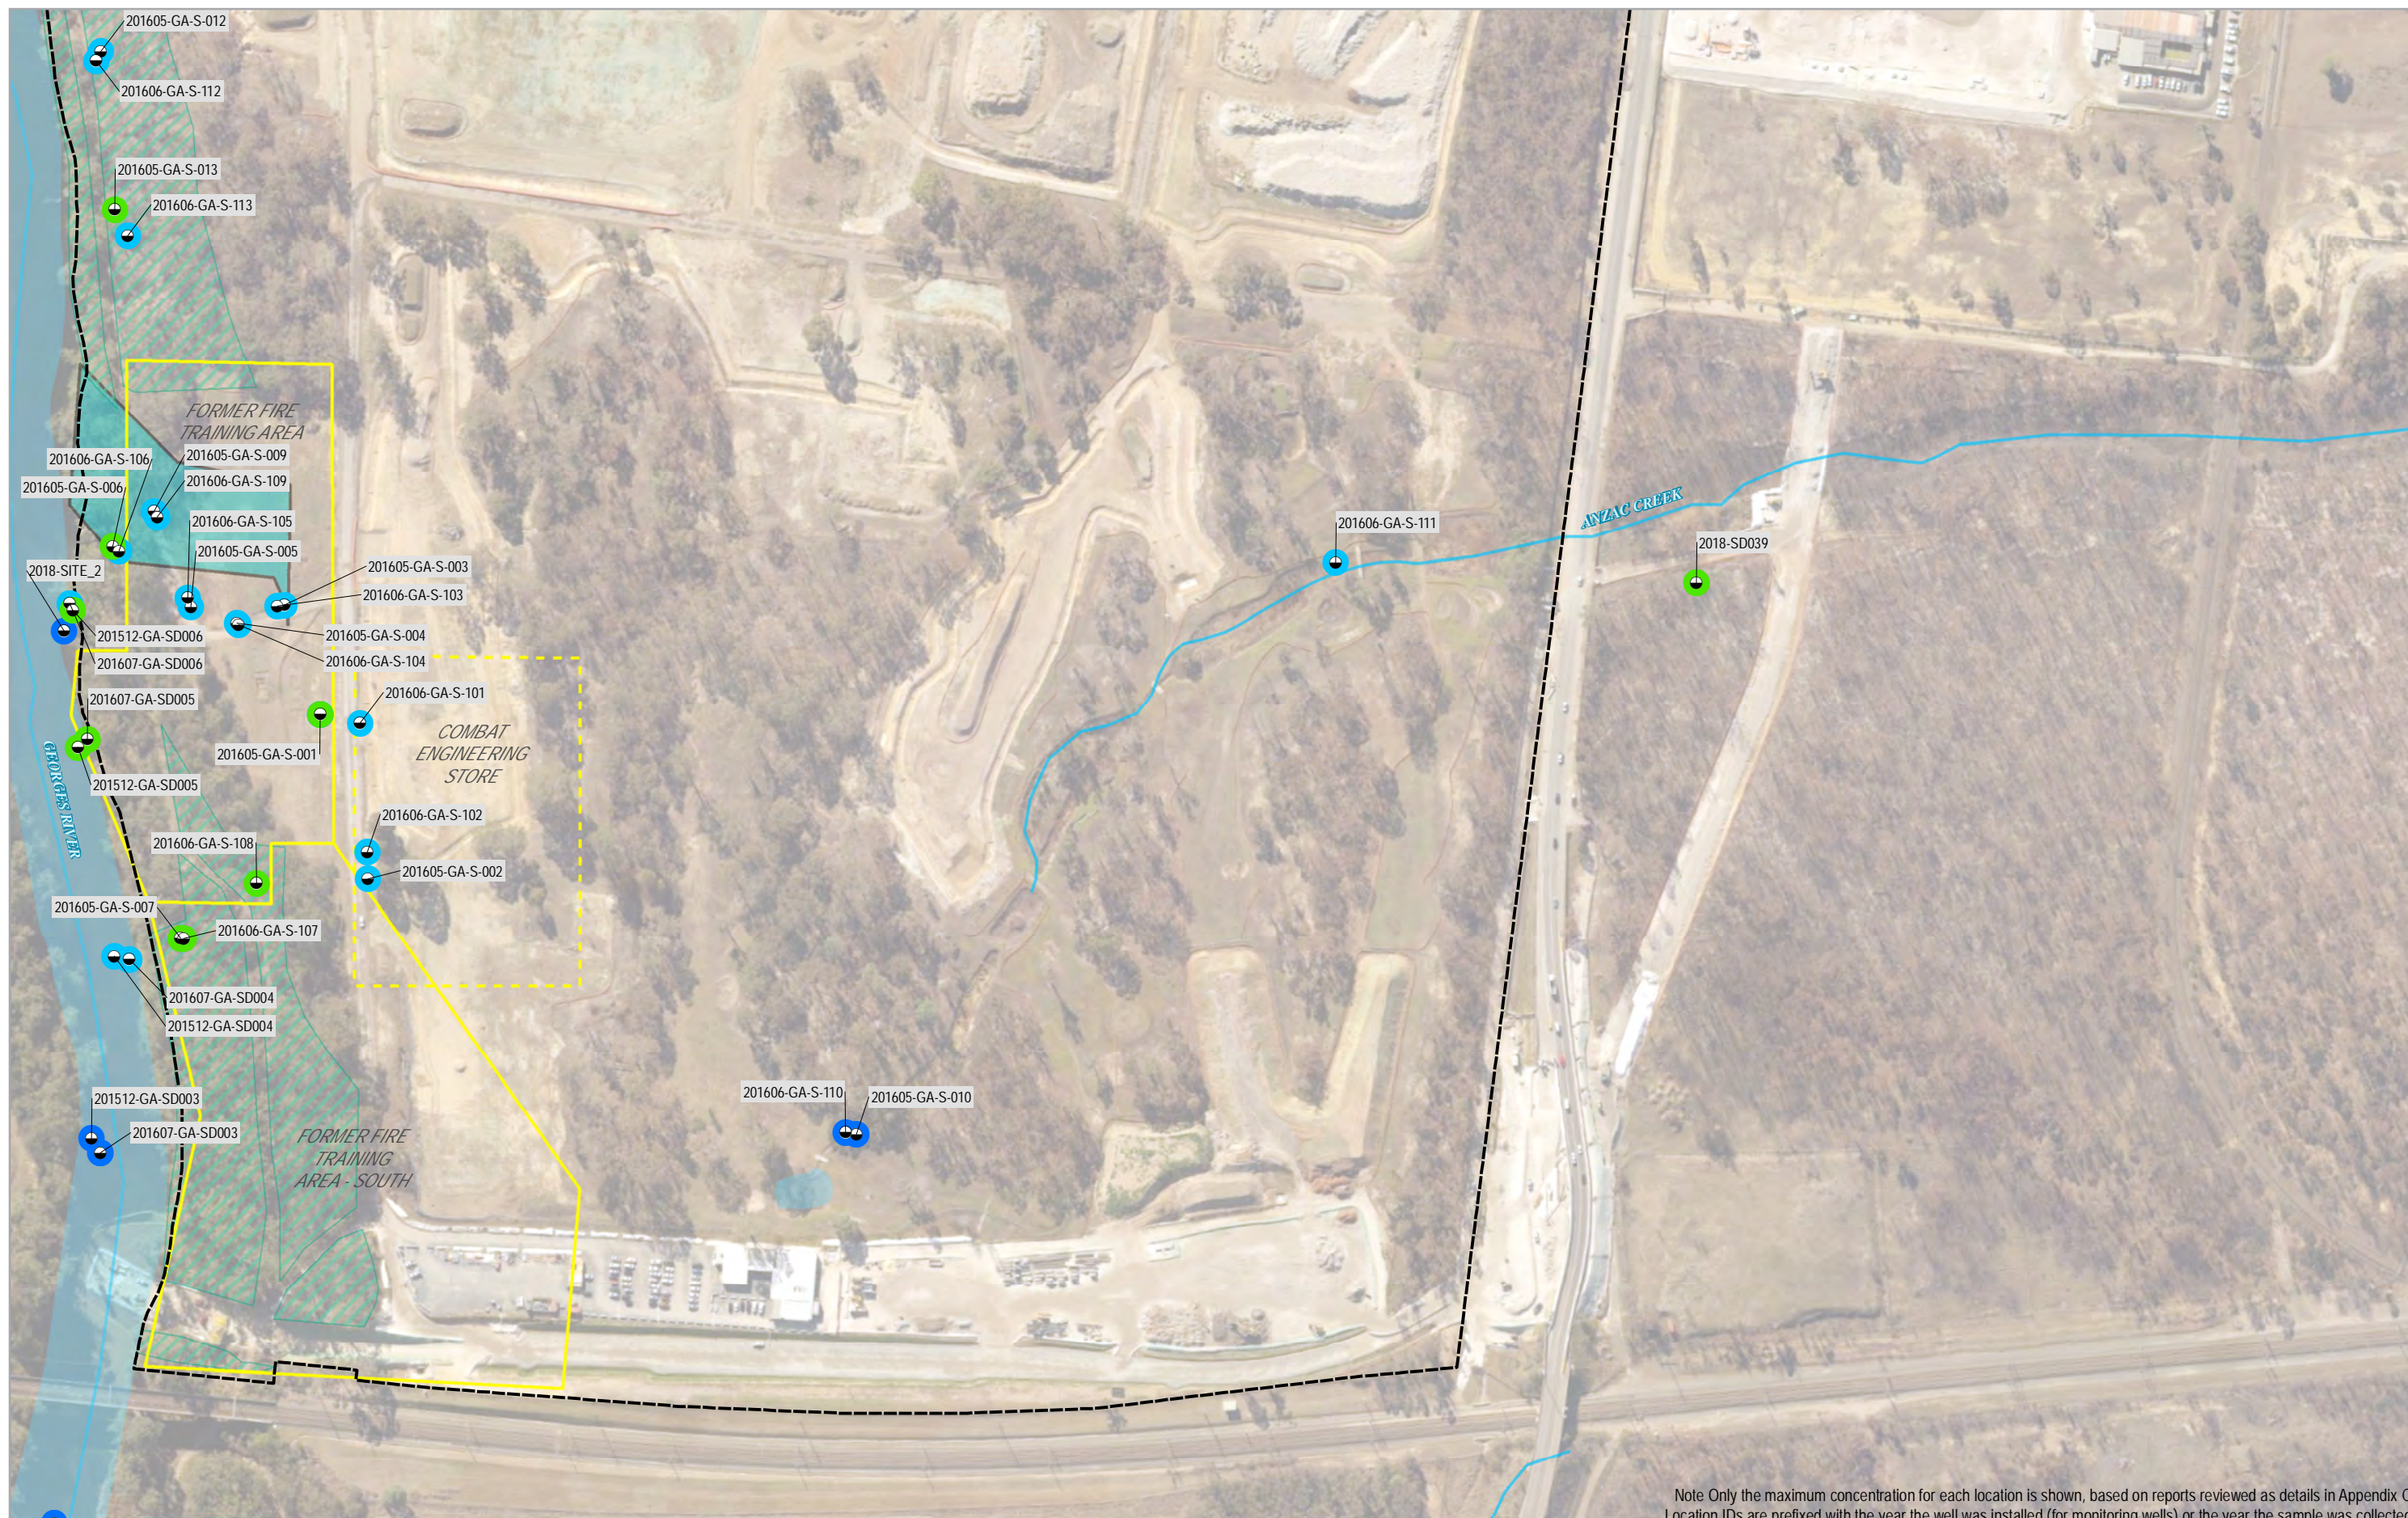
FIGURE 7E

Note Only the maximum concentration for each location is shown, based on reports reviewed as details in Appendix C. Location IDs are prefixed with the year the well was installed (for monitoring wells) or the year the sample was collected.

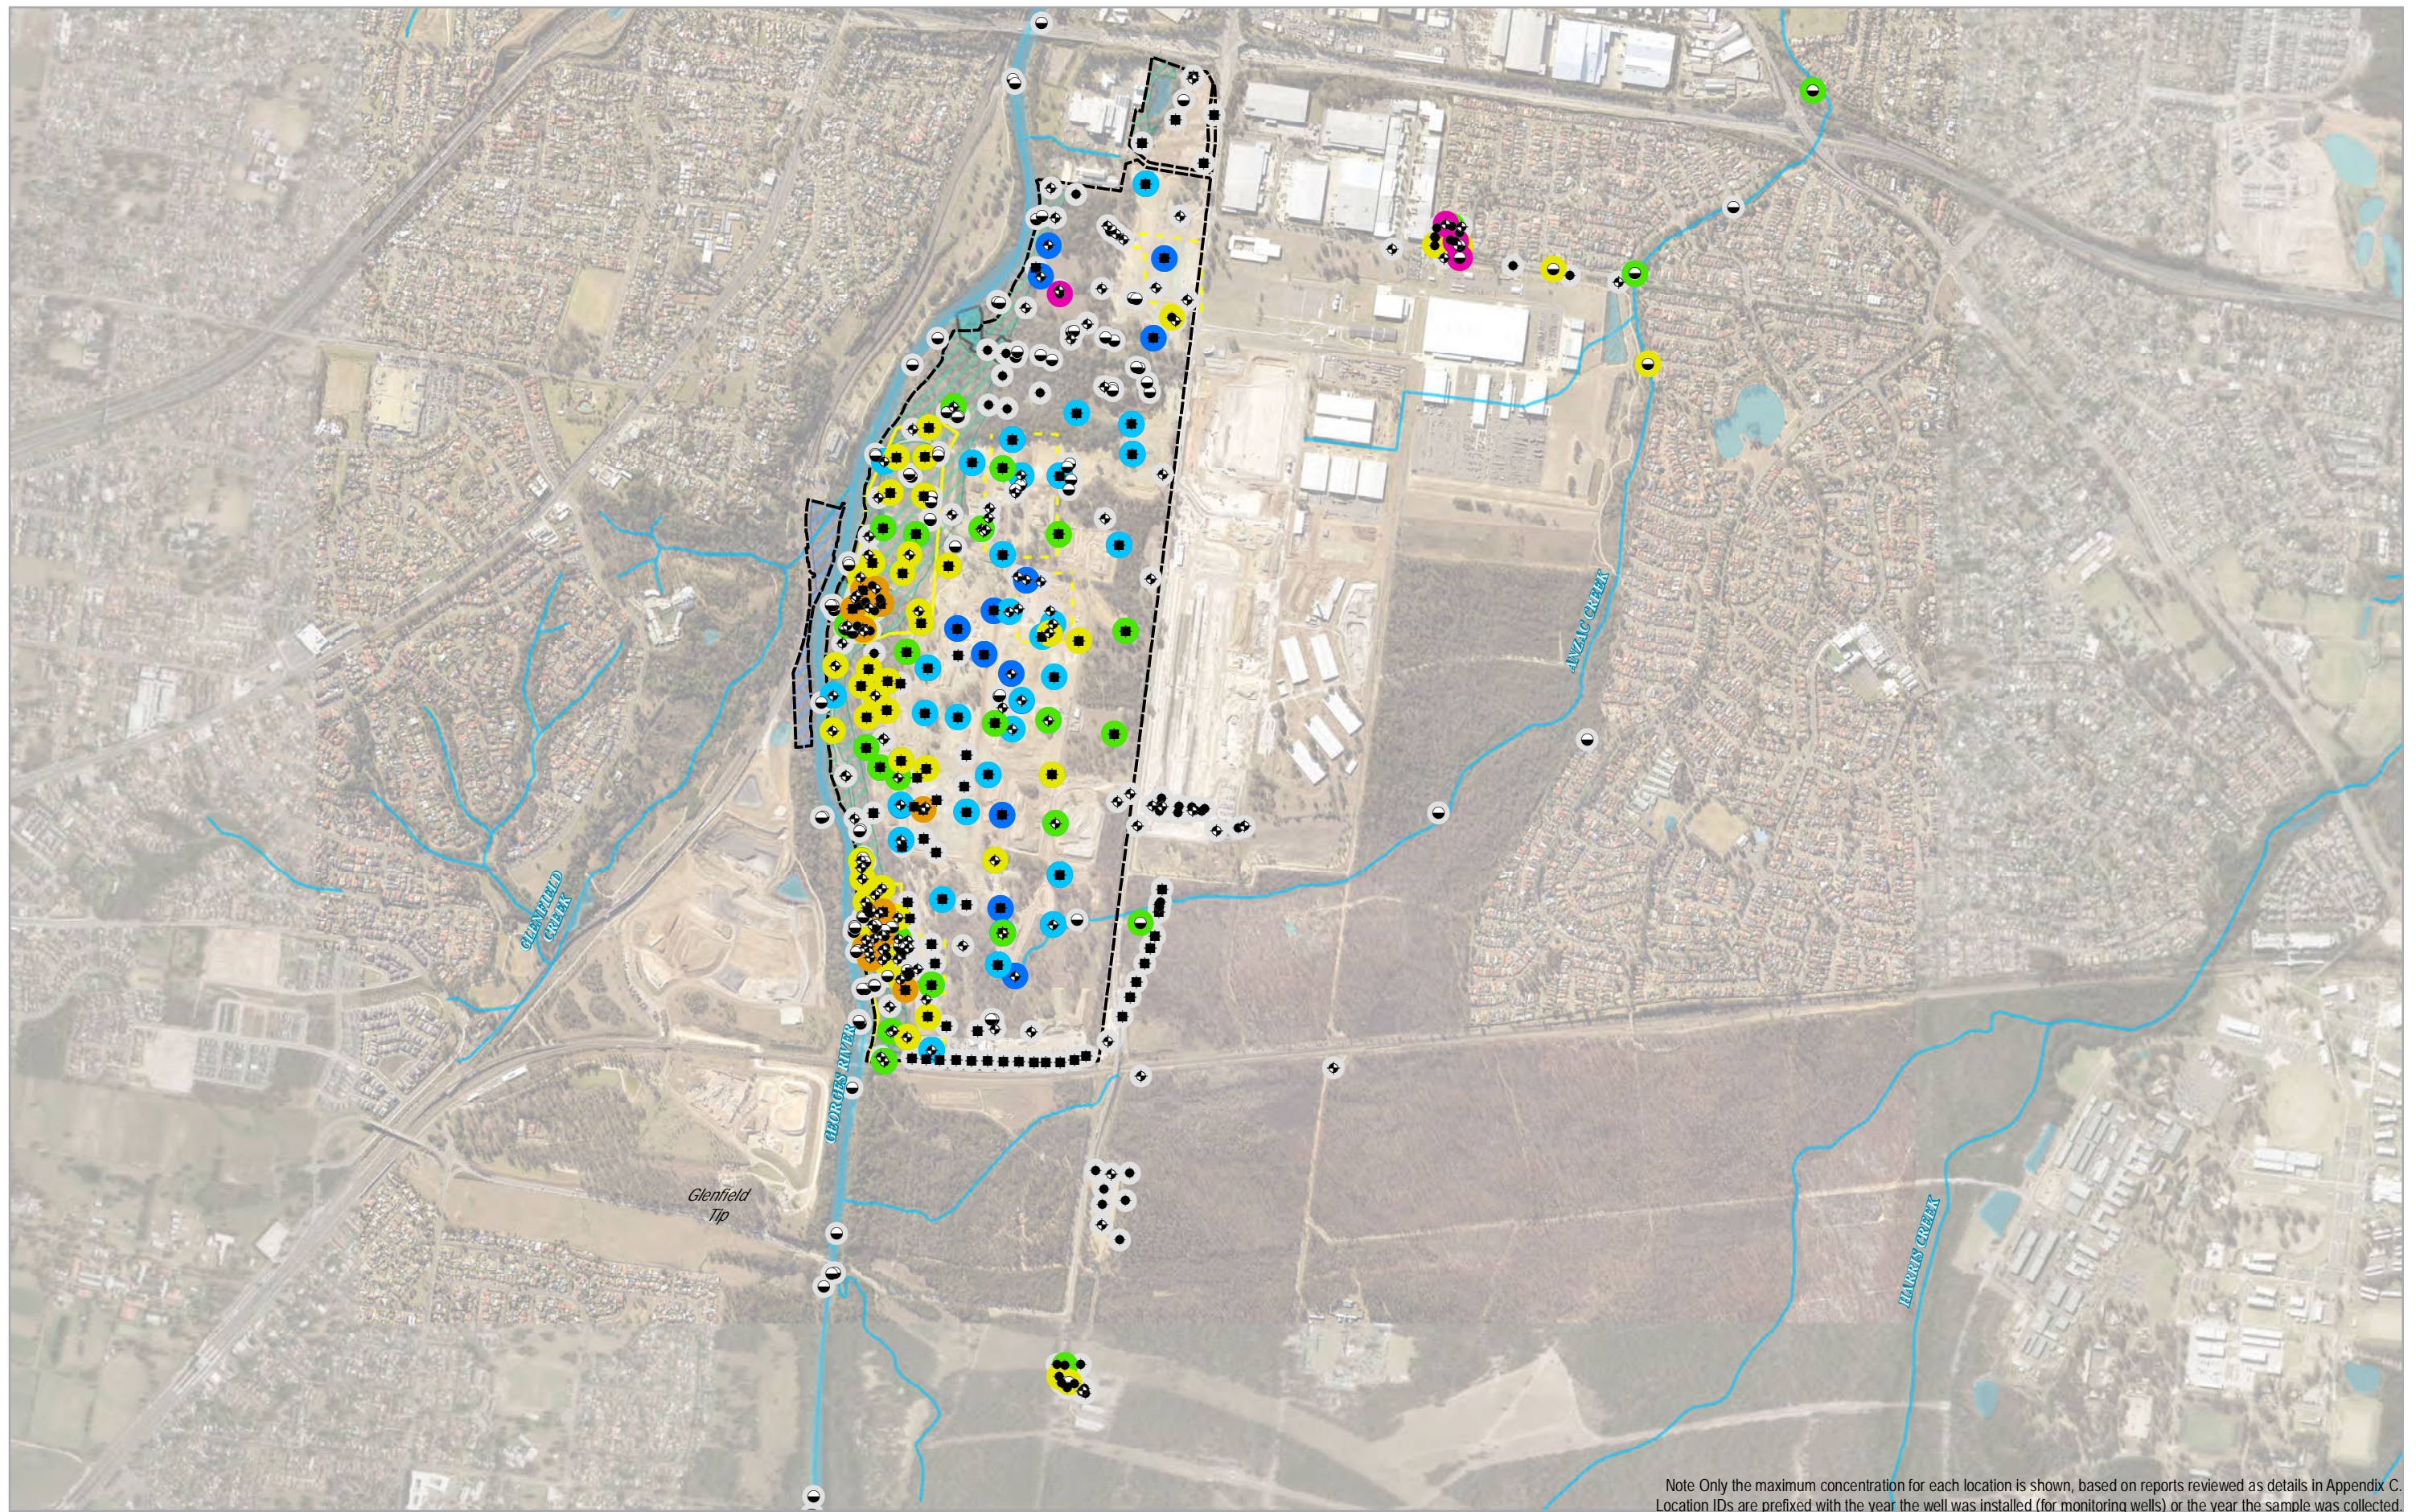
Note Only the maximum concentration for each location is shown, based on reports reviewed as details in Appendix C. Location IDs are prefixed with the year the well was installed (for monitoring wells) or the year the sample was collected.
