# Long-Term Environmental Management Plan

S3, S4, S6, S7, S8 and S9 Warehouse, Moorebank Precinct  
West, 400 Moorebank Avenue, Moorebank, NSW

Prepared for: ESR Australia and New Zealand c/o Tactical Group Pty Ltd  
EP1489.024\_v1 7 February 2025

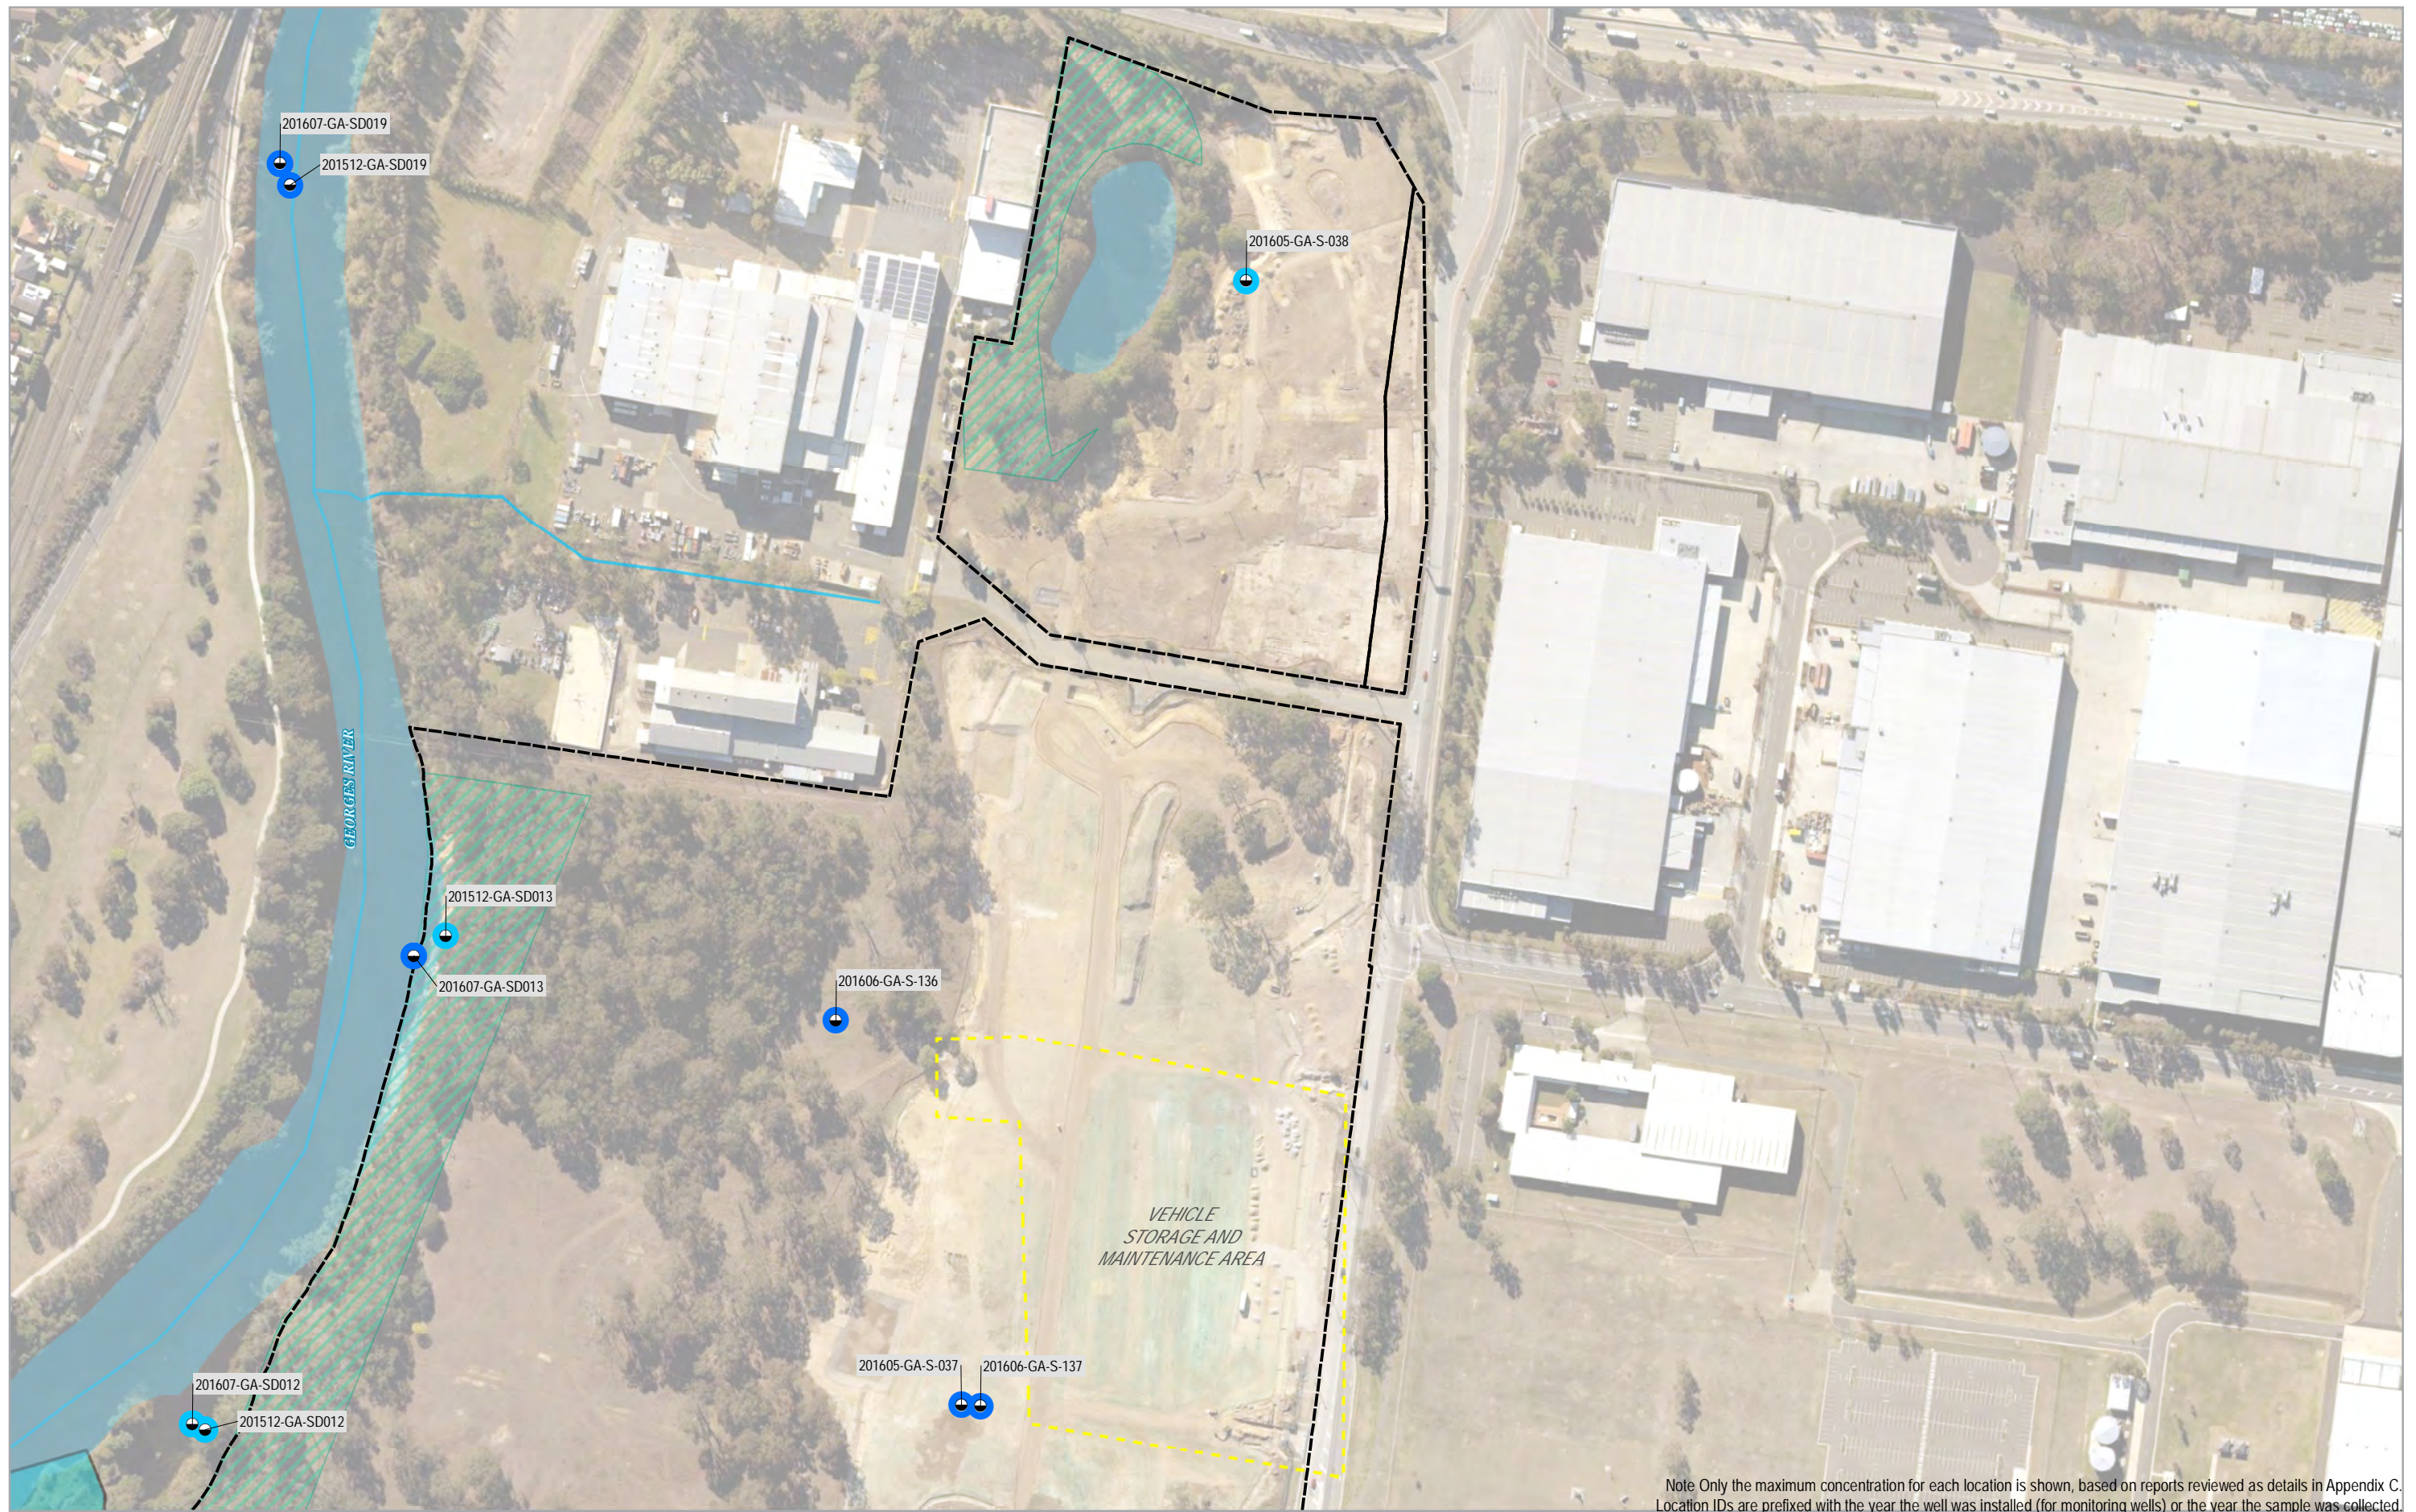
**FIGURE 7B**

Note Only the maximum concentration for each location is shown, based on reports reviewed as details in Appendix C. Location IDs are prefixed with the year the well was installed (for monitoring wells) or the year the sample was collected.

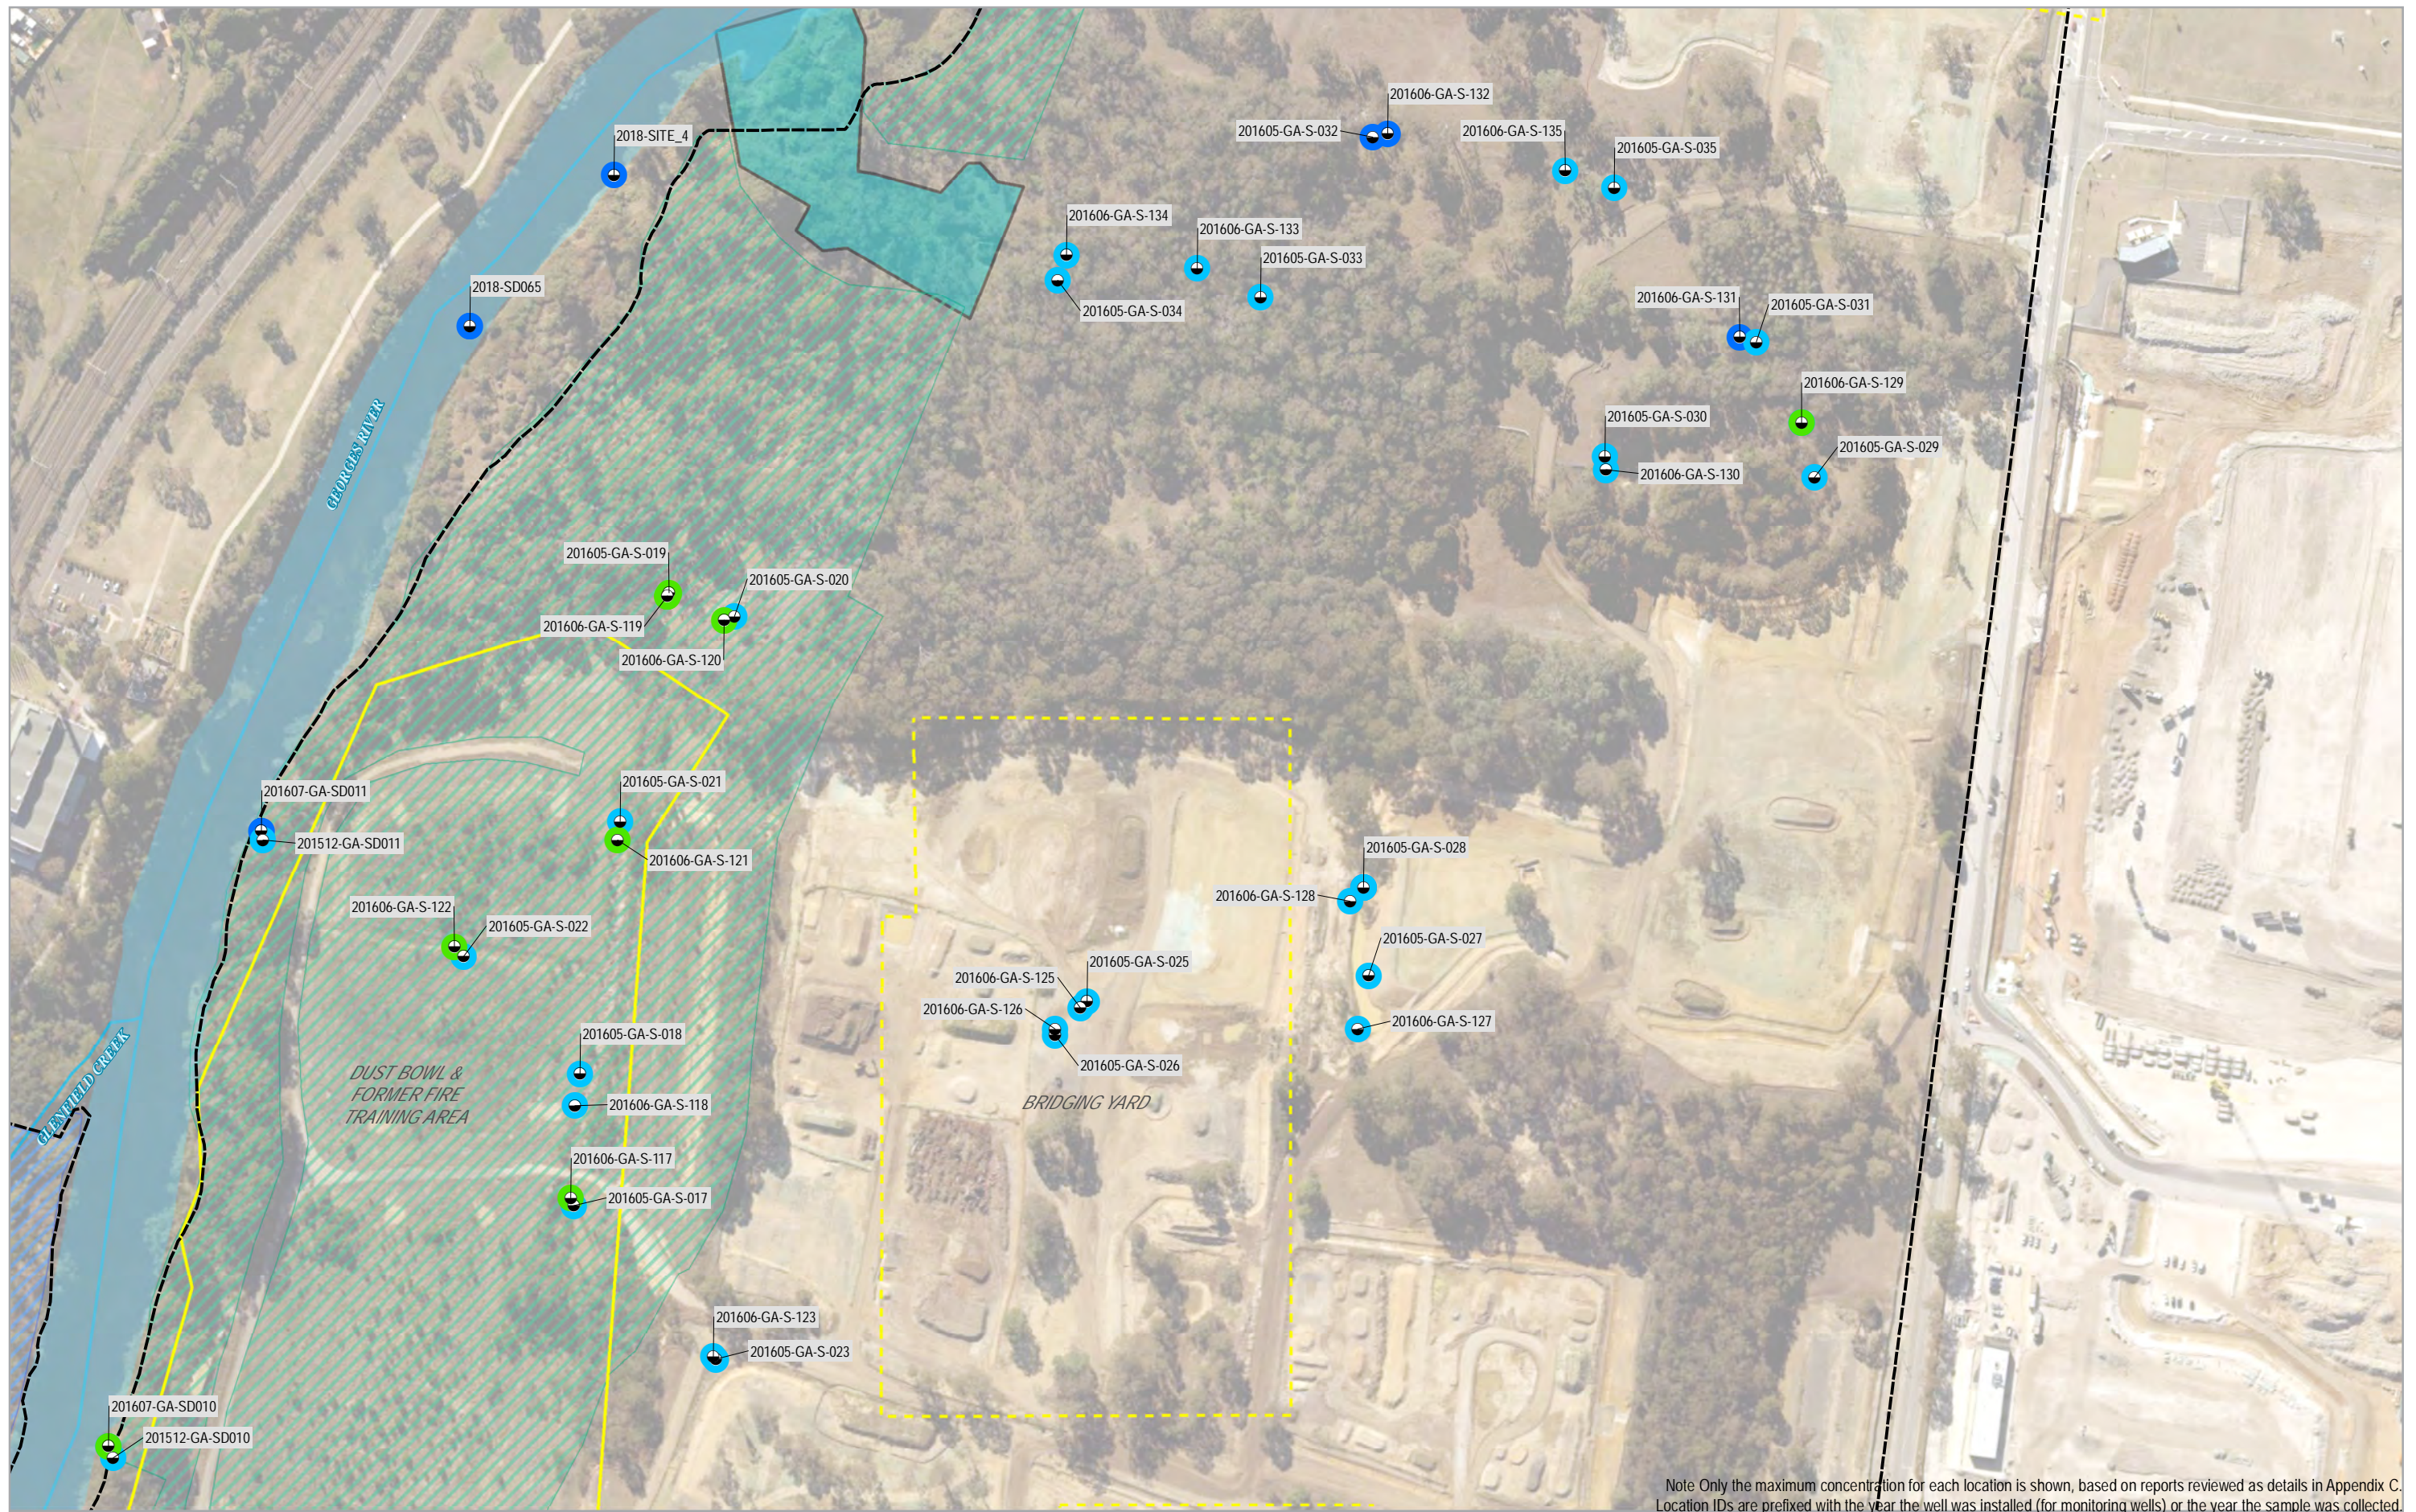
**FIGURE 7C**

Note Only the maximum concentration for each location is shown, based on reports reviewed as details in Appendix C. Location IDs are prefixed with the year the well was installed (for monitoring wells) or the year the sample was collected.

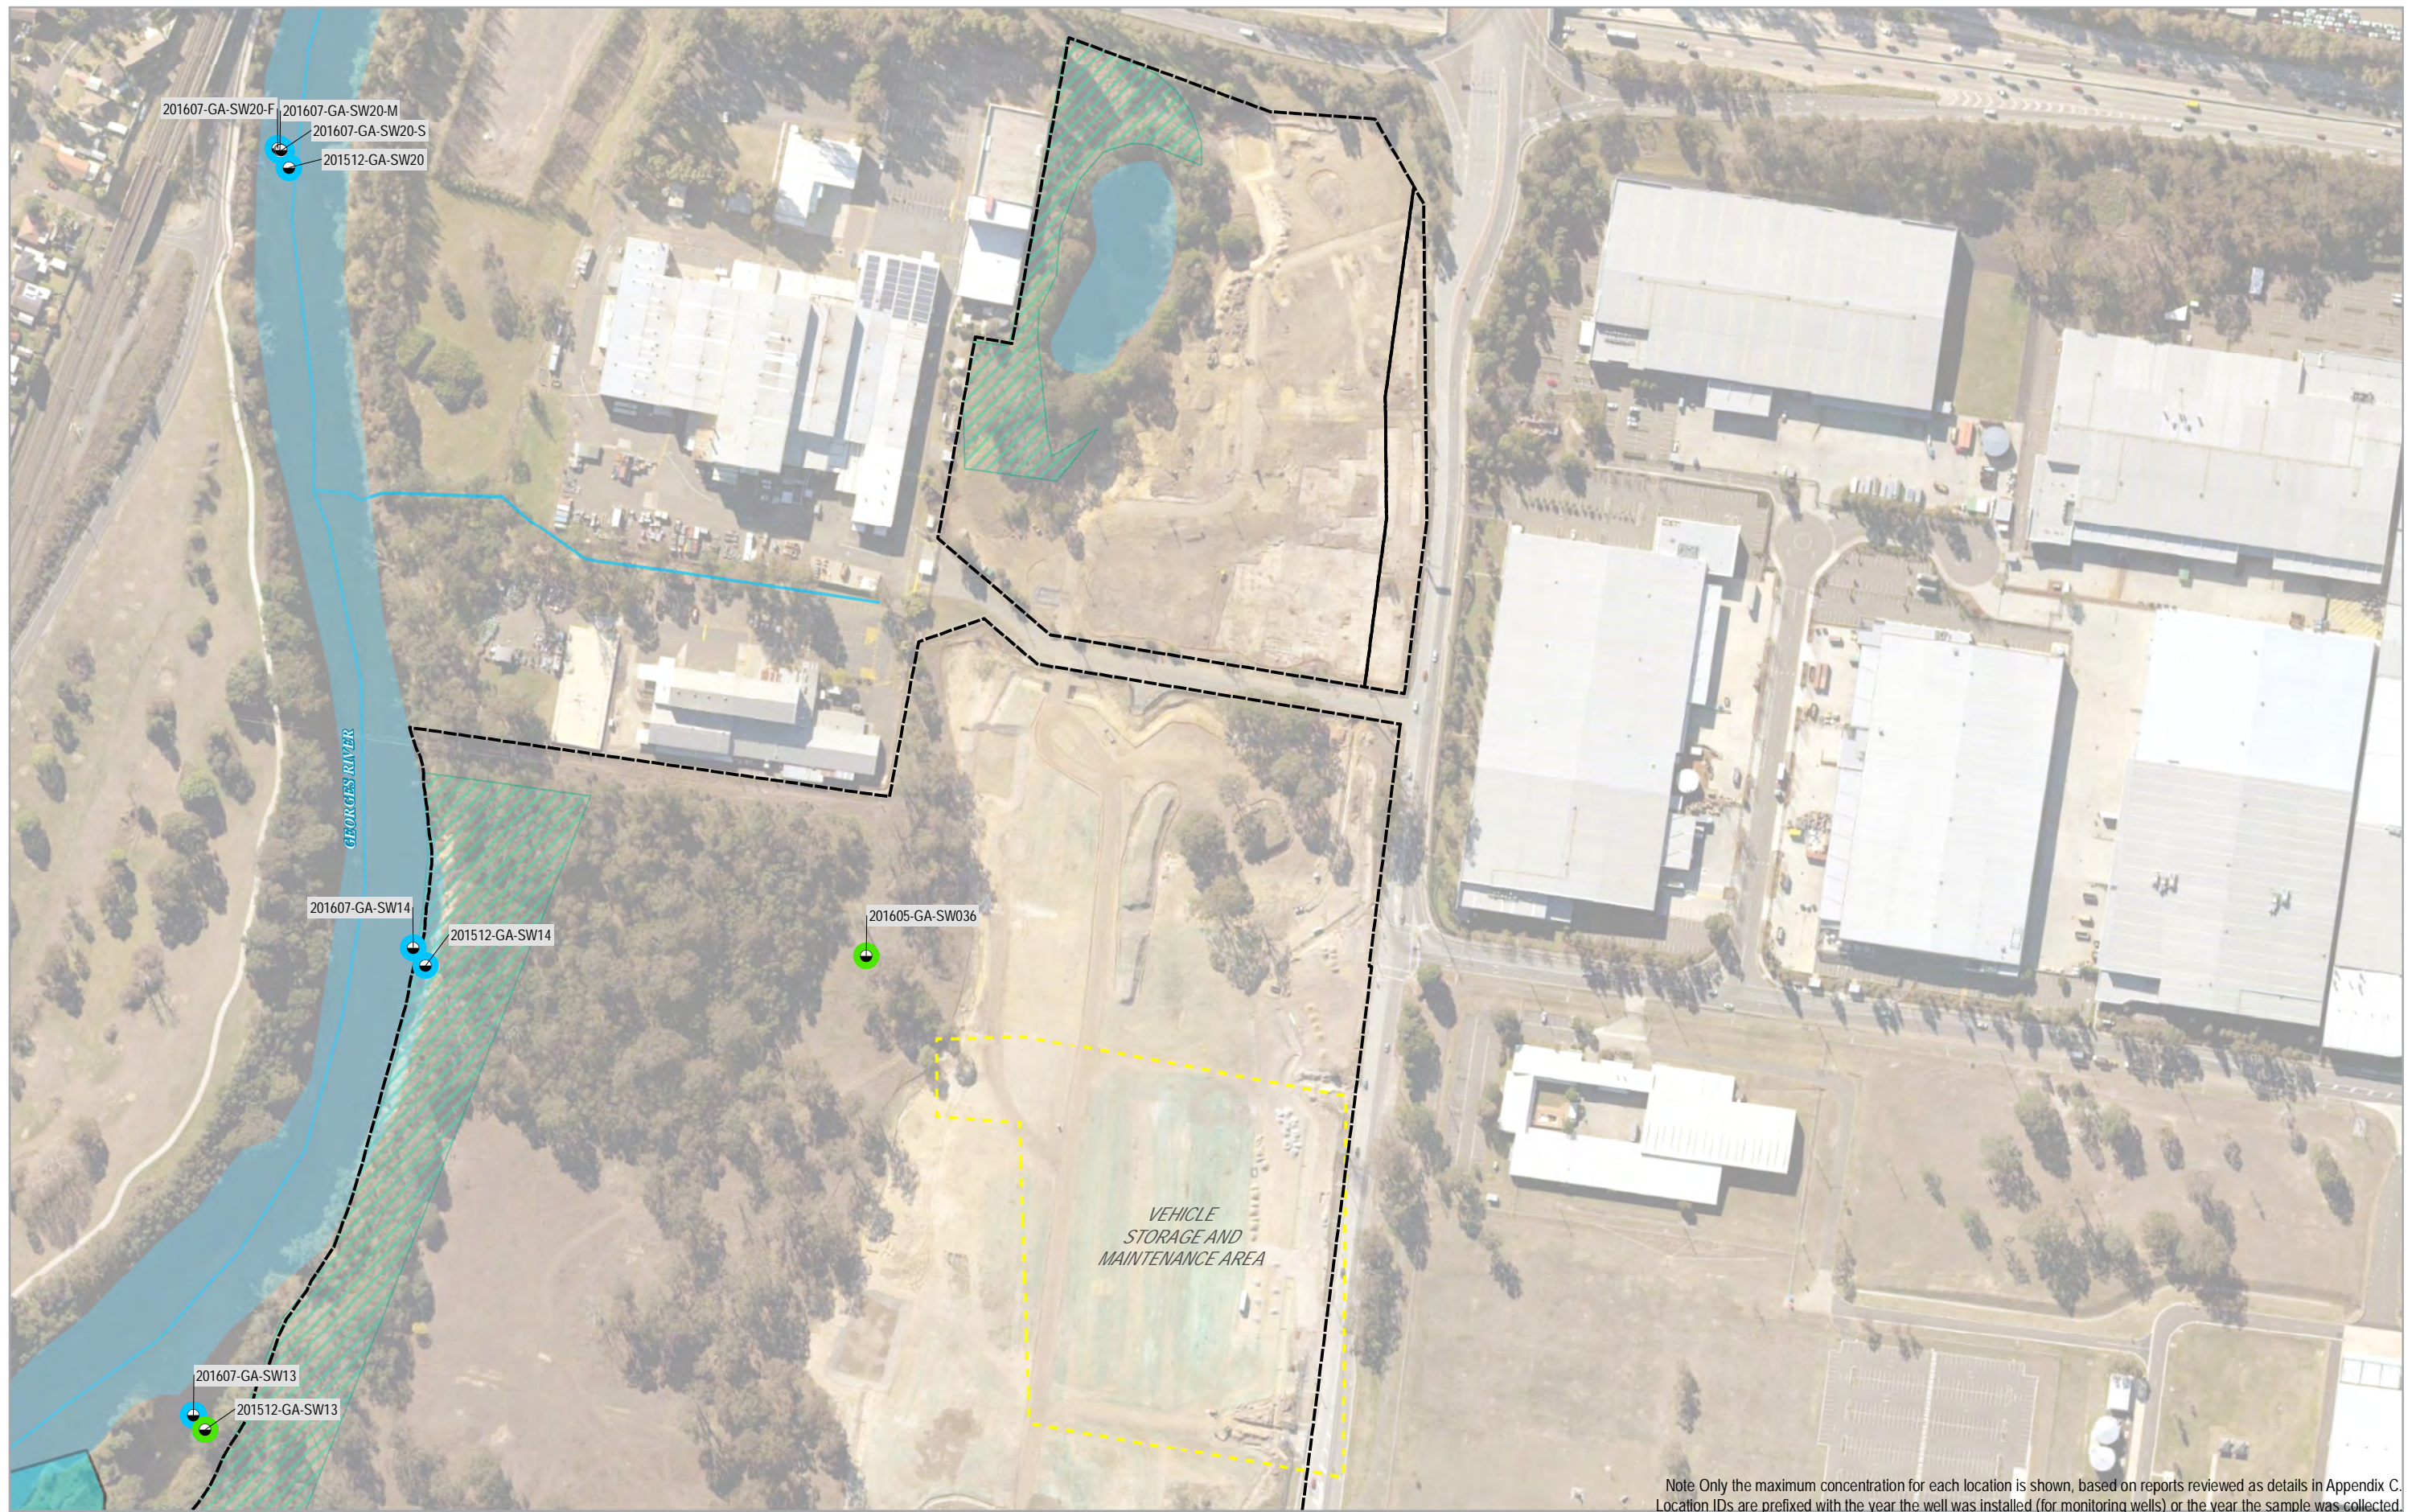
**FIGURE 7E**

- LEGEND**
- Investigation Area
  - Other Potential PFAS Source
  - Moorebank Offset
  - Drainage Basin (Approximate)
  - Surface Water
- Max PFOS + PFHxS Concentration (µg/L)
- <LOR
  - LOR - 0.13
  - >0.13
  - >0.7
  - >10
  - >100
  - No PFAS Data

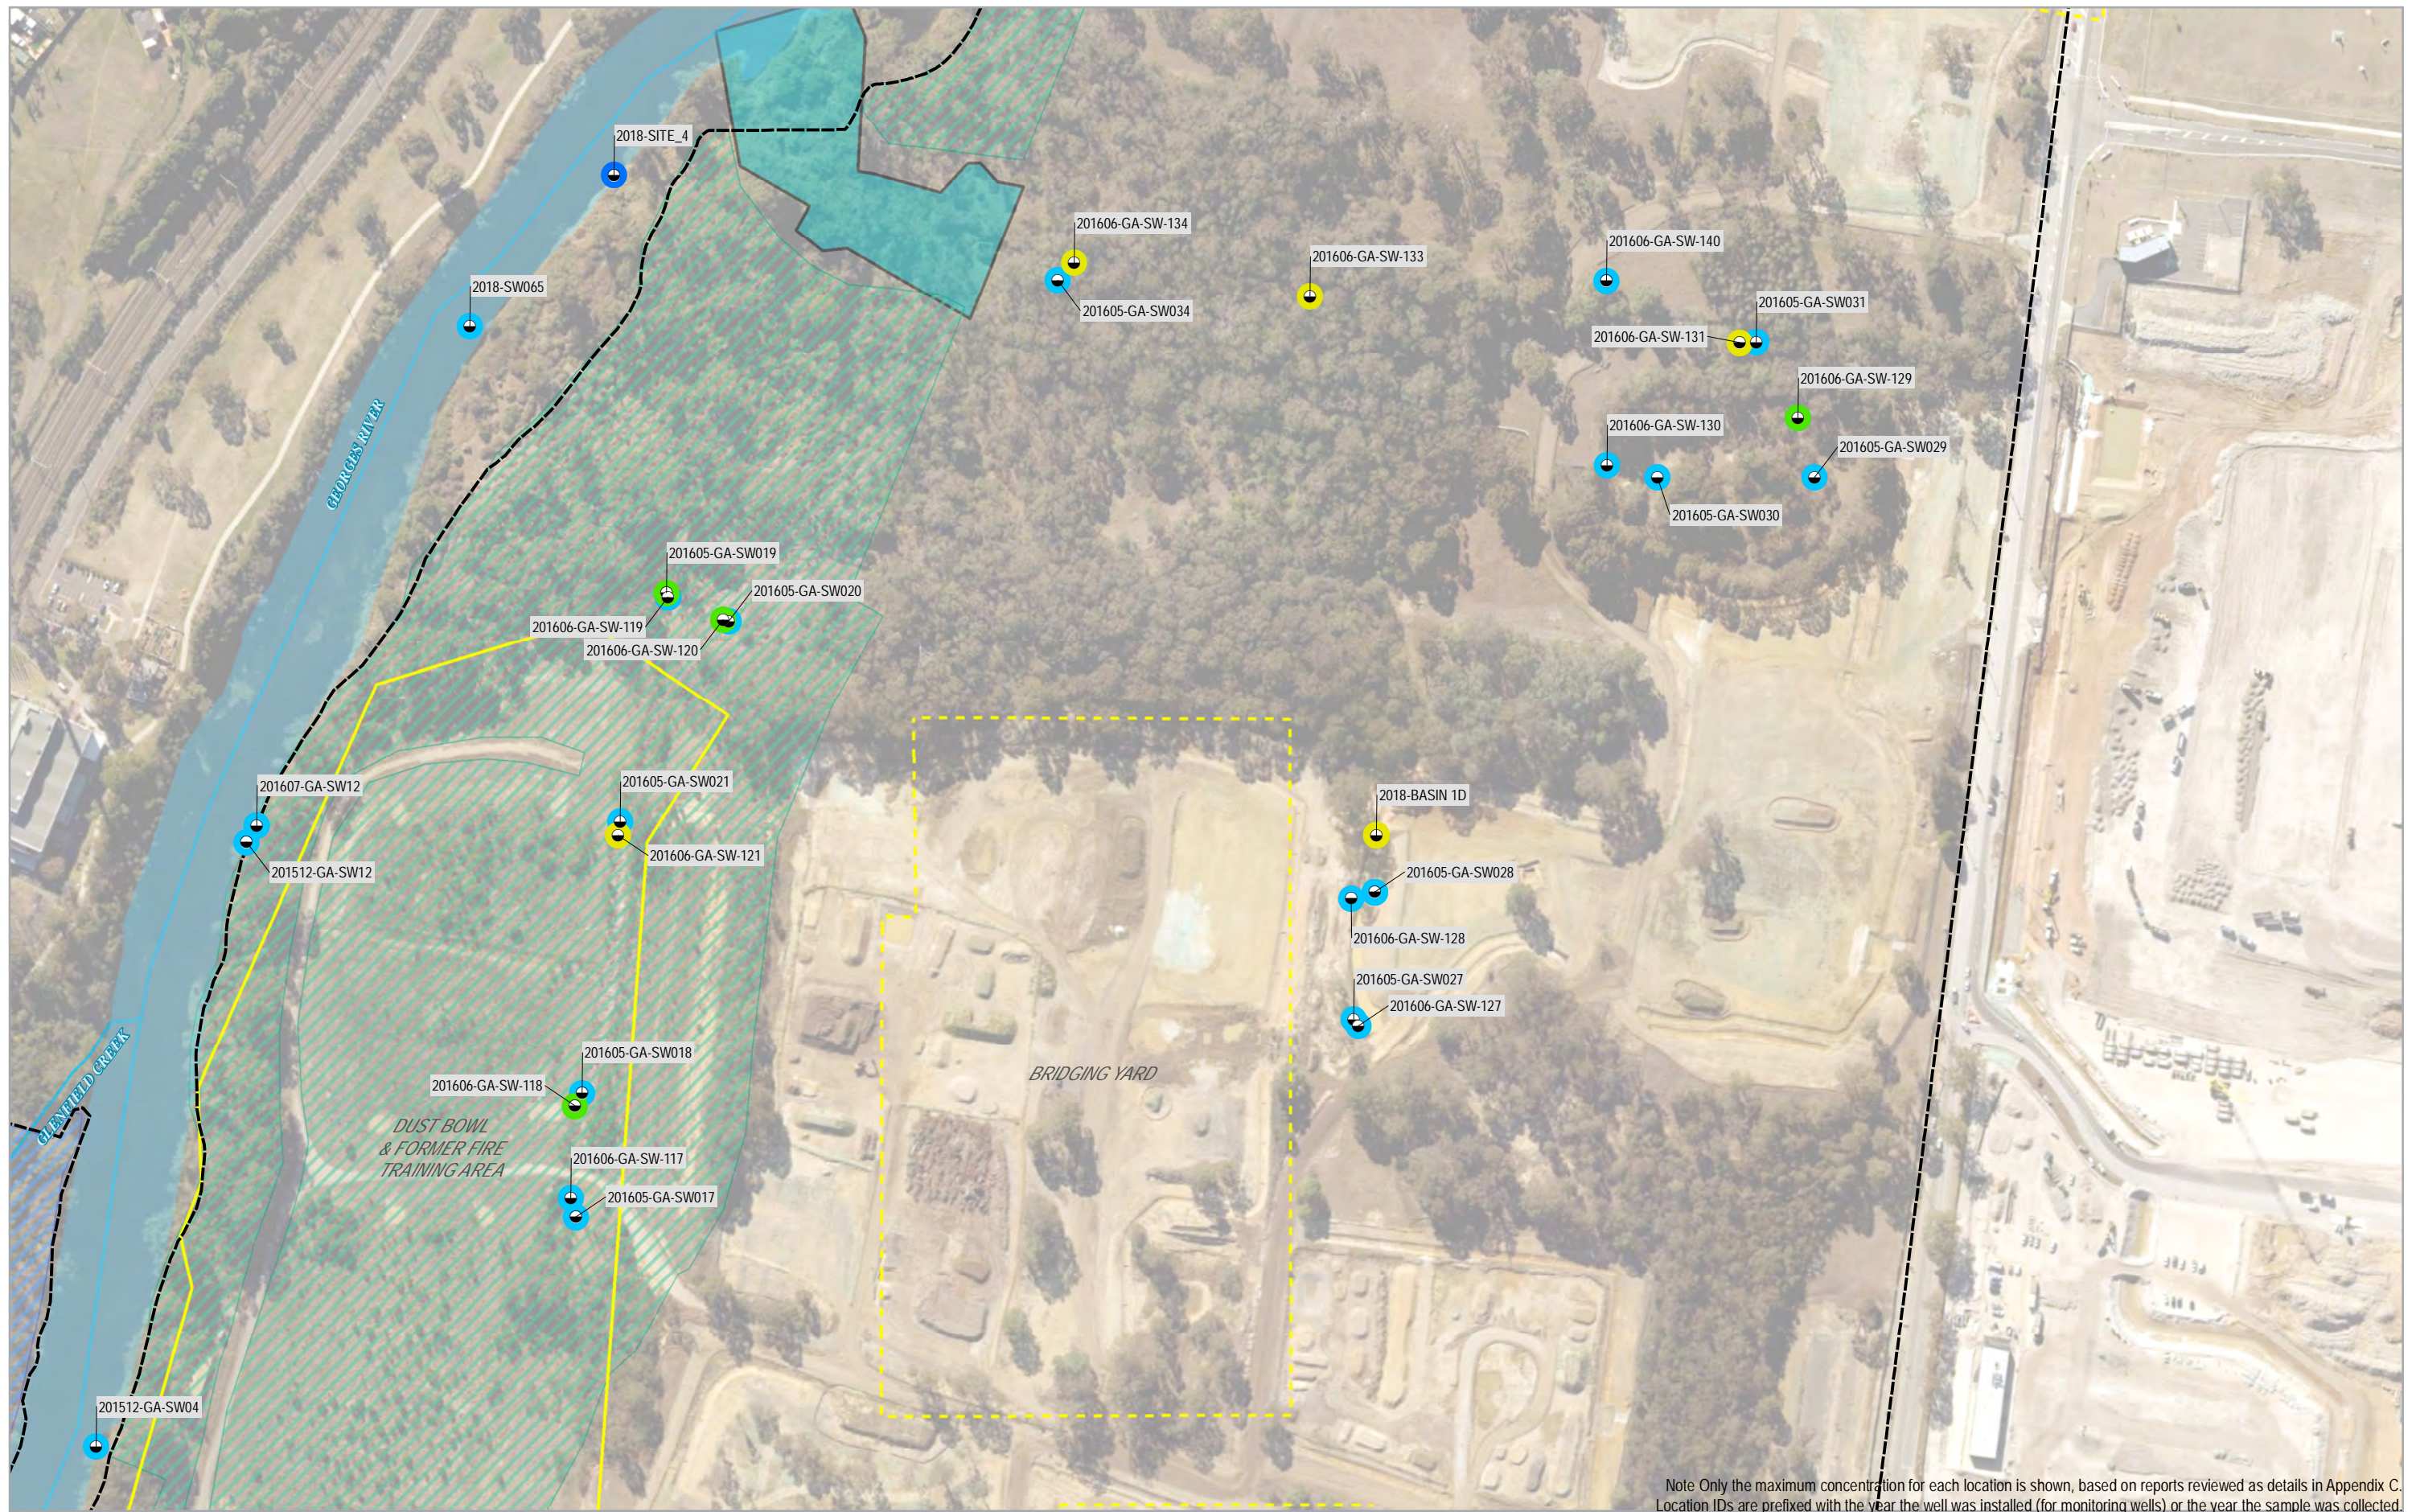
**FIGURE 8B**

Note Only the maximum concentration for each location is shown, based on reports reviewed as details in Appendix C. Location IDs are prefixed with the year the well was installed (for monitoring wells) or the year the sample was collected.

- LEGEND**
- Investigation Area
  - Key PFAS Source
  - Other Potential PFAS Source
  - Casula (Hourglass) Offset Biobank Site
  - Moorebank Offset
  - Drainage Basin (Approximate)
  - Surface Water
  - Max PFOS + PFHxS Concentration (µg/L) <LOR
  - LOR - 0.13
  - >0.13
  - >0.7
  - >10
  - >100
  - No PFAS Data
