# Appendix C

## CONDITIONS OF CONSENT COMPLIANCE MATRIX

Report No

MIC2-QPMS-EN-APP-00022

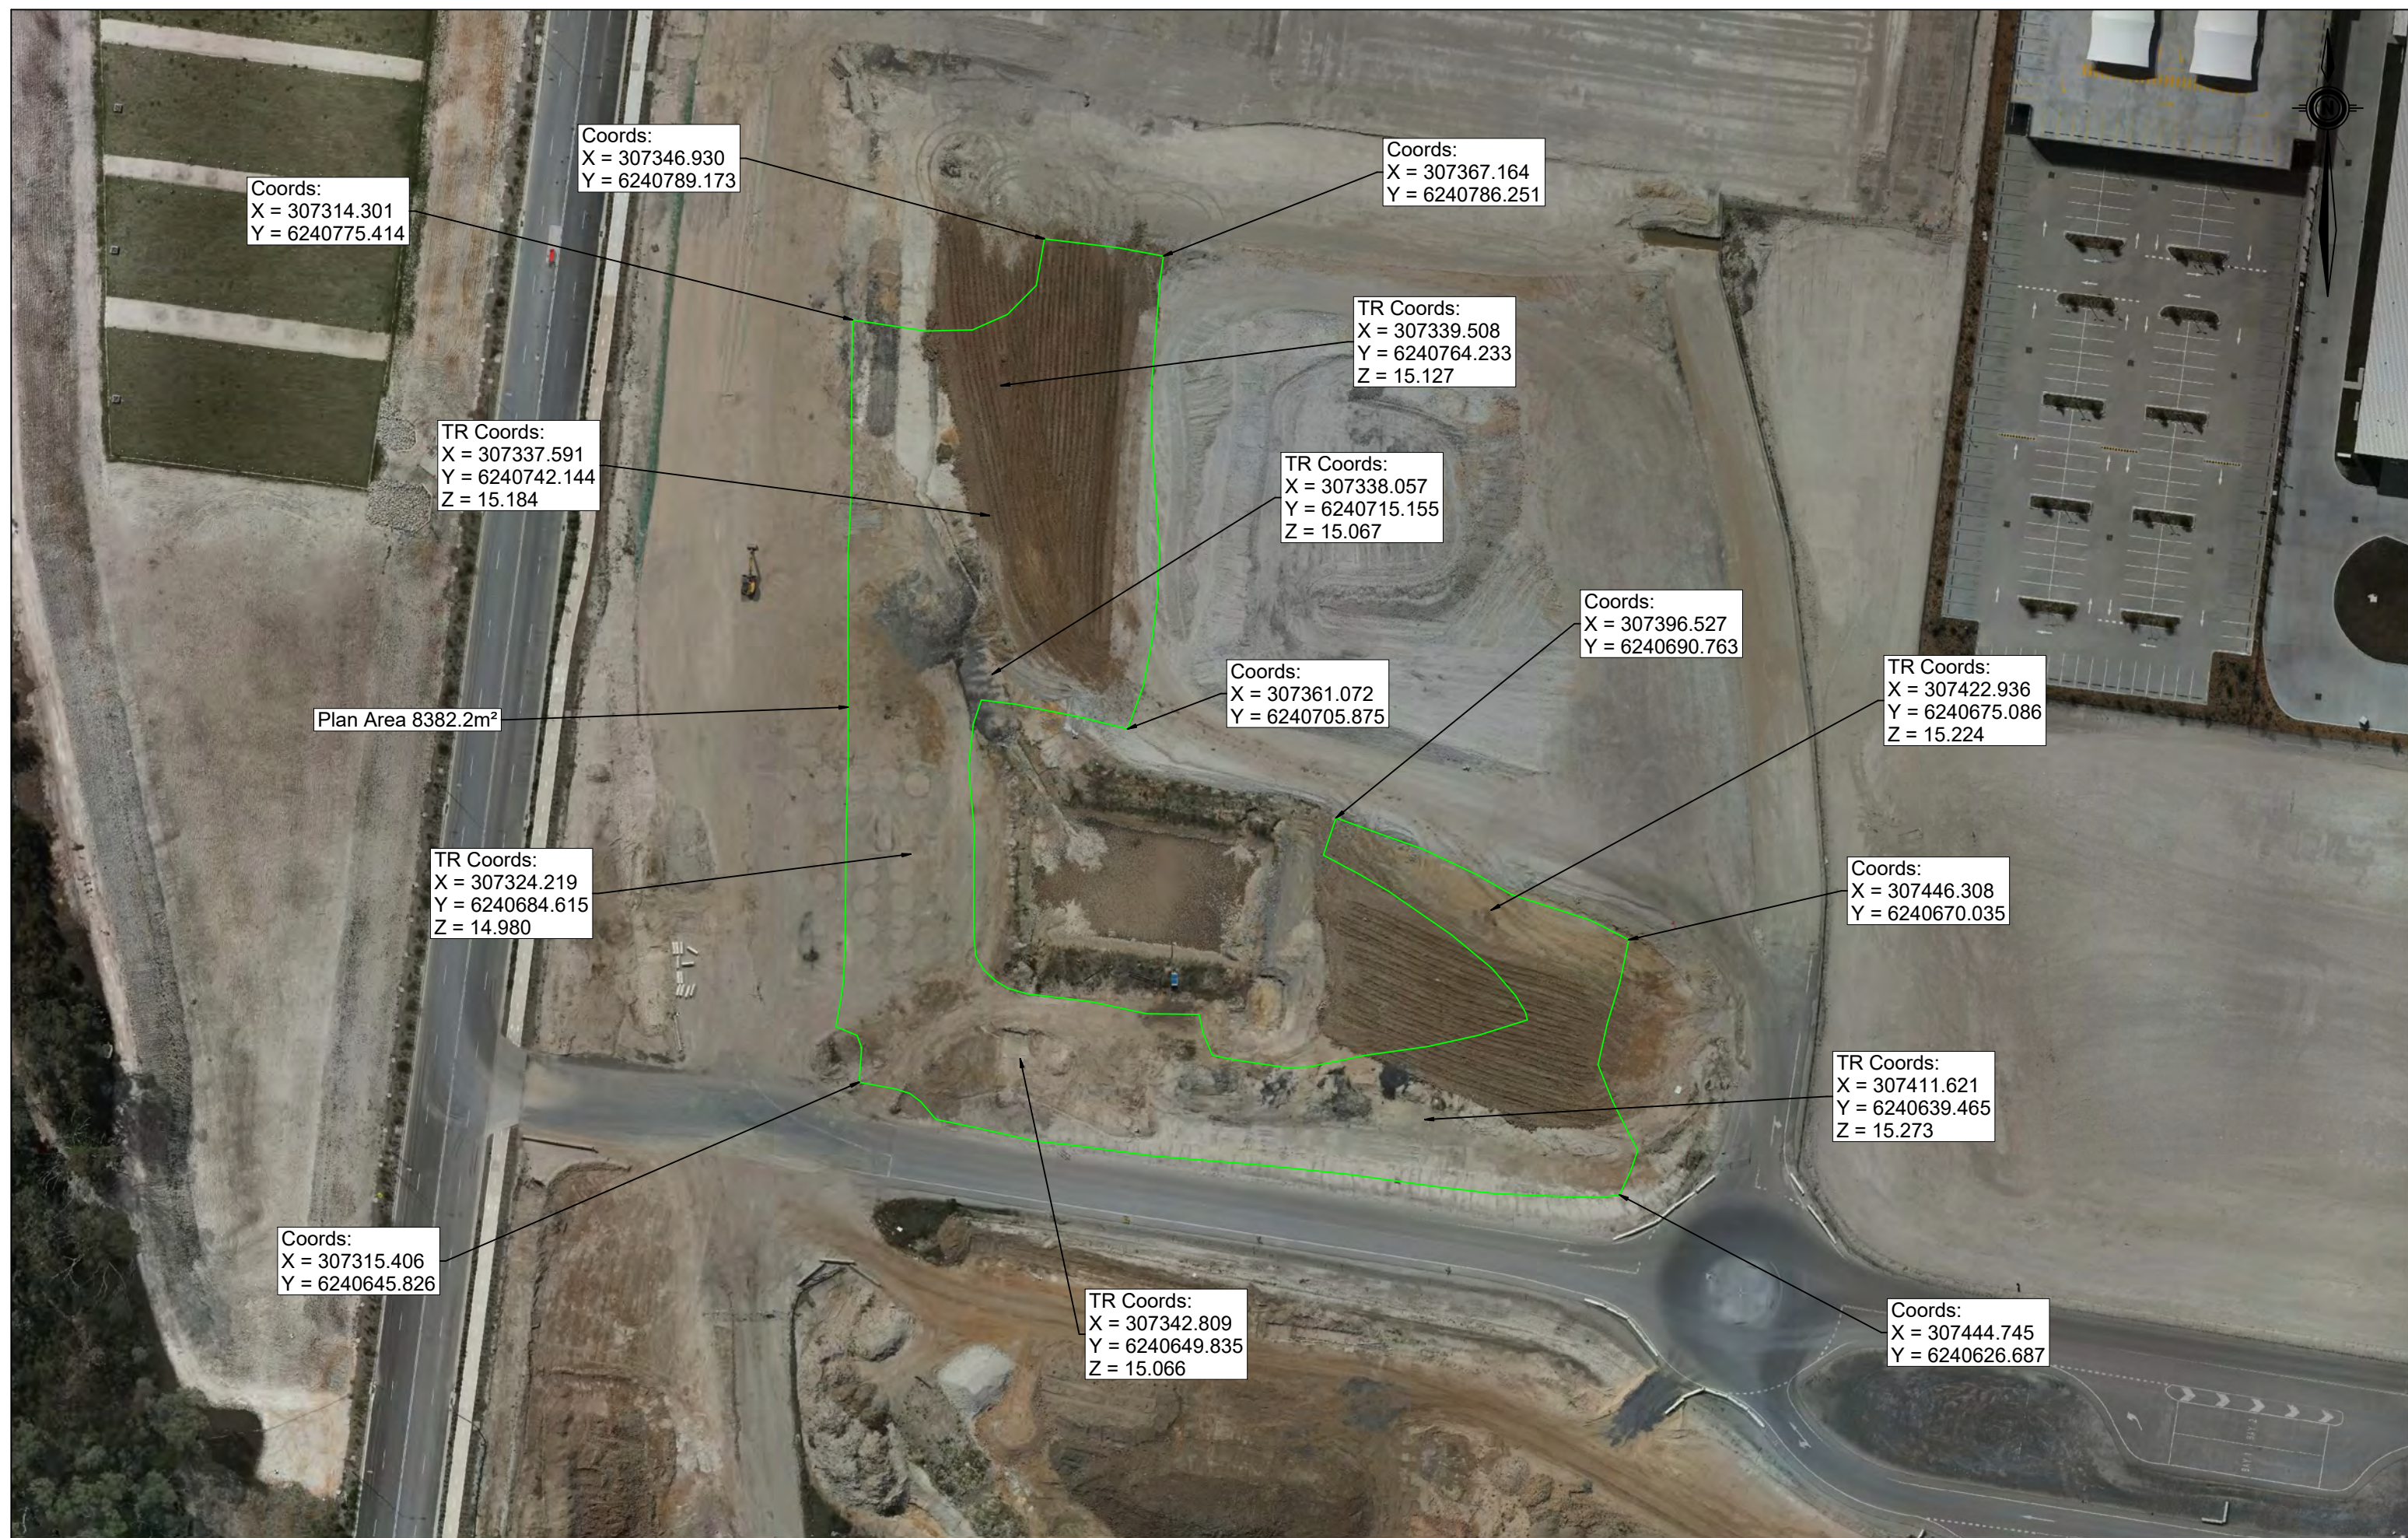
PRECINCT INFRASTRUCTURE WORKS WEST  
TITLE  
MRW - Project Bell  
Chatham Ave  
Moorebank  
THIRD ANGLE  
PROJECTION  
Sheet No. 1  
PROJECT NO. 190050

WH8  
EF-WH8-066  
TR5391 L1

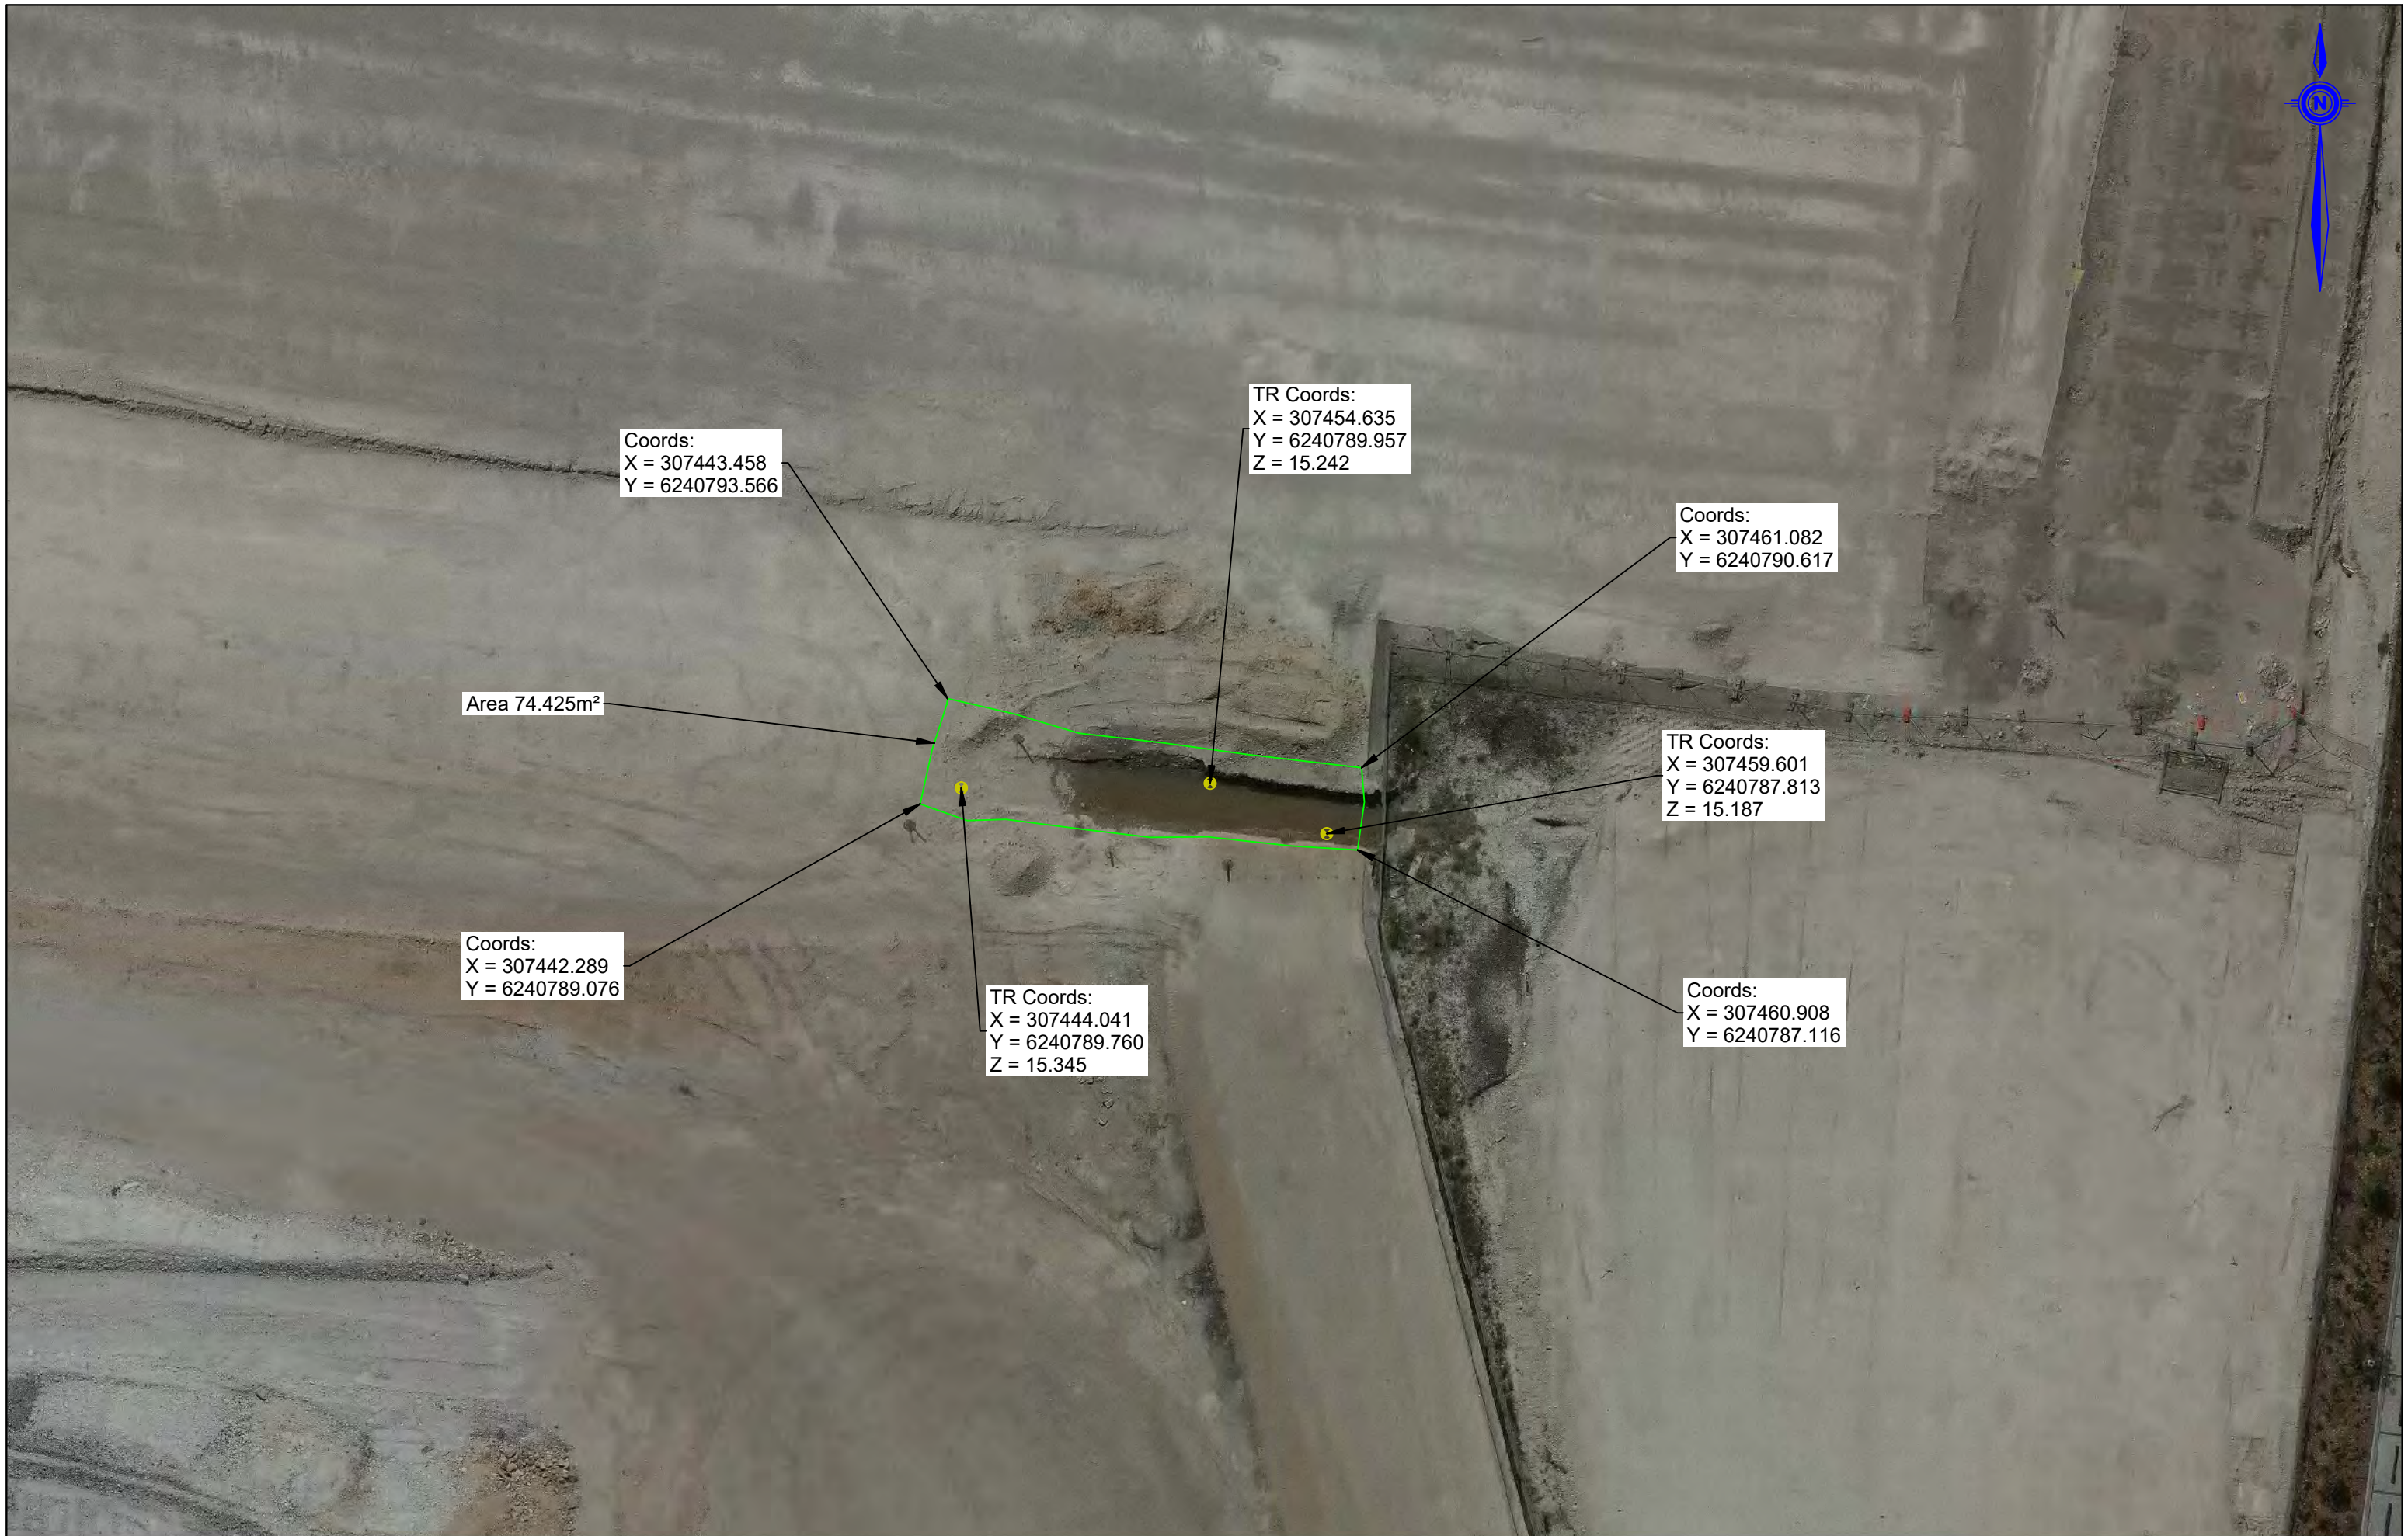
PRECINCT INFRASTRUCTURE WORKS WEST  
TITLE  
MRW - Project Bell  
Chatham Ave  
Moorebank  
THIRD ANGLE  
PROJECTION  
Sheet No. 1

SCALE:  
1:250  
DATUM:  
A.H.D / M.G.A

Coords:  
X = 307443.458  
Y = 6240793.566

TR Coords:  
X = 307454.635  
Y = 6240789.957  
Z = 15.242

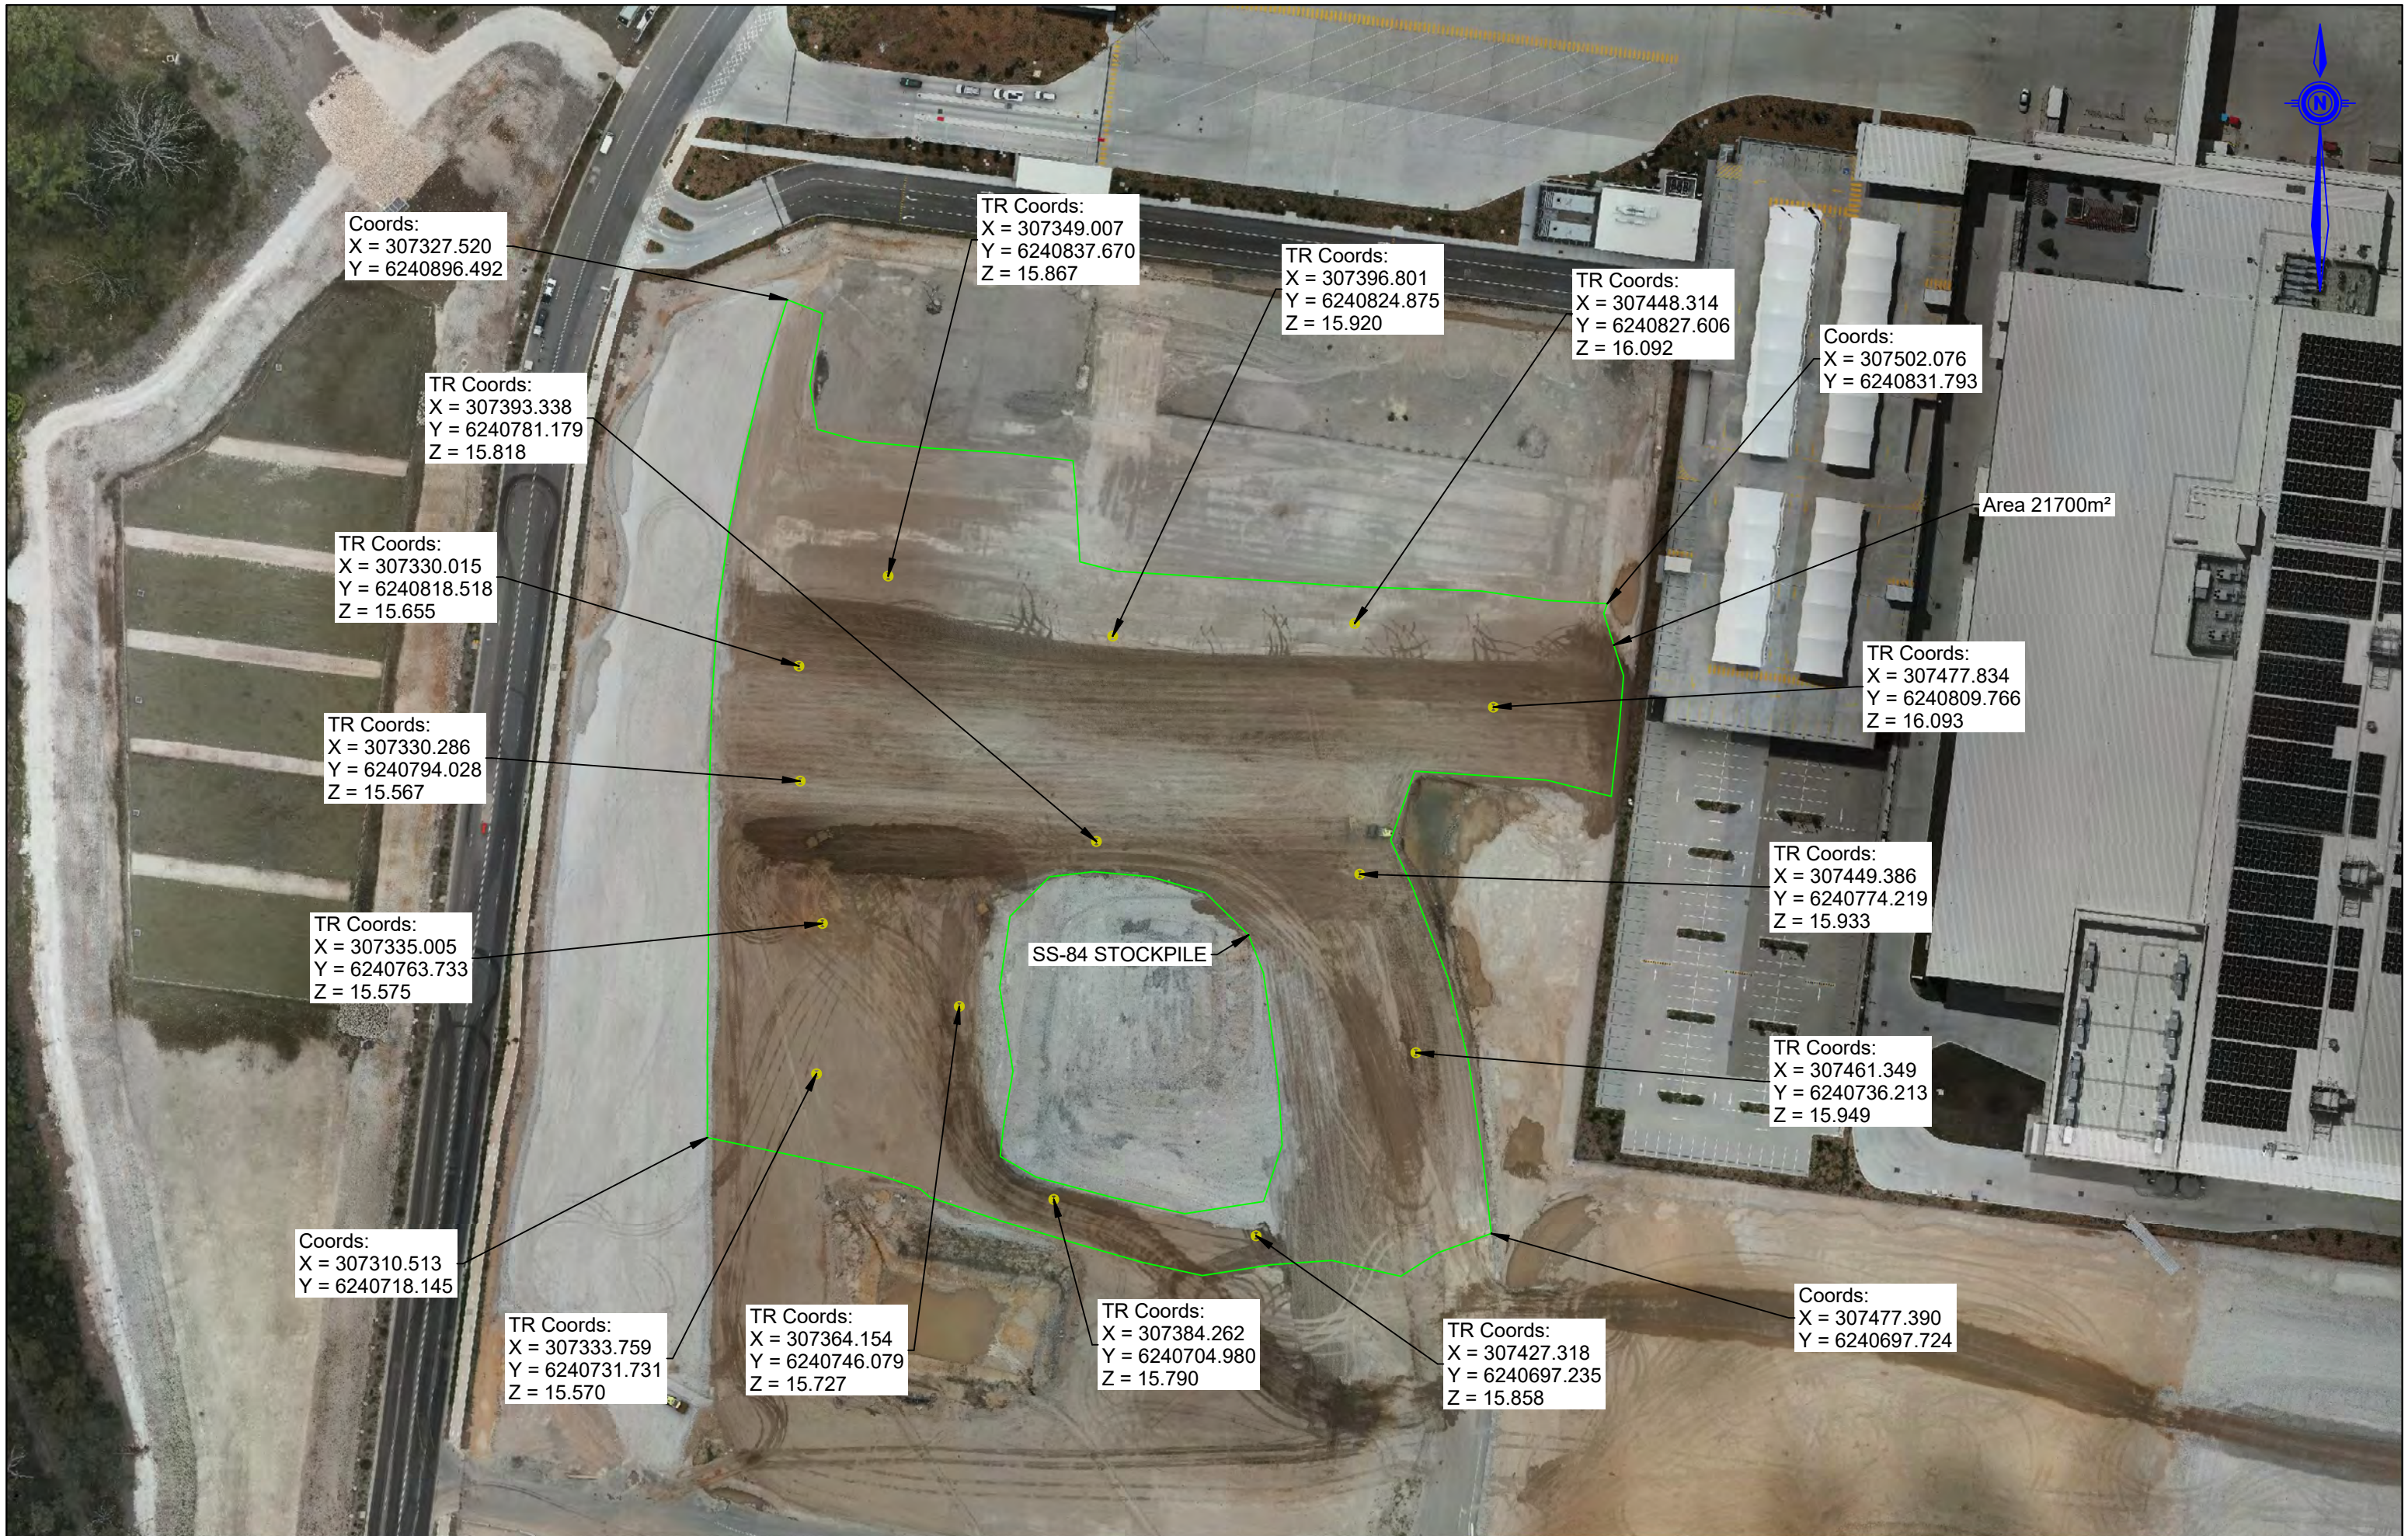
TITLE  
MRW - Project Bell  
Chatham Ave  
Moorebank  
THIRD ANGLE  
PROJECTION  
Sheet No. 1

NOTES:  
FILL AROUND BASIN 6E AND SS84 L2  
WH8  
TR5578

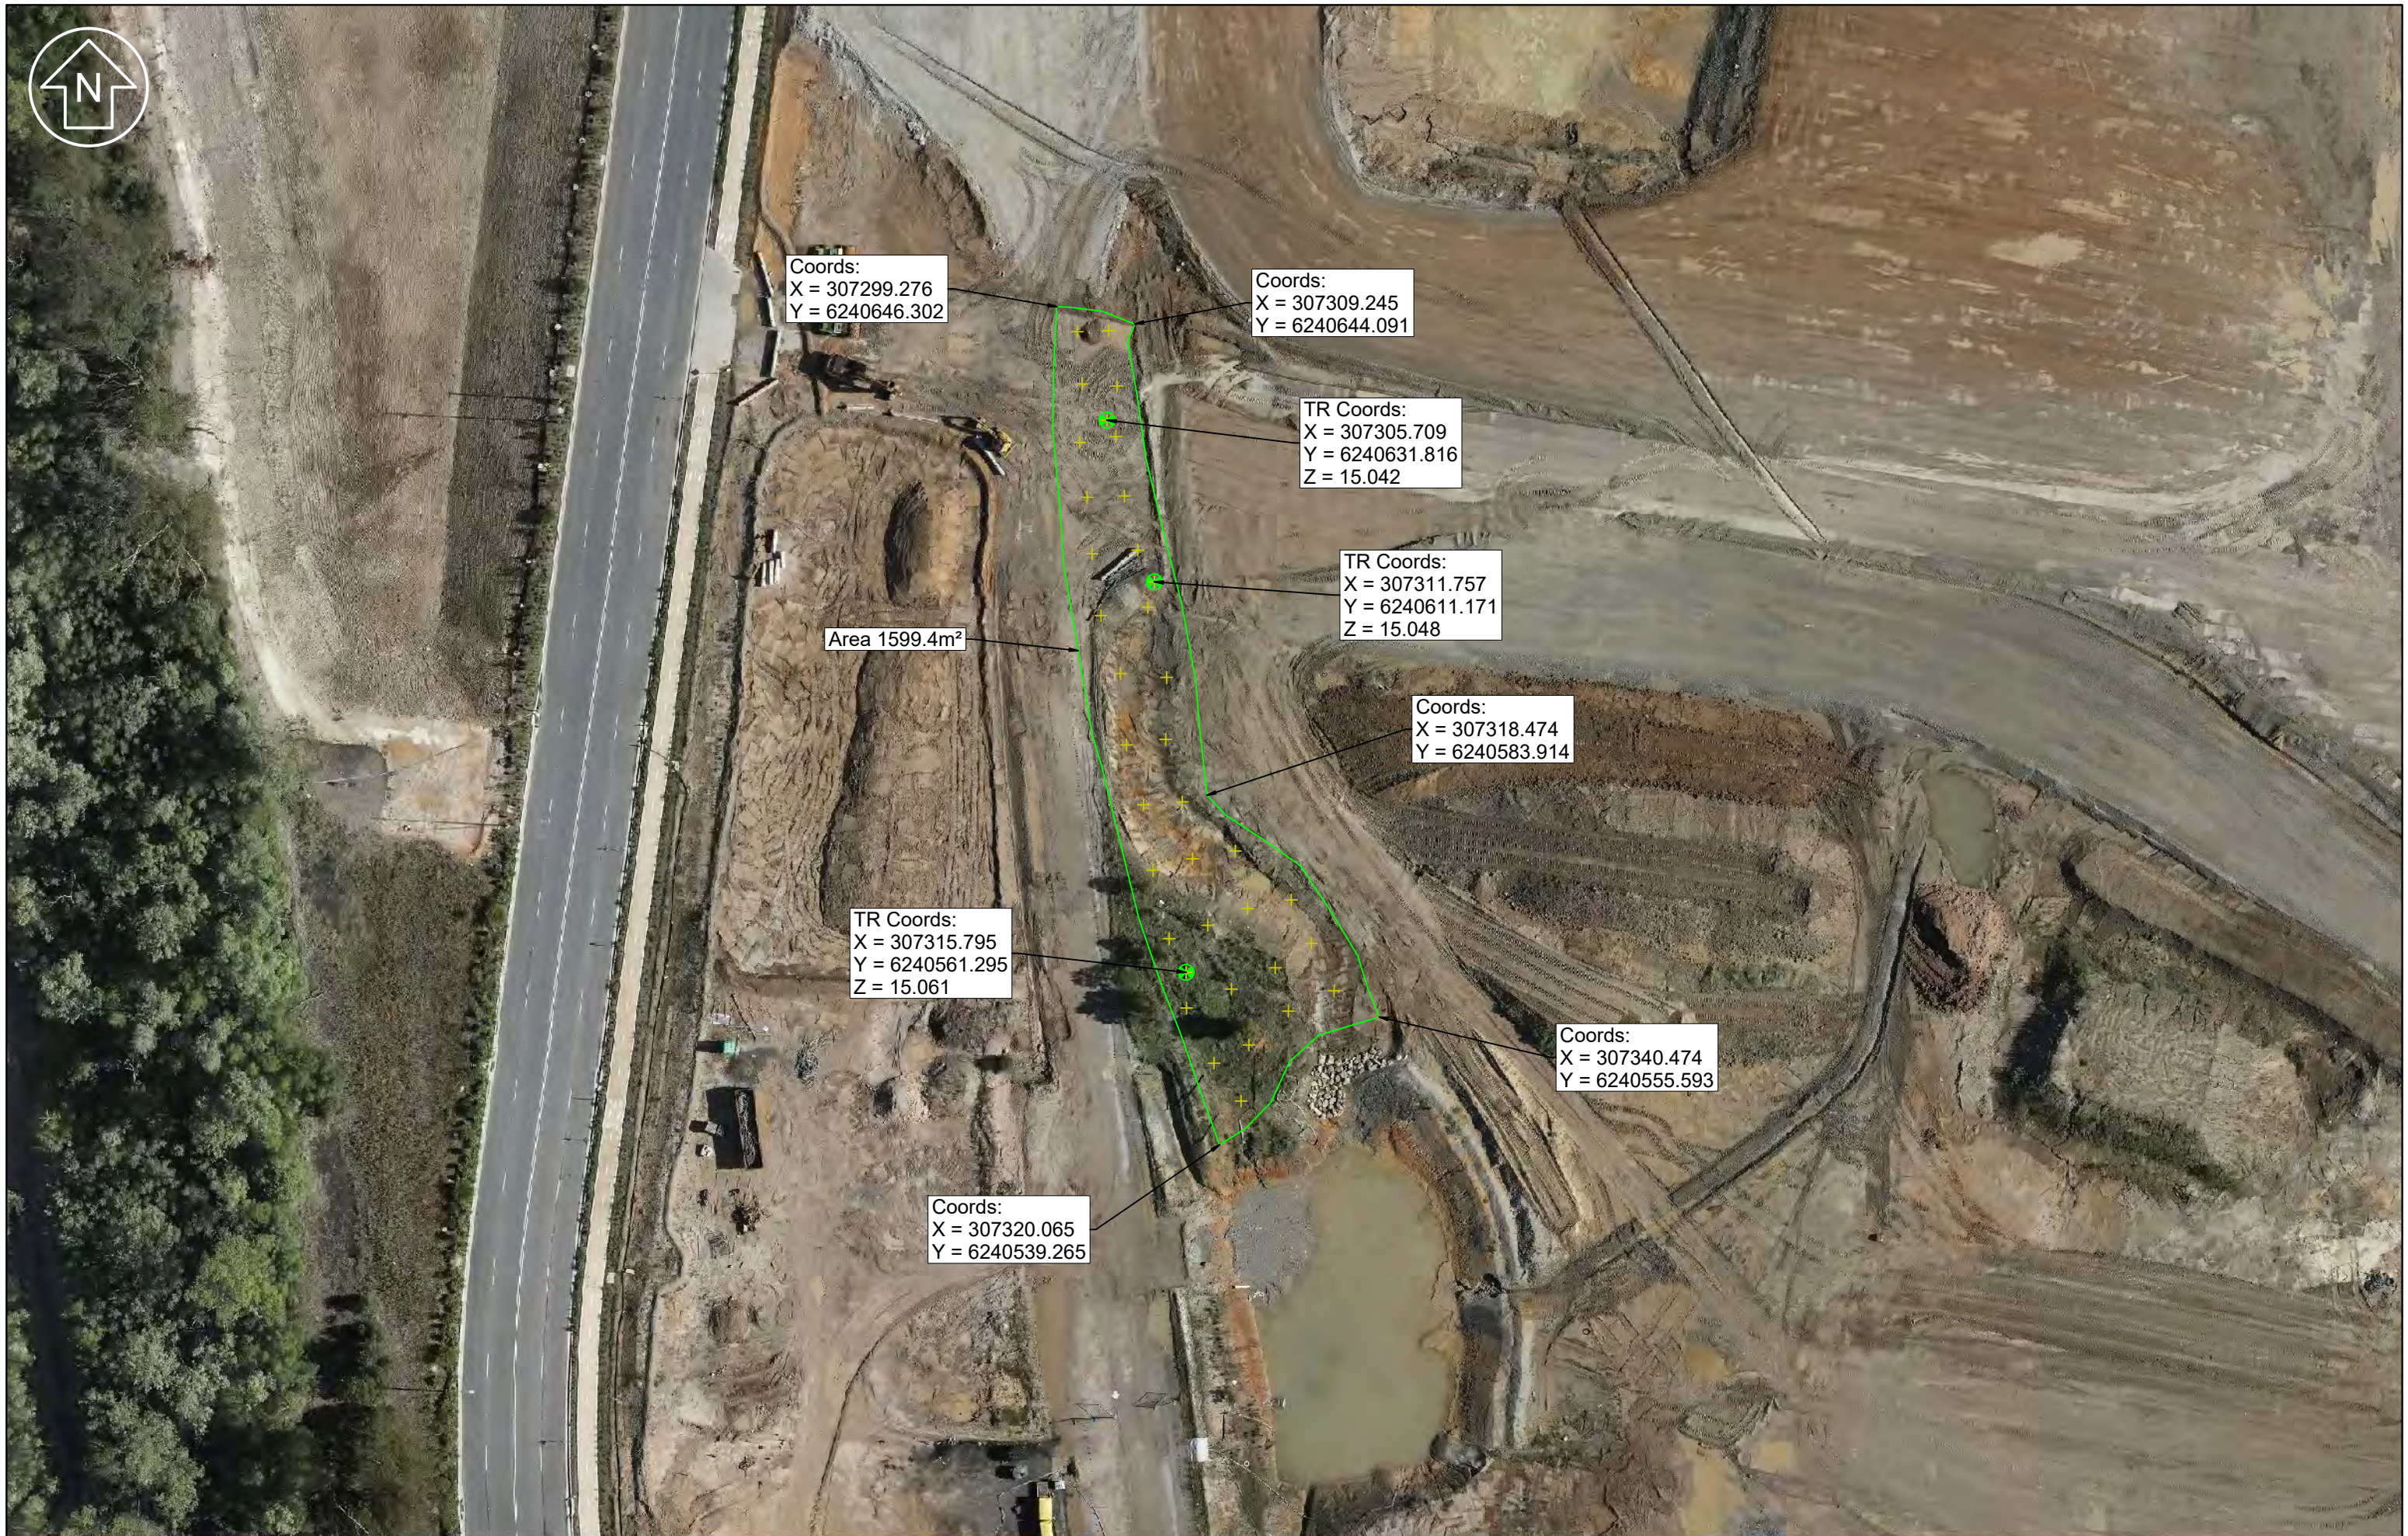
PRECINCT INFRASTRUCTURE WORKS WEST  
TITLE  
MRW - Project Bell  
Chatham Ave  
Moorebank  
THIRD ANGLE  
PROJECTION  
Sheet No. 1

EF-WH8-137 BACKFILL L5  
 WH8 / 7A SWALE  
 TR5694

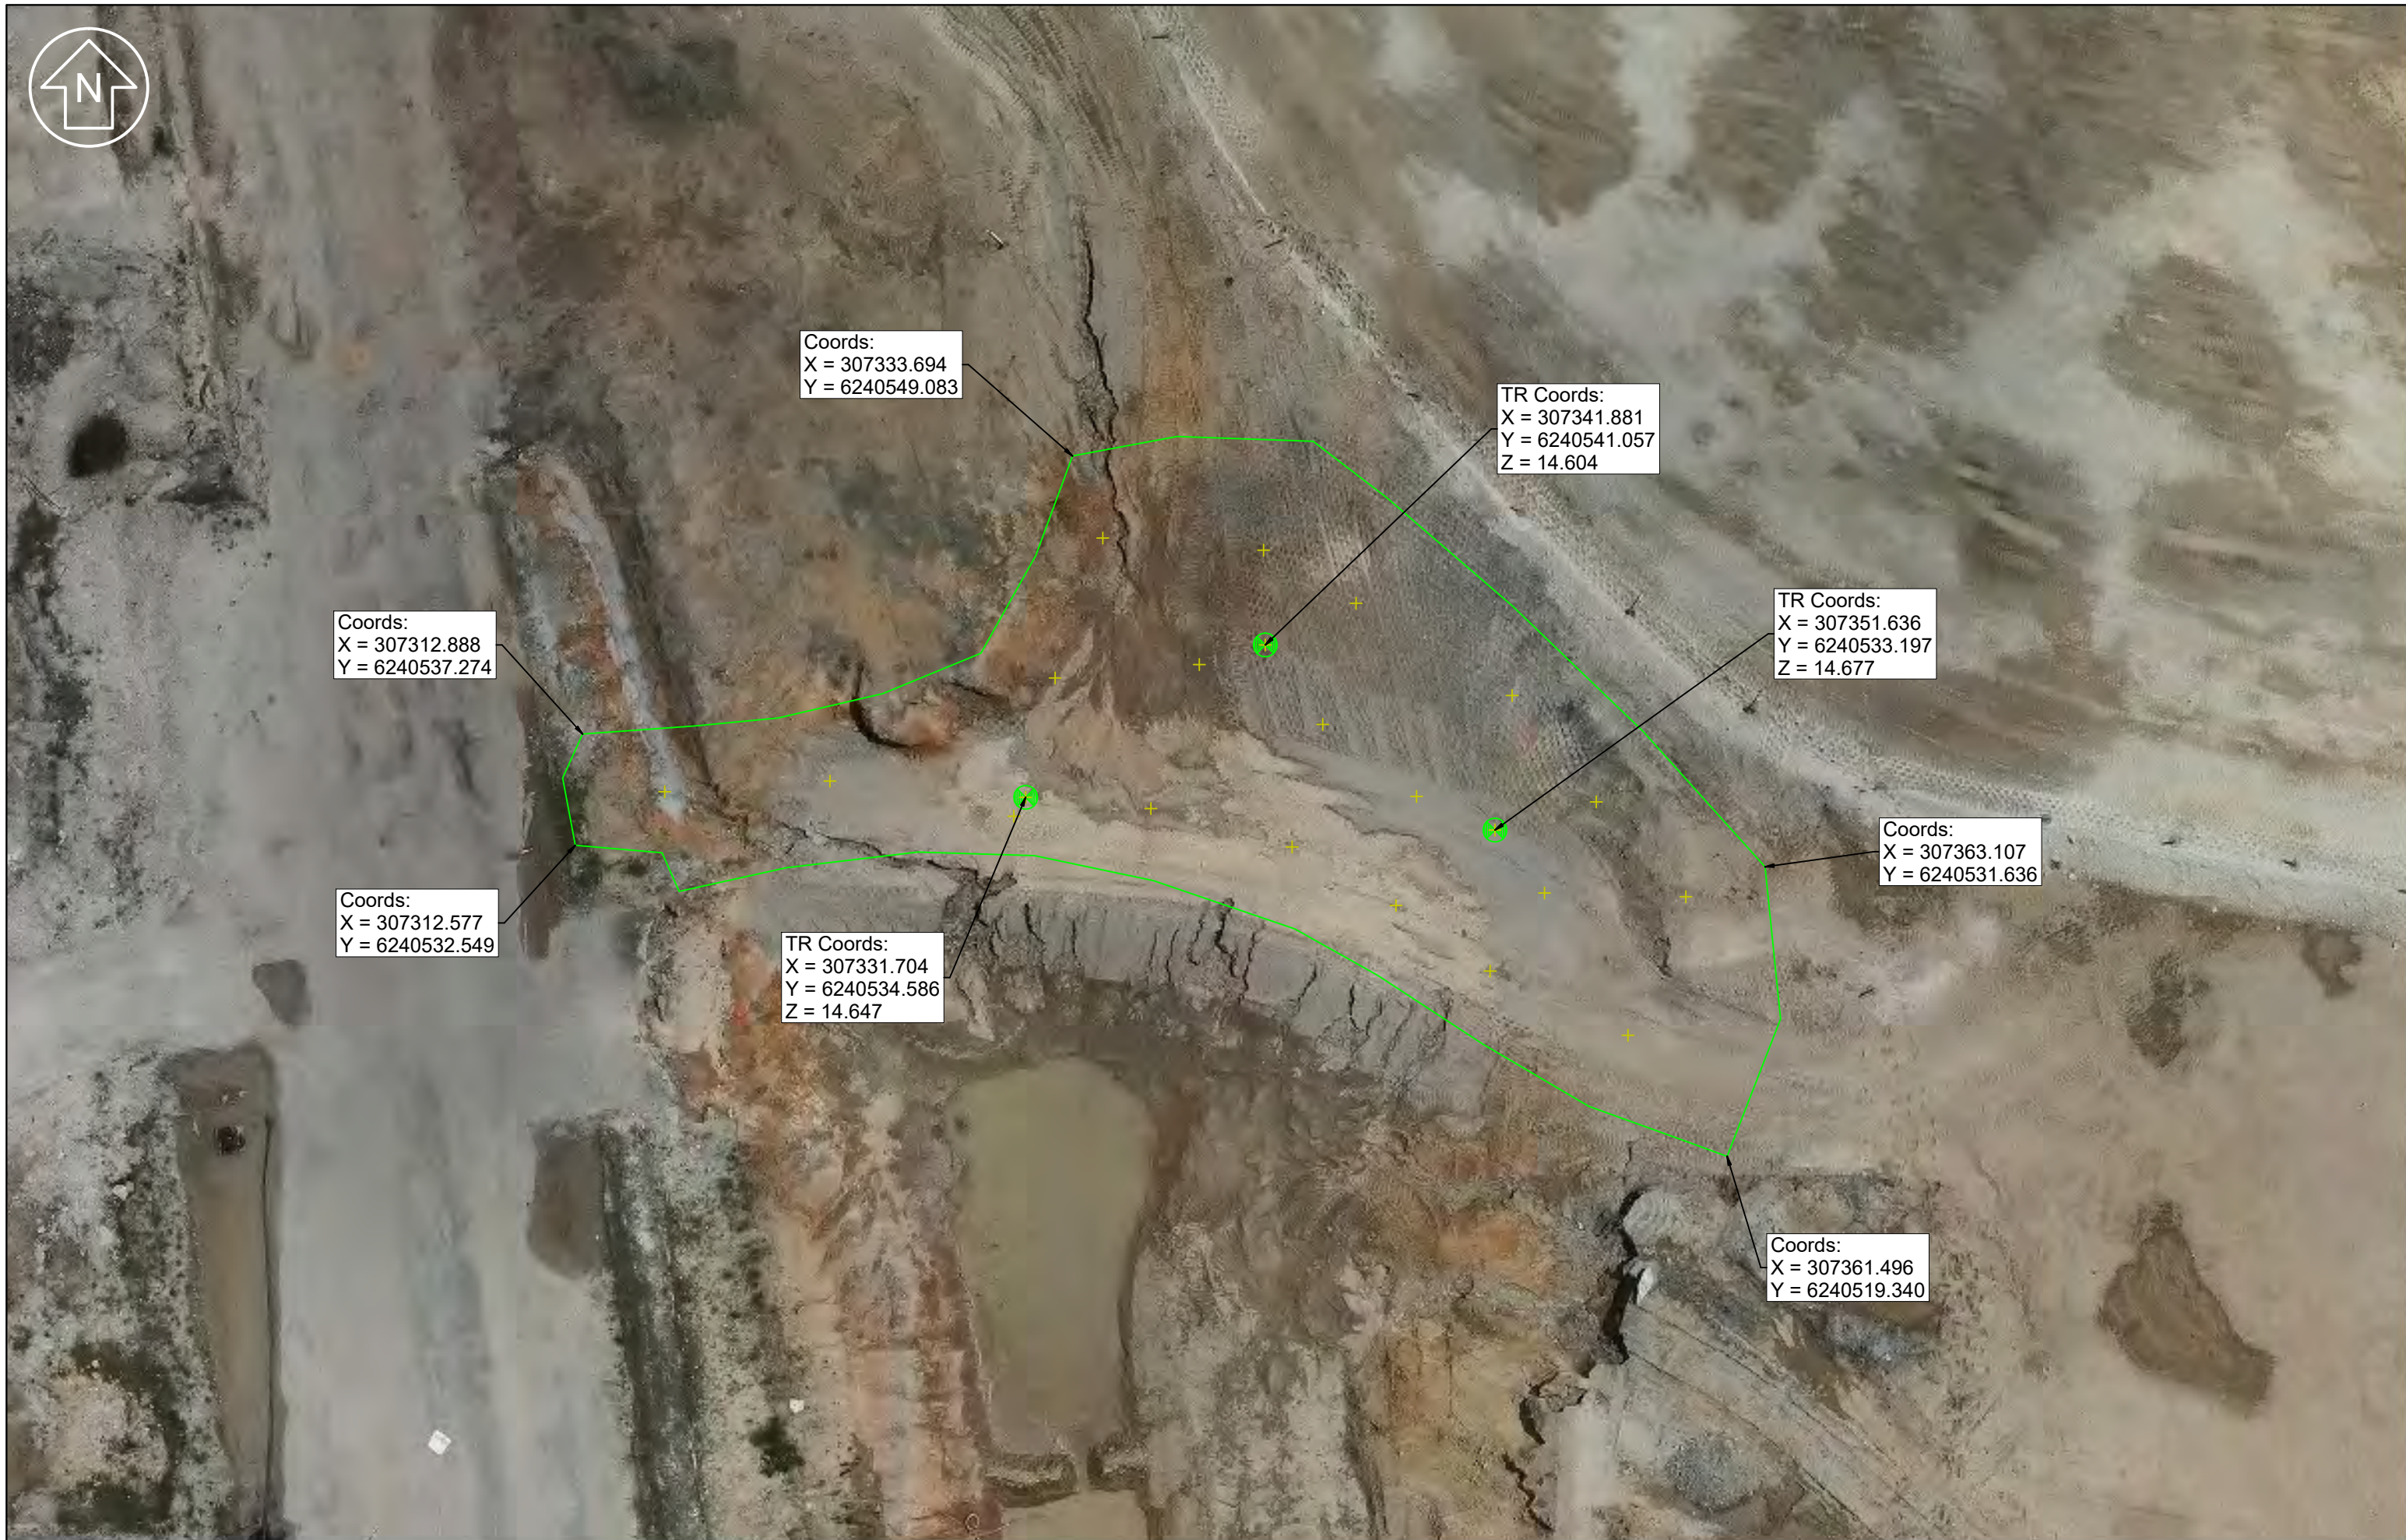
Sheet No. 1

Coords:  
X = 307333.694  
Y = 6240549.083

TR Coords:  
X = 307341.881  
Y = 6240541.057  
Z = 14.604

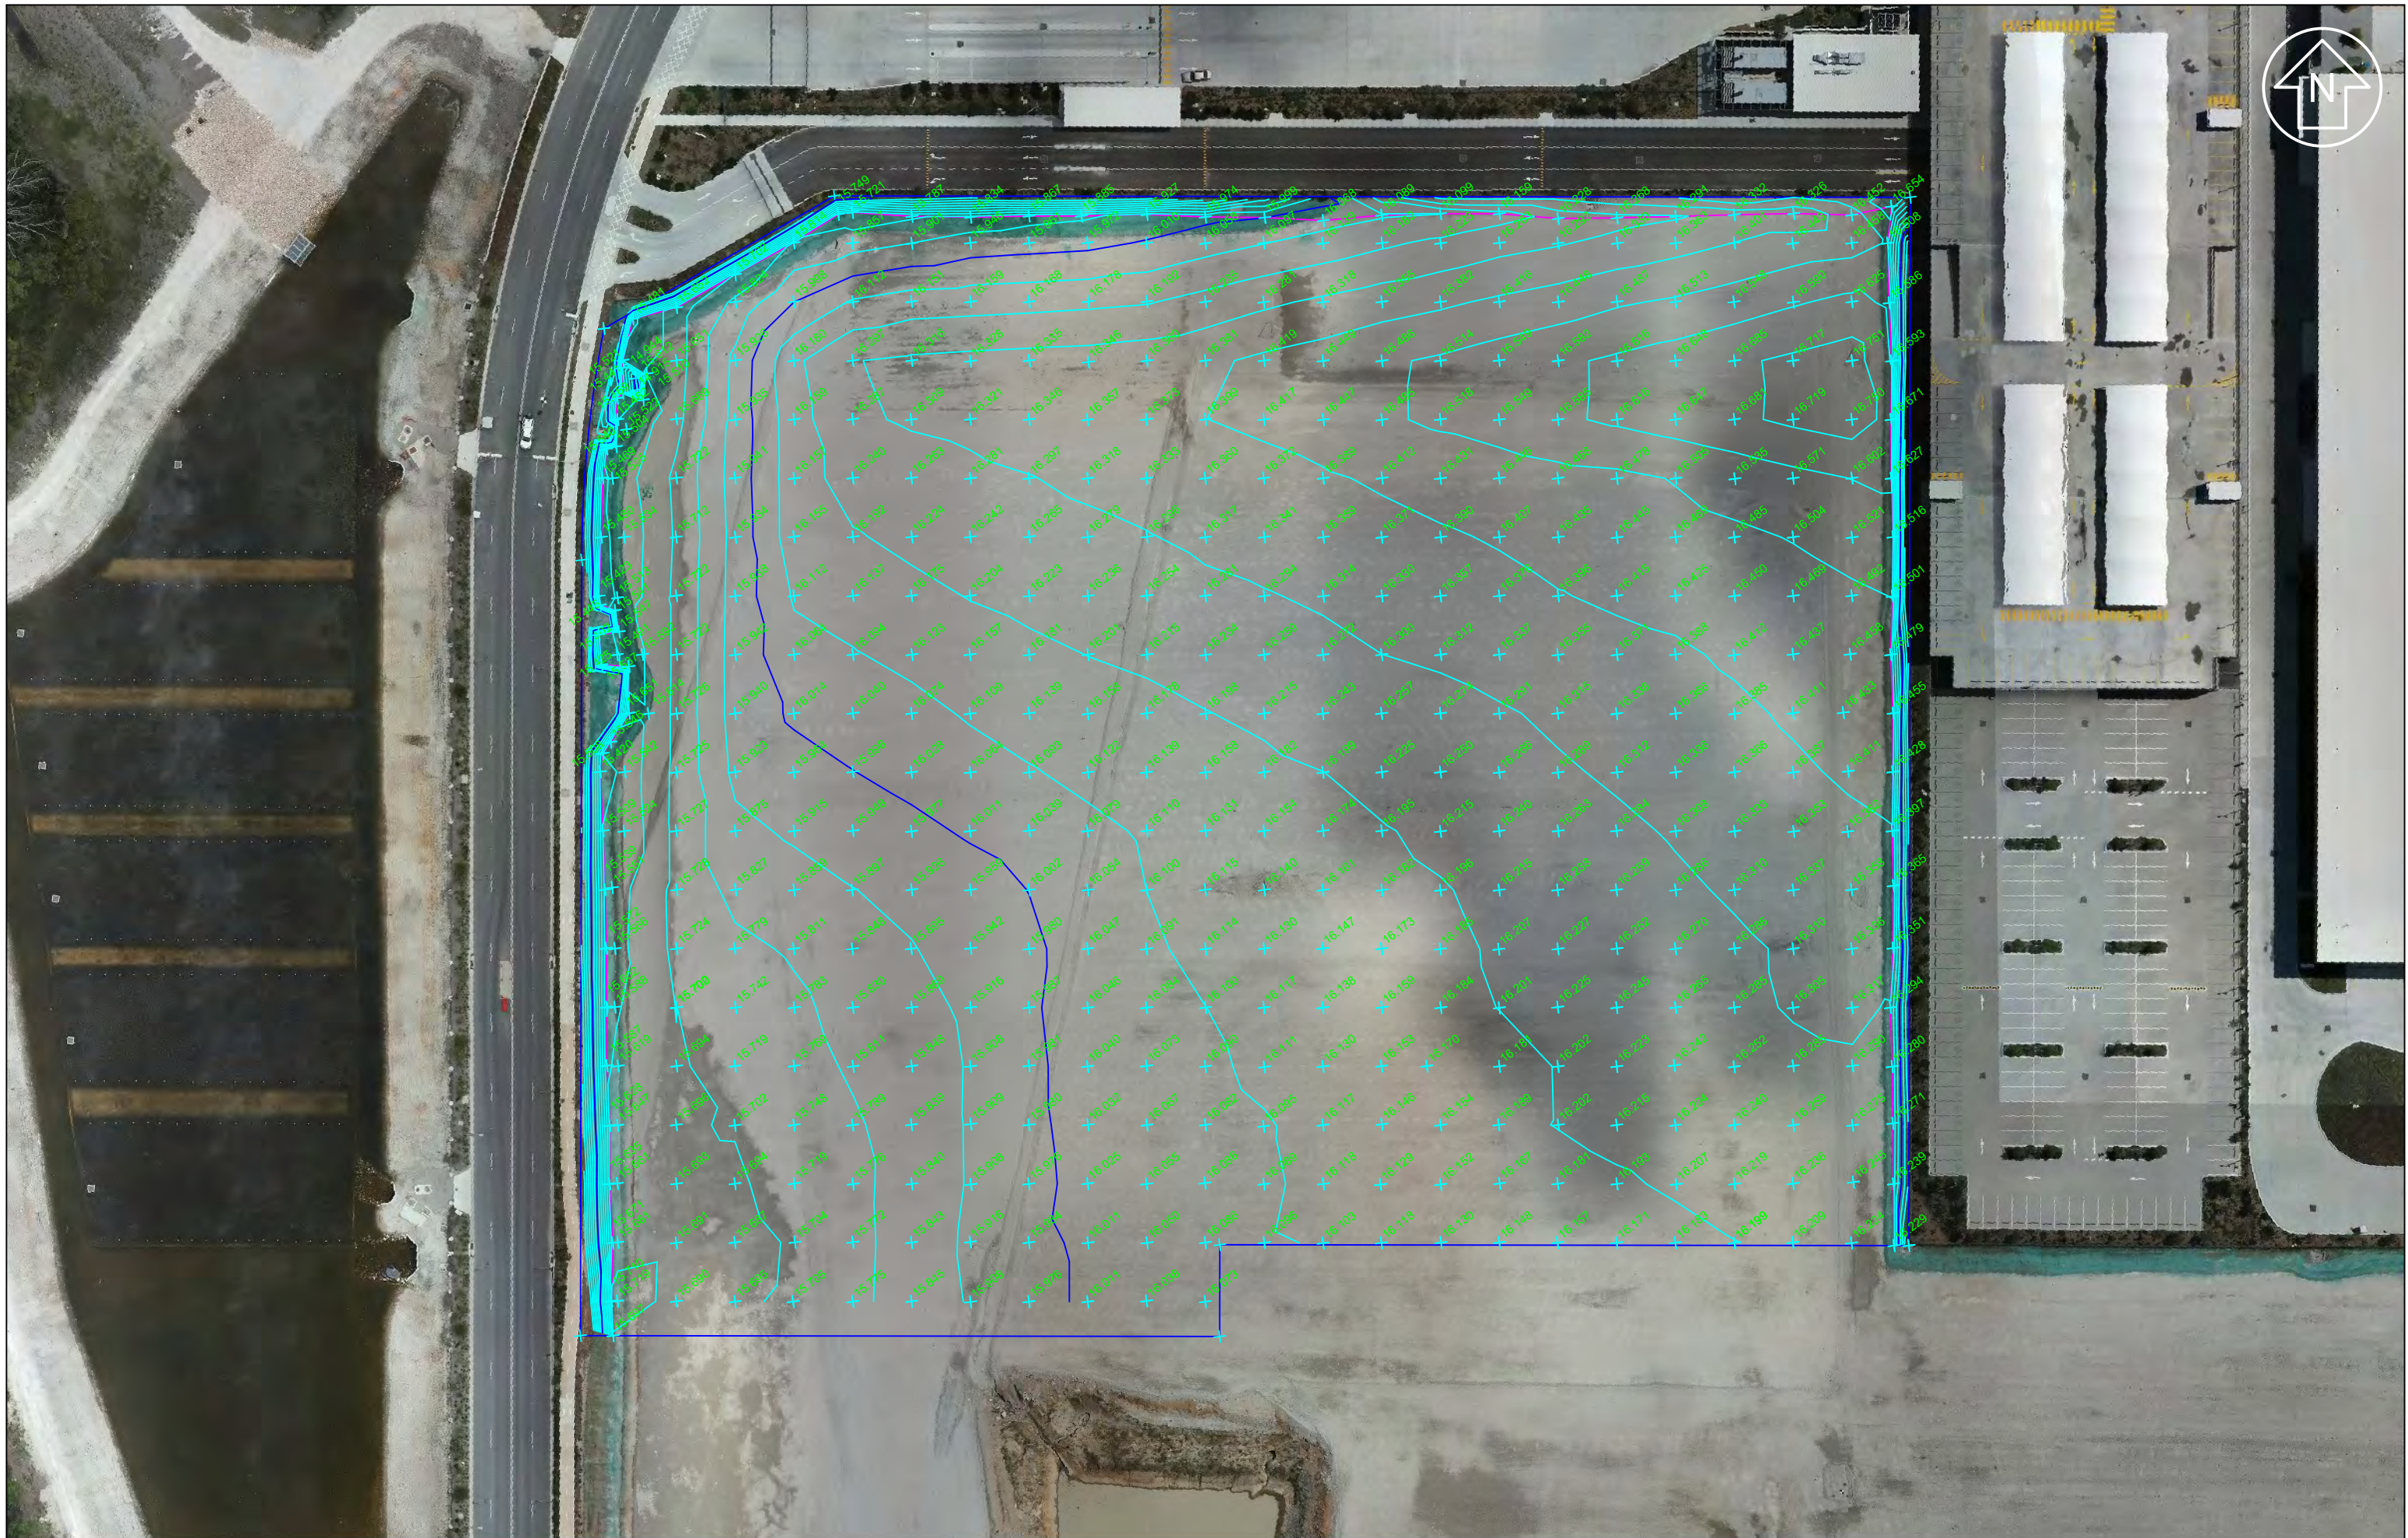
PRECINCT INFRASTRUCTURE WORKS WEST  
TITLE  
MRW - Project Bell  
Chatham Ave  
Moorebank  
THIRD ANGLE  
PROJECTION  
Sheet No. 1  
PROJECT NO. 190050

**PROJECT BELL WAE**  
**WH8 S1**  
**EASTERN LIFT CONCEPT ELEVATIONS**
