# Appendix C

## CONDITIONS OF CONSENT COMPLIANCE MATRIX

Report No

MIC2-QPMS-EN-APP-00022

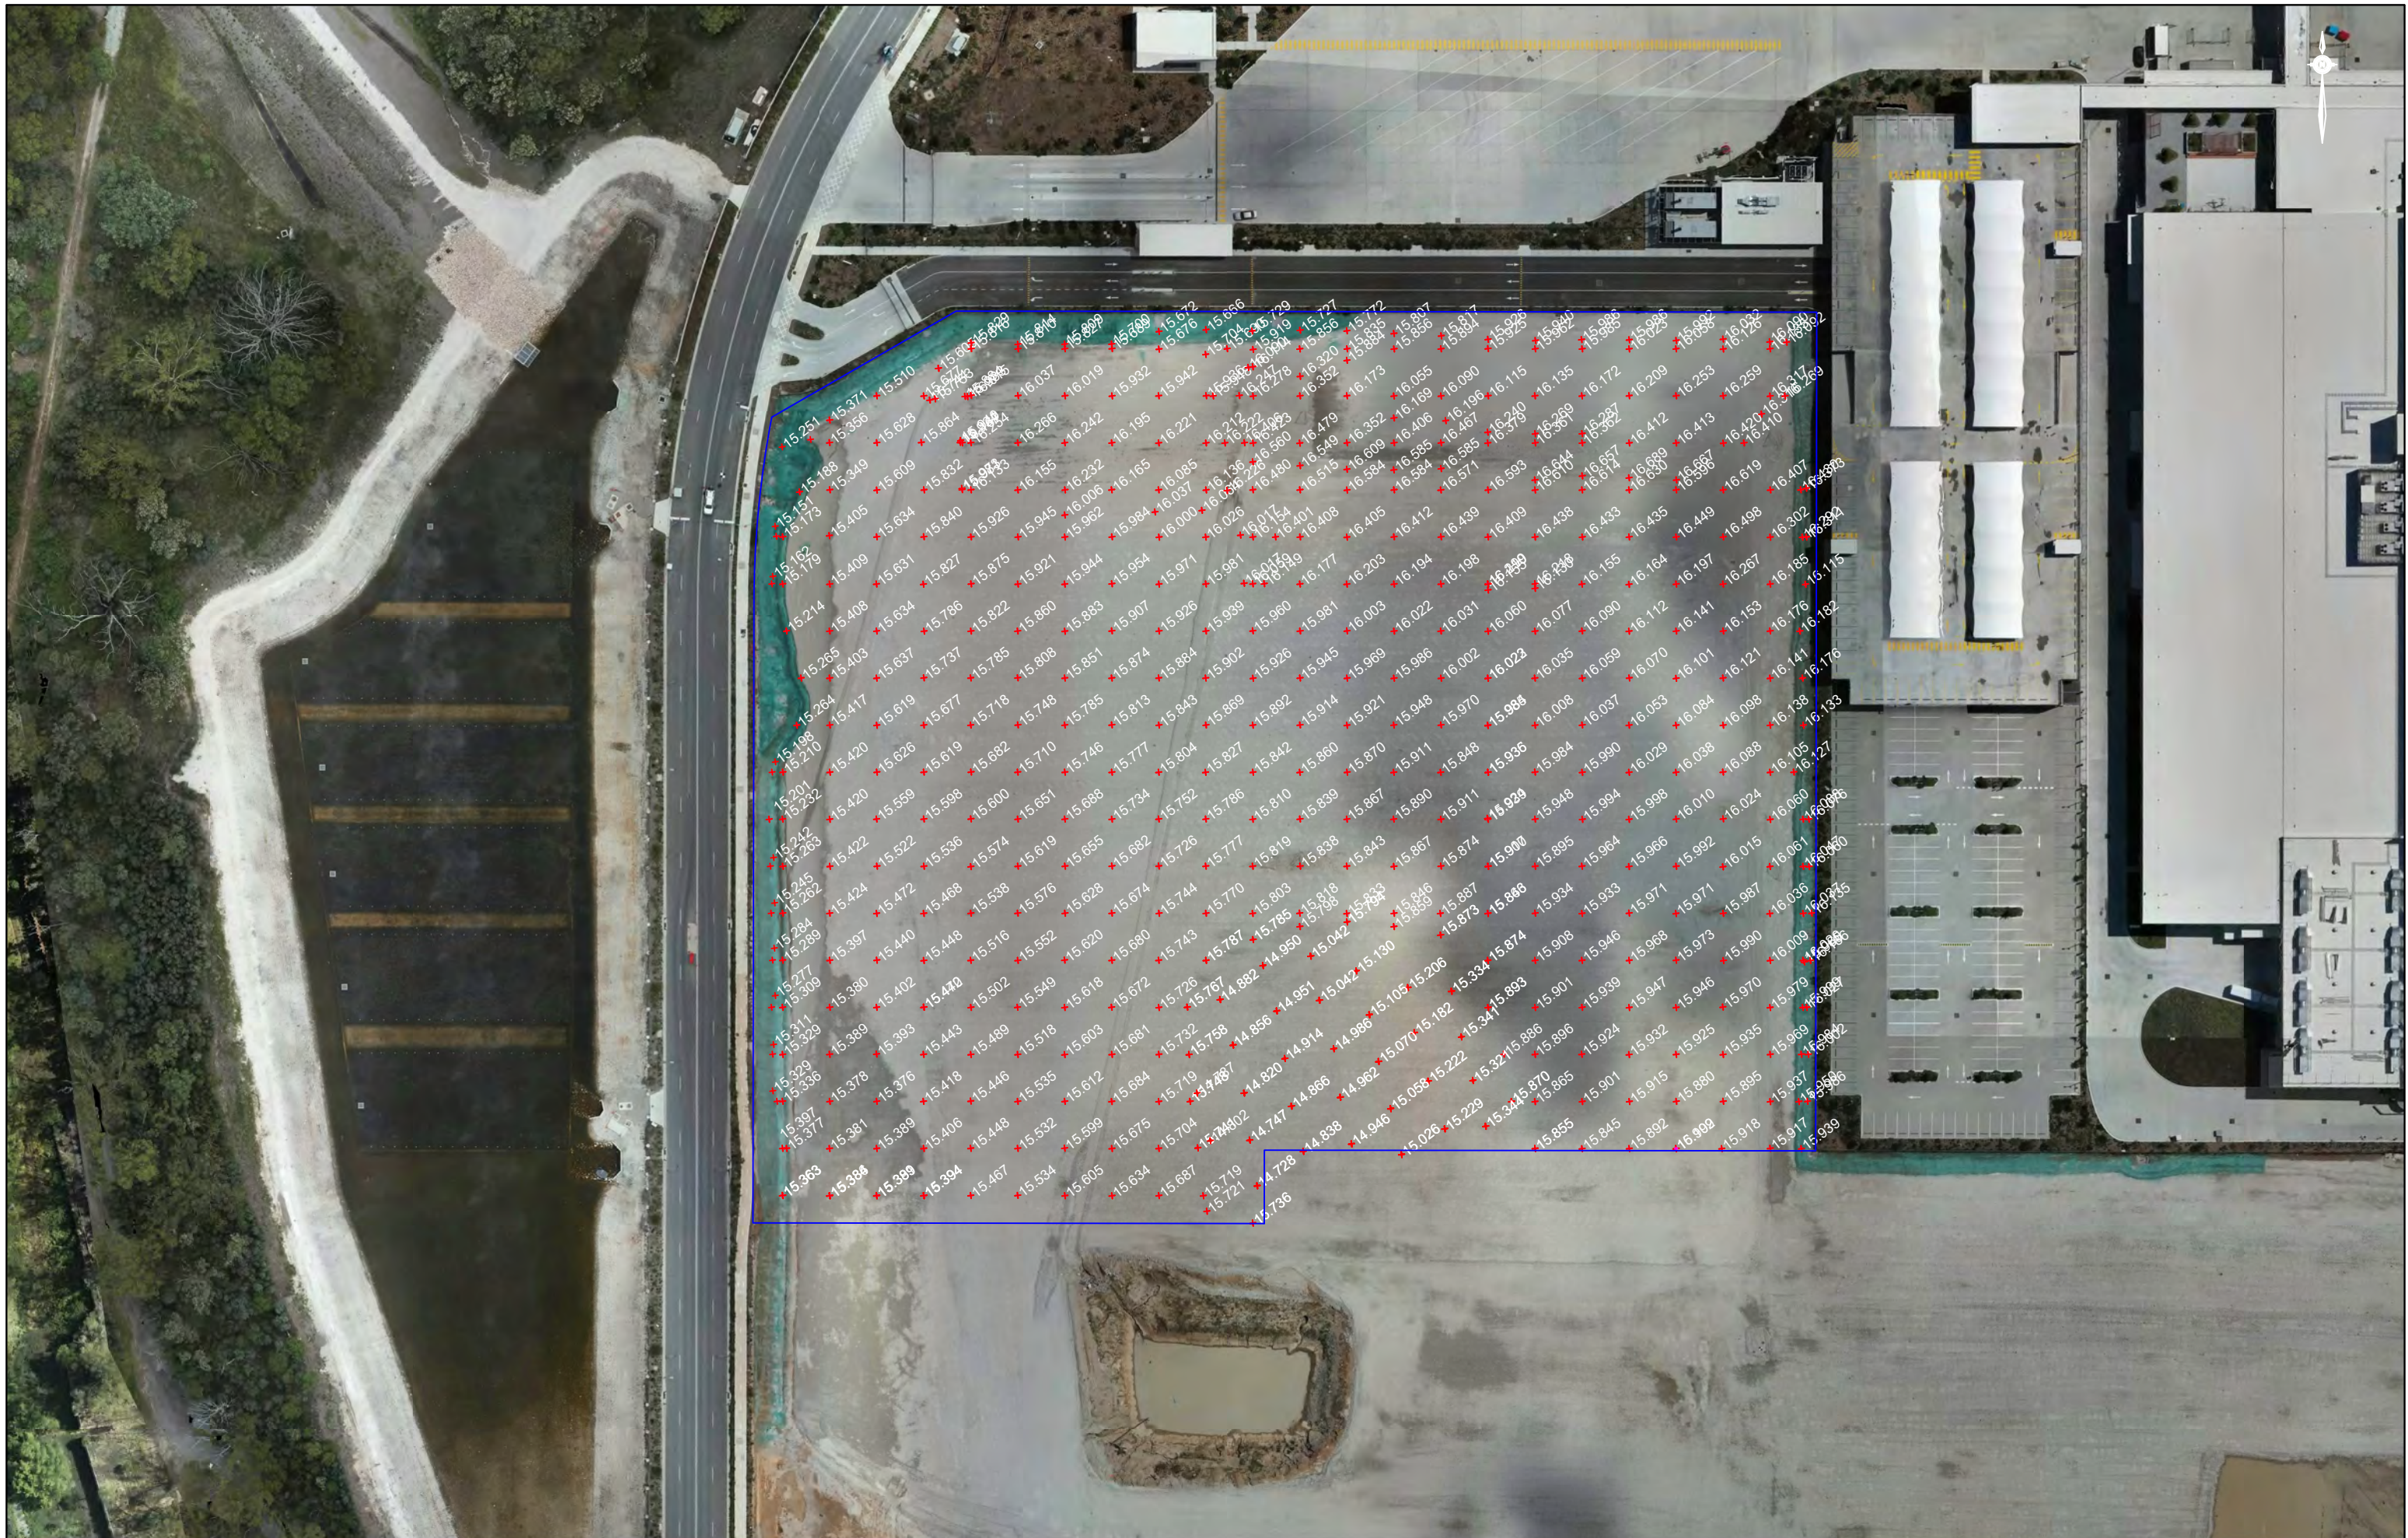
Sheet No. 1

**PROJECT BELL WAE**  
**WH 8 S1 300 BELOW / SANDSTONE**  
**EASTERN LIFT SUBGRADE**

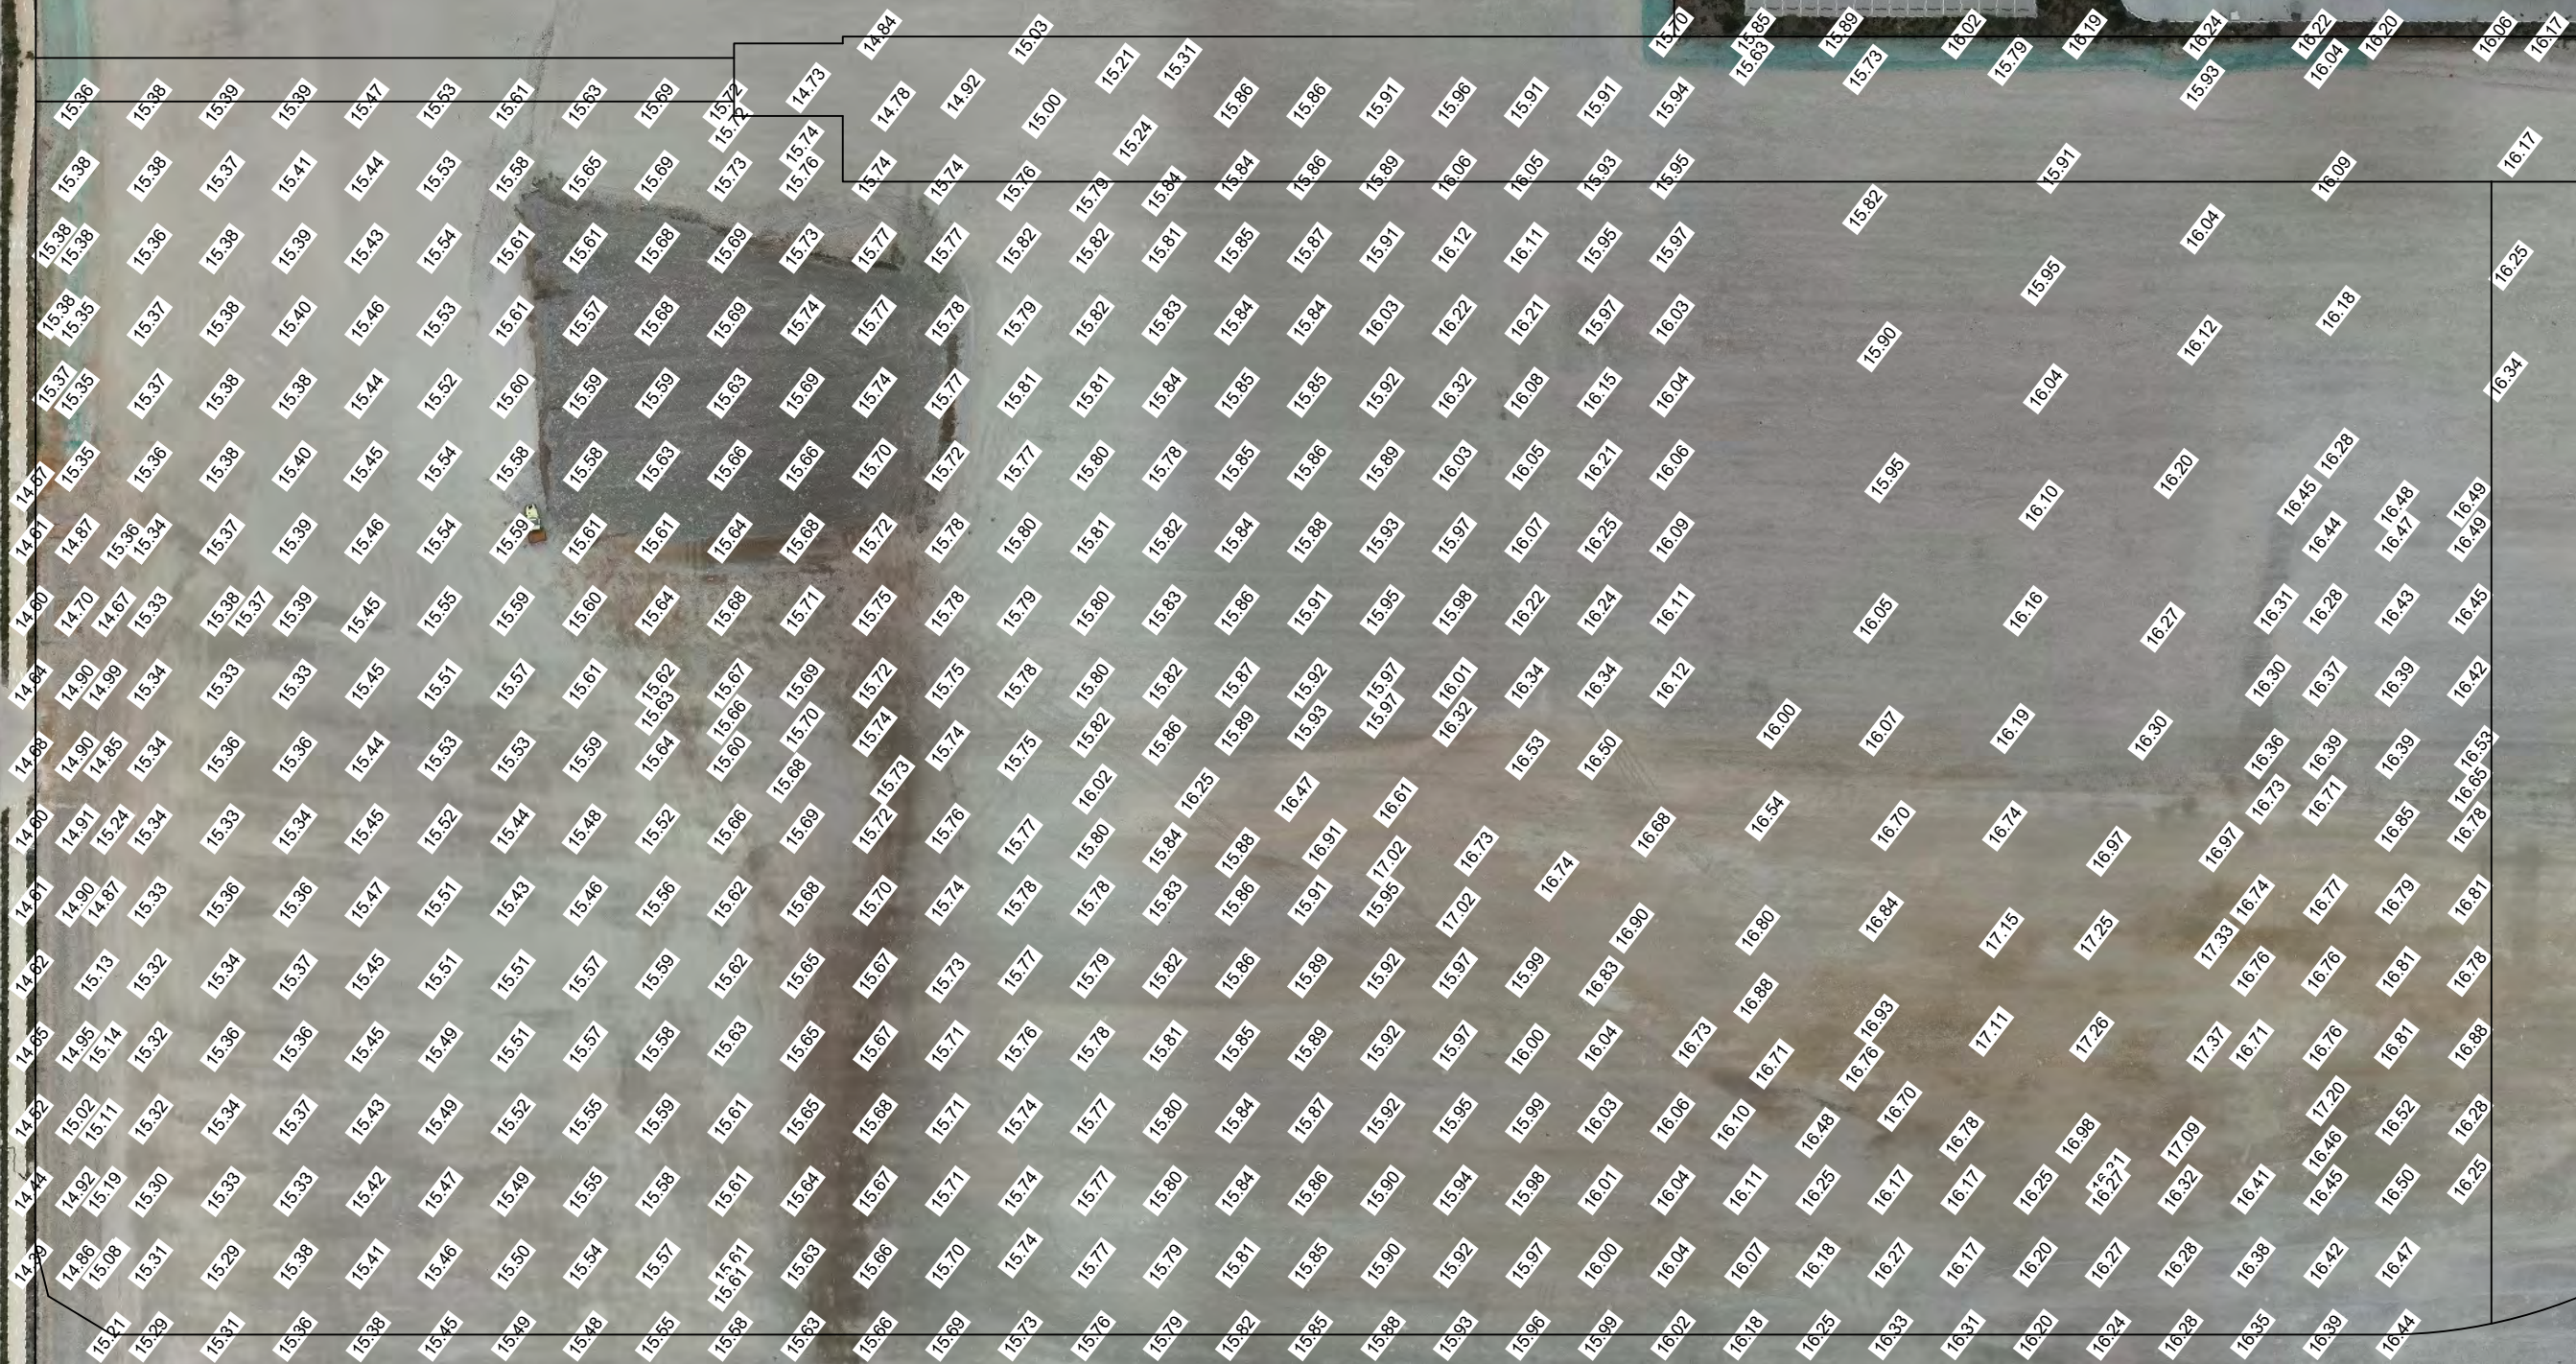
Sheet No. 1

WAREHOUSE S2  
300mm BELOW FSL  
RL REPORT
